## PHASE I ENVIRONMENTAL SITE ASSESSMENT

29508 ROADSIDE DRIVE  
AGOURA HILLS, CALIFORNIA 91301

Hillmann Project No: C3-6288

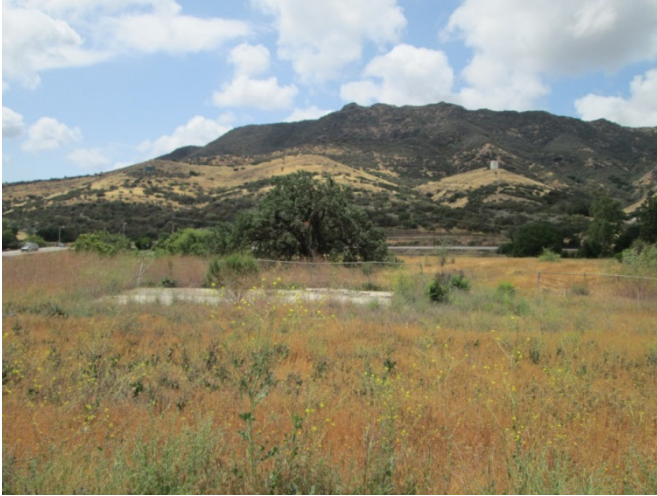
View of the Property facing south

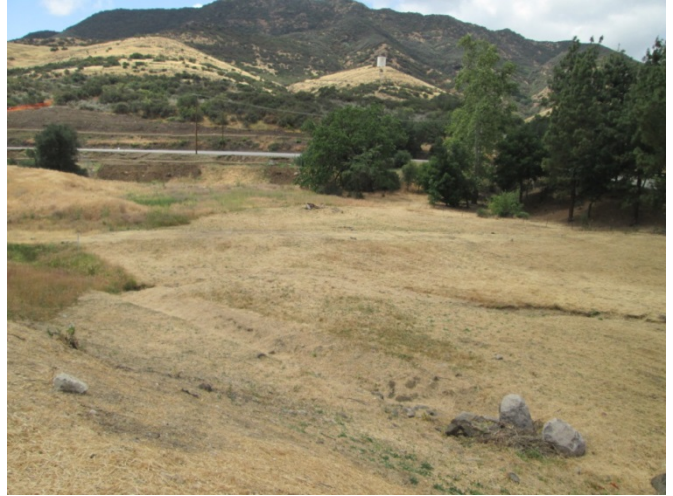
View of the southwest portion of the Property

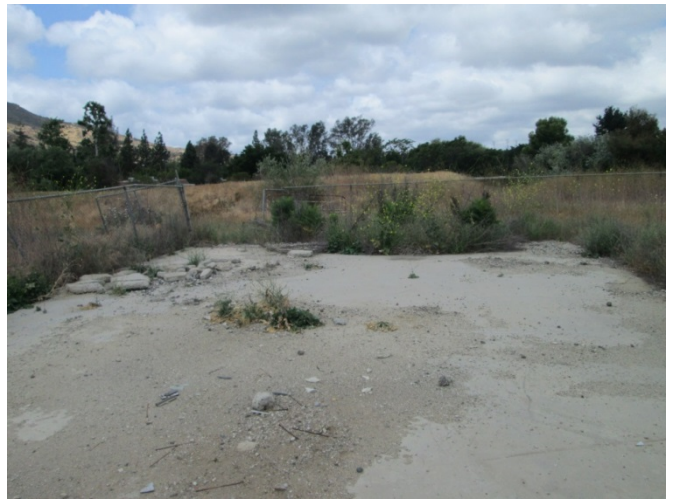
What appeared to be three drain lines associated with the former building's sanitary plumbing were observed on the concrete building foundation. No staining was observed in the vicinity of the drains. No other floor drains or sump pits were noted at the Property.

View of the building pad at the northwest portion of the Property

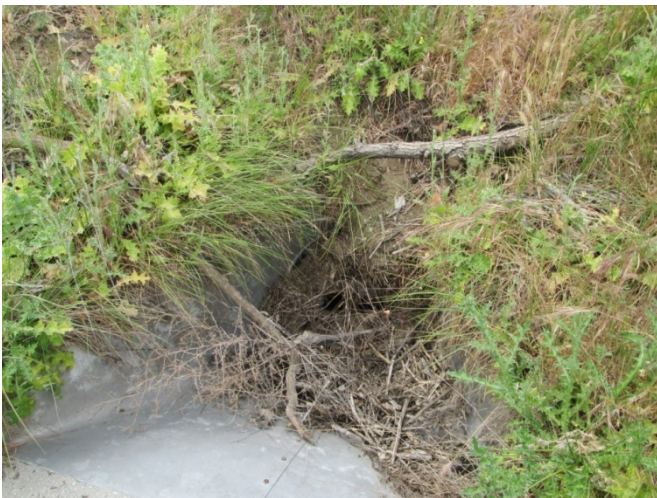
One large drain was observed in the central portion of the Property which appeared to be related to storm water management. Review of the assessor's parcel map for the Property shows that a drainage easement is present traversing the southern portion of the Property from east to west. No wastewater discharges were noted at the Property.

View of a large storm drain at the center of the Property

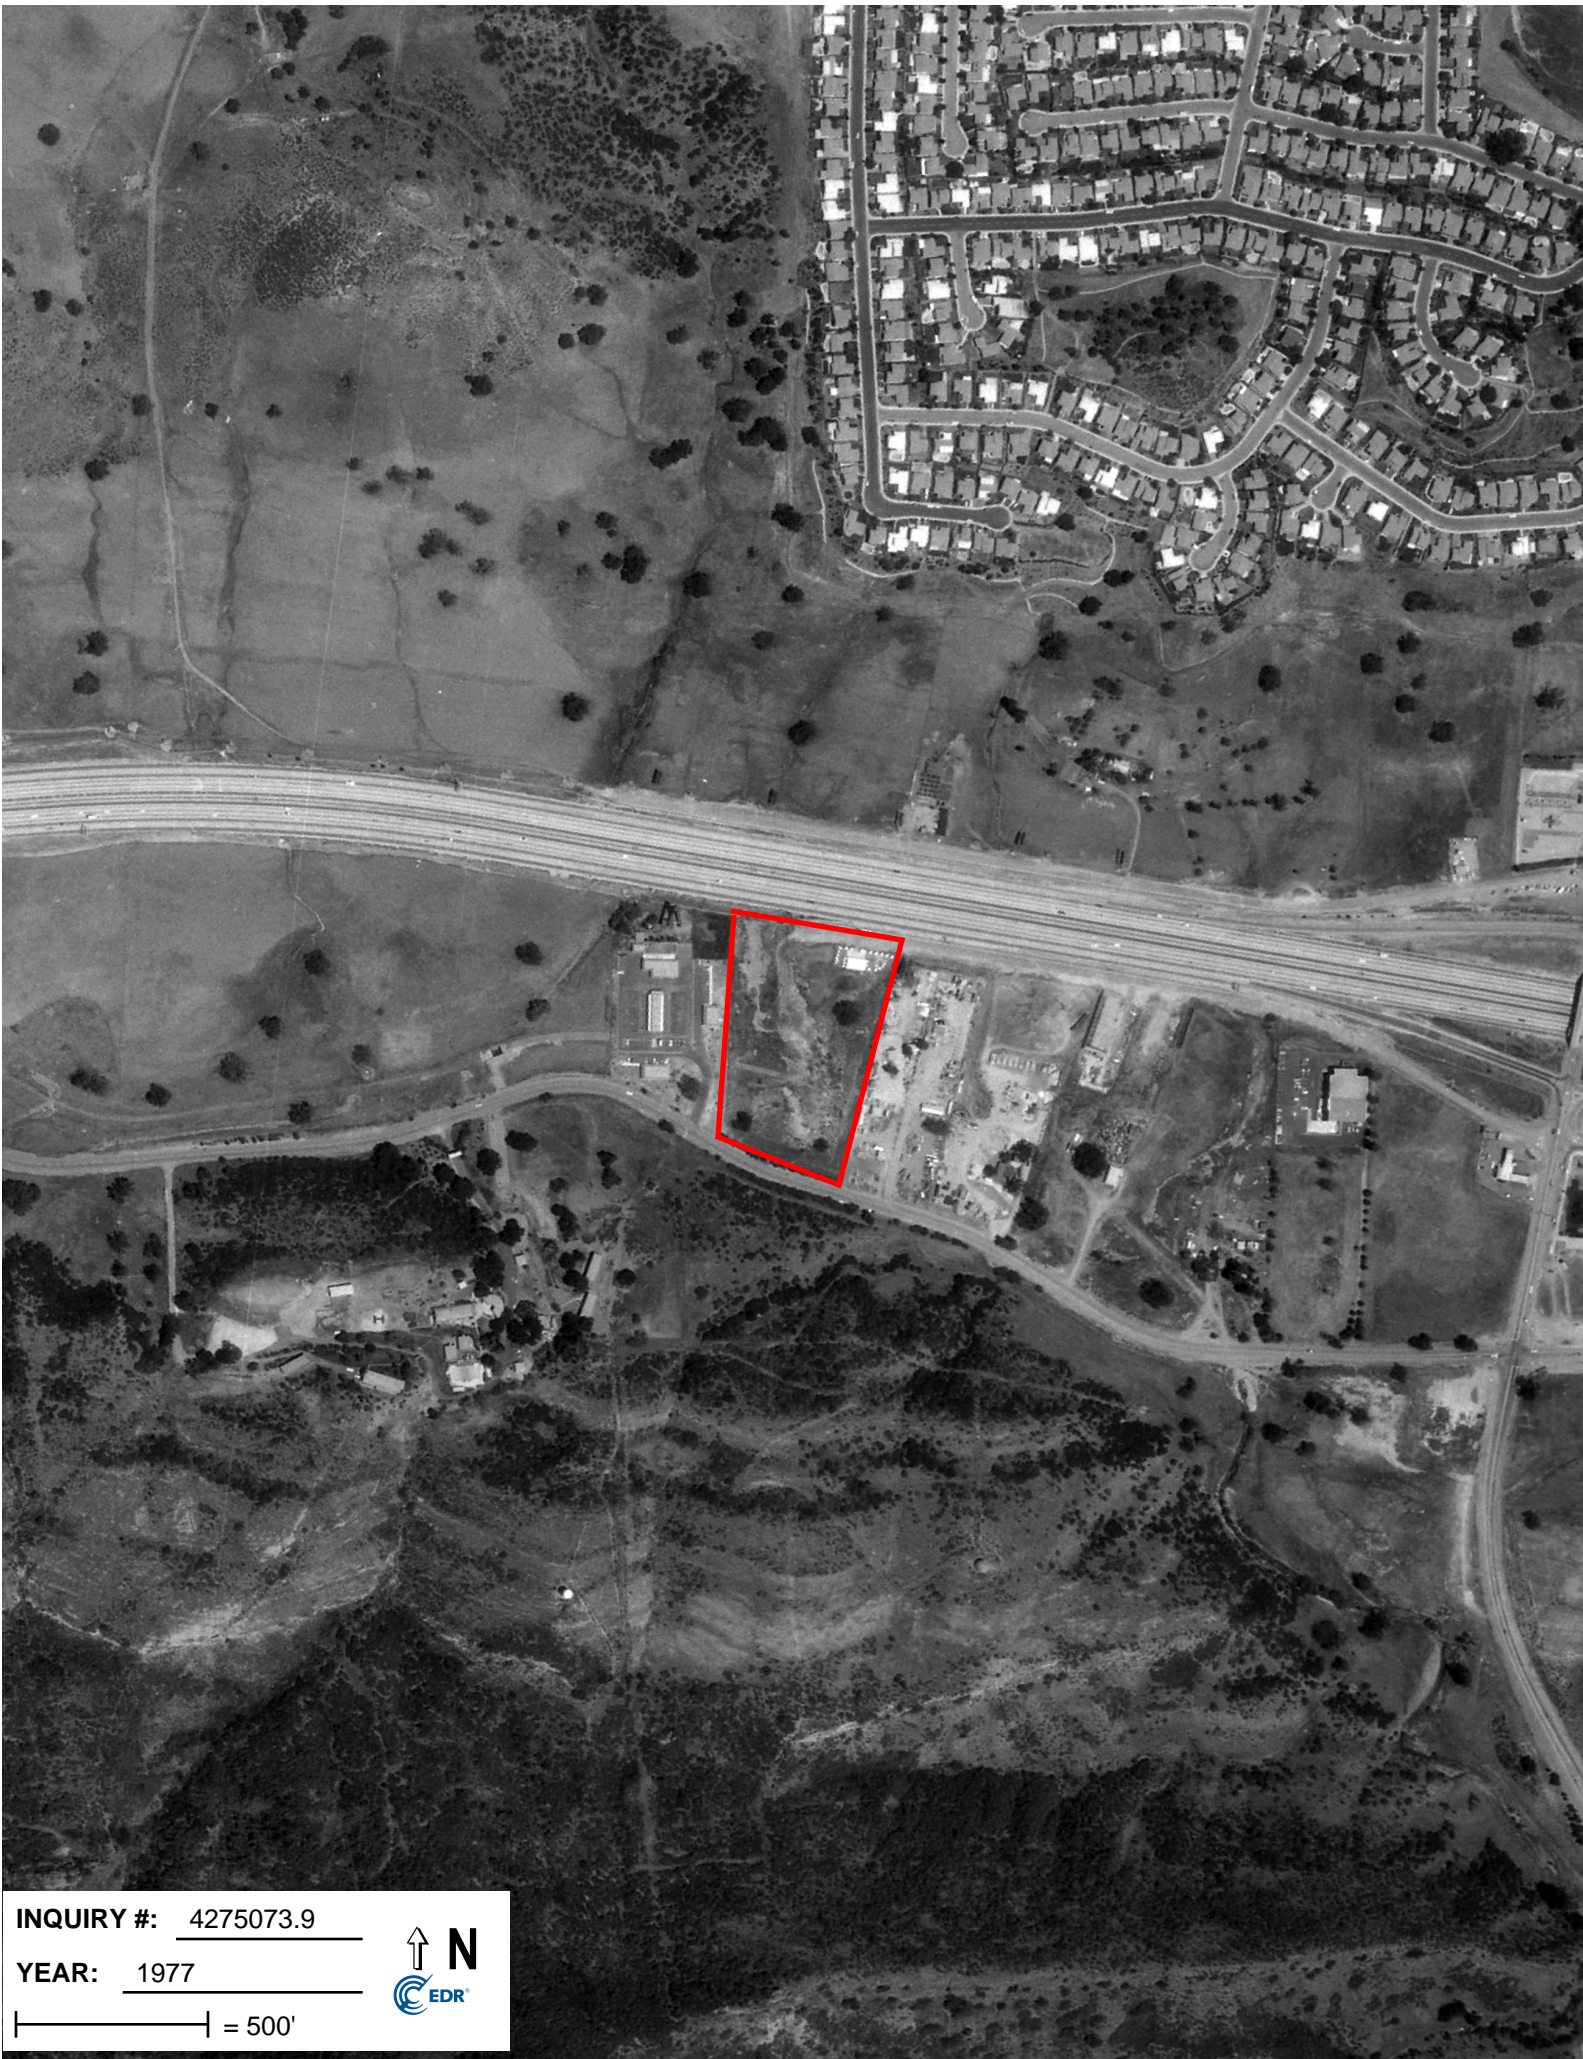
YEAR: 1977

A review of the aerial photographs of the Property indicates that the intermittent stream at the southern portion of the Property was filled between 1970 and 1977. Additional fill material also appears to be present at the Property in 1983. Further, fill material was deposited on the central portion of the Property from approximately 2004 through 2007 as shown in photographs provided via Google Earth. No evidence of on-site solid waste dumping was noted at the Property. Analysis of the soil stockpiles on the central and northwestern portions of the Property were conducted in 2007. Laboratory results indicated arsenic and lead were within background levels, TPH concentrations were below screening levels, and no pesticides were detected. However, because detectable TPH levels were identified, exporting the soils from the property may require profiling for acceptance at the receiving facility.

The unknown source and condition of the fill materials deposited in the 1970s at the southern portion of the Property are considered to be a REC in connection with the Property. Additionally, the fill material previously analyzed at the northwestern and central portions of the Property only went to a maximum depth of 10 feet bgs. The full depth of fill material at the Property has not been characterized and is considered a REC.

Based on the findings of the Phase I Environmental Site Assessment, Hillmann recommends a Phase II investigation to further assess the suspected fill materials identified by historic research for environmental contamination to the depth of native soils. In addition, soil vapor and groundwater samples should be taken at the eastern Property boundary in order to determine if any adjoining contamination which was left in place has adversely impacted the subsurface of the Property.
