**City Oak Tree
Consultant's Memorandum
and Oak Tree Report**

OAKMONT SENIOR LIVING

OAK TREE REPORT

March 28, 2016

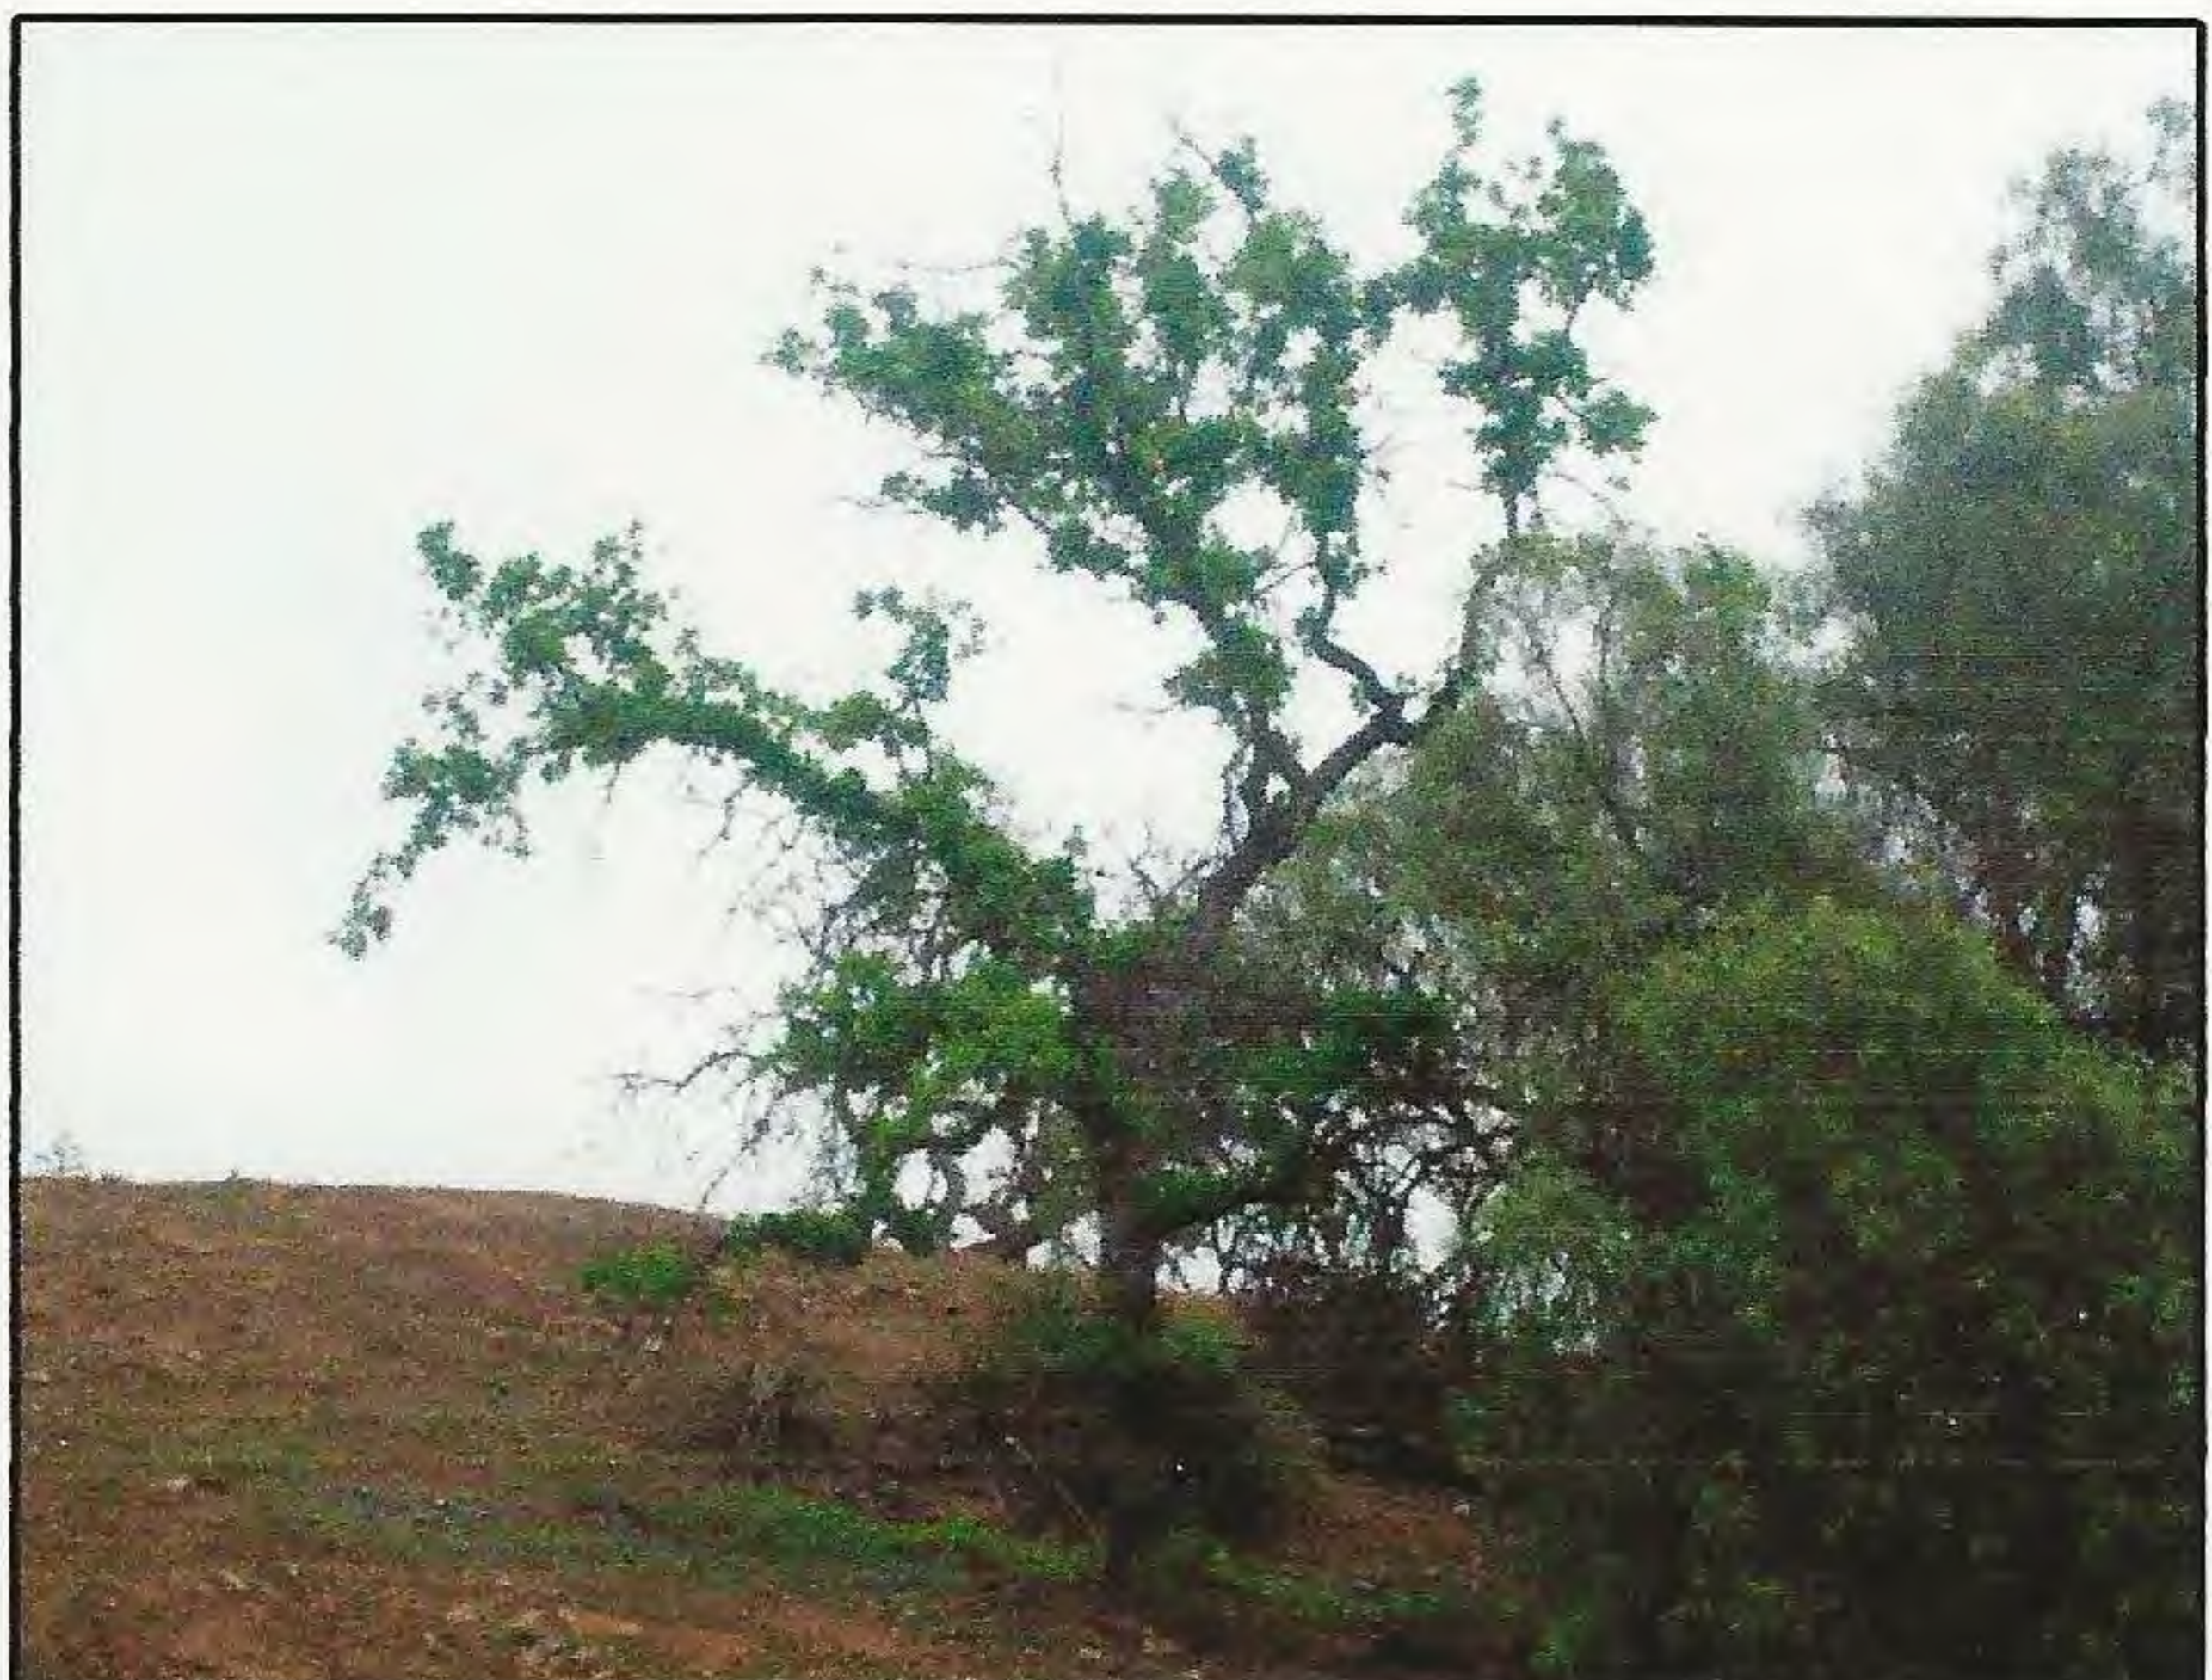
TREE NO.	TREE NAME	TRUNK DIA(S) IN INCHES	N	NE	E	SE	S	SW	W	NW	HT+ IN FEET	H'LTH	AESTH	NOTES & REMARKS
OSL-10	QUERCUS AGRIFOLIA	12	19/2	18/6	16/20	12/20	9/0	10/0	16/5	17/1	32	C-	C-	LOCATED ON STEEP SLOPE, BARBED WIRE AROUND TRUNK, BRANCHES ON GROUND, BROKEN BRANCH SCARS, DEADWOOD, EPICORMIC GROWTH, INTERTWINED IN PEPPER TREE, STRESSED, THINNING CANOPY
OSL-11	QUERCUS LOBATA	29	25/15	25/8	34/8	35/8	22/11	32/2	15/12	18/17	36	C-	C-	LOCATED ON RIDGE, BRANCH CAVITY, BRANCHES ON GROUND, DEADWOOD, EPICORMIC GROWTH, INTERTWINED IN OSL-12 & PEPPER TREE, LEANS TO EAST, STRESSED, THINNING CANOPY, WATER TRAP
OSL-12	QUERCUS LOBATA	21 5/8	30/1	23/2	7/15	5/11	21/2	26/3	25/1	30/14	34	C-	C-	LOCATED ON RIDGE, BRANCH CAVITY, BROKEN BRANCH SCARS, DEADWOOD, EPICORMIC GROWTH, INTERTWINED IN OSL-11, THINNING CANOPY
OSL-13	QUERCUS AGRIFOLIA	6, 3, 2,	11/1	13/1	12/1	15/0	14/0	12/3	9/1	10/1	30	B	B	BRANCHES ON GROUND, FILL ON TRUNK, LOW BRANCHING, REGROWN STUMP

It is our recommendation that pruning be performed to allow for clearance from the proposed retaining wall construction, as no construction activity is proposed within the Protected Zone of any other Oak Tree(s). Only Oak Trees OSL-10, OSL-54 and OSL-55 appear to be affected by the proposed retaining wall or any other construction activity.

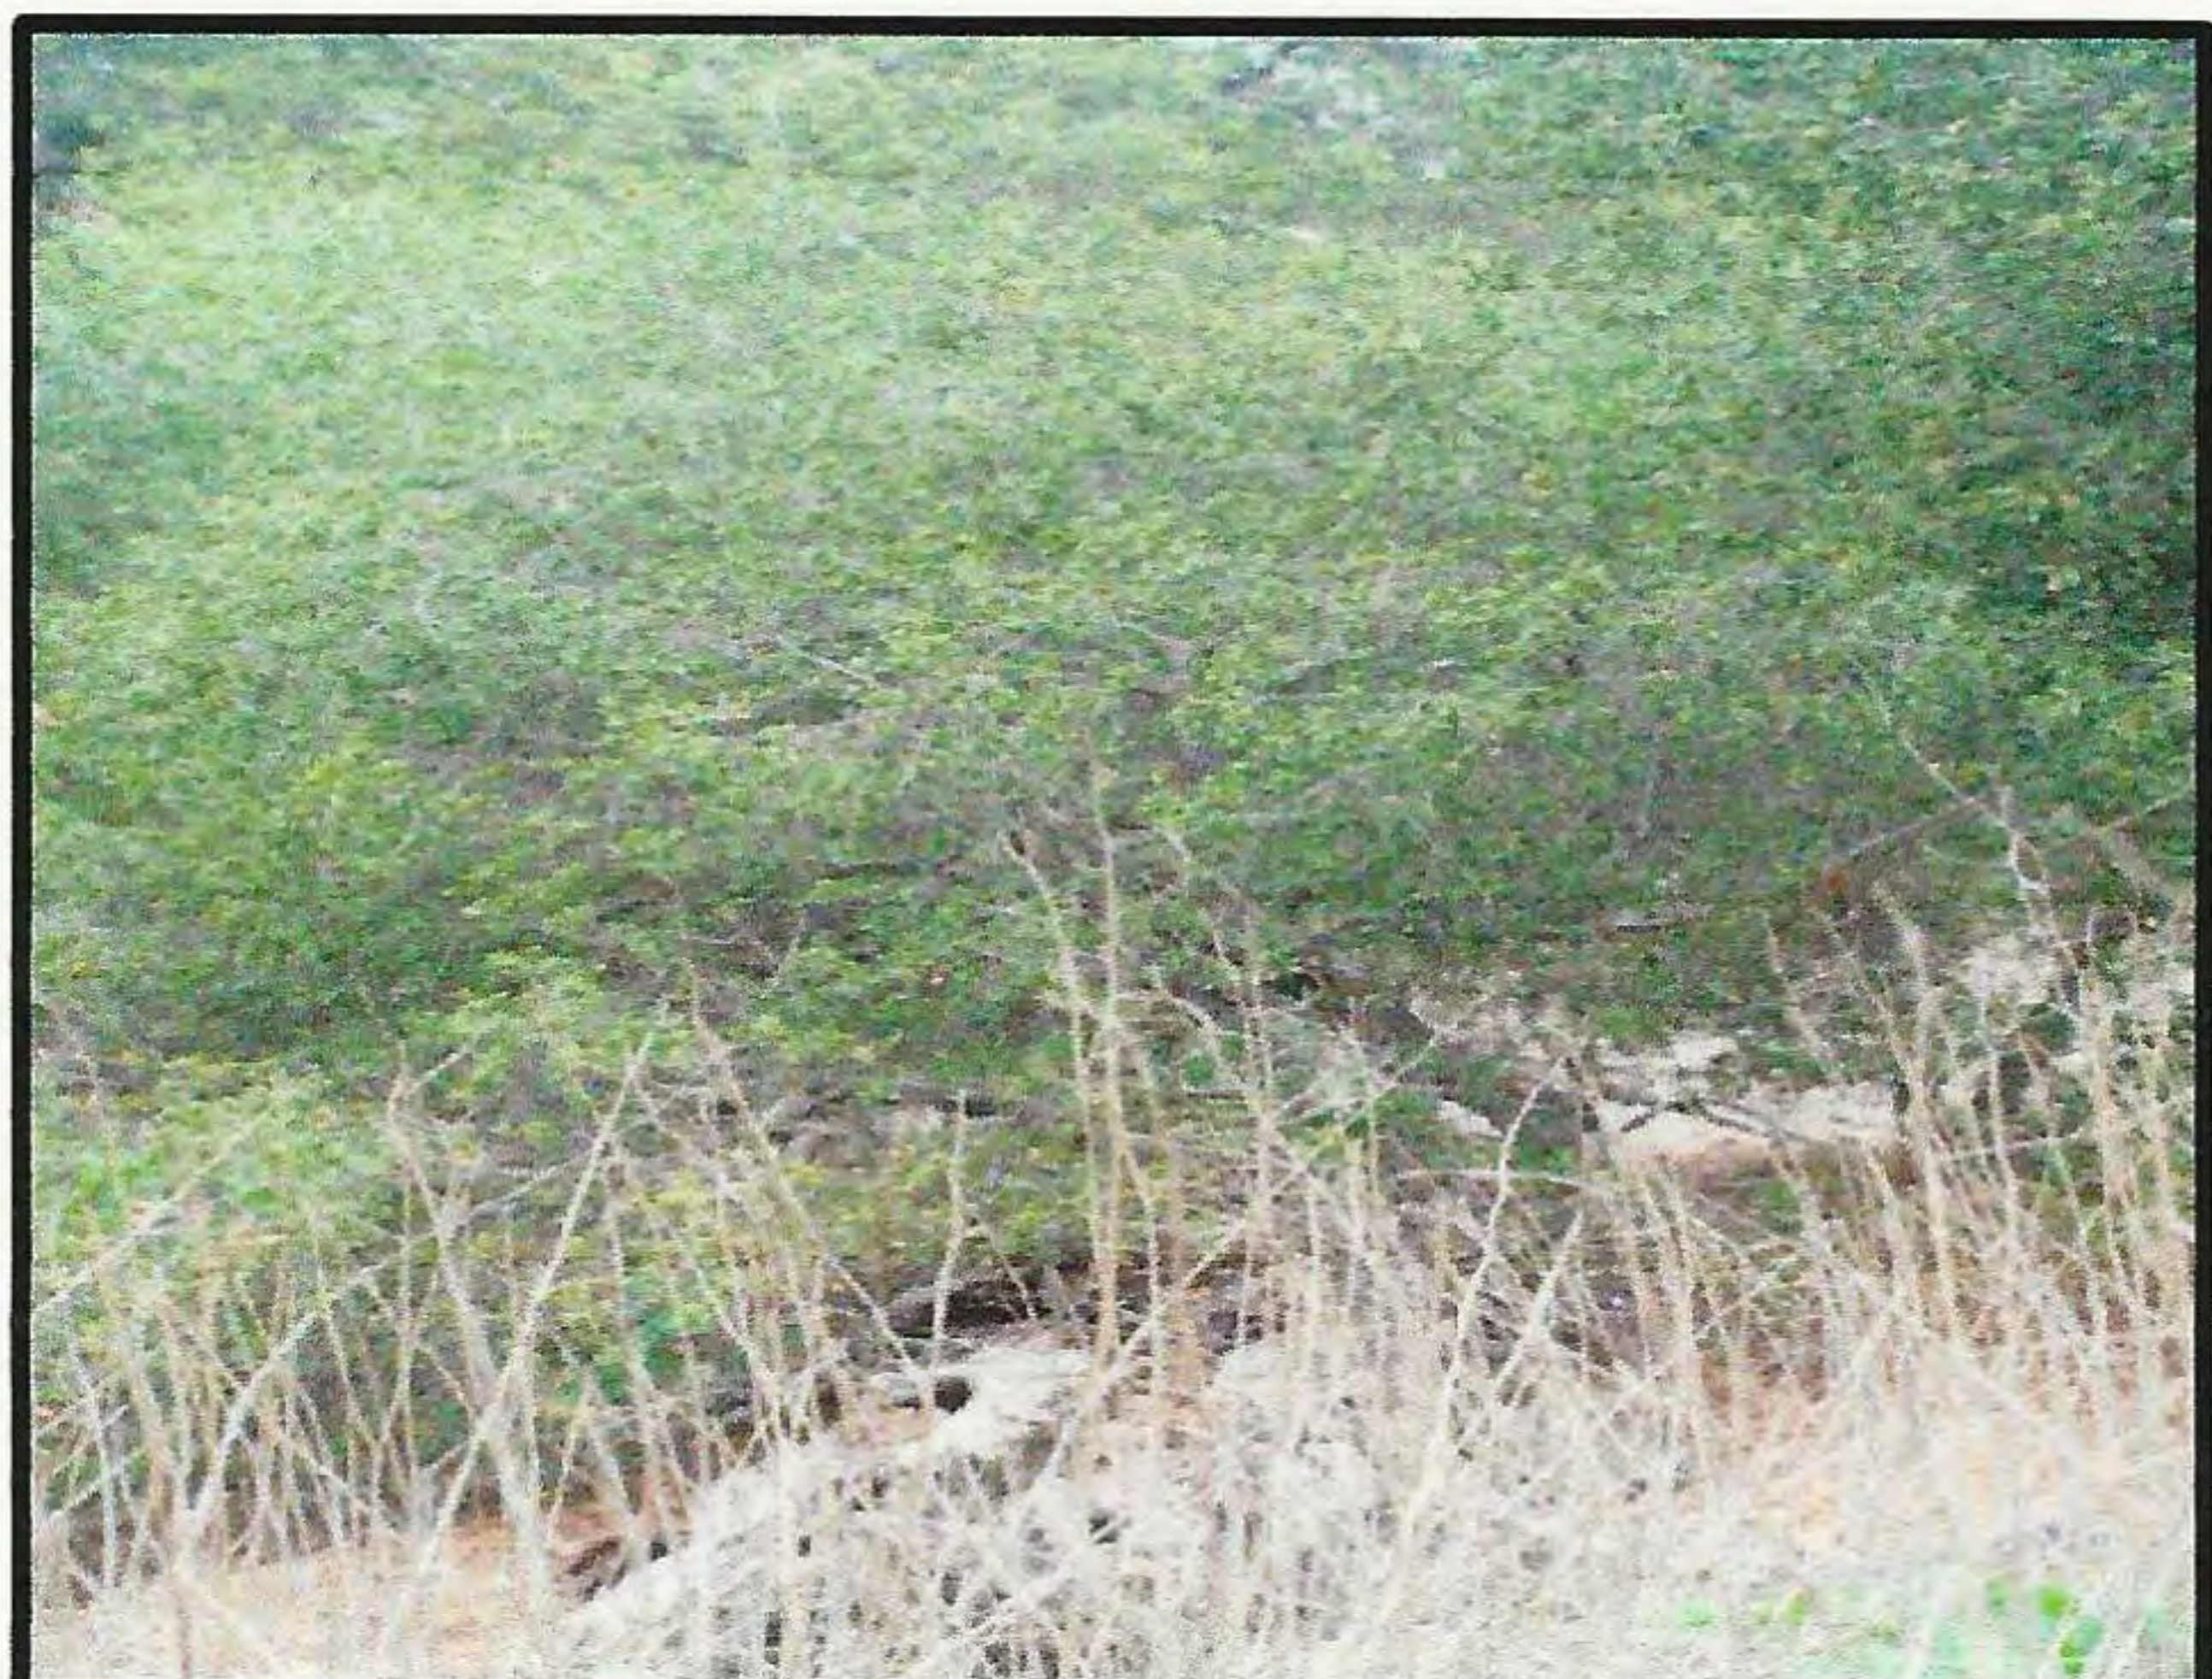
OSL-14	QUERCUS AGRIFOLIA	5 1/2	12/4	4/3	4/5	6/2	11/2	15/0	10/3	10/0	10	D+	C-	DEADWOOD, DIEBACK, GALLS, STRESSED,
OSL-15a	QUERCUS AGRIFOLIA	3 3/4, 2 1/4, 1 3/4, 1 1/4	10/1	4/1	2/6	2/6	1/8	8/1	7/1	9/1	18	C+	C+	BRANCHES ON GROUND, CROSSING BRANCHES, FILL ON TRUNK, INTERTWINED IN OSL-15b, LOW BRANCHING
OSL-15b	QUERCUS AGRIFOLIA	3 1/4	5/8	4/12	5/10	8/5	4/14	6/14	4/6	5/11	19	C+	C+	FILL ON TRUNK, INTERTWINED IN OSL-15a & 15c, LOW BRANCHING
OSL-15c	QUERCUS AGRIFOLIA	3 3/8	3/11	0/0	0/0	5/6	8/7	8/12	6/6	6/14	18	C+	C+	FILL ON TRUNK, INTERTWINED IN OSL-15b & 15d, LOW BRANCHING
OSL-15d	QUERCUS AGRIFOLIA	4 1/8, 3, 1 1/4	0/0	0/0	0/0	0/0	10/10	10/10	9/0	5/7	20	C+	C+	BRANCHES ON GROUND, FILL ON TRUNK, INTERTWINED IN OSL-15c, 15e & 15f, LOW BRANCHING
OSL-15e	QUERCUS AGRIFOLIA	2, 1	0/0	0/0	0/0	4/1	4/1	4/1	4/2	0/0	15	C+	C+	FILL ON TRUNK, INTERTWINED IN OSL-15d, LOPSIDED CANOPY, LOW BRANCHING
OSL-15f	QUERCUS AGRIFOLIA	(2) 1 1/2	0/0	3/6	5/5	5/5	5/5	4/2	4/4	2/2	12	C+	C+	FILL ON TRUNK, INTERTWINED IN OSL-15d, LOW BRANCHING

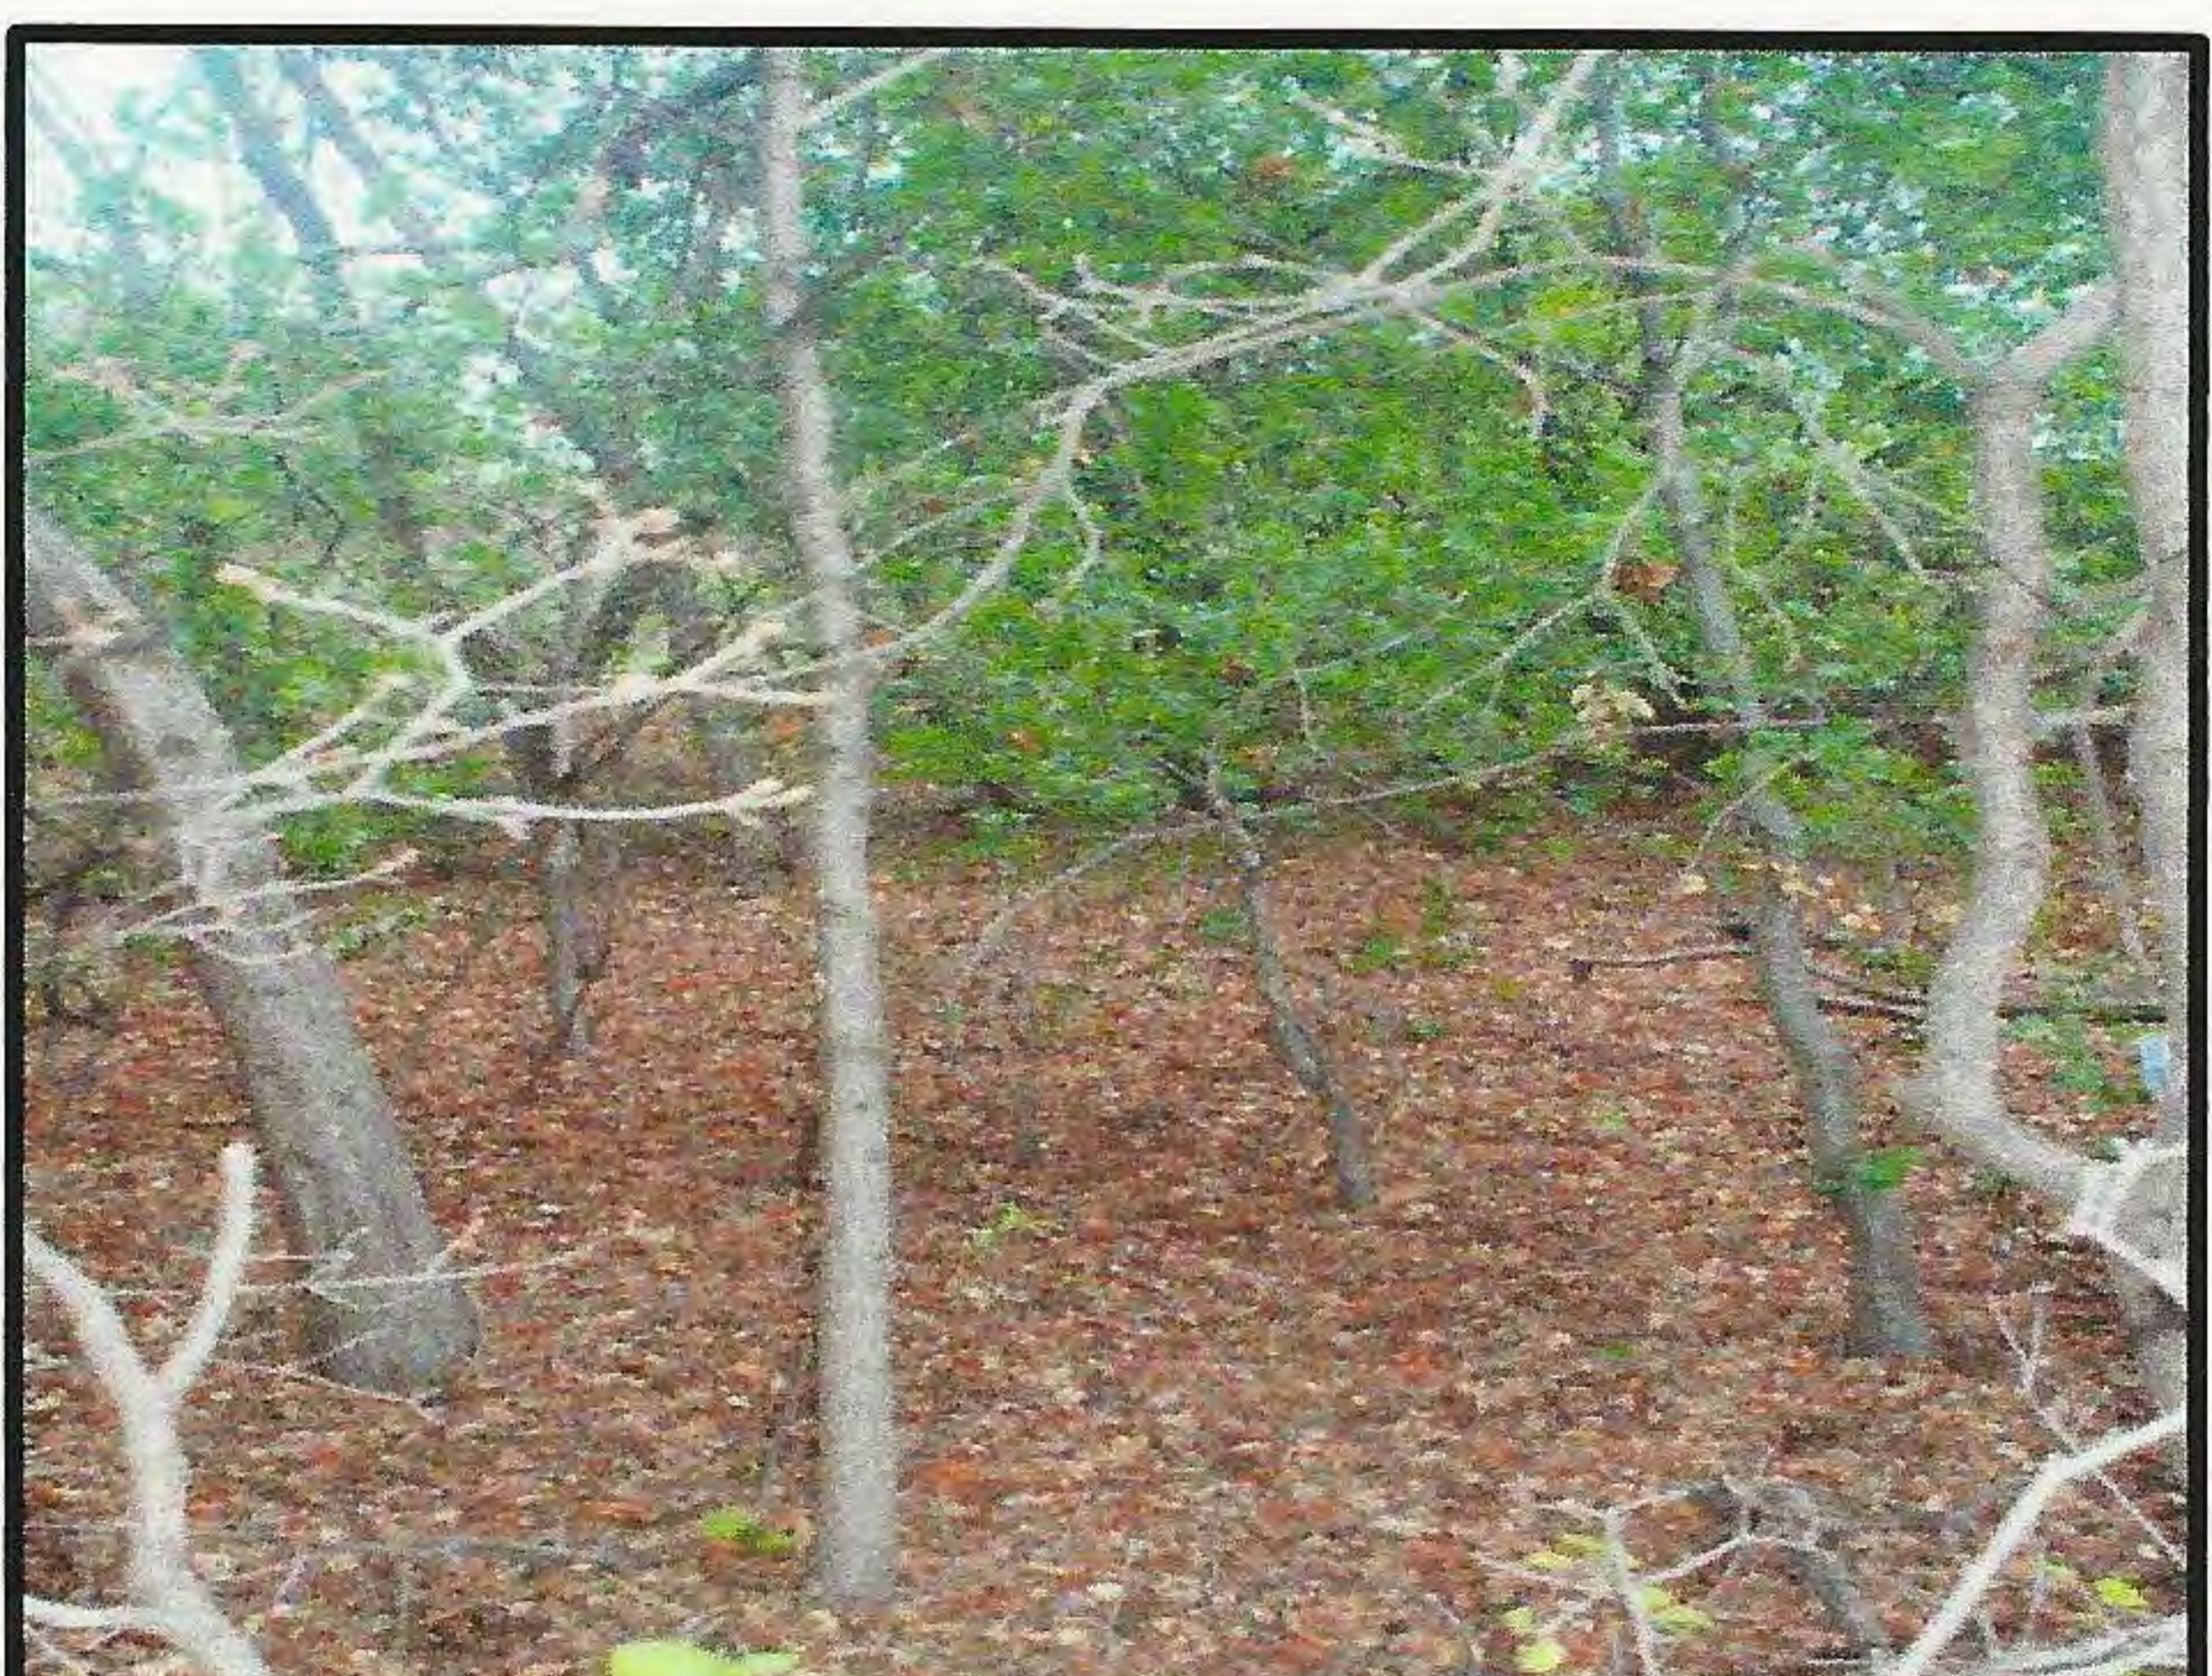
OSL-47a	QUERCUS AGRIFOLIA	2 3/8	4/4	6/5	8/5	6/8	3/2	3/2	3/4	3/7	22	C+	C	FILL ON TRUNK, GALLS, LOW BRANCHING, TWIG GIRDLER
OSL-48	QUERCUS LOBATA	3	6/20	7/18	9/20	0/0	0/0	0/0	6/16	6/18	24	D+	C-	BROKEN BRANCH SCARS, DEADWOOD, DIEBACK, EPICORMIC GROWTH, FILL ON TRUNK, GALLS, LOPSIDED CANOPY
OSL-49	QUERCUS LOBATA	8	14/34	0/0	0/0	0/0	0/0	0/0	0/0	15/32	48	C	C	DEADWOOD, EPICORMIC GROWTH, FILL ON TRUNK, LOPSIDED CANOPY
OSL-50	QUERCUS LOBATA	3 7/8	15/29	19/17	0/0	0/0	0/0	0/0	0/0	7/16	32	D+	C-	DEADWOOD, DIEBACK, FILL ON TRUNK, LOPSIDED CANOPY
OSL-50a	QUERCUS AGRIFOLIA	2 3/4	15/22	16/4	10/3	0/0	0/0	0/0	0/0	0/0	26	C+	C	BRANCHES ON GROUND, FILL ON TRUNK, LOPSIDED CANOPY, LOW BRANCHING, TWIG GIRDLER
OSL-51	QUERCUS AGRIFOLIA	22	38/3	30/8	22/12	18/0	16/3	24/1	20/1	30/0	70	B	B	DEADWOOD, FILL ON TRUNK, INTERTWINED IN OSL-54, BIRD'S NEST IN CANOPY

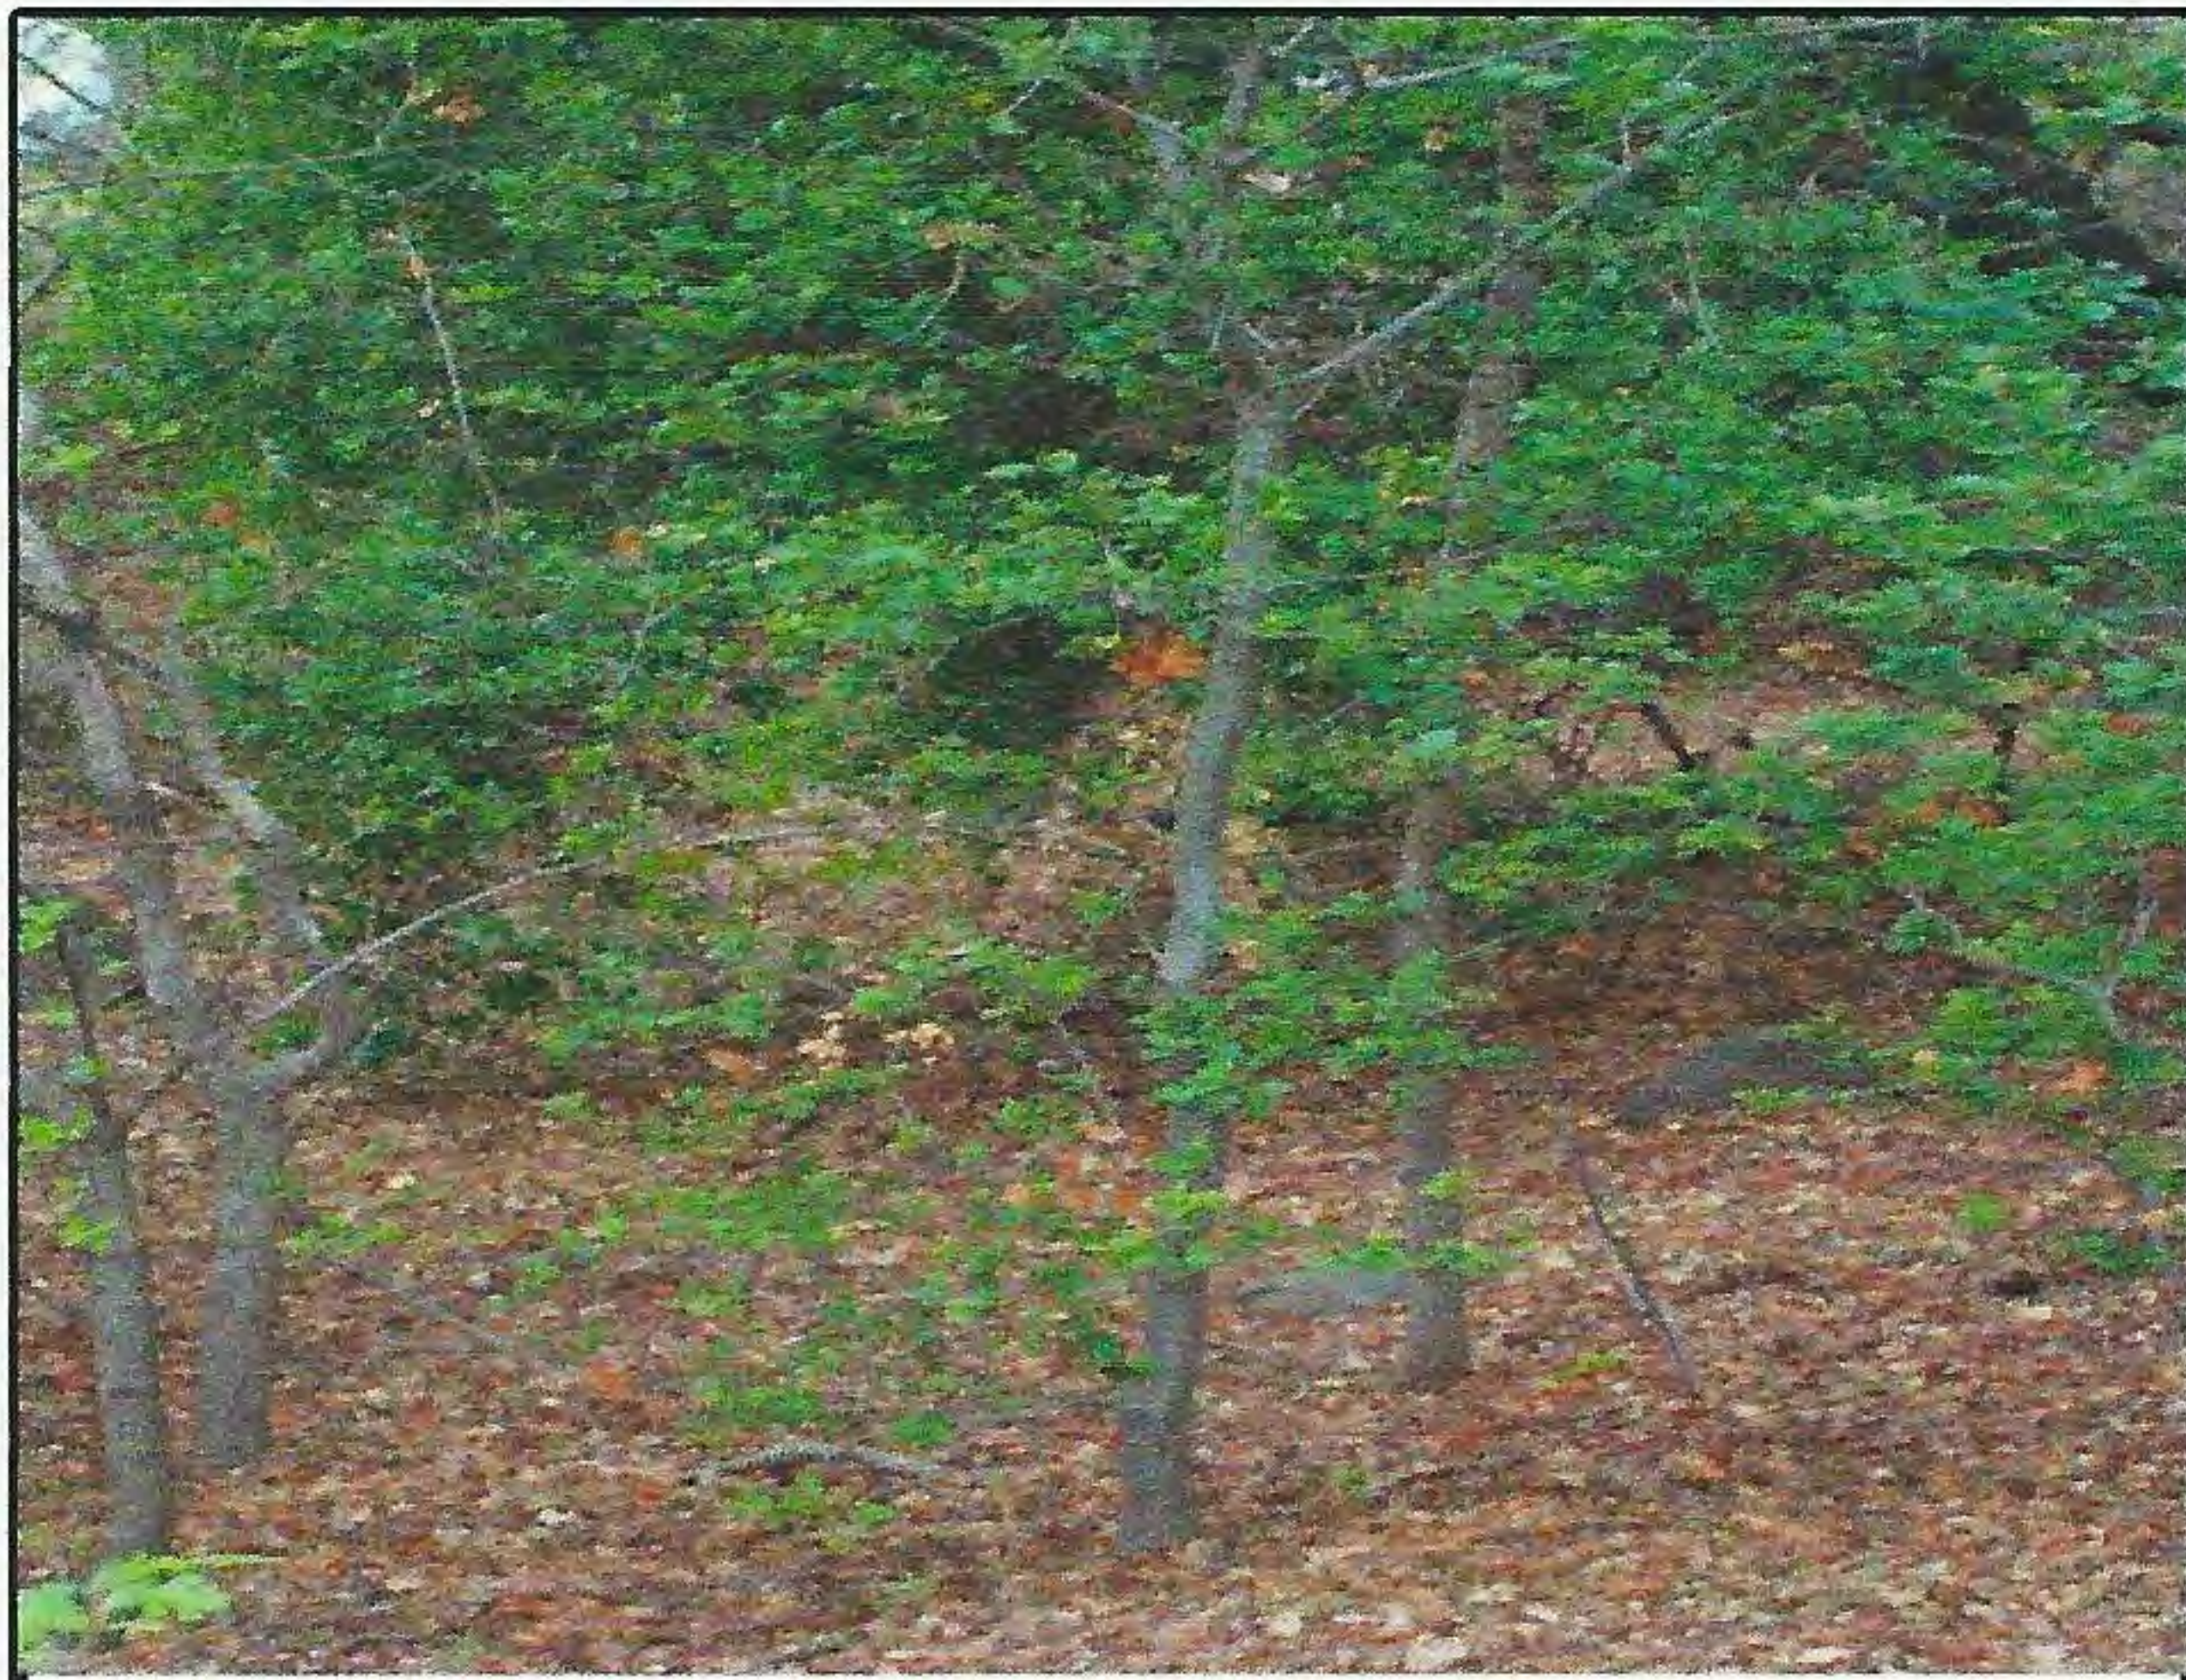
TREE NO.	TREE NAME	TRUNK DIA(S) IN INCHES	N	NE	E	SE	S	SW	W	NW	HT+ IN FEET	H'LTH	AESTH	NOTES & REMARKS
OSL-52	QUERCUS LOBATA	3 1/4, 2	0/0	0/0	0/0	0/0	8/11	7/15	15/6	8/6	23	D+	C-	DEADWOOD, DIEBACK, EPICORMIC GROWTH, FILL ON TRUNK, LOPSIDED CANOPY
OSL-53	QUERCUS AGRIFOLIA	3 3/8, 2 3/4	0/0	0/0	0/0	8/11	9/0	11/4	13/3	5/0	15	C+	C	BRANCHES ON GROUND, CO-DOMINANT SCAFFOLDS, DEADWOOD, QUERCUS AGRIFOLIA AND LOBATA SEEDLINGS IN DUFF, TWIG GIRDLER
OSL-54	QUERCUS LOBATA	60	42/22	50/18	44/26	52/0	56/0	48/0	53/24	42/14	60	C-	B+	LOCATED ON RIPARIAN SLOPE, BRANCH CAVITY, BRANCHES ON GROUND, BROKEN BRANCH SCARS, CONJOINED TRUNKS, CROSSING BRANCHES, DEADWOOD, EPICORMIC GROWTH, FILL ON TRUNK, GALLS, INTERTWINED IN OSL-35, 39, 45 AND 51, QUERCUS AGRIFOLIA AND LOBATA SEEDLINGS IN DUFF, ROT SUSPECTED, STRESSED, THINNING CANOPY, WATER TRAP
OSL-55	QUERCUS LOBATA	12 1/4, 8 1/4, 5, 2 3/8, 2 1/4	8/5	8/18	11/2	18/18	17/17	30/0	26/4	12/2	50	C	C	LOCATED ON RIPARIAN SLOPE, BRANCHES ON GROUND, CONJOINED TRUNKS, CROSSING BRANCHES, DEADWOOD, EPICORMIC GROWTH, FILL ON TRUNK, GALLS, QUERCUS AGRIFOLIA AND LOBATA SEEDLINGS IN DUFF, ROT SUSPECTED, STRESSED, THINNING CANOPY

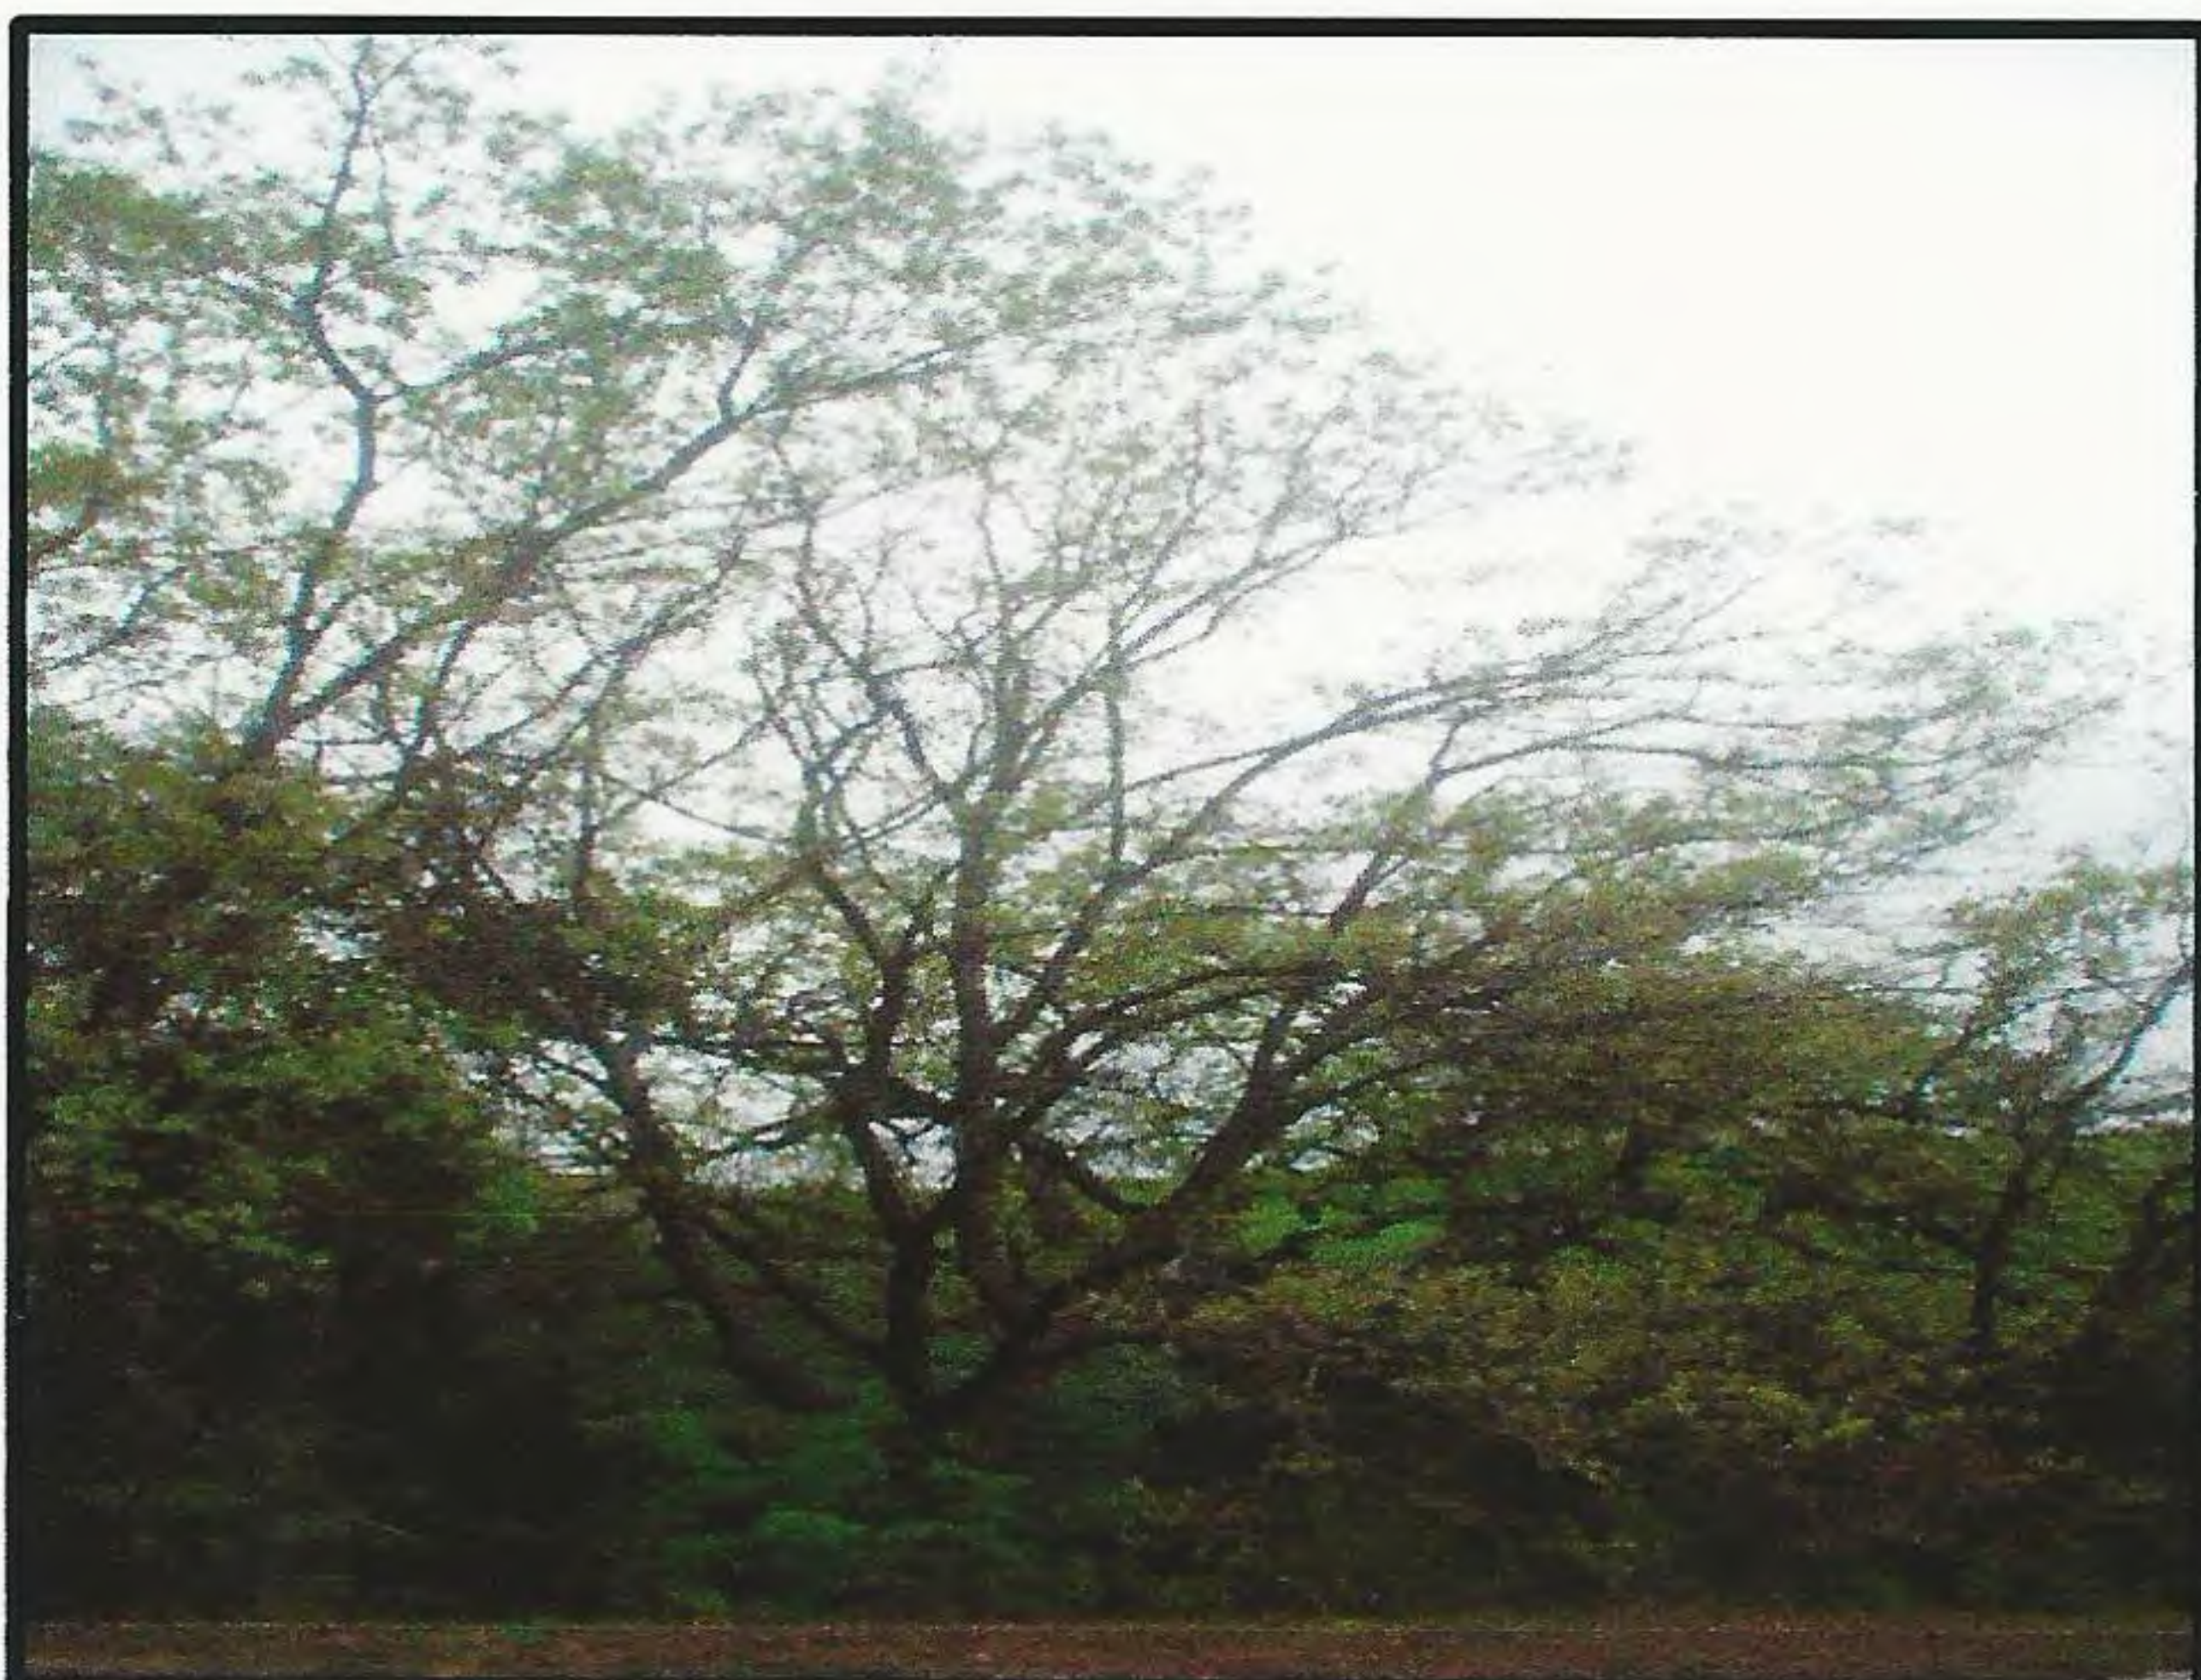
OSL-56	QUERCUS LOBATA	2 1/8	0/0	0/0	0/0	0/0	4/7	13/14	10/12	10/6	32	C-	C	LOCATED ON RIPARIAN SLOPE, DEADWOOD, EPICORMIC GROWTH, FILL ON TRUNK, LEANS TO WEST
OSL-56a	QUERCUS LOBATA	2 1/4	3.4	3/12	4/4	4/3	5/3	3/3	4/3	4/4	18	C	C	DEADWOOD, EPICORMIC GROWTH, FILL ON TRUNK, LOW BRANCHING
OSL-57	QUERCUS LOBATA	23	16/22	21/35	12/17	35/14	30/36	32/0	37/1	28/35	32	C-	C	LOCATED ON RIPARIAN SLOPE, BRANCHES ON GROUND, CO-DOMINANT SCAFFOLDS, DEADWOOD, EPICORMIC GROWTH, FILL ON TRUNK, INCLUDED BARK, LEANS TO WEST, LOW BRANCHING
