**City Oak Tree
Consultant's Memorandum
and Oak Tree Report**

OAK TREE REPORT

OAKMONT SENIOR LIVING

OAKMONT SENIOR LIVING
29353 CANWOOD STREET
ALONG THE "101 FREEWAY CORRIDOR" AREA
OF THE CITY OF AGOURA HILLS, CALIFORNIA

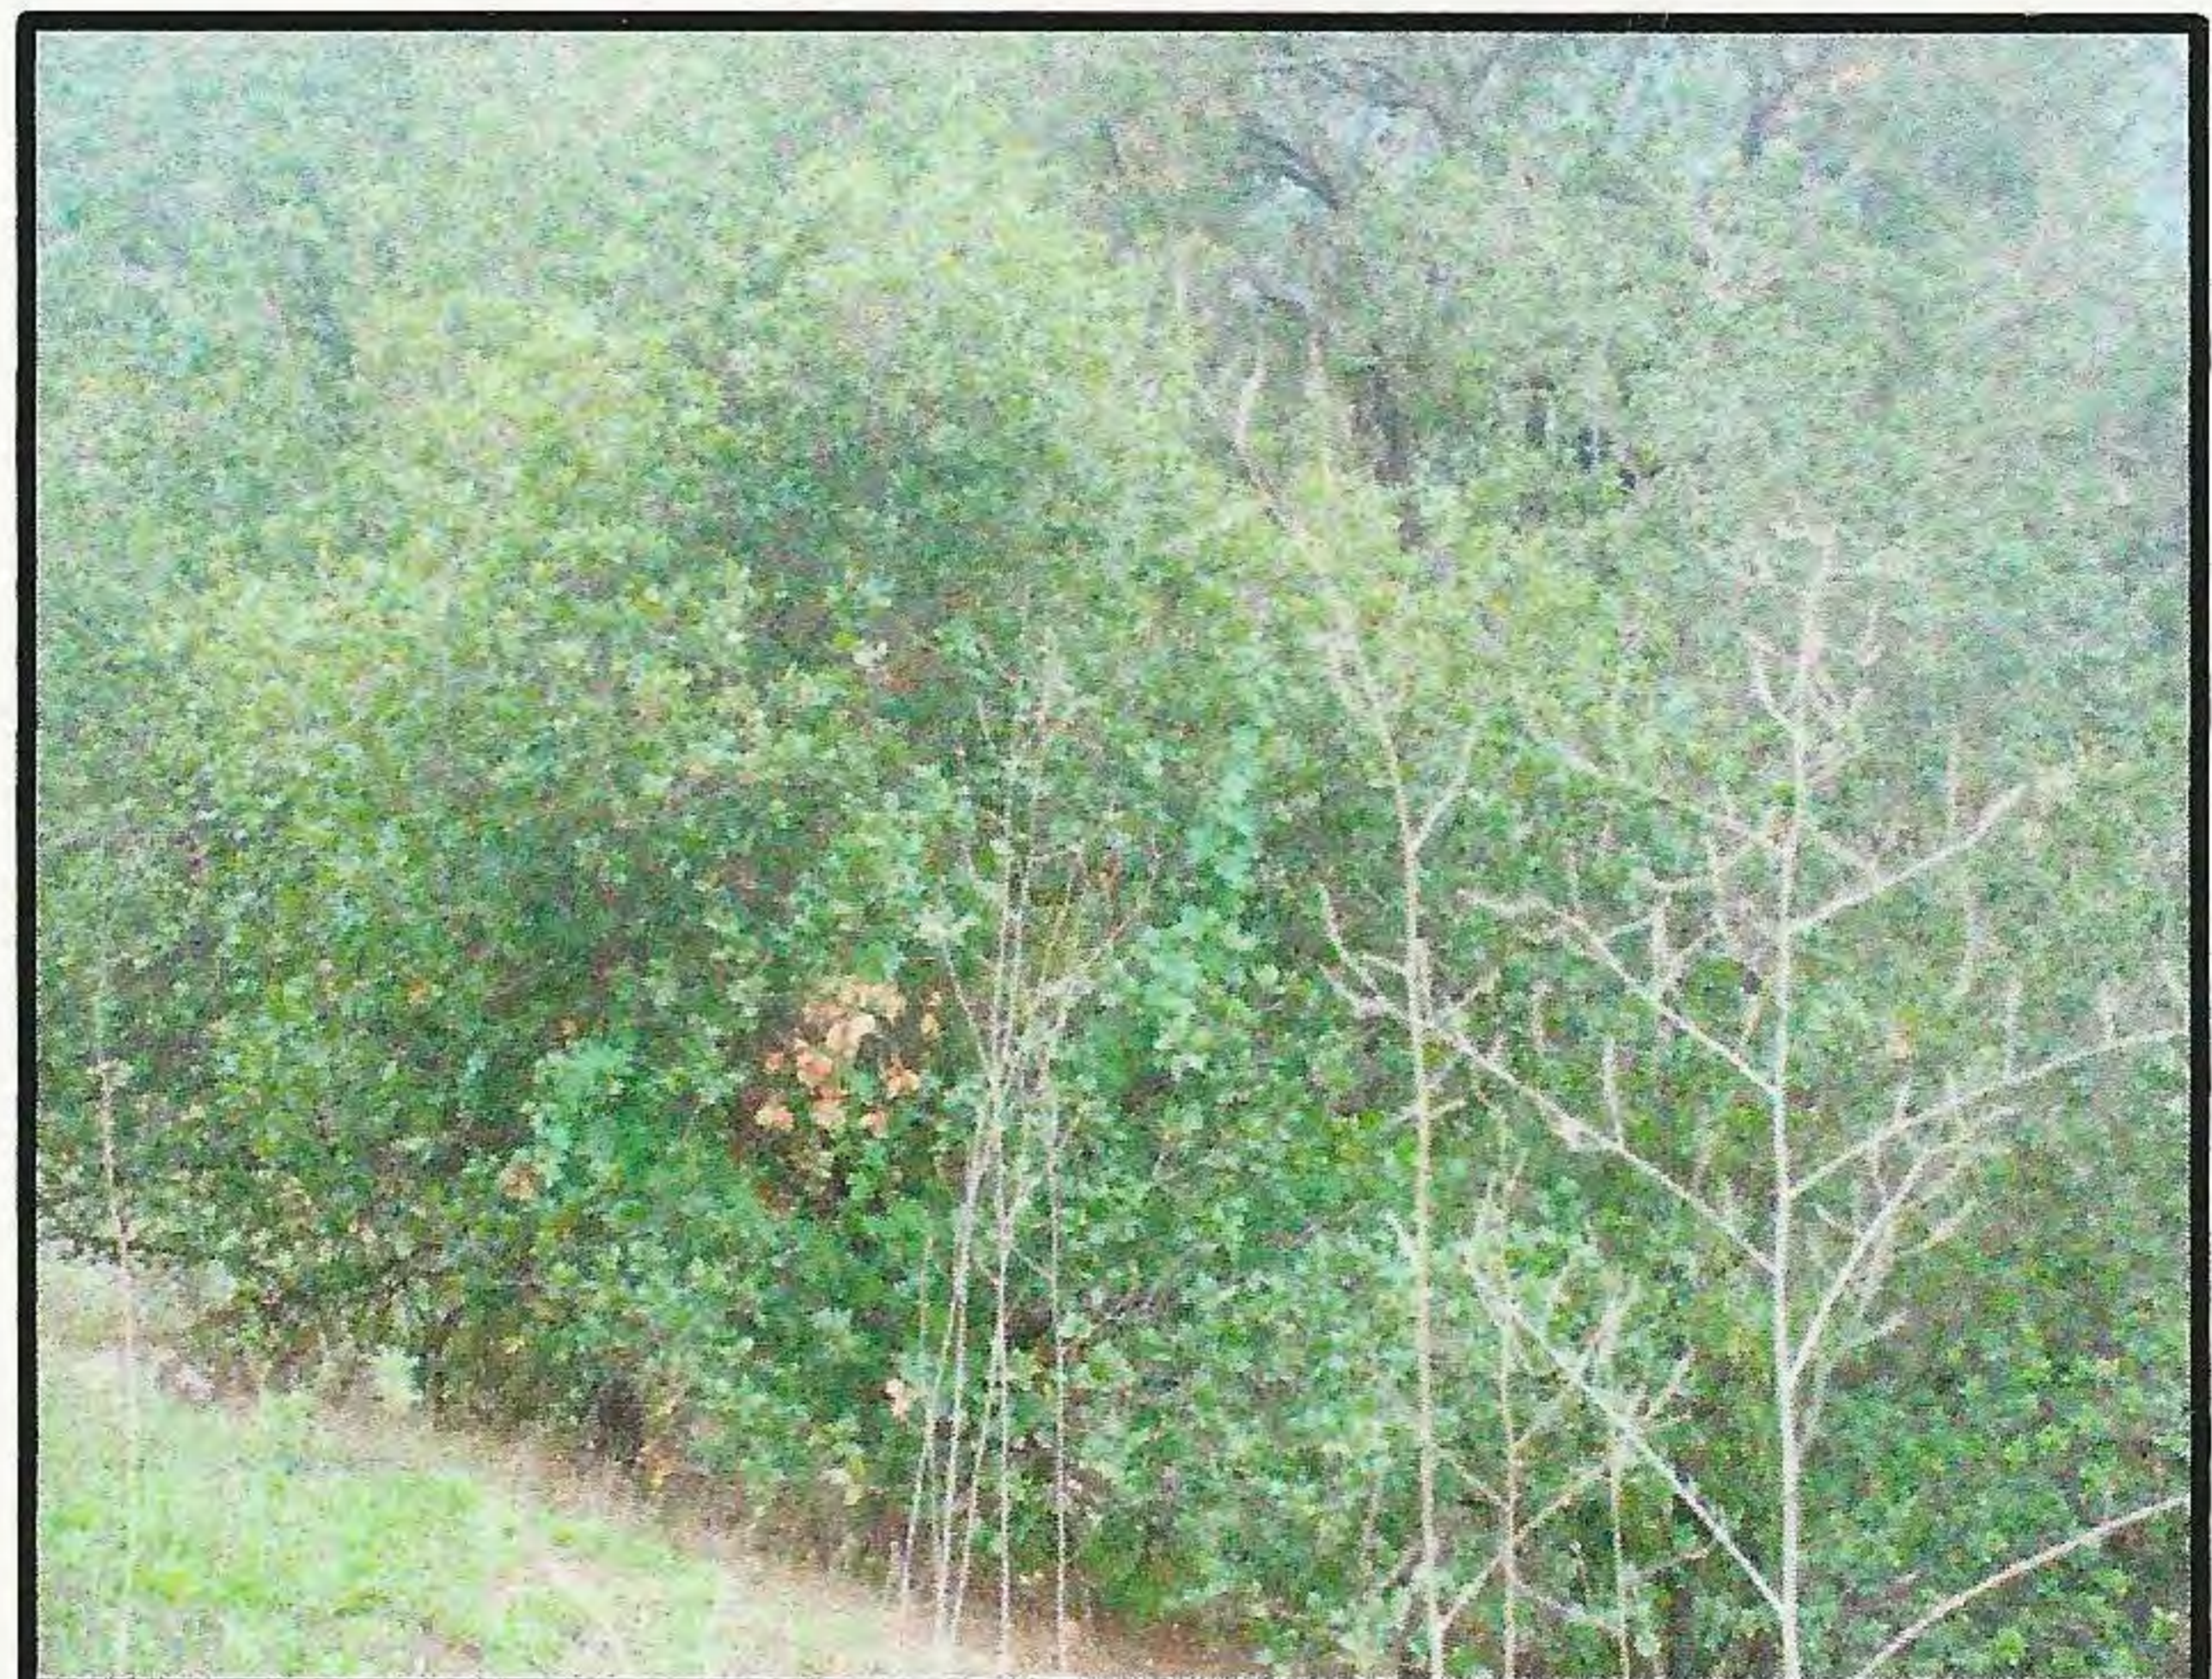
OSL-6	QUERCUS AGRIFOLIA	(2) 3.1/8, (2) 1 3/4, (3) 3/4	8/1	7/2	7/2	3/2	4/2	7/2	7/2	7/2	15	B	B	FILL ON TRUNK, INTERTWINED IN OSL-5 & 7, LOW BRANCHING, TWIG GIRDLER
OSL-7	QUERCUS AGRIFOLIA	2 1/2	7/1	5/1	3/5	3/4	4/8	5/4	4/4	4/4	12	B	B	FILL ON TRUNK, INTERTWINED IN OSL-6&7a, LOW BRANCHING, TWIG GIRDLER
OSL-7a	QUERCUS AGRIFOLIA	1 1/2, 1	6/4	6/1	5/2	0/0	2/2	2/4	5/2	6/4	10	D+	C+	FILL ON TRUNK, INTERTWINED IN OSL-7, LOW BRANCHING
OSL-8	QUERCUS AGRIFOLIA	3, 1 1/4	6/3	5/5	5/0	0/0	0/0	0/0	6/10	6/4	16	B-	B	FILL ON TRUNK, INTERTWINED IN OSL-9, LOPSIDED CANOPY, LOW BRANCHING
OSL-8a	QUERCUS AGRIFOLIA	2 1/2, 1	8/3	8/4	7/1	4/3	4/2	3/8	4/3	5/1	14	B	B	FILL ON TRUNK, INTERTWINED IN OSL-9, LOW BRANCHING
OSL-9	QUERCUS AGRIFOLIA	21 1/4, 16 3/4, 11 3/4	21/10	12/12	22/0	31/0	23/0	28/1	27/1	20/2	50	B-	B+	BRANCHES ON GROUND, BROKEN BRANCH SCARS, EPICORMIC GROWTH, TWIG GIRDLER, WATER TRAP

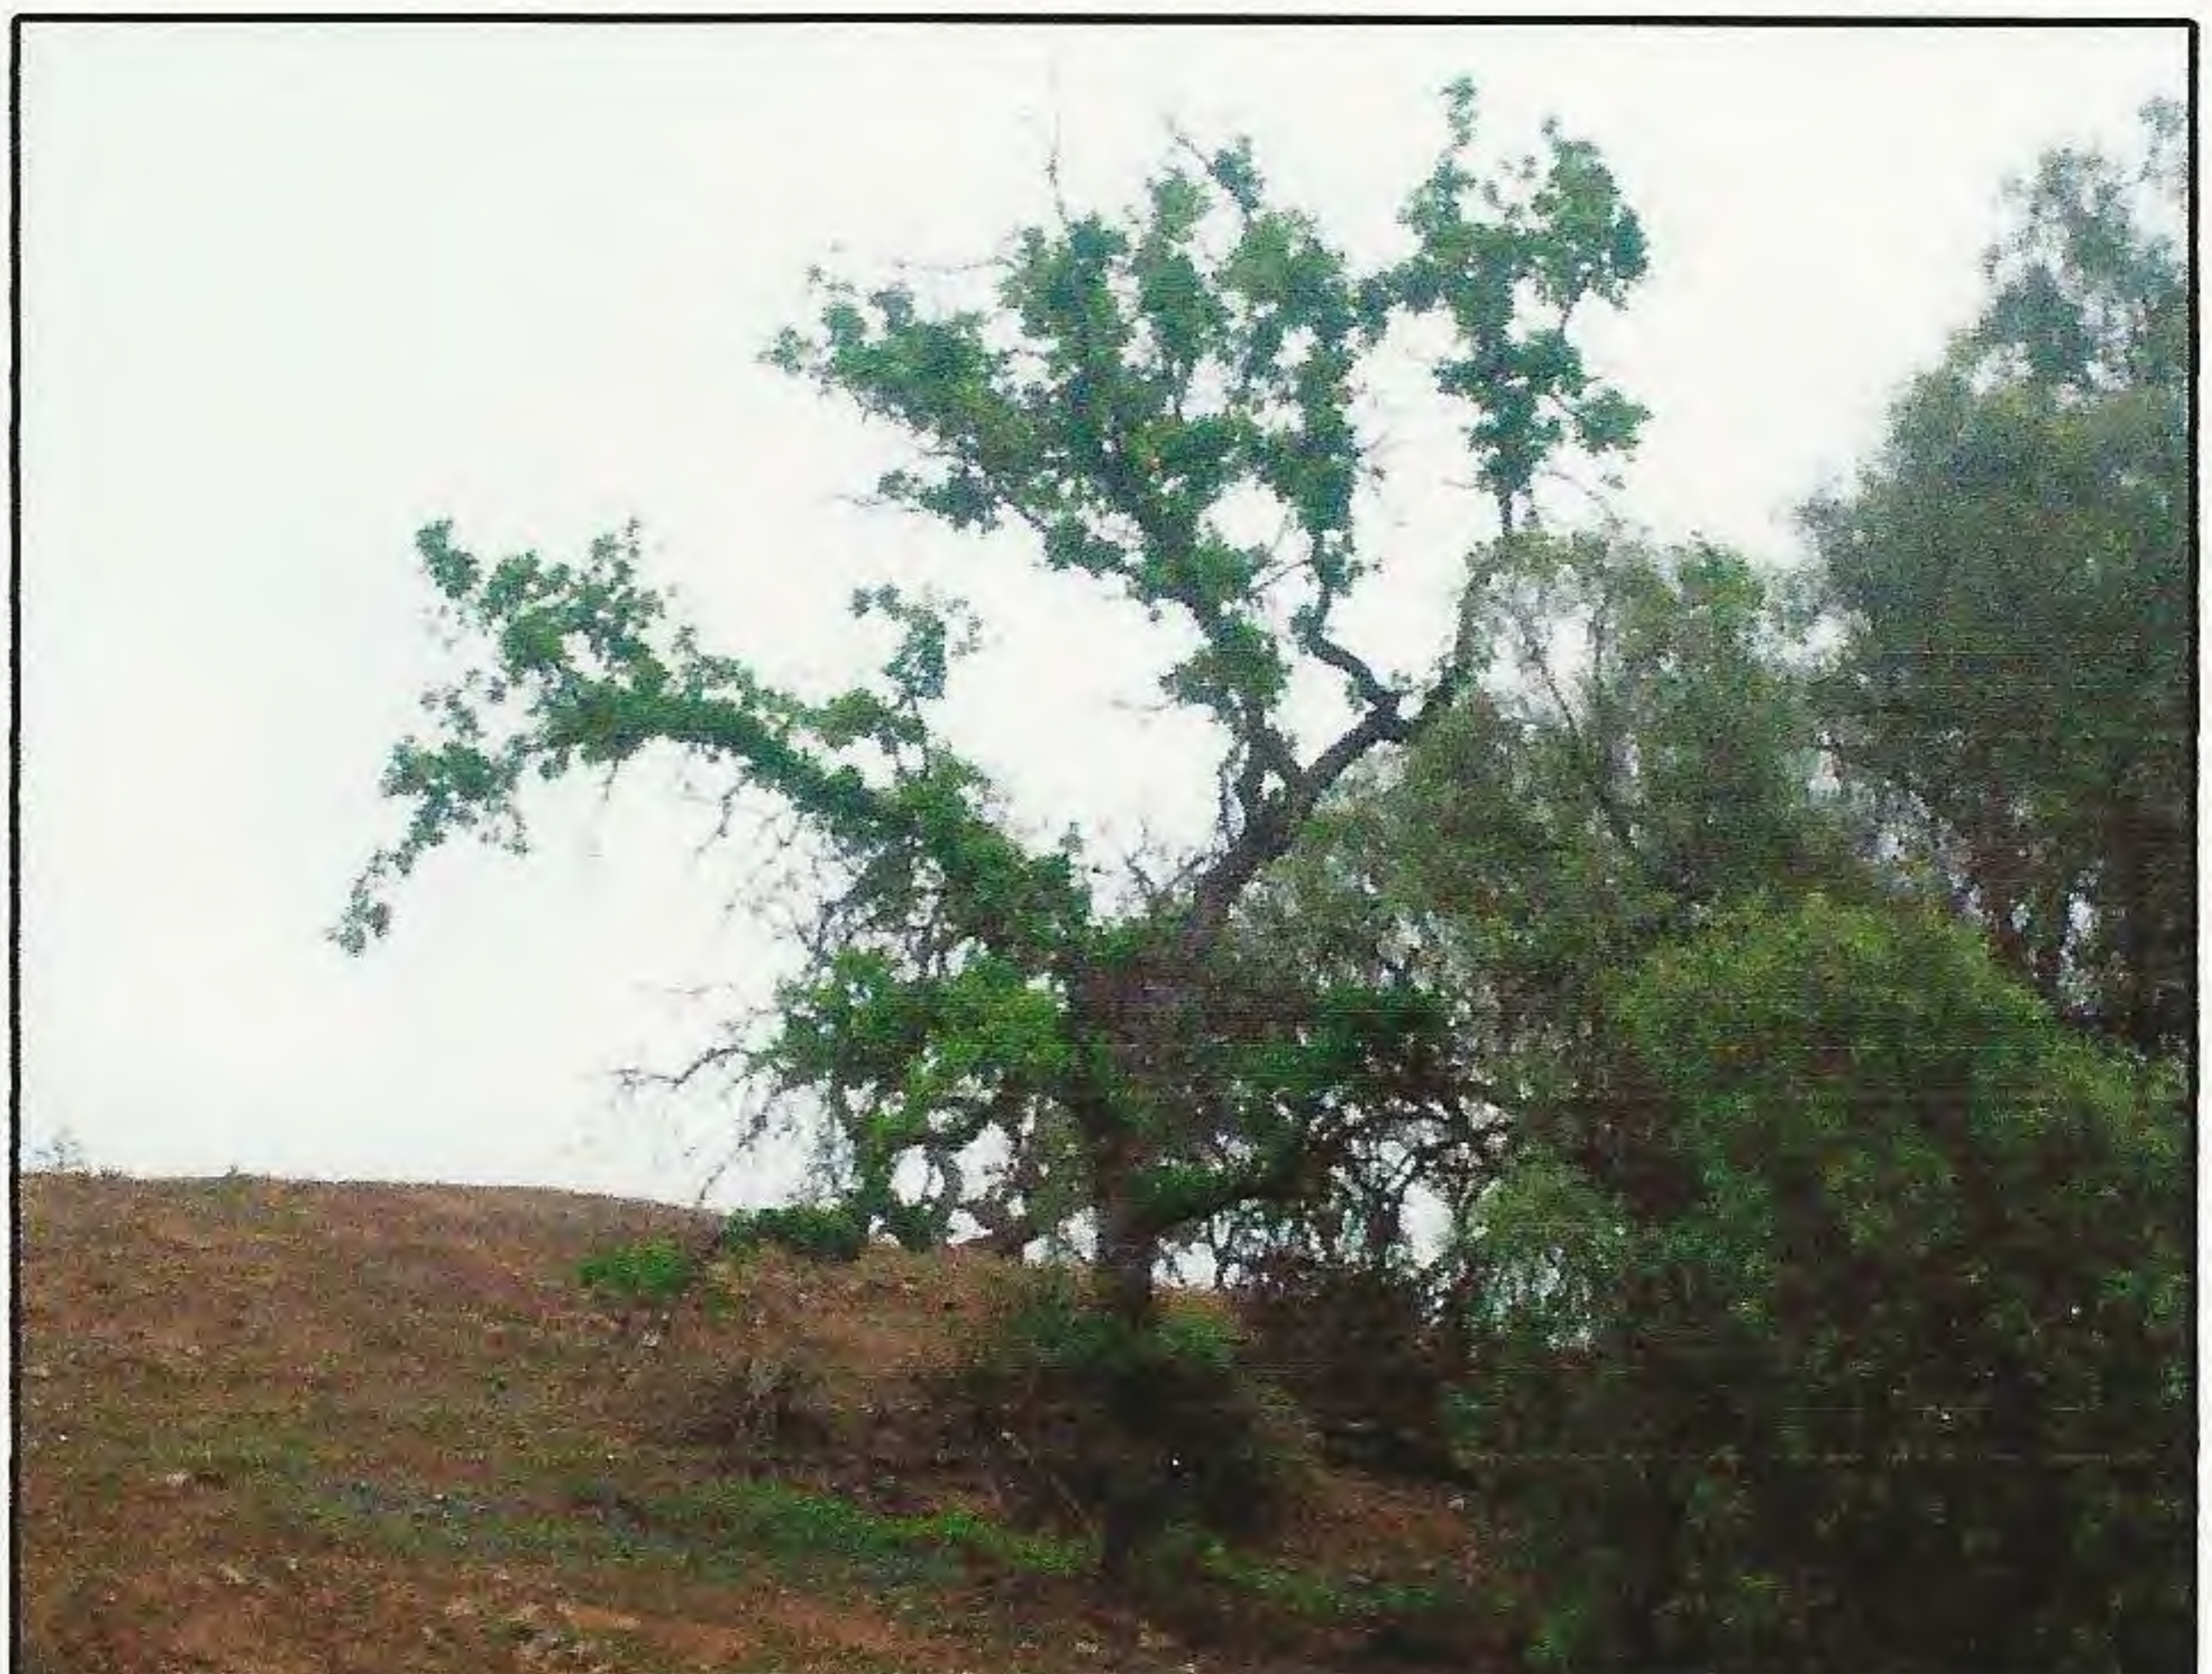
It is our recommendation that pruning be performed to allow for clearance from the proposed retaining wall construction, as no construction activity is proposed within the Protected Zone of any other Oak Tree(s). Only Oak Trees OSL-10, OSL-54 and OSL-55 appear to be affected by the proposed retaining wall or any other construction activity.

TREE NO.	TREE NAME	TRUNK DIA(S) IN INCHES	N	NE	E	SE	S	SW	W	NW	HT± IN FEET	H'LTH	AESTH	NOTES & REMARKS
OSL-10	QUERCUS AGRIFOLIA	12	19/2	18/6	16/20	12/20	9/0	10/0	16/5	17/1	32	C-	C-	LOCATED ON STEEP SLOPE, BARBED WIRE AROUND TRUNK, BRANCHES ON GROUND, BROKEN BRANCH SCARS, DEADWOOD, EPICORMIC GROWTH, INTERTWINED IN PEPPER TREE, STRESSED, THINNING CANOPY
OSL-11	QUERCUS LOBATA	29	25/15	25/8	34/8	35/8	22/11	32/2	15/12	18/17	36	C-	C-	LOCATED ON RIDGE, BRANCH CAVITY, BRANCHES ON GROUND, DEADWOOD, EPICORMIC GROWTH, INTERTWINED IN OSL-12 & PEPPER TREE, LEANS TO EAST, STRESSED, THINNING CANOPY, WATER TRAP
OSL-12	QUERCUS LOBATA	21 5/8	30/1	23/2	7/15	5/11	21/2	26/3	25/1	30/14	34	C-	C-	LOCATED ON RIDGE, BRANCH CAVITY, BROKEN BRANCH SCARS, DEADWOOD, EPICORMIC GROWTH, INTERTWINED IN OSL-11, THINNING CANOPY
OSL-13	QUERCUS AGRIFOLIA	6, 3, 2,	11/1	13/1	12/1	15/0	14/0	12/3	9/1	10/1	30	B	B	BRANCHES ON GROUND, FILL ON TRUNK, LOW BRANCHING, REGROWN STUMP

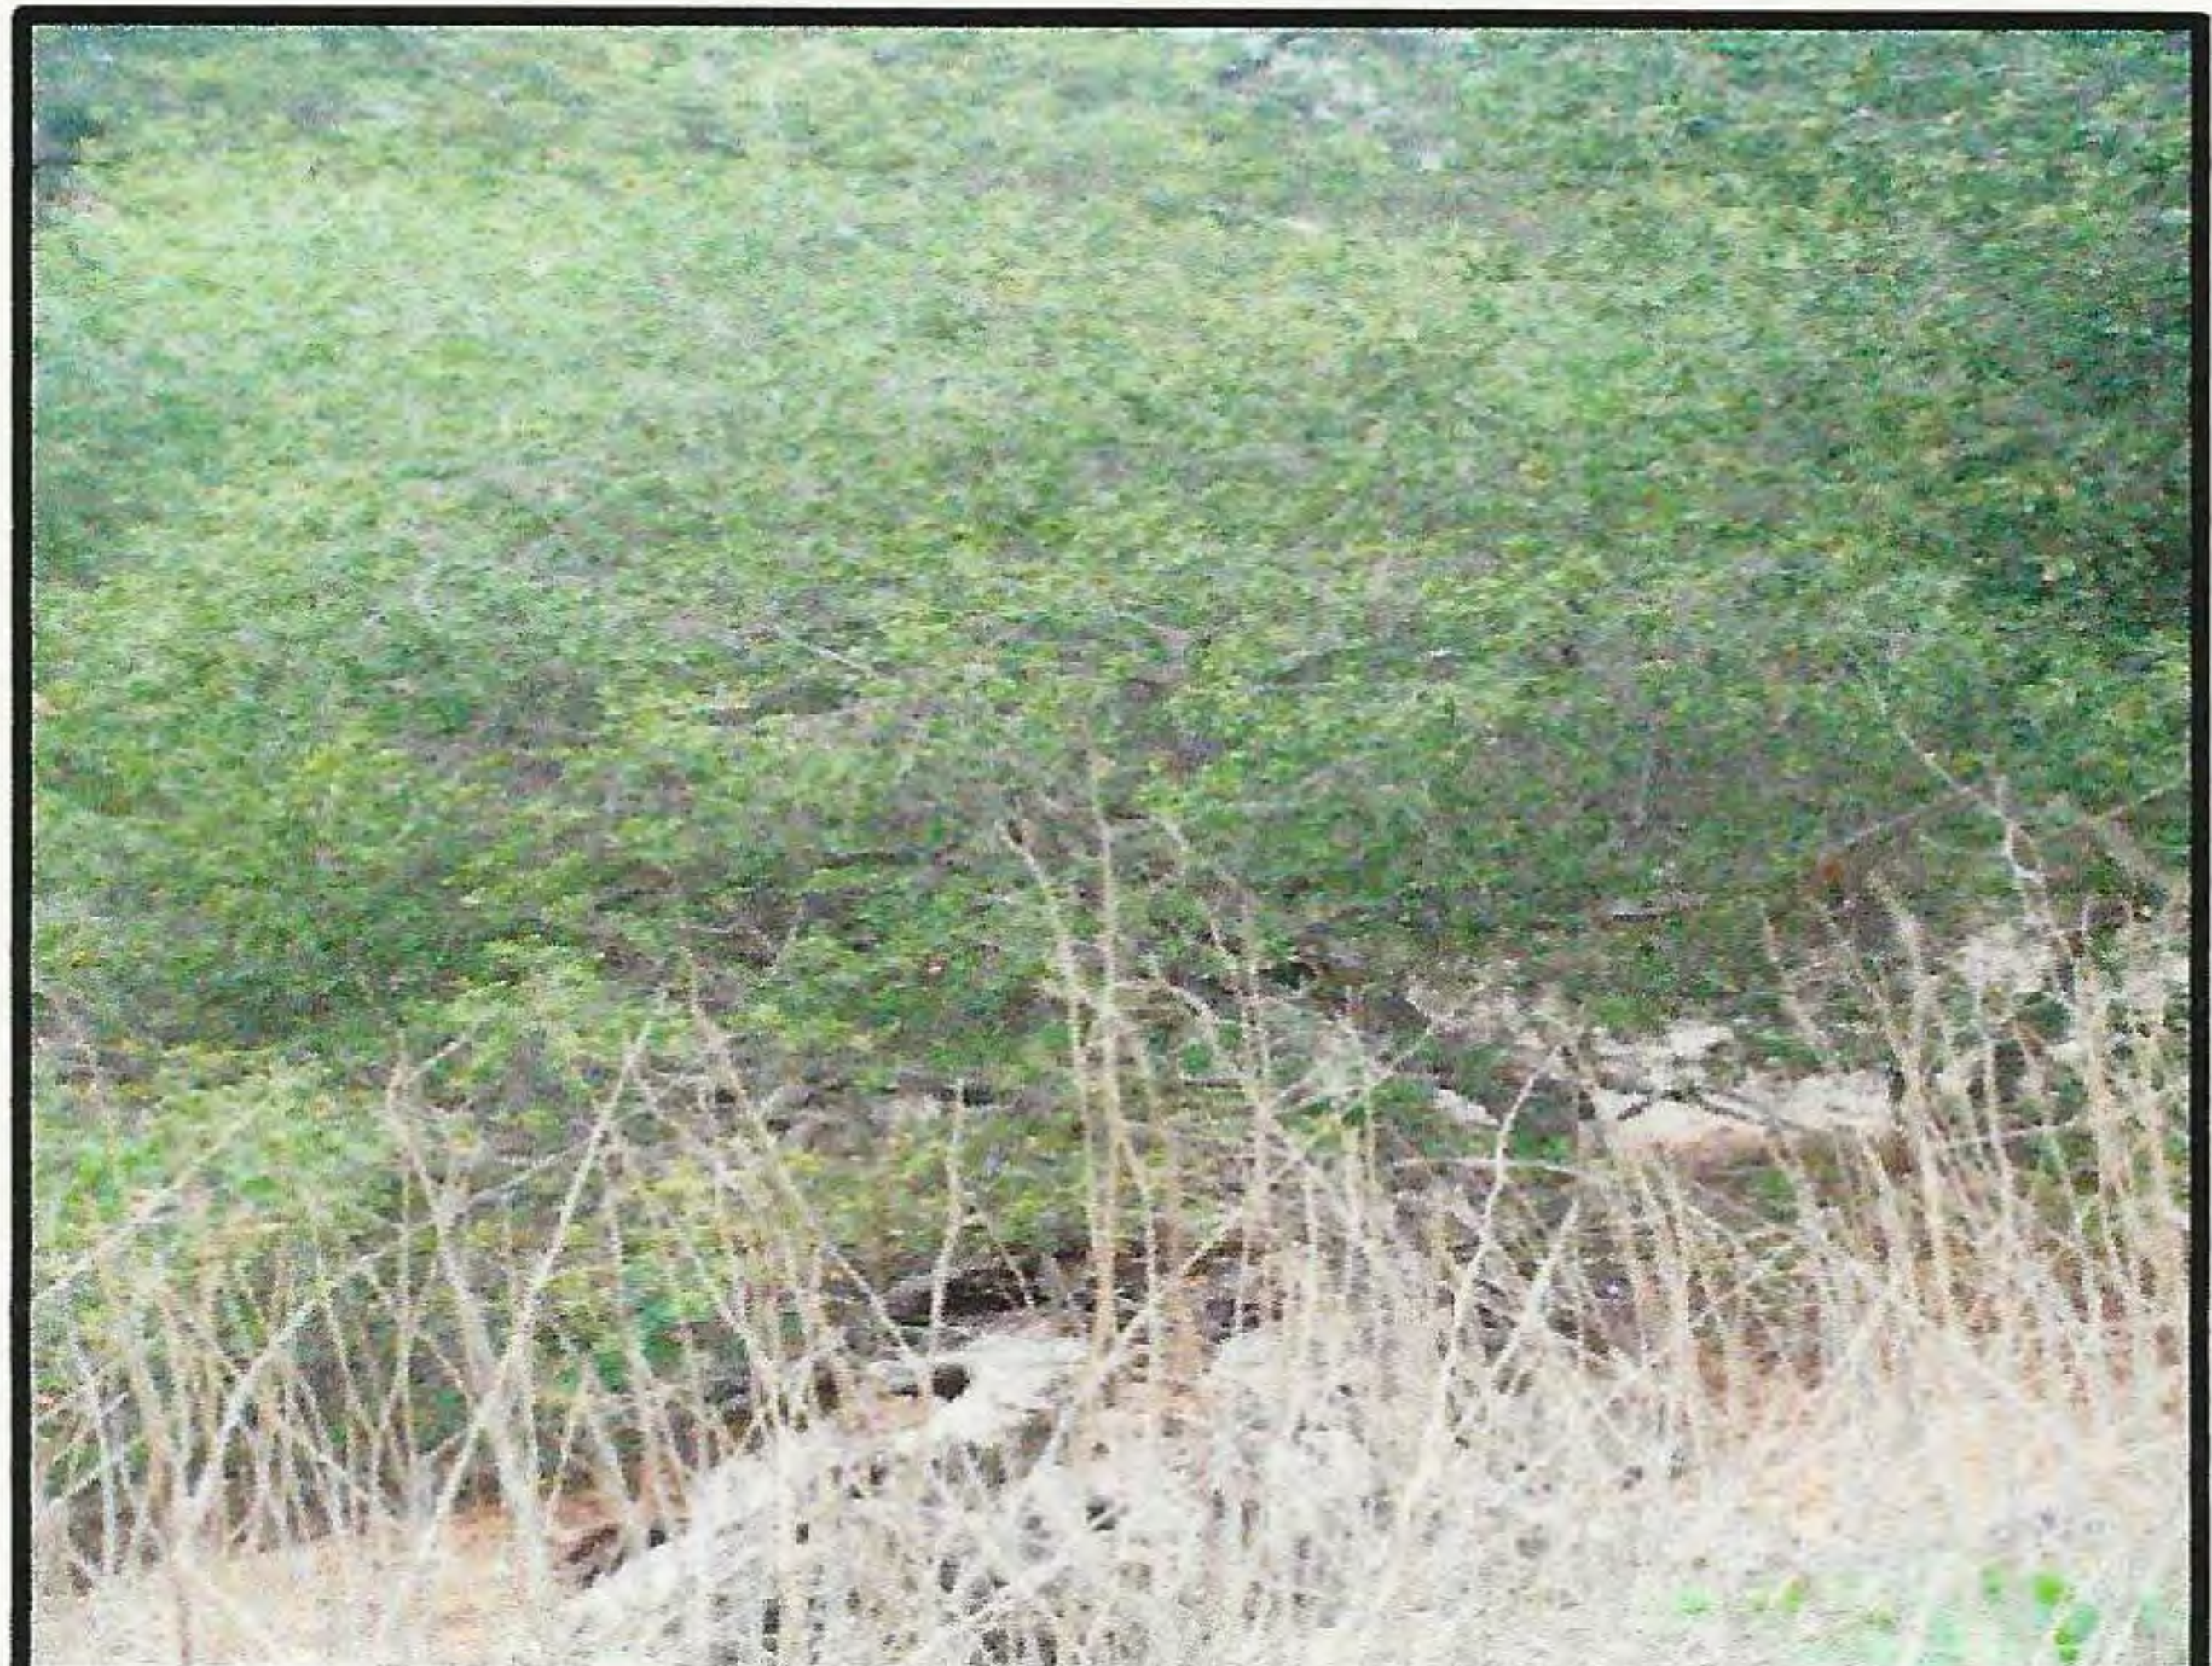
OSL-14	QUERCUS AGRIFOLIA	5 1/2	12/4	4/3	4/5	6/2	11/2	15/0	10/3	10/0	10	D+	C-	DEADWOOD, DIEBACK, GALLS, STRESSED,
OSL-15a	QUERCUS AGRIFOLIA	3 3/4, 2 1/4, 1 3/4, 1 1/4	10/1	4/1	2/6	2/6	1/8	8/1	7/1	9/1	18	C+	C+	BRANCHES ON GROUND, CROSSING BRANCHES, FILL ON TRUNK, INTERTWINED IN OSL-15b, LOW BRANCHING
OSL-15b	QUERCUS AGRIFOLIA	3 1/4	5/8	4/12	5/10	8/5	4/14	6/14	4/6	5/11	19	C+	C+	FILL ON TRUNK, INTERTWINED IN OSL-15a & 15c, LOW BRANCHING
OSL-15c	QUERCUS AGRIFOLIA	3 3/8	3/11	0/0	0/0	5/6	8/7	8/12	6/6	6/14	18	C+	C+	FILL ON TRUNK, INTERTWINED IN OSL-15b & 15d, LOW BRANCHING
OSL-15d	QUERCUS AGRIFOLIA	4 1/8, 3, 1 1/4	0/0	0/0	0/0	0/0	10/10	10/10	9/0	5/7	20	C+	C+	BRANCHES ON GROUND, FILL ON TRUNK, INTERTWINED IN OSL-15c, 15e & 15f, LOW BRANCHING
OSL-15e	QUERCUS AGRIFOLIA	2, 1	0/0	0/0	0/0	4/1	4/1	4/1	4/2	0/0	15	C+	C+	FILL ON TRUNK, INTERTWINED IN OSL-15d, LOPSIDED CANOPY, LOW BRANCHING
OSL-15f	QUERCUS AGRIFOLIA	(2) 1 1/2	0/0	3/6	5/5	5/5	5/5	4/2	4/4	2/2	12	C+	C+	FILL ON TRUNK, INTERTWINED IN OSL-15d, LOW BRANCHING

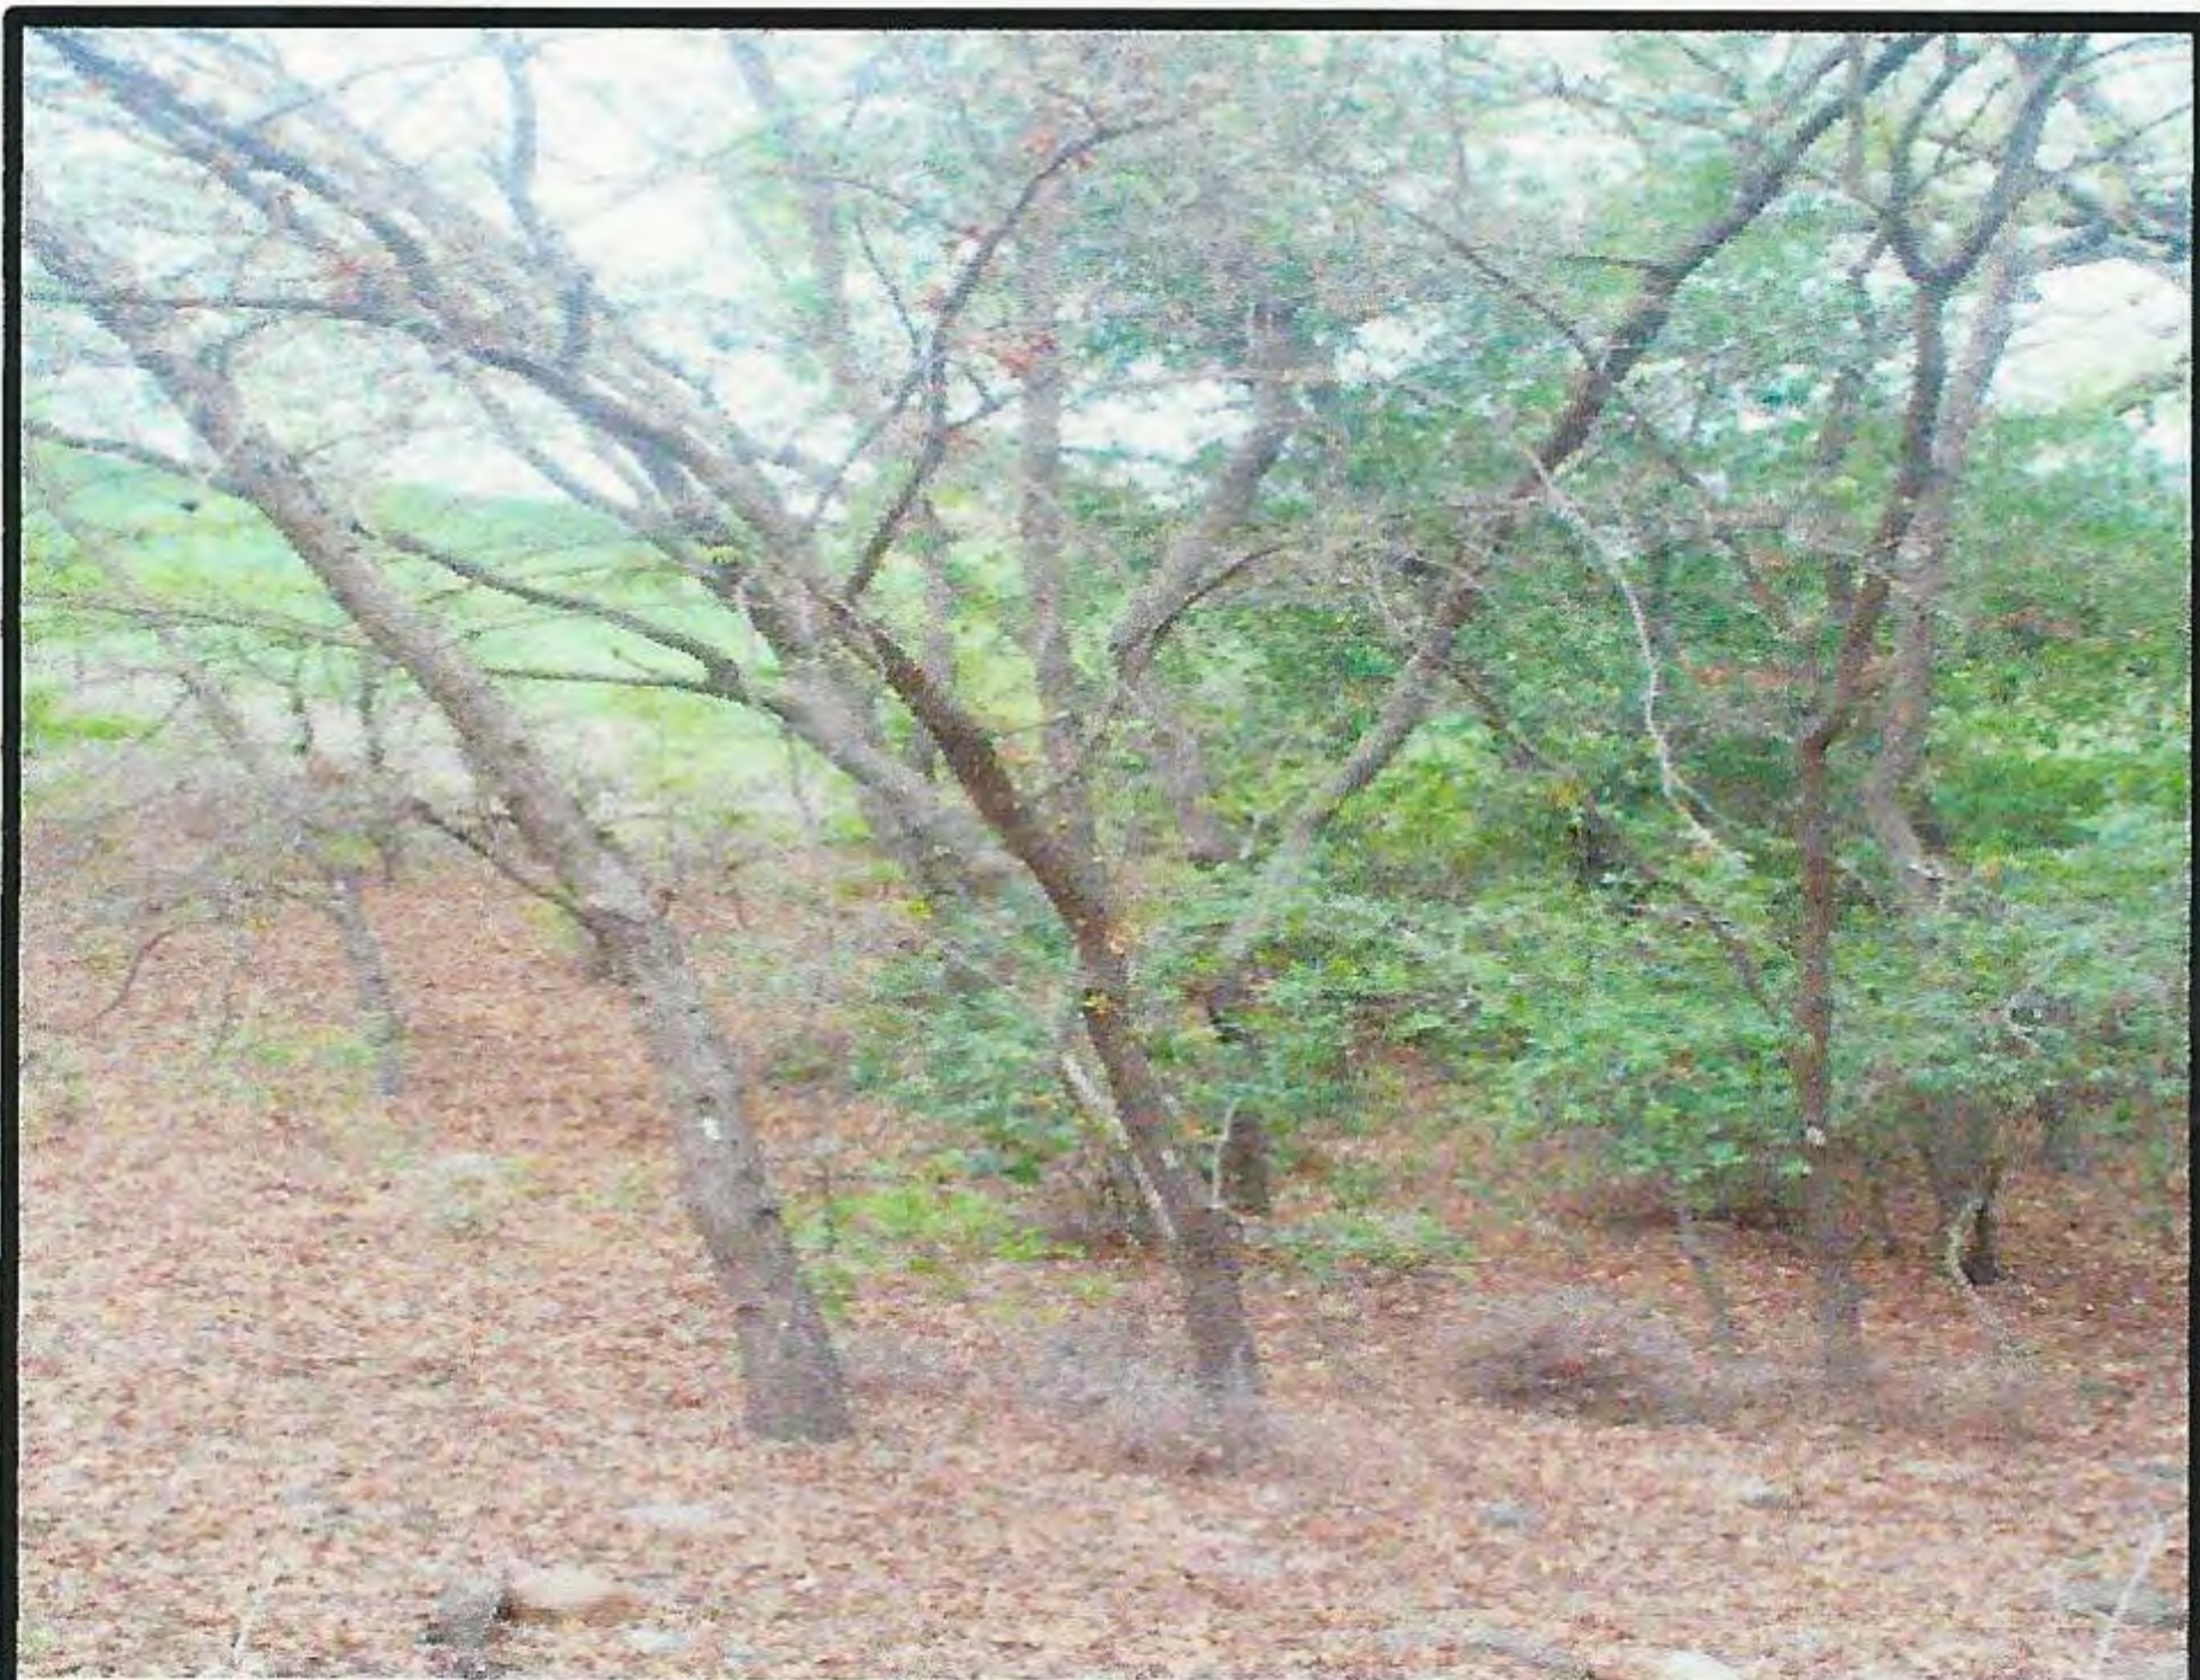
TREE NO.	TREE NAME	TRUNK DIA(S) IN INCHES	N	NE	E	SE	S	SW	W	NW	HT+ IN FEET	H'LTH	AESTH	NOTES & REMARKS
OSL-26	QUERCUS LOBATA	4 ½	16/14	23/12	0/0	0/0	0/0	0/0/	0/0	10/14	28	C+	C+	DEADWOOD, EPICORMIC GROWTH, FILL ON TRUNK, INTERTWINED IN OSL-25, LOPSIDED CANOPY, QUERCUS LOBATA SEEDLINGS IN DUFF
OSL-27	QUERCUS LOBATA	3 ½	23/18	14/6	0/0	0/0	0/0	0/0	0/0	0/0	28	D	D	FILL ON TRUNK, LOPSIDED CANOPY
OSL-28	QUERCUS LOBATA	3 3/8, 5 3/4	11/24	28/1	6/11	0/0	0/0	5/8	3/7	7/14	35	C	C	CO-DOMINANT TRUNKS, DEADWOOD, EPICORMIC GROWTH, FILL ON TRUNK, GALLS, INTERTWINED IN OSL-29 & 30 LOPSIDED CANOPY,
OSL-29	QUERCUS LOBATA	5 3/8	0/0	2/12	0/0	0/0	0/0	0/0	11/18	26/20	22	C	C	CO-DOMINANT TRUNKS, DEADWOOD, EPICORMIC GROWTH, FILL ON TRUNK, GALLS, INTERTWINED IN OSL-28 LOPSIDED CANOPY,
OSL-29a	QUERCUS LOBATA	4 3/8	0/0	5/2	20/2	5/3	4/5	0/0	0/0	0/0	40	C+	C+	DEADWOOD, EPICORMIC GROWTH, FILL ON TRUNK, LOPSIDED CANOPY, MECHANICAL DAMAGE, QUERCUS LOBATA SEEDLINGS IN DUFF, WATER TRAP

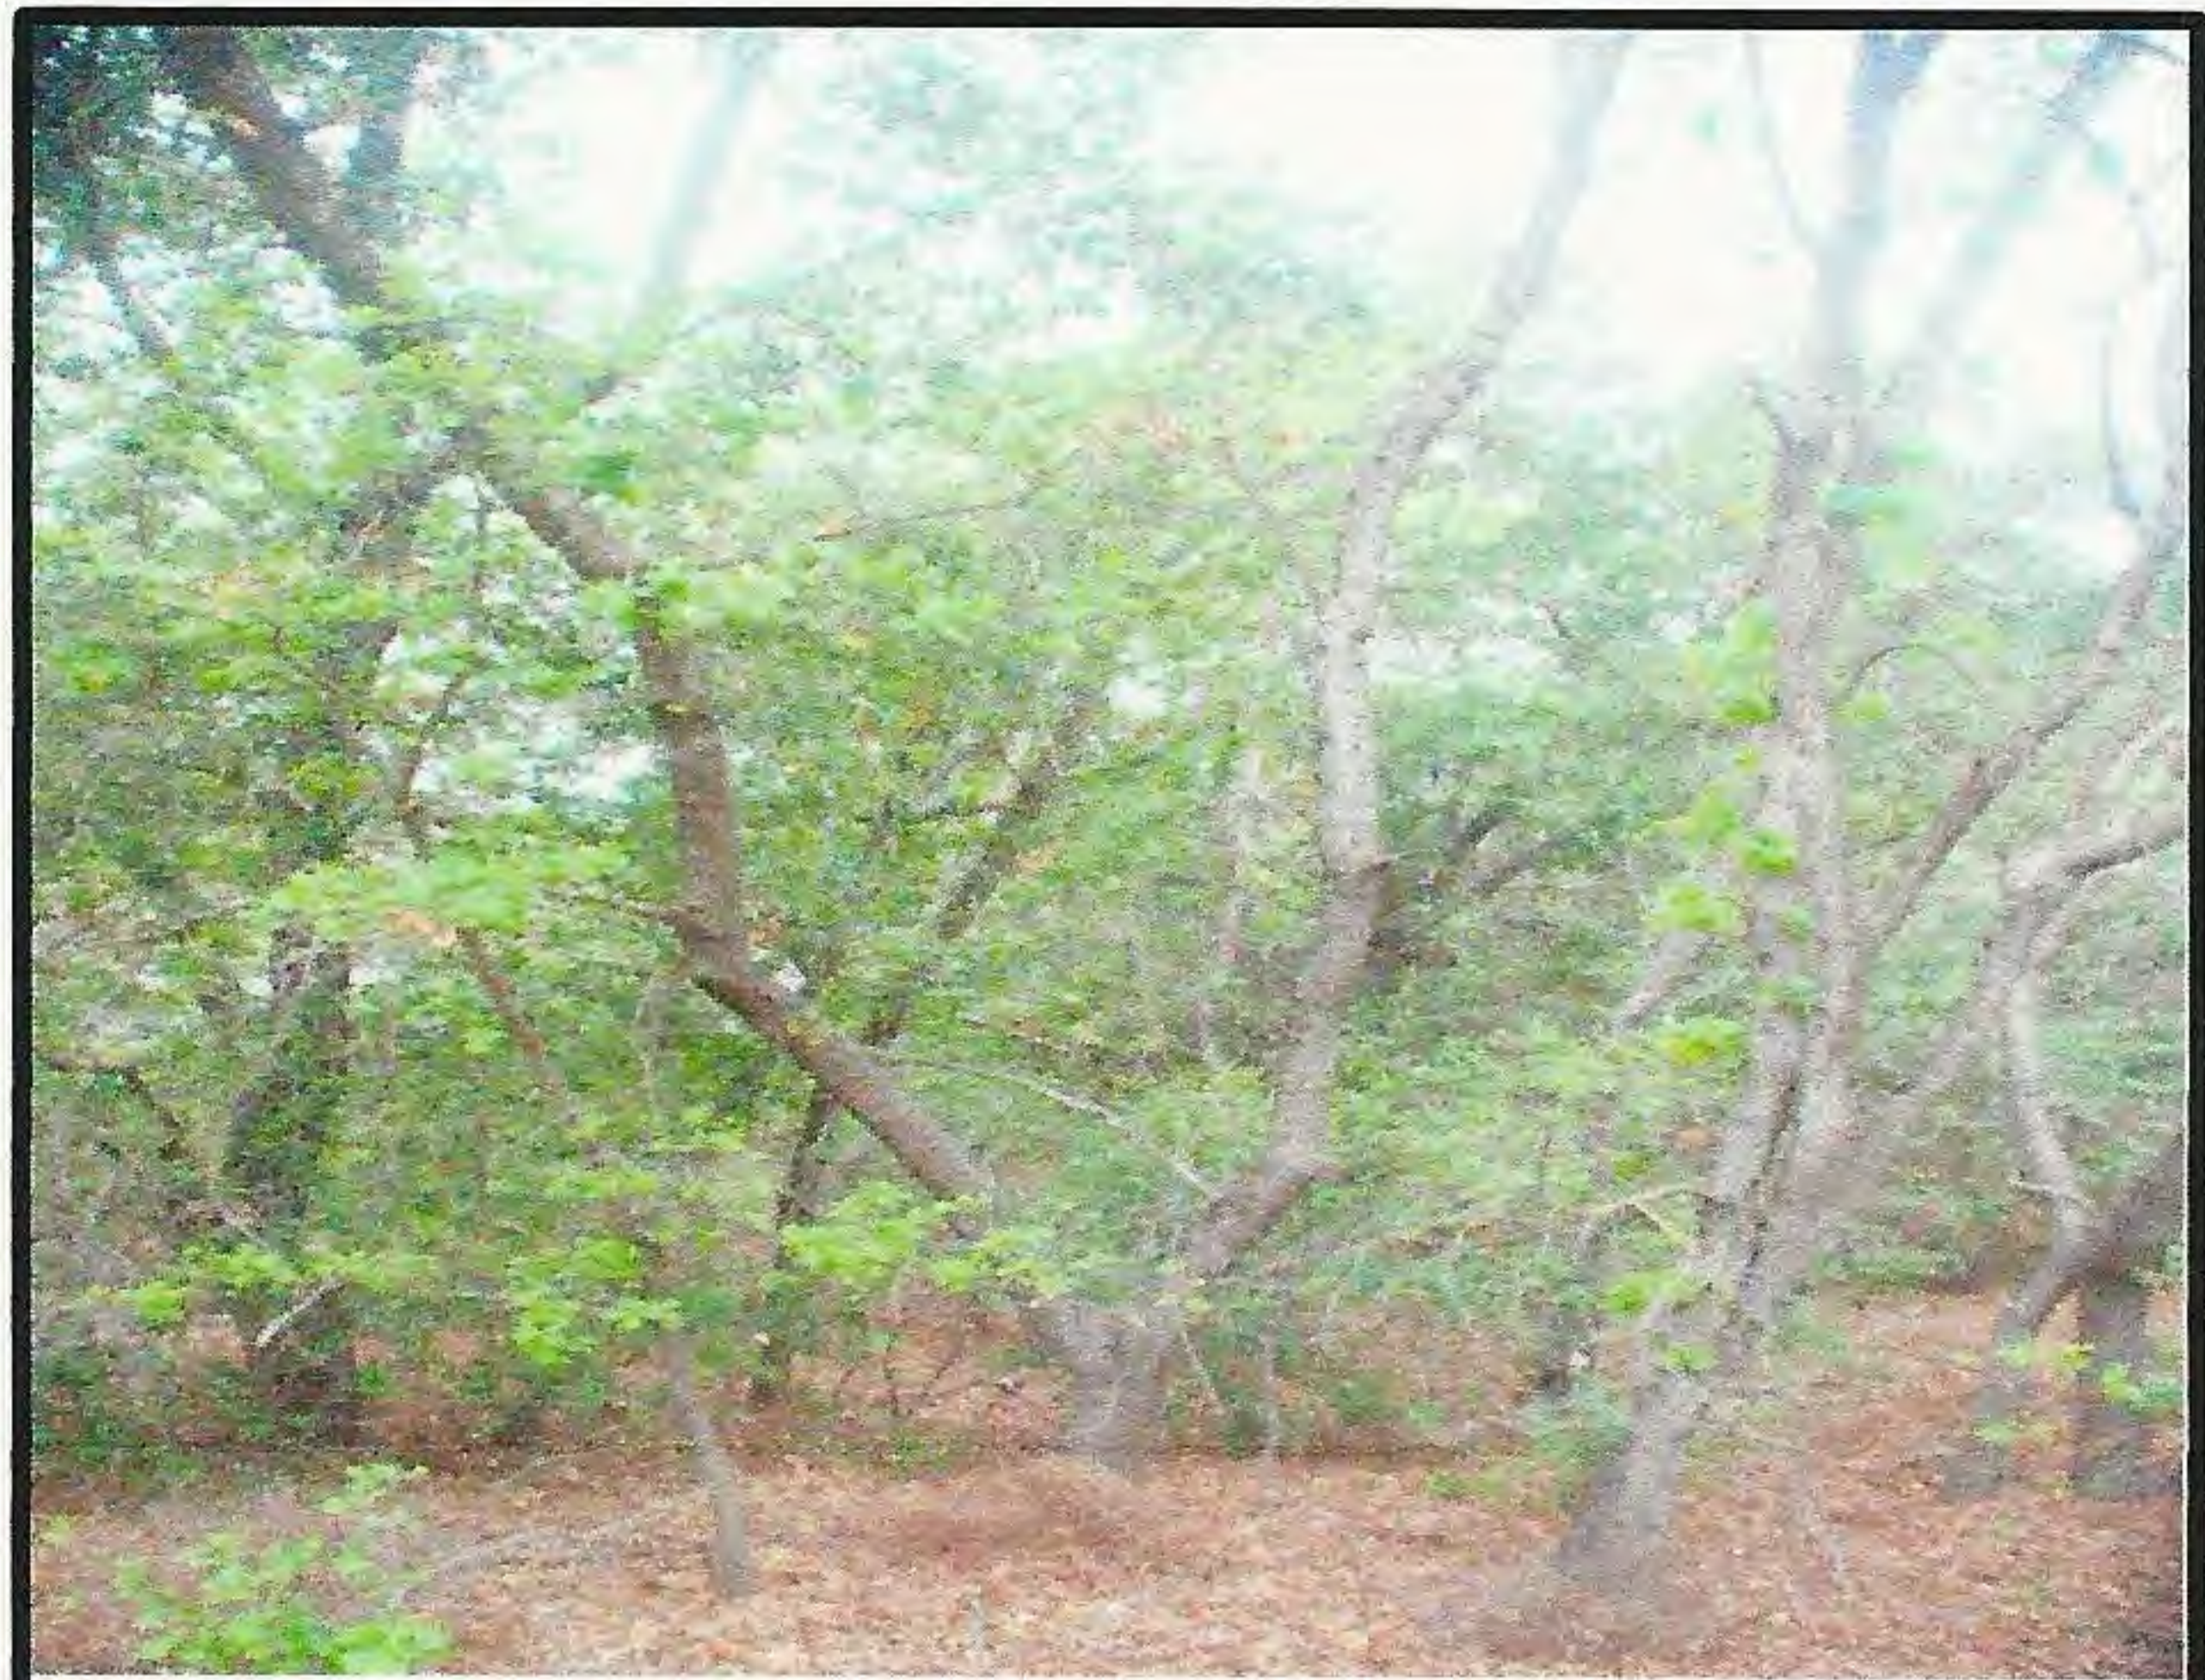
OSL-30	QUERCUS LOBATA	7 1/4, 6 3/8	20/23	25/21	26/20	6/5	0/0	0/0	0/0	0/0	40	C+	C+	CO-DOMINANT TRUNKS, CROSSING BRANCHES, DEADWOOD, EPICORMIC GROWTH, FILL ON TRUNK, INTERTWINED IN OSL-28 & 31, QUERCUS LOBATA SEEDLINGS IN DUFF
OSL-31	QUERCUS LOBATA	8, 7 1/4	13/22	26/20	24/17	12/0	9/24	14/15	16/22	14/14	37	C+	B-	CO-DOMINANT TRUNKS, DEADWOOD, EPICORMIC GROWTH, FILL ON TRUNK, GALLS, INTERTWINED IN OSL-30, 34 & 35
OSL-32	QUERCUS LOBATA	2 ½, 1	0/0	7/6	10/12	13/4	1/5	0/0	0/0	0/0	20	C	C	EPICORMIC GROWTH, FILL ON TRUNK,
OSL-33	QUERCUS LOBATA	2 ½	0/0	0/0	16/4	12/3	0/0	0/0	0/0	0/0	10	C	C	BRANCHES ON GROUND, DEADWOOD, EPICORMIC GROWTH, FILL ON TRUNK, GALLS, INTERTWINED IN OSL-35 & 40, LOW BRANCHING, TWIG GIRDLER
