**City Oak Tree
Consultant's Memorandum
and Oak Tree Report**

OAK TREE REPORT

OAKMONT SENIOR LIVING

OAKMONT SENIOR LIVING
29353 CANWOOD STREET
ALONG THE "101 FREEWAY CORRIDOR" AREA
OF THE CITY OF AGOURA HILLS, CALIFORNIA

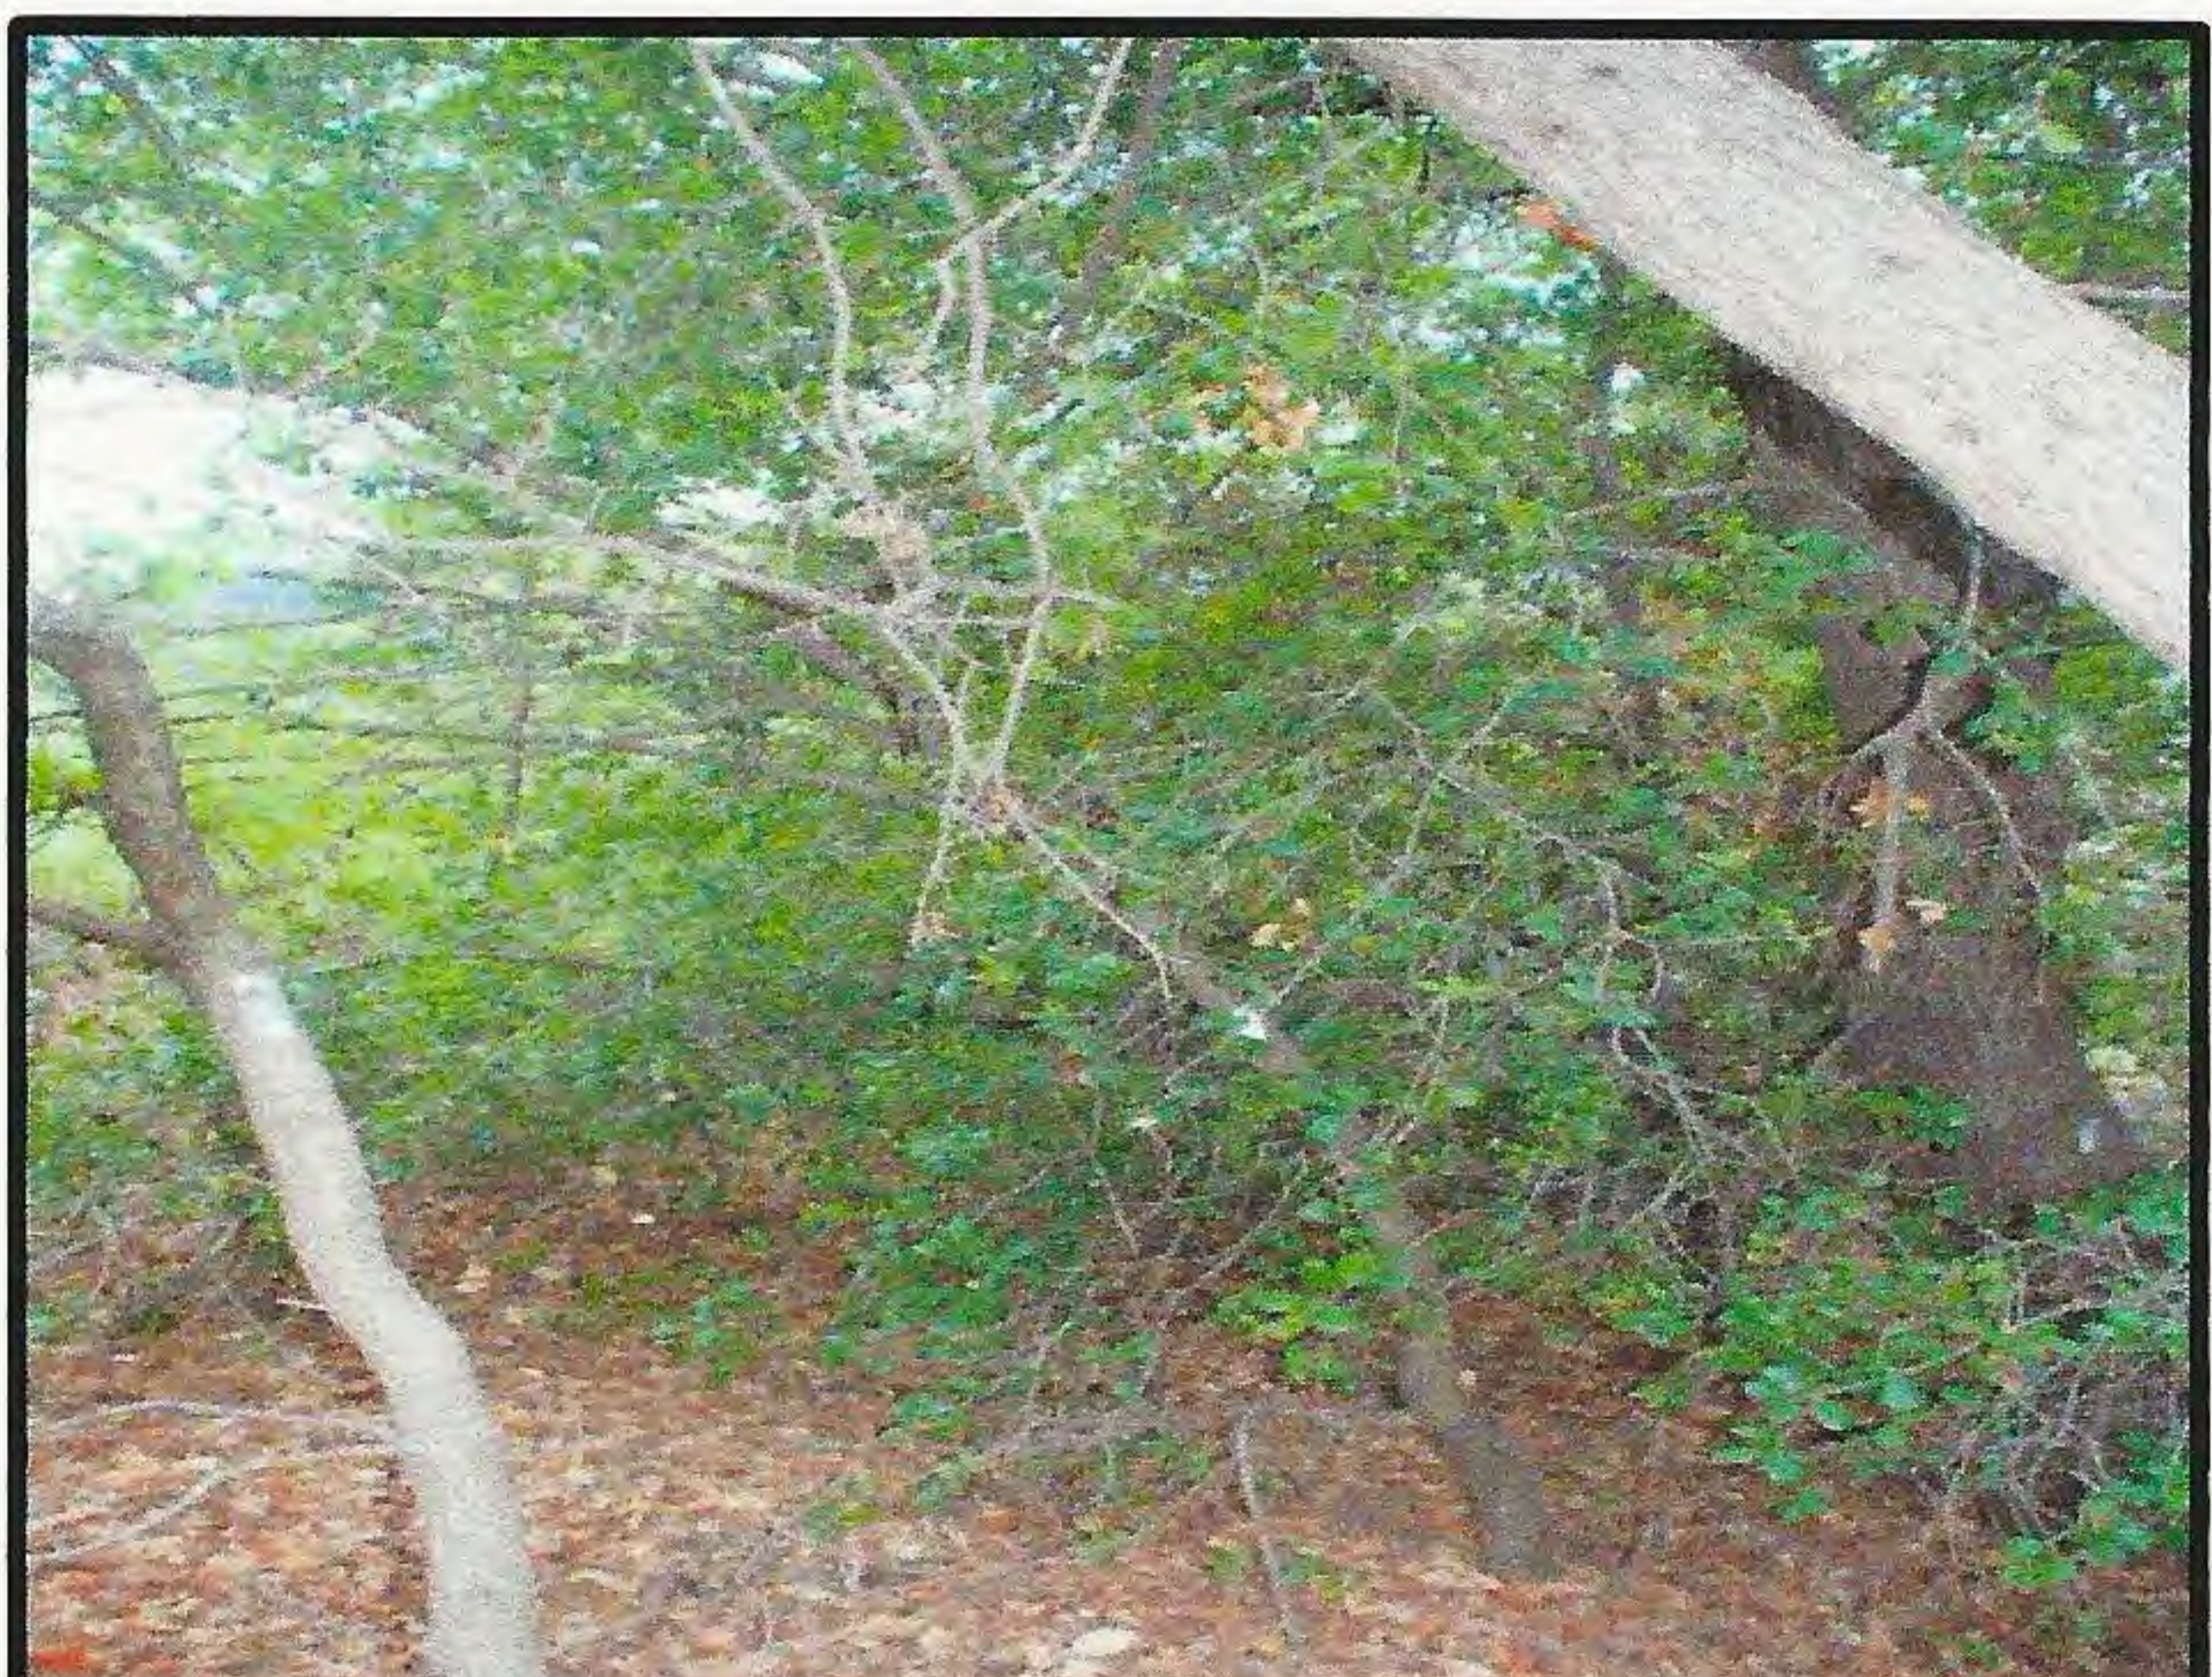
TREE NO.	TREE NAME	TRUNK DIA(S) IN INCHES	N	NE	E	SE	S	SW	W	NW	HT± IN FEET	H'LTH	AESTH	NOTES & REMARKS
OSL-34	QUERCUS AGRIFOLIA	4	9/0	10/2	4/10	0/0	0/0	3/6	6/6	8/12	28	C	C	FILL ON TRUNK, GALLS, INTERTWINED IN OSL-31 & 35, LEANS TO NORTH, TWIG GIRDLER
OSL-35	QUERCUS AGRIFOLIA	12 7/8	12/0	18/12	14/12	13/0	14/14	5/8	4/1	8/1	46	C+	B-	BRANCHES ON GROUND, CO-DOMINANT SCAFFOLDS, FILL ON TRUNK, GALLS, INTERTWINED IN OSL-31, 34, 36 & 54, LOW BRANCHING, BIRD'S NEST IN CANOPY
OSL-36	QUERCUS AGRIFOLIA	4 1/8, 3 7/8, (2) 2 3/4, 2 1/8, 1	11/12	9/4	10/0	8/0	8/0	10/1	6/10	10/3	30	C+	C	BRANCHES ON GROUND, CO-DOMINANT TRUNKS, CROSSING BRANCHES, FILL ON TRUNK, GALLS, INTERTWINED IN OSL-35, LOW BRANCHING
OSL-37	QUERCUS LOBATA	4	0/0	0/0	8/5	13/4	13/13	11/11	0/0	0/0	16	C	C	EPICORMIC GROWTH, FILL ON TRUNK, GALLS, LOW BRANCHING, TWIG GIRDLER, WOOD RAT NEST IN DUFF
OSL-37a	QUERCUS AGRIFOLIA	3 1/4	3/1	4/6	8/1	10/1	10/1	3/1	4/1	4/1	14	C+	C	BRANCH CAVITY, DEADWOOD, FILL ON TRUNK, LOW BRANCHING, TWIG GIRDLER

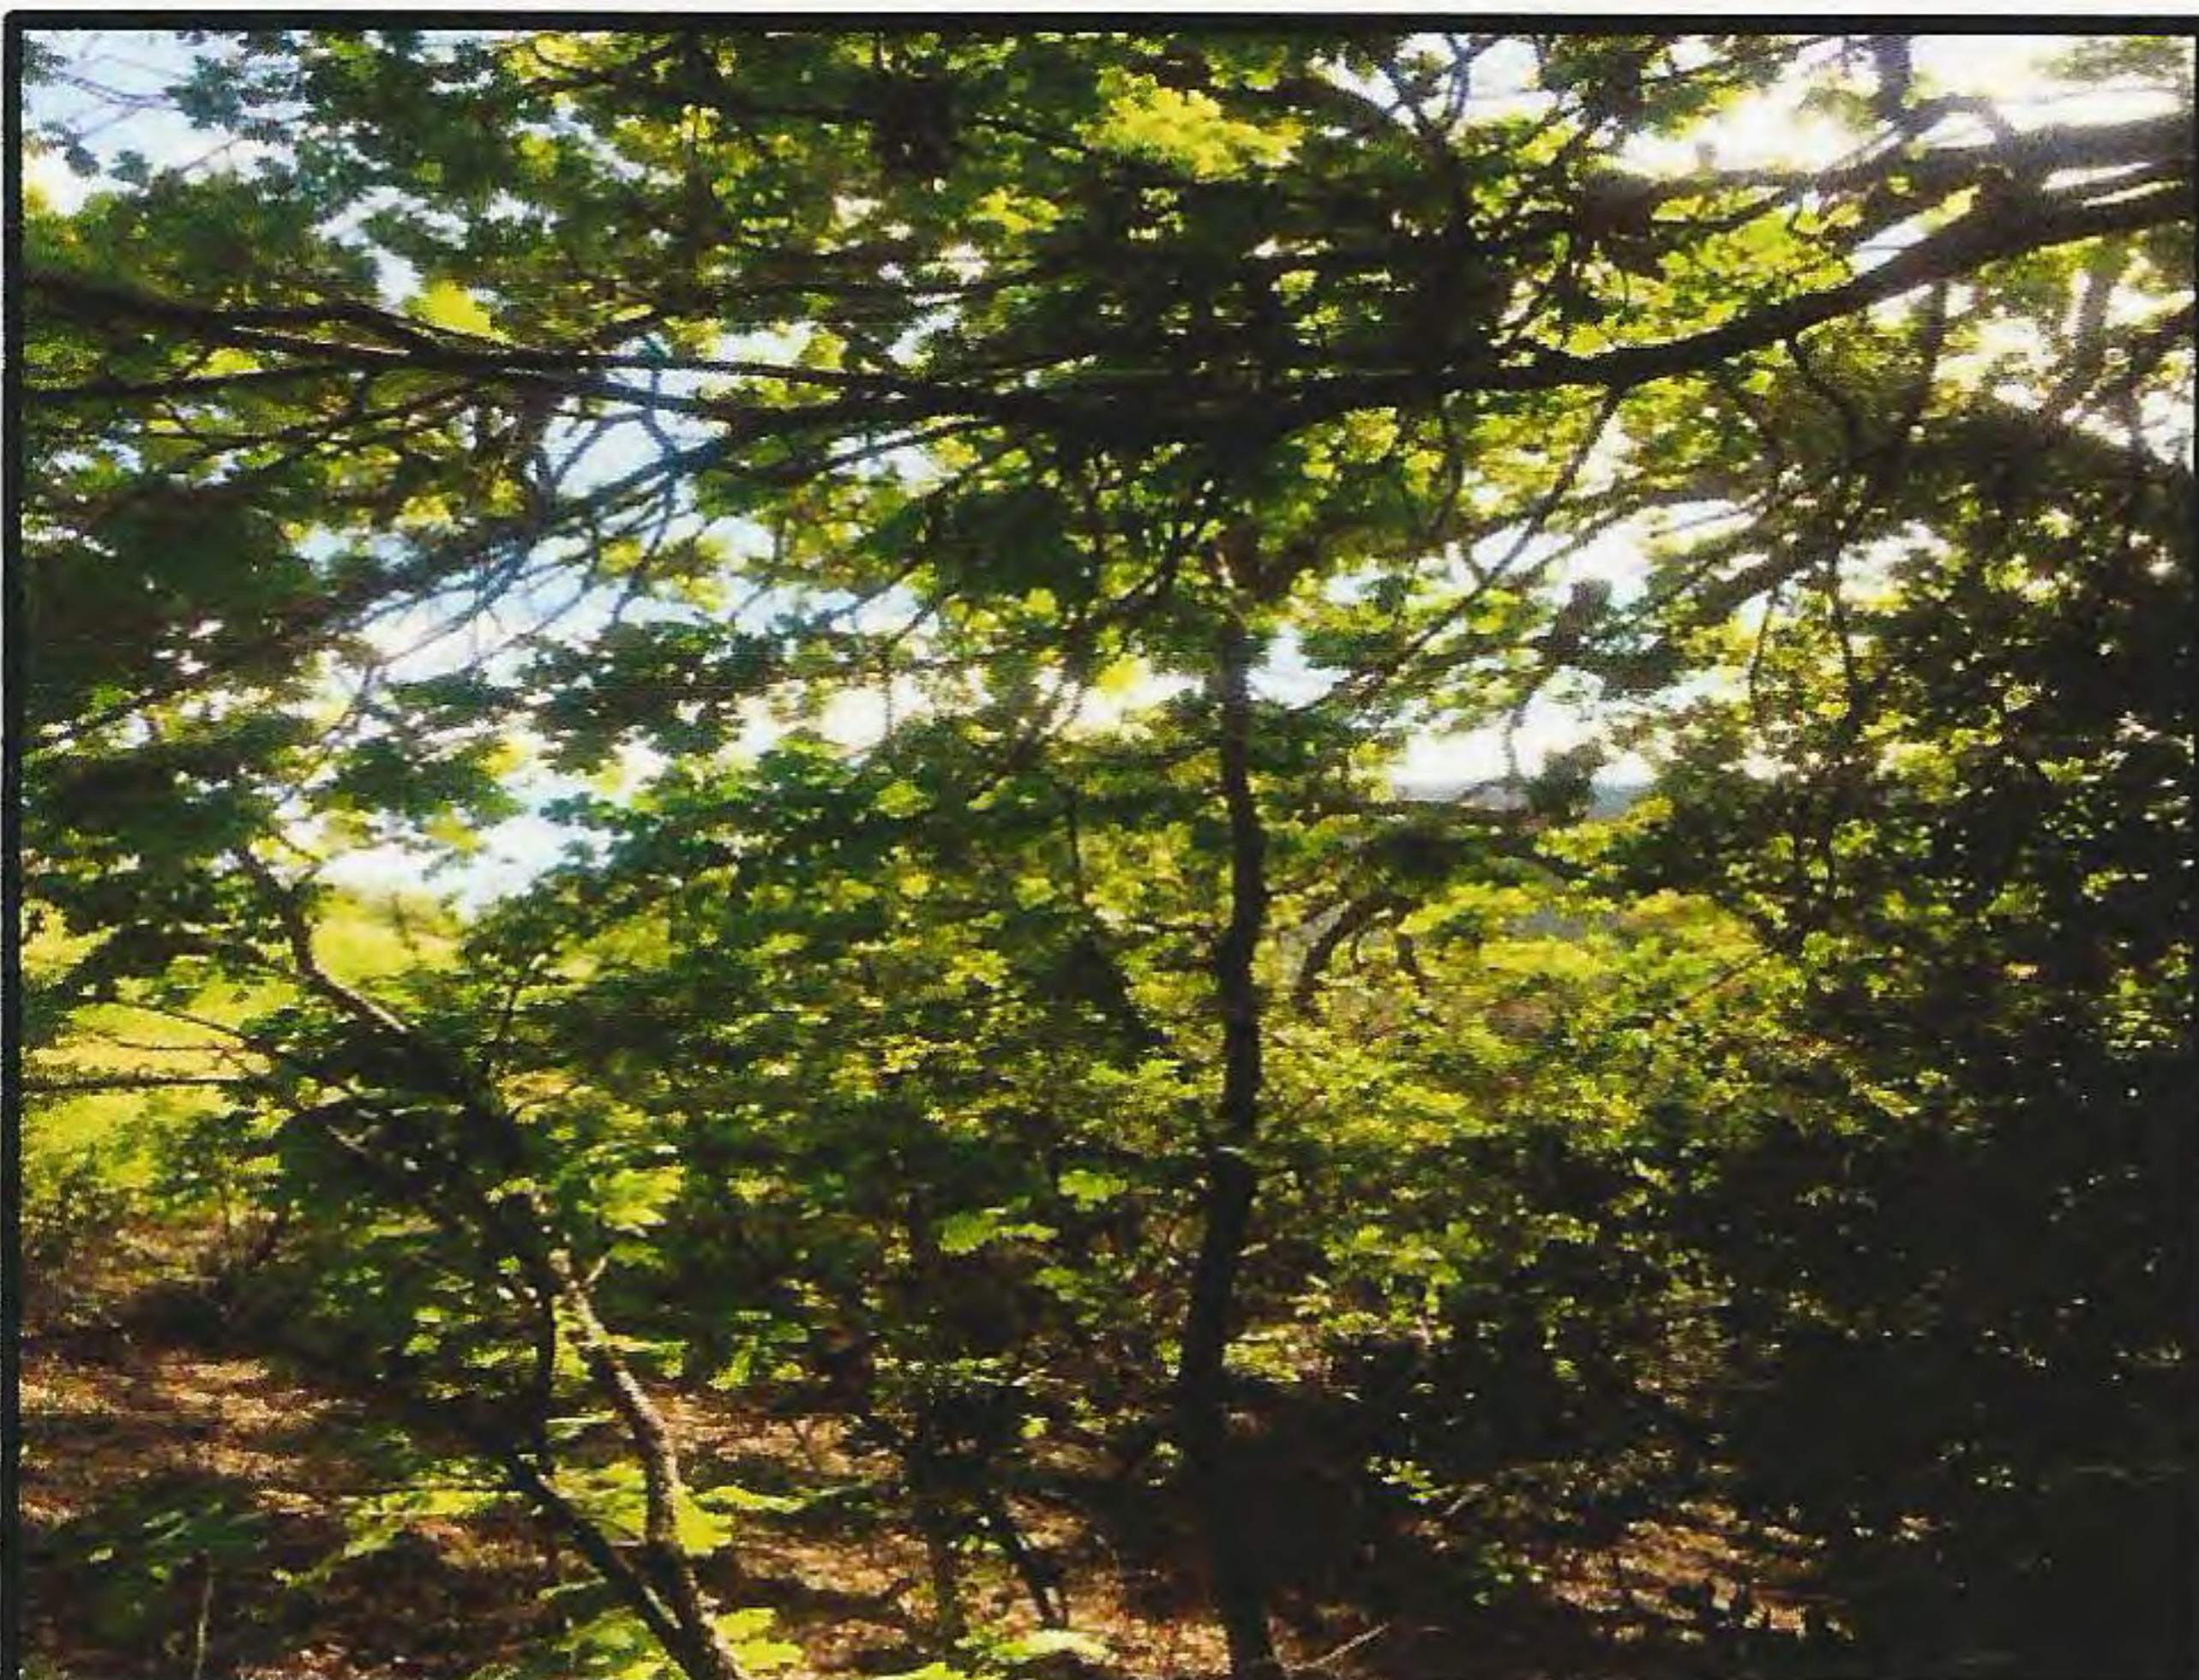
OSL-37b	QUERCUS LOBATA	2 1/4	0/0	5/8	3/7	5/4	6/5	6/5	1/11	0/0	17	C	C	DEADWOOD, EPICORMIC GROWTH, FILL ON TRUNK, GALLS, LOW BRANCHING
OSL-38	QUERCUS LOBATA	3 1/8	2/6	2/6	4/2	7/3	4/4	5/8	0/0	0/0	25	C	C	DEADWOOD, EPICORMIC GROWTH, FILL ON TRUNK, GALLS, LOW BRANCHING
OSL-38a	QUERCUS LOBATA	3 1/4	3/1	4/6	8/1	10/1	10/1	3/1	4/1	4/1	14	C+	C	DEADWOOD, EPICORMIC GROWTH, FILL ON TRUNK, GALLS, LOW BRANCHING
OSL-39	QUERCUS LOBATA	4, 3 3/8	8/12	11/15	13/15	10/10	9/6	6/10	6/12	7/11	20	C	C	CO-DOMINANT SCAFFOLDS, DEADWOOD, EPICORMIC GROWTH, FILL ON TRUNK, INTERTWINED IN OSL-54
OSL-40	QUERCUS LOBATA	5 3/4	21/25	4/12	0/0	0/0	0/0	0/0	0/0	0/0	40	C	C	DEADWOOD, EPICORMIC GROWTH, FILL ON TRUNK, LOPSIDED CANOPY
OSL-41	QUERCUS LOBATA	5 3/4	11/26	0/0	4/13	0/0	0/0	0/0	5/25	6/25	38	C	C	DEADWOOD, EPICORMIC GROWTH, FILL ON TRUNK, QUERCUS LOBATA SEEDLINGS IN DUFF

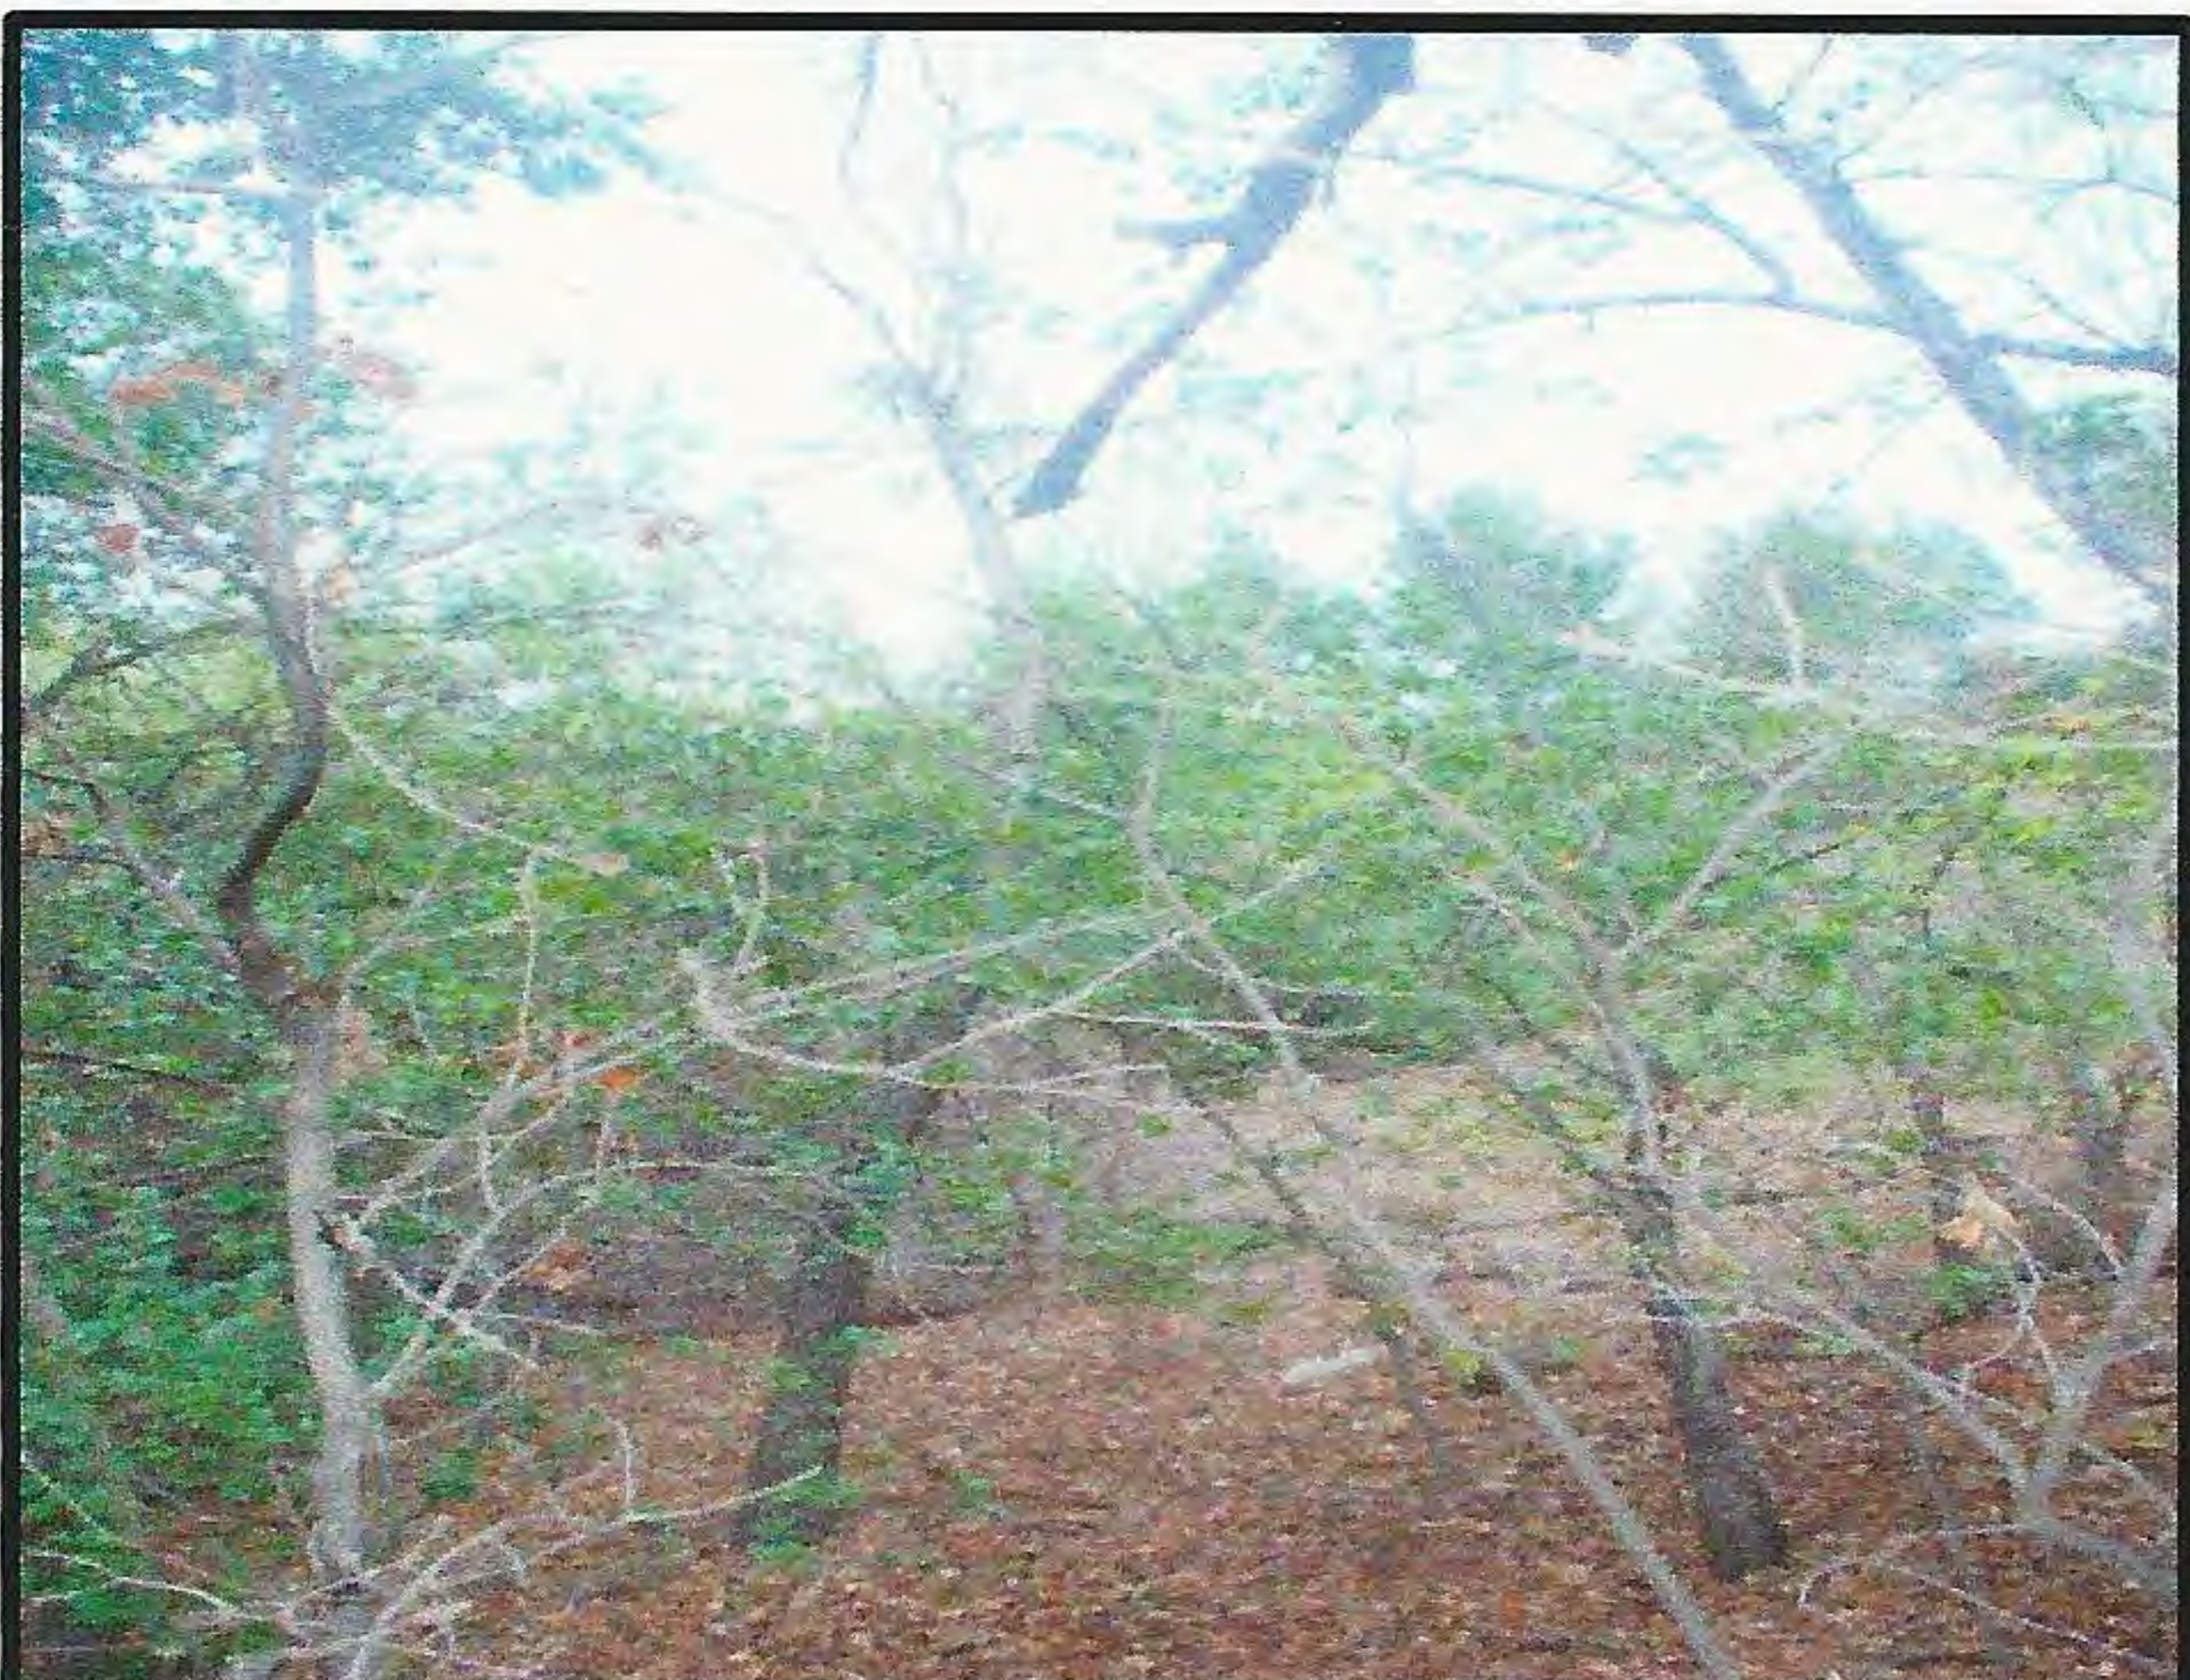
TREE NO.	TREE NAME	TRUNK DIA(S) IN INCHES	N	NE	E	SE	S	SW	W	NW	HT+ IN FEET	H'LTH	AESTH	NOTES & REMARKS
OSL-42	QUERCUS LOBATA	7 1/4	24/16	0/0	0/0	0/0	0/0	0/0	0/0	14/14	42	C	C	DEADWOOD, EPICORMIC GROWTH, FILL ON TRUNK, LOPSIDED CANOPY
OSL-43	QUERCUS AGRIFOLIA	3 3/8, 2	19.2	6/6	3/3	4/3	4/4	4/7	6/3	9/3	15	C-	B-	CO-DOMINANT TRUNKS, FILL ON TRUNK, INCLUDED BARK, LOPSIDED CANOPY, LOW BRANCHING, TWIG GIRDLER
OSL-44	QUERCUS LOBATA	5 1/4, 3 1/8	14/15	8/20	4/30	3/20	5/27	14/28	20/30	8/4	42	C-	C	BROKEN BRANCH SCARS, CO-DOMINANT TRUNKS, FILL ON TRUNK, GALLS, INTERTWINED IN OSL-51, LOPSIDED CANOPY
OSL-45	QUERCUS LOBATA	7 1/4	35	94	9/4	8/10	12/6	3/5	3/5	2/5	30	C	C	DEADWOOD, EPICORMIC GROWTH, FILL ON TRUNK, INTERTWINED IN OSL-46 & 54, LOW BRANCHING
OSL-46	QUERCUS LOBATA	5	8/6	8/13	9/11	6/16	7/12	10/17	14/19	11/23	31	C	C	DEADWOOD, EPICORMIC GROWTH, FILL ON TRUNK, INTERTWINED IN OSL-45
OSL-47	QUERCUS LOBATA	2 3/8	5/0	0/0	3/5	4/6	4/10	7/13	7/16	7/15	21	C	C	BROKEN BRANCH SCARS, DEADWOOD, EPICORMIC GROWTH, FILL ON TRUNK

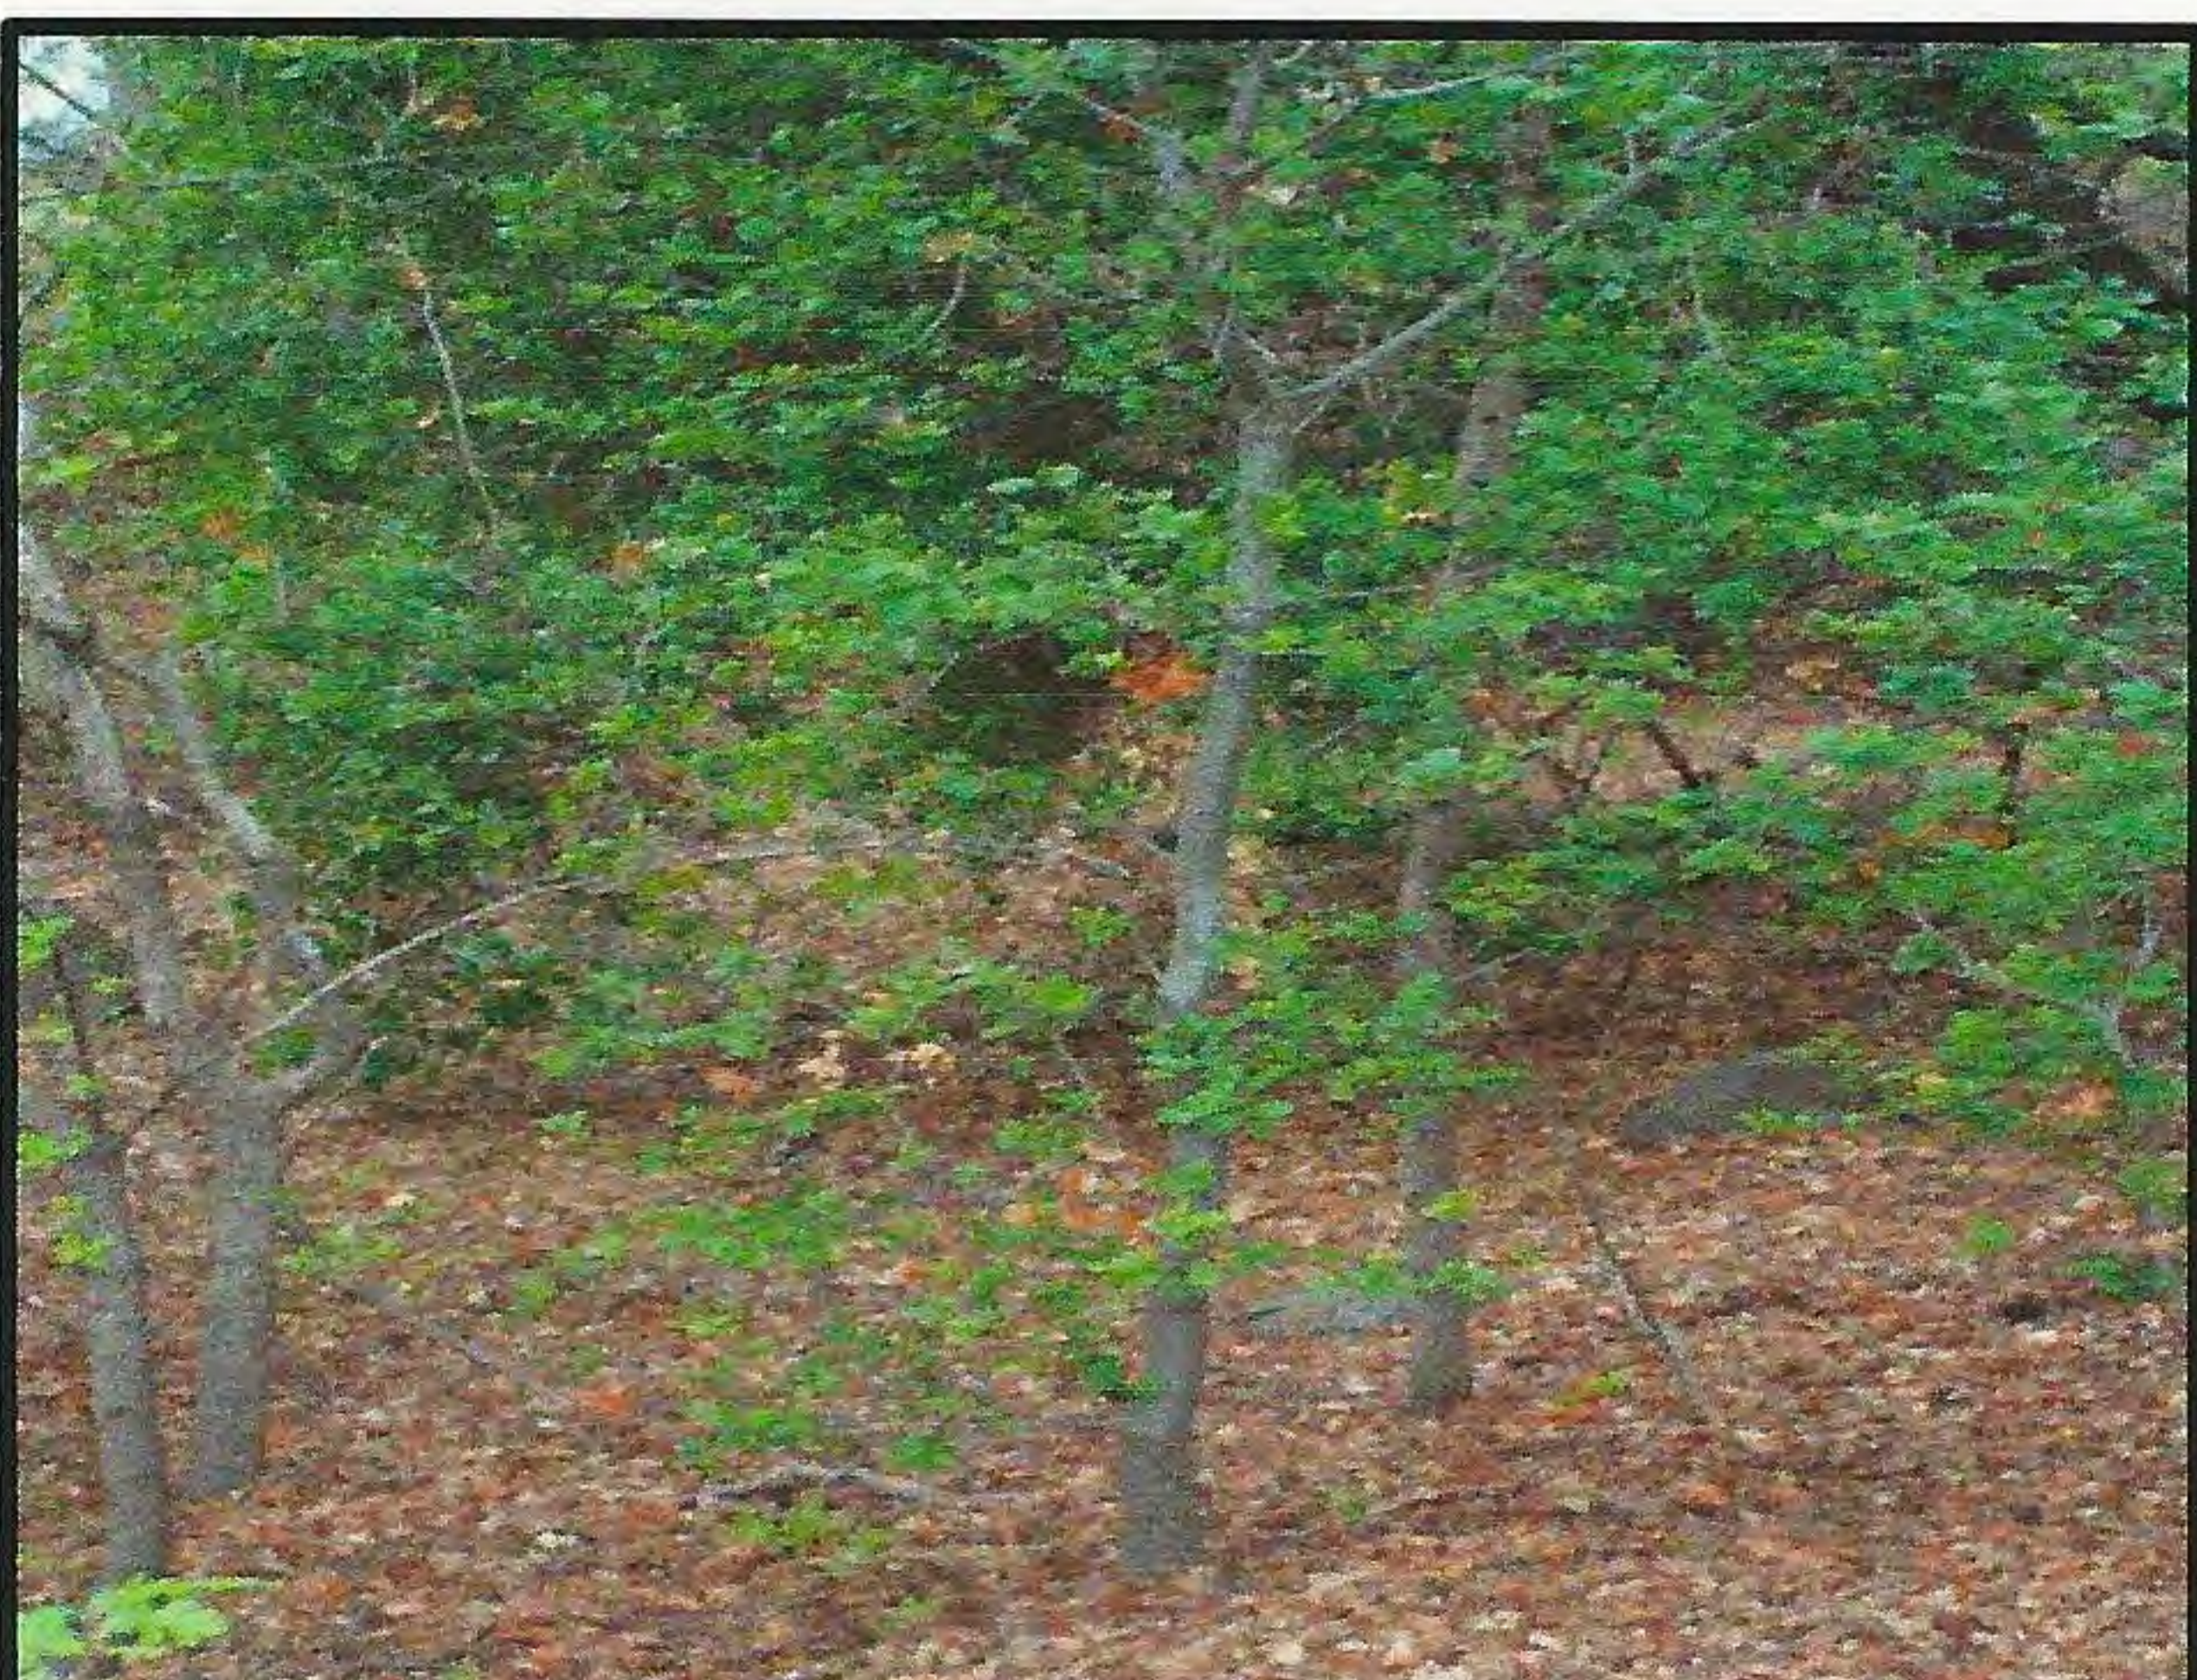
OSL-47a	QUERCUS AGRIFOLIA	2 3/8	4/4	6/5	8/5	6/8	3/2	3/2	3/4	3/7	22	C+	C	FILL ON TRUNK, GALLS, LOW BRANCHING, TWIG GIRDLER
OSL-48	QUERCUS LOBATA	3	6/20	7/18	9/20	0/0	0/0	0/0	6/16	6/18	24	D+	C-	BROKEN BRANCH SCARS, DEADWOOD, DIEBACK, EPICORMIC GROWTH, FILL ON TRUNK, GALLS, LOPSIDED CANOPY
OSL-49	QUERCUS LOBATA	8	14/34	0/0	0/0	0/0	0/0	0/0	0/0	15/32	48	C	C	DEADWOOD, EPICORMIC GROWTH, FILL ON TRUNK, LOPSIDED CANOPY
OSL-50	QUERCUS LOBATA	3 7/8	15/29	19/17	0/0	0/0	0/0	0/0	0/0	7/16	32	D+	C-	DEADWOOD, DIEBACK, FILL ON TRUNK, LOPSIDED CANOPY
OSL-50a	QUERCUS AGRIFOLIA	2 3/4	15/22	16/4	10/3	0/0	0/0	0/0	0/0	0/0	26	C+	C	BRANCHES ON GROUND, FILL ON TRUNK, LOPSIDED CANOPY, LOW BRANCHING, TWIG GIRDLER
OSL-51	QUERCUS AGRIFOLIA	22	38/3	30/8	22/12	18/0	16/3	24/1	20/1	30/0	70	B	B	DEADWOOD, FILL ON TRUNK, INTERTWINED IN OSL-54, BIRD'S NEST IN CANOPY

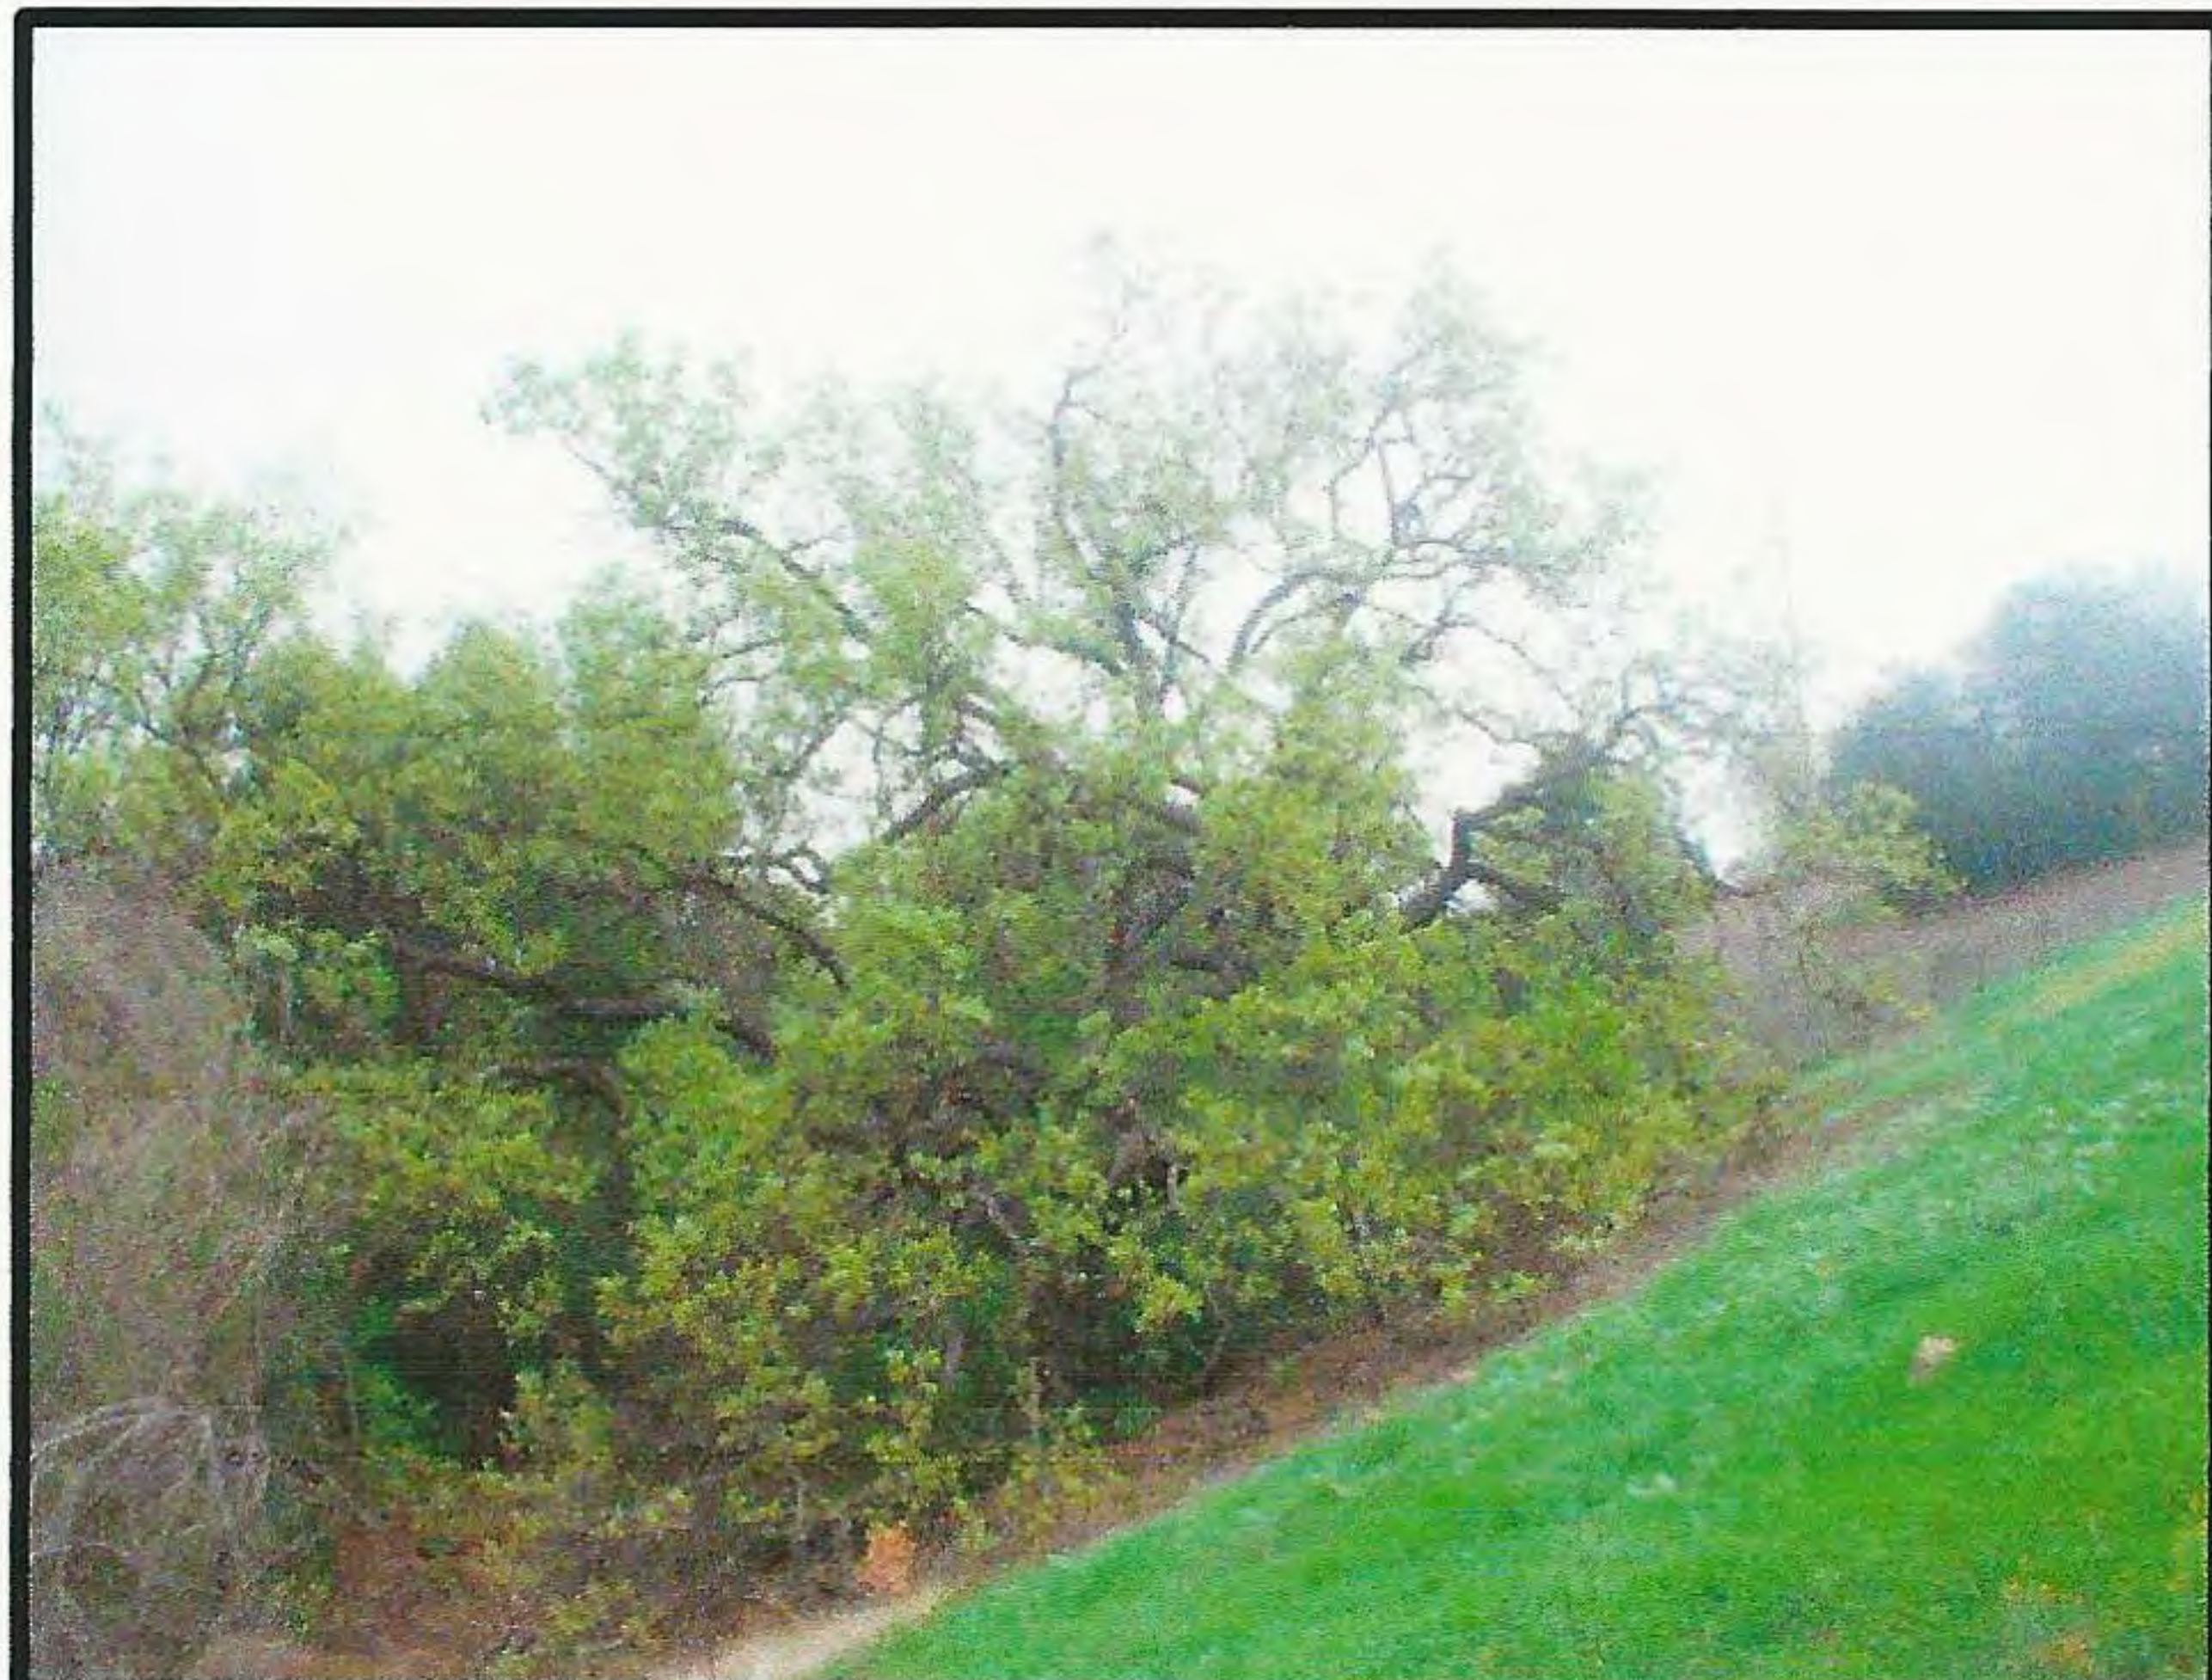
It is our recommendation that pruning be performed to allow for clearance from the proposed retaining wall construction, as no construction activity is proposed within the Protected Zone of any other Oak Tree(s). Only Oak Trees OSL-10, OSL-54 and OSL-55 appear to be affected by the proposed retaining wall or any other construction activity.
