**City Oak Tree
Consultant's Memorandum
and Oak Tree Report**

OAK TREE REPORT

OAKMONT SENIOR LIVING

OAKMONT SENIOR LIVING
29353 CANWOOD STREET
ALONG THE "101 FREEWAY CORRIDOR" AREA
OF THE CITY OF AGOURA HILLS, CALIFORNIA

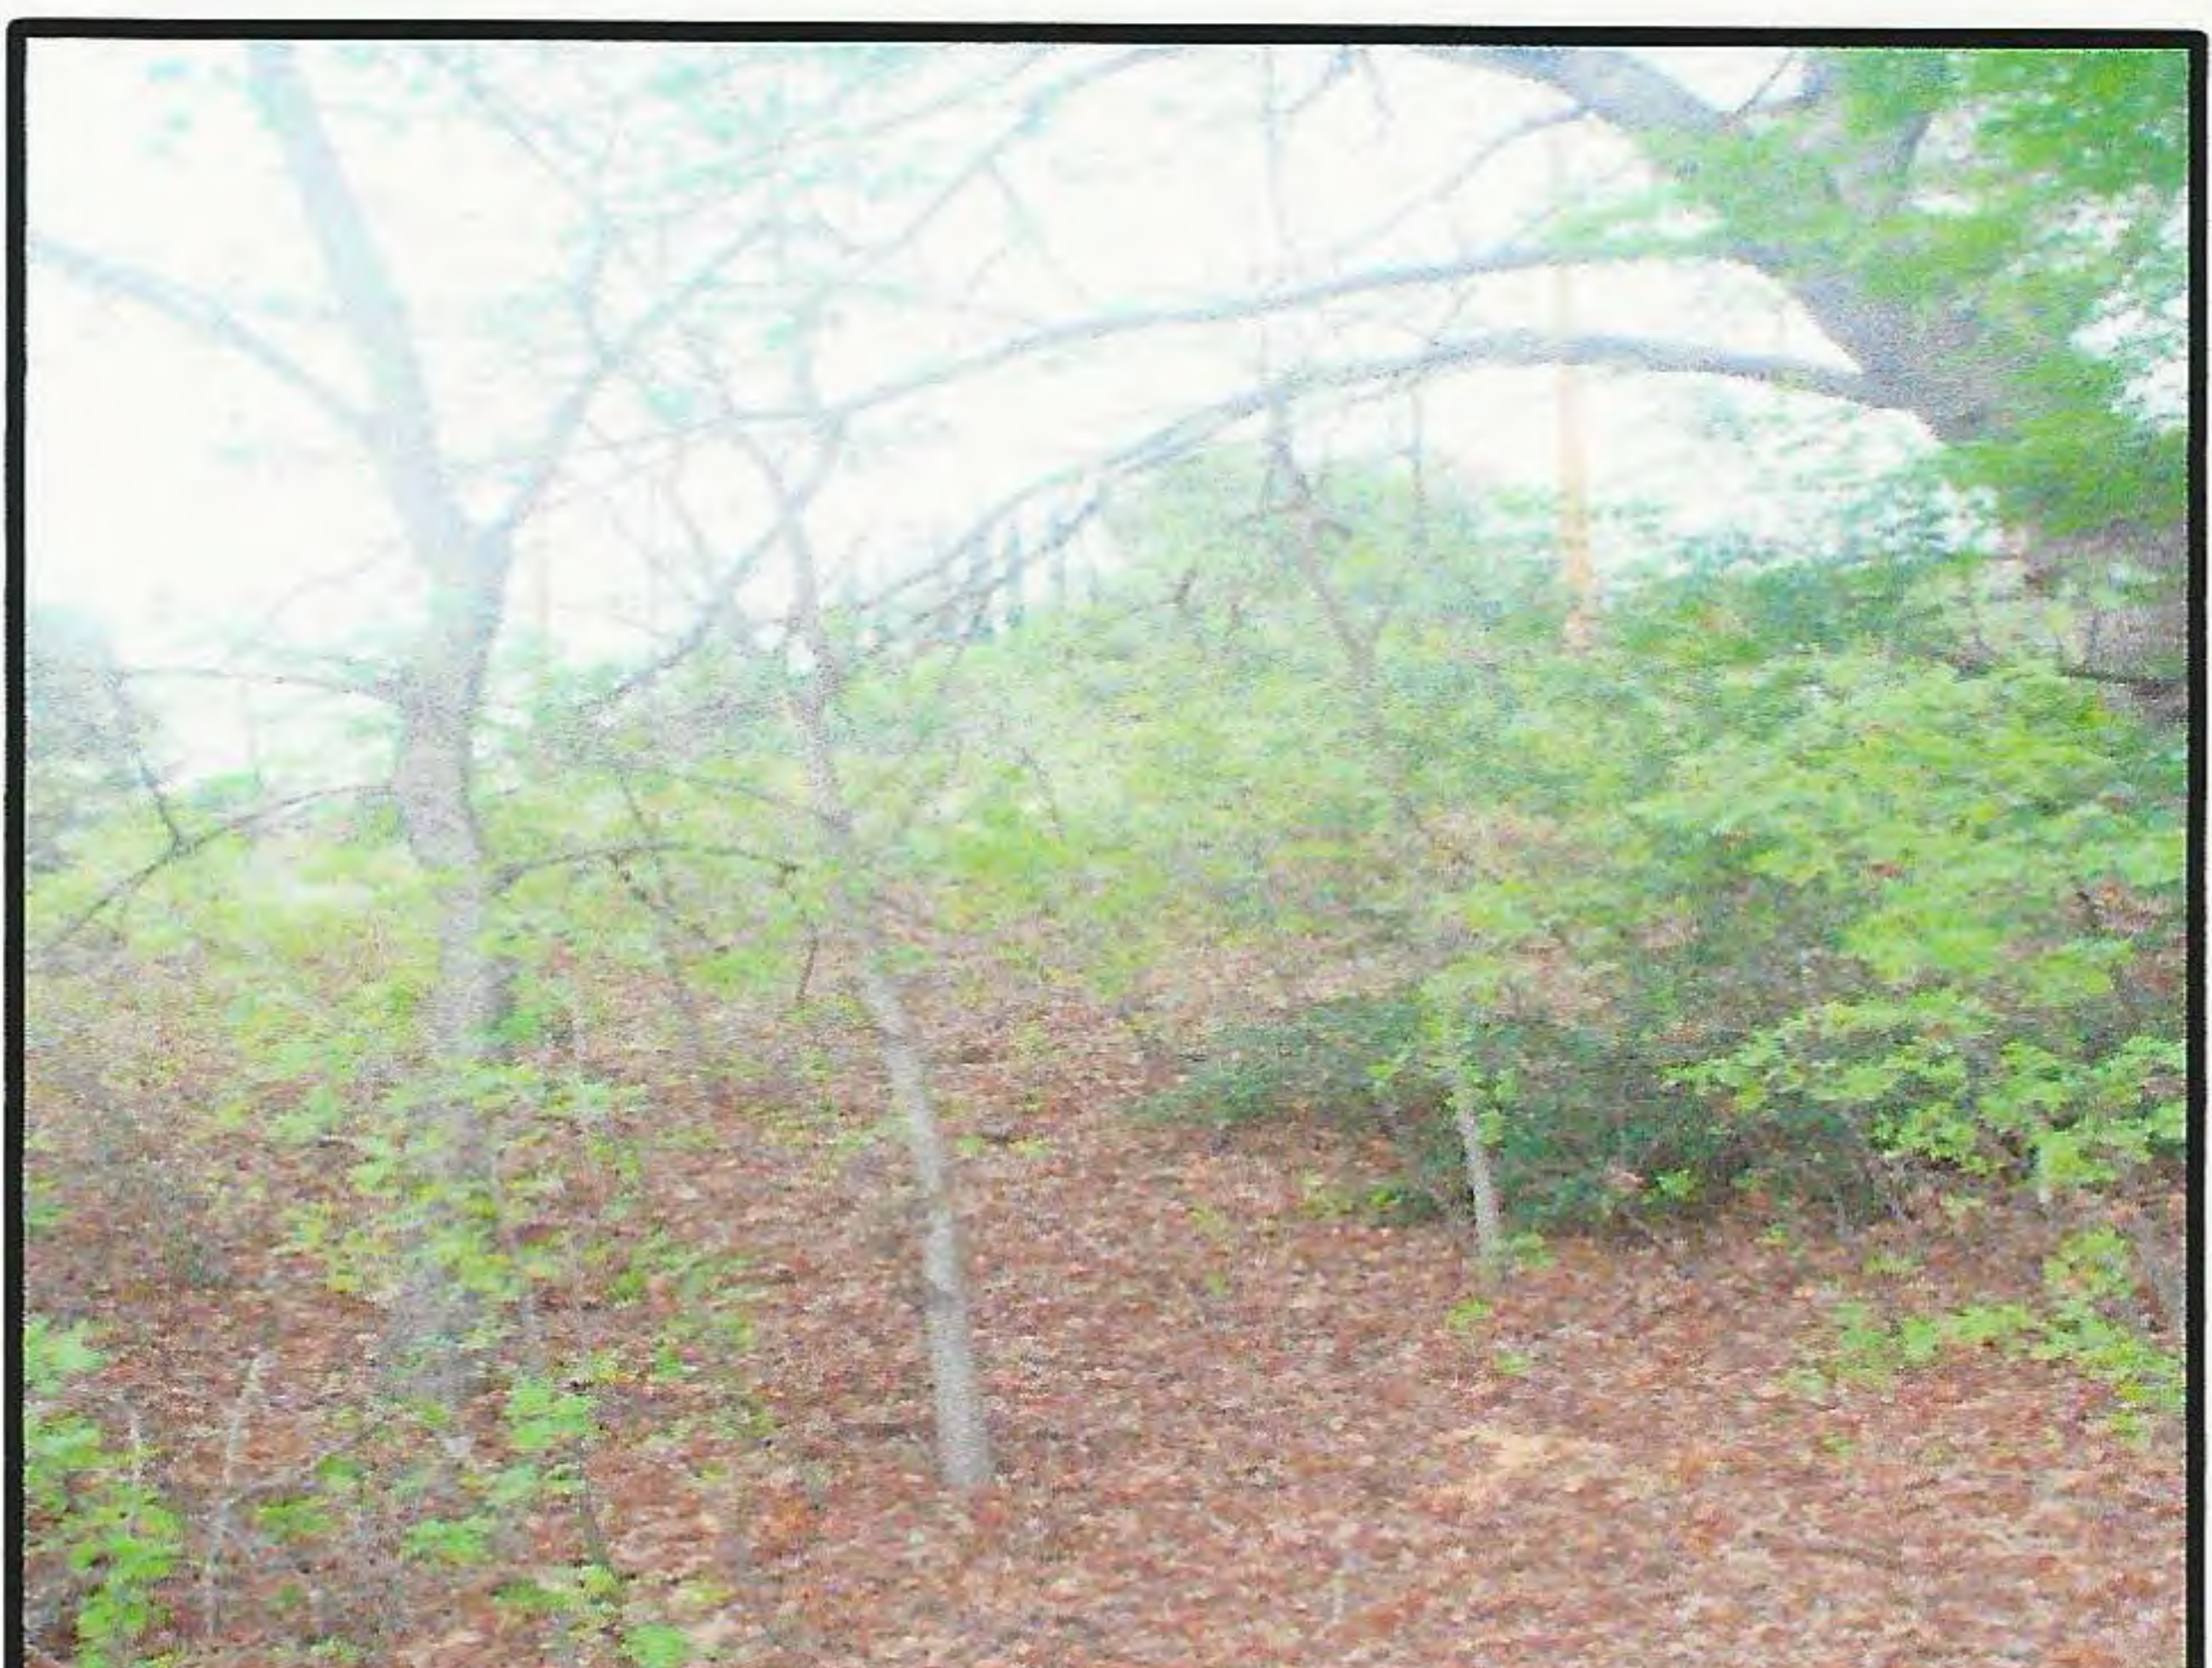
TREE NO.	TREE NAME	TRUNK DIA(S) IN INCHES	N	NE	E	SE	S	SW	W	NW	HT+ IN FEET	H'LTH	AESTH	TREE NO.
OSL-58	QUERCUS LOBATA	11 1/4, 5 1/4	0/0	0/0	0/0	8/8	7/2	34/5	32/4	0/0	34	C+	C+	LOCATED ON RIPARIAN SLOPE, BROKEN BRANCH SCARS, CONJOINED TRUNKS, GALLS, LEANS TO WEST, QUERCUS AGRIFOLIA AND LOBATA SEEDLINGS IN DUFF
OSL-59	QUERCUS LOBATA	26	48/16	44/30	20/28	18/22	18/33	25/35	010	45/2	65	C+	C+	LOCATED ON RIPARIAN SLOPE, CROSSING BRANCHES, DEADWOOD, EPICORMIC GROWTH, FILL ON TRUNK, GALLS, LEANS TO WEST, BIRD'S NEST IN CANOPY, QUERCUS AGRIFOLIA AND LOBATA SEEDLINGS IN DUFF
OSL-60	QUERCUS LOBATA	3 1/4	0/0	0/0	0/0	0/0	5/13	10/0	11/1	0/0	14	C-	C	BRANCHES ON GROUND, DEADWOOD, EPICORMIC GROWTH, FILL ON TRUNK. GALLS, LEANS TO SOUTHWEST, LOPSIDED CANOPY, QUERCUS AGRIFOLIA SEEDLINGS IN DUFF
