Oak Tree Reports

OAK TREE SURVEY
FOR
AGOURA OAKS PLAZA
29701 AGOURA ROAD

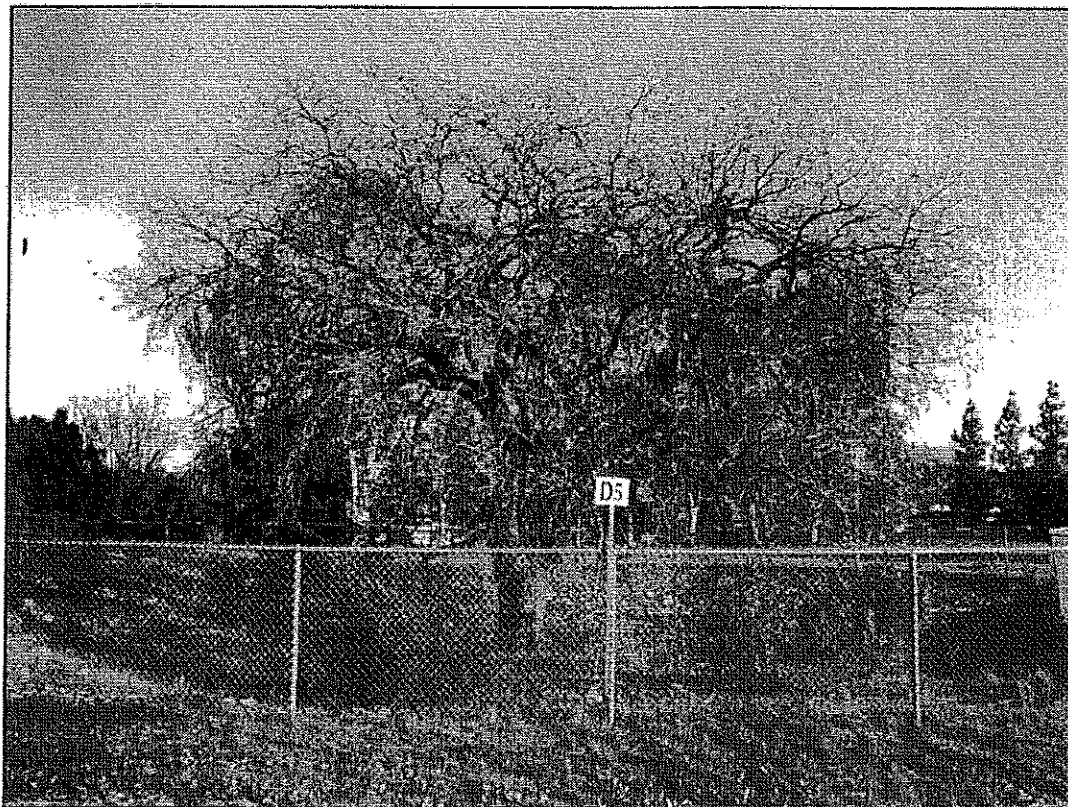
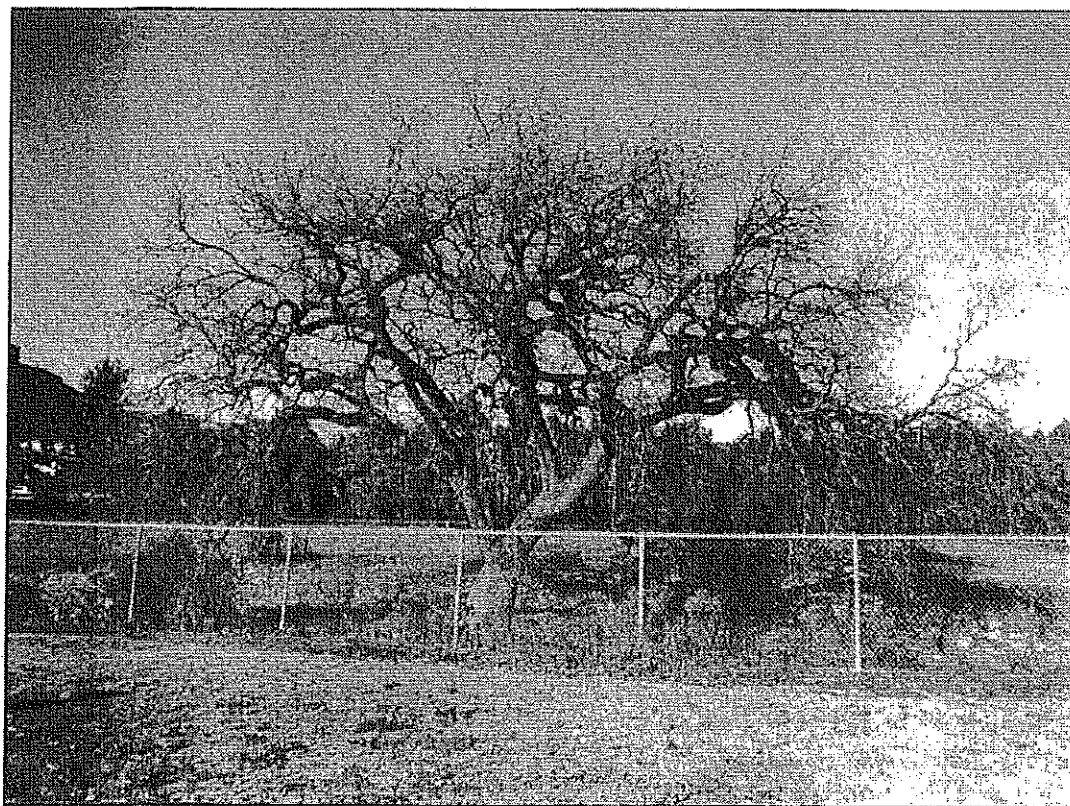
Tree 100 facing east

Tree #100 is a heritage Valley Oak tree that is located in the central portion of the subject property (Figure 1). Currently the tree has a health rating of "A" and an appearance rating of "B" (Plates 1-4). This tree that has thrived in a location with no competition, but has been subjected to poor care. There are several locations where this tree has been poorly pruned and exudations or bark stains are representative. There is a fair amount of dead wood in this tree, and the canopy appears to overweight for the tree structure. The remains of broken cables are still present in the tree. There are a number of exotic species growing under the canopy and pieces of broken concrete.

- Remove deadwood from the canopy,
- Remove exotic species growing under the canopy,
- Remove concrete and other rubbish from under the canopy,
- Do not remove the leaf mulch under the canopy,
- Remove broken cables, and
- Reduce weight in the canopy as may be necessary to avoid limb failure where cables have broken.

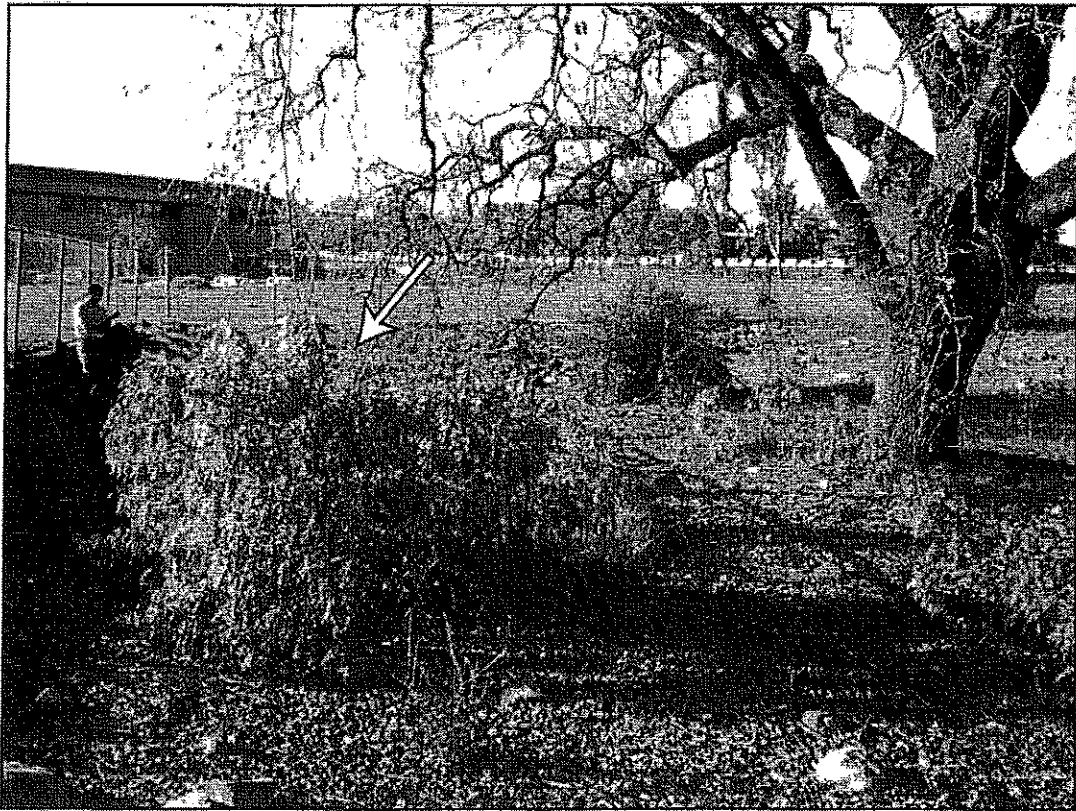
Exotic species (California pepper) located under the canopy of the tree

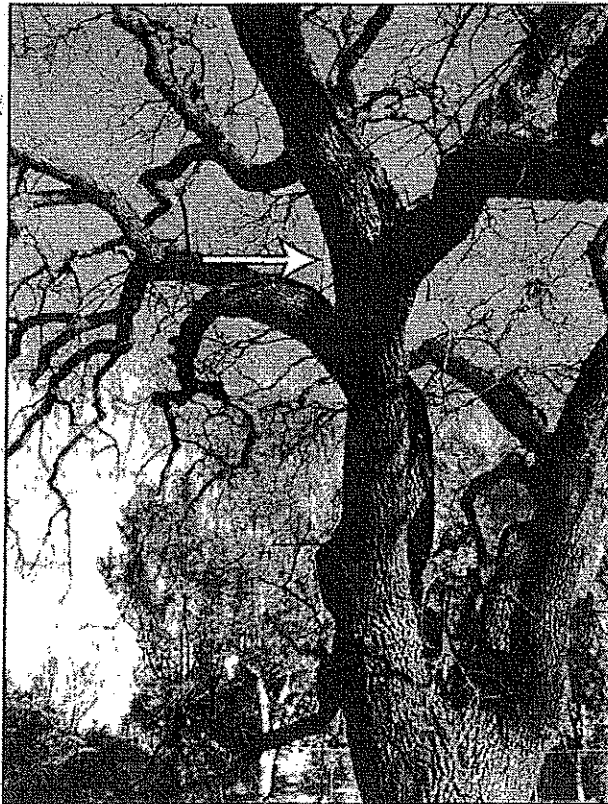
Broken cable hanging from a limb

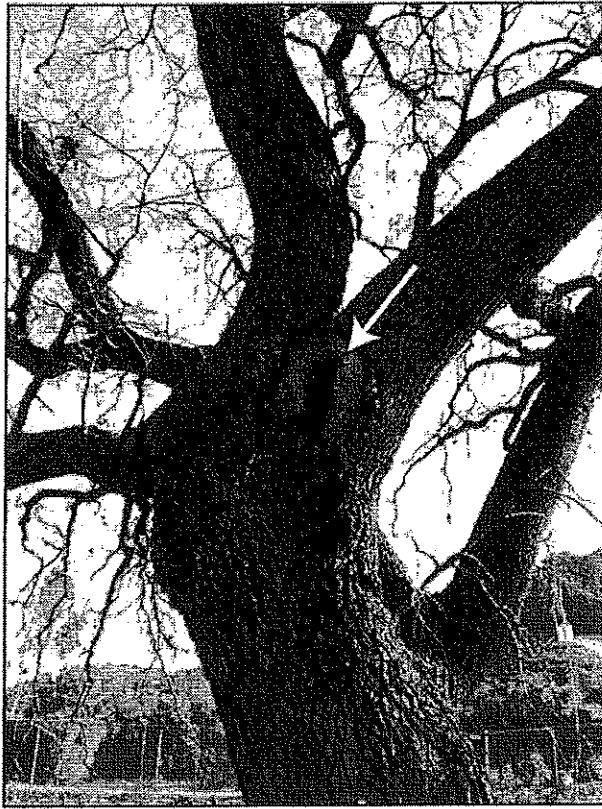
Cavity located below main crotch

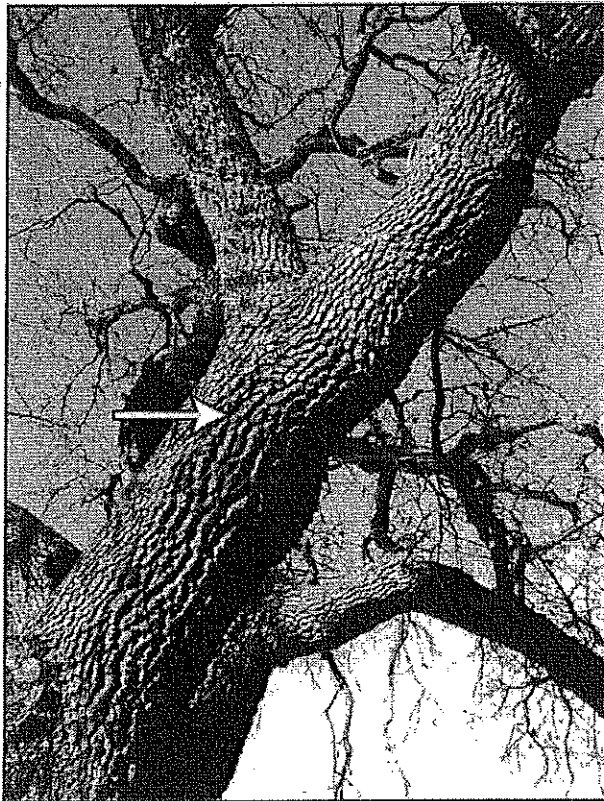
Exudation (stain) along underside of major limb

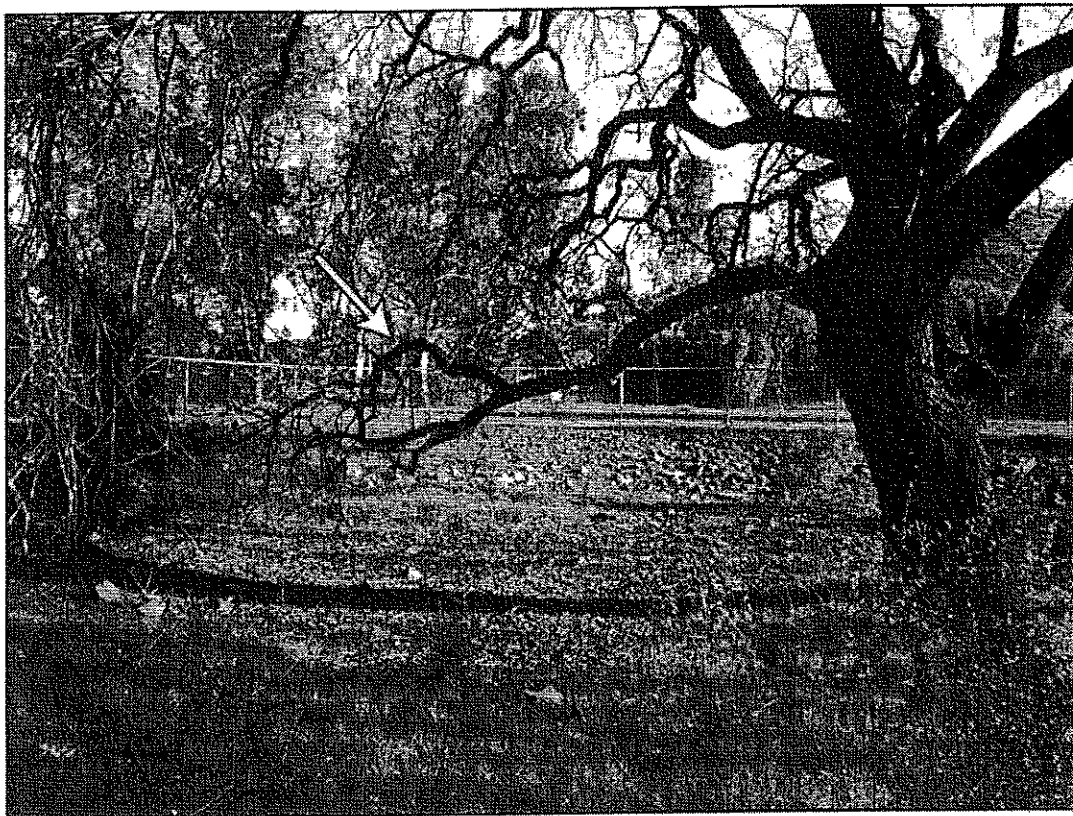
Low hanging branch trending north east from trunk.

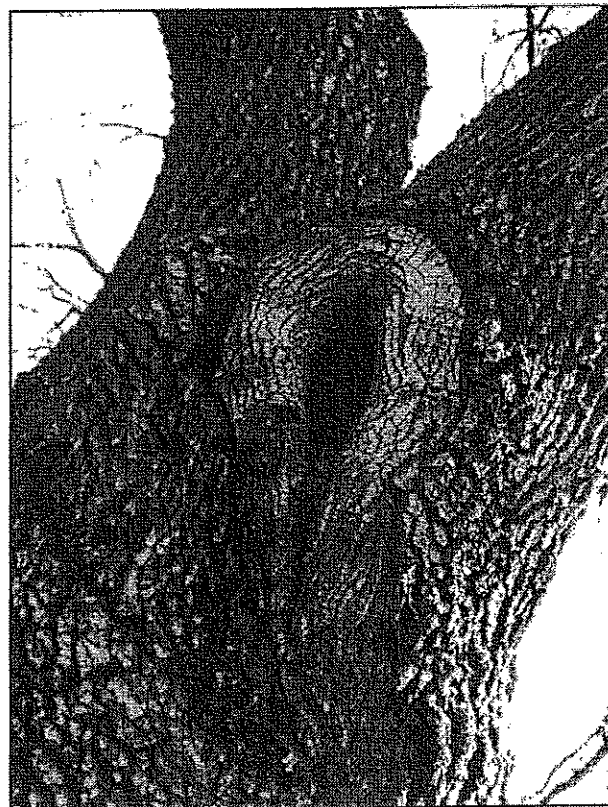
Cavity located below main crotch

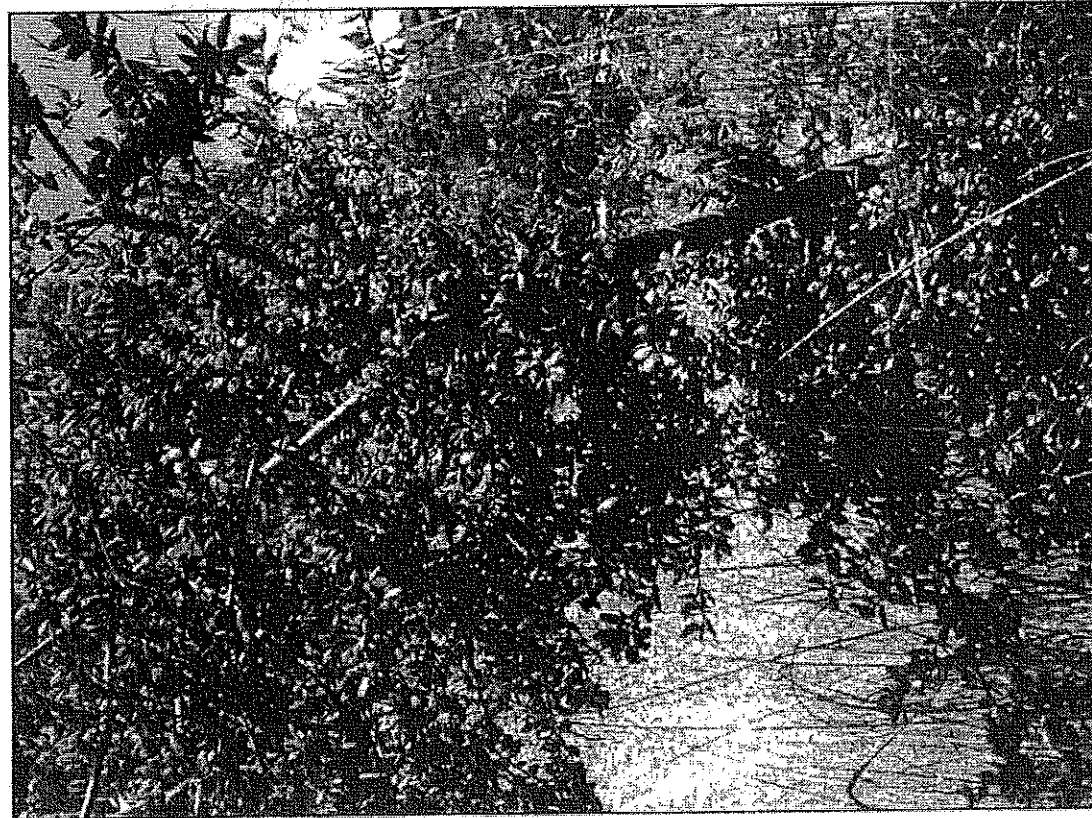
Tree 85 facing south

Tree #85 is located at the eastern edge of the tree well of tree #100. The proposed improvements will include a retaining wall, which supports a pedestrian access, directly adjacent to the tree's location. Despite efforts by the applicant to move the access and retaining wall away from the tree and reduce the width of the access, tree #85 cannot remain in its current location. In the proposed condition, the access is directly adjacent to the building, and is four feet in width. Given the size and health rating of the tree, it is a candidate for transplant. The applicant respectfully requests the ability to transplant or remove the tree.

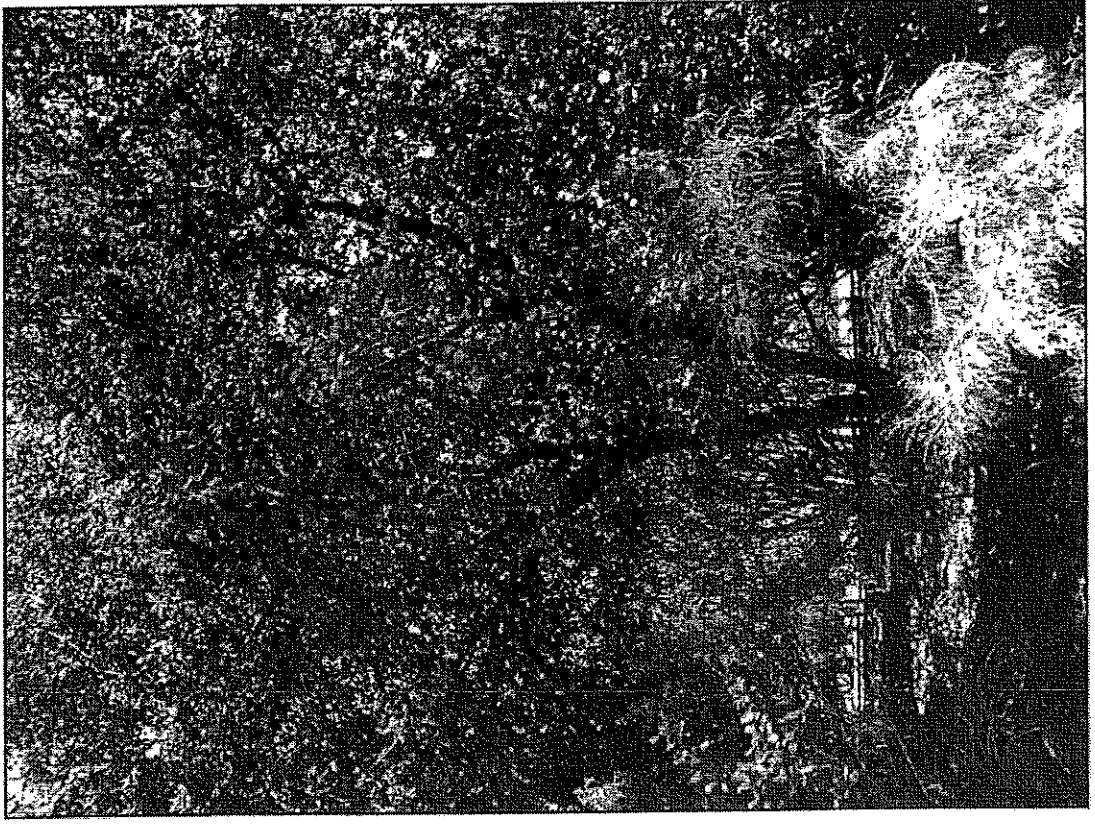
Tree 84 facing south

As indicated on the tree location map, the proposed project will develop parking stalls in the southwestern portion of the property to within three to four feet of the trunk of tree #84. In order to prepare the soils for development, excavations and recompaction will need to occur in close proximity to the tree as well. Based on the proposed improvements, tree #84 cannot remain in its current location. Due to the proximity of this tree to underground storm drain facilities, transport of this tree is not recommended. Therefore the applicant respectfully requests the ability to remove this tree.

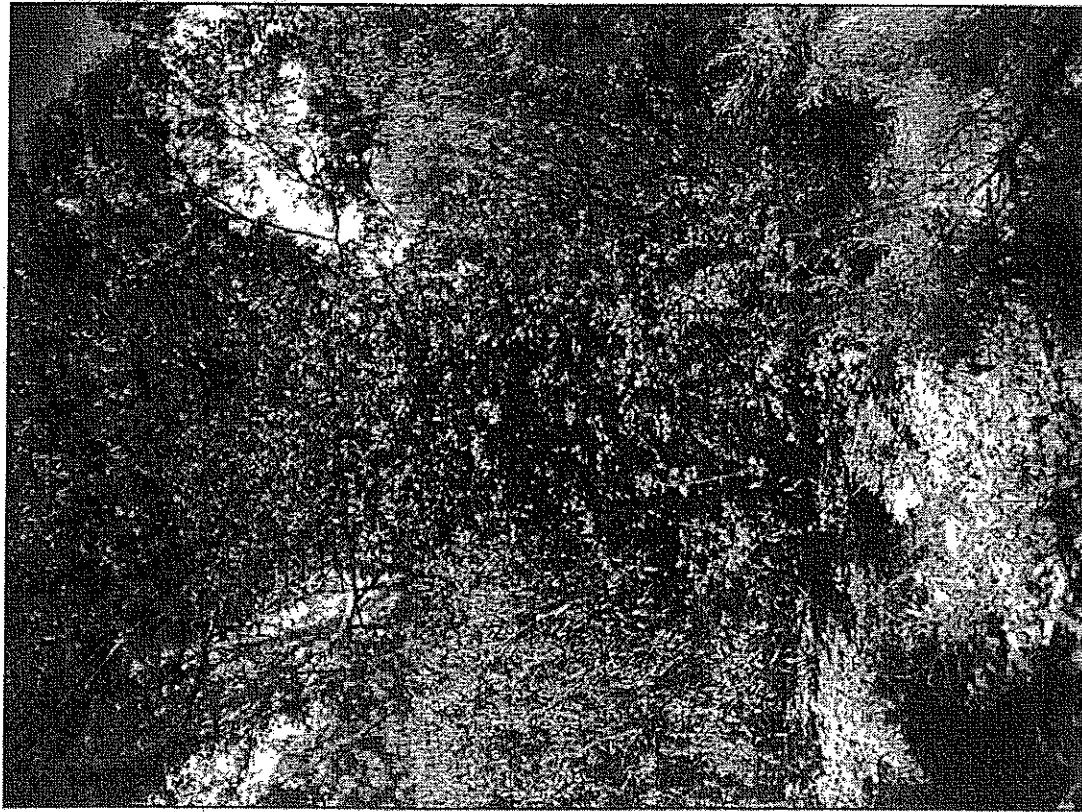
Tree 83 facing northeast

Tree #83 is an eight foot tall Coast Live oak located in the southwestern corner of the subject property near Agoura Road, just north of tree #84. Currently the tree has a health rating of "A" and an appearance rating of "A" (Plate 7). Tree #84 is competing with the oleanders to the south, and is located in the area of a subterranean storm drain utility.

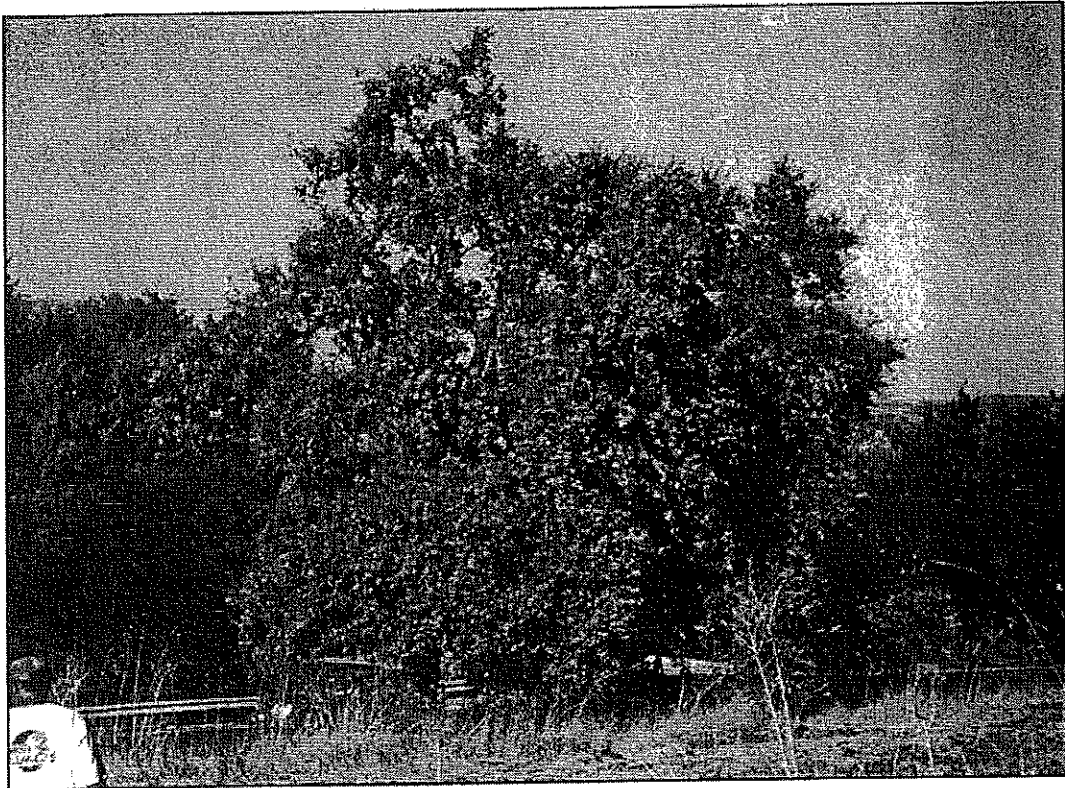
Tree 6
(Facing Northeast)

Tree #6 is a heritage Valley Oak tree that is located in the shoulder of Agoura Road (Appendix A). Currently the tree has a health rating of "B" and an appearance rating of "C" (Plate 1). This tree has been significantly impacted by Agoura Road. The asphalt extends to within a few feet of the base of the tree, and the tree is leaning to the south away from Agoura Road. There are several locations where this tree has been poorly pruned and or hit by passing vehicles and exudations or bark stains are representative. Additionally there is a significant recent scar at the base of the tree on the east side. It appears that the tree was struck by a vehicle, or large piece of equipment. This scar will require a fungicide treatment. There is a fair amount of dead wood in this tree and the tree appears to infested with ants.

Tree #6 is currently located approximately three feet to the south of the existing extent of pavement for Agoura Road. In the area of this tree, the proposed improvements would expand the pavement approximately eight feet to the south. The proposed improvements would encompass the tree and require its removal. Therefore, the applicant respectfully requests the ability to remove this tree.

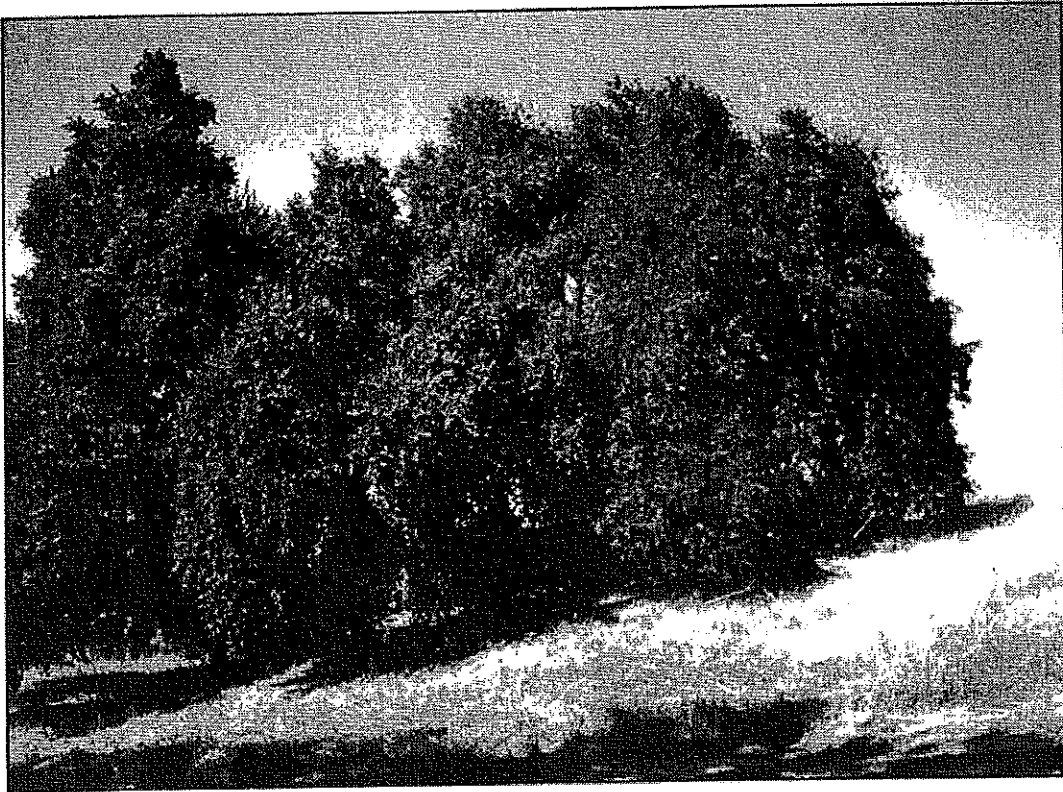
Tree 129
(Facing North)

Tree #129 is a 35 foot tall Coast Live oak located within a cluster of four trees in the southern portion of the study area. Currently this tree has a health rating of "B" and an appearance rating of "B" (Plate 2). There is a major limb failure on a northeast trending limb, and several broken branches within the canopy. There is also an evidence of decay with the cavity that has formed as a result of the major limb failure. There is also a raptor nest in the upper central portion of the canopy.

- Remove deadwood from the canopy,
- Clean cut broken branches.

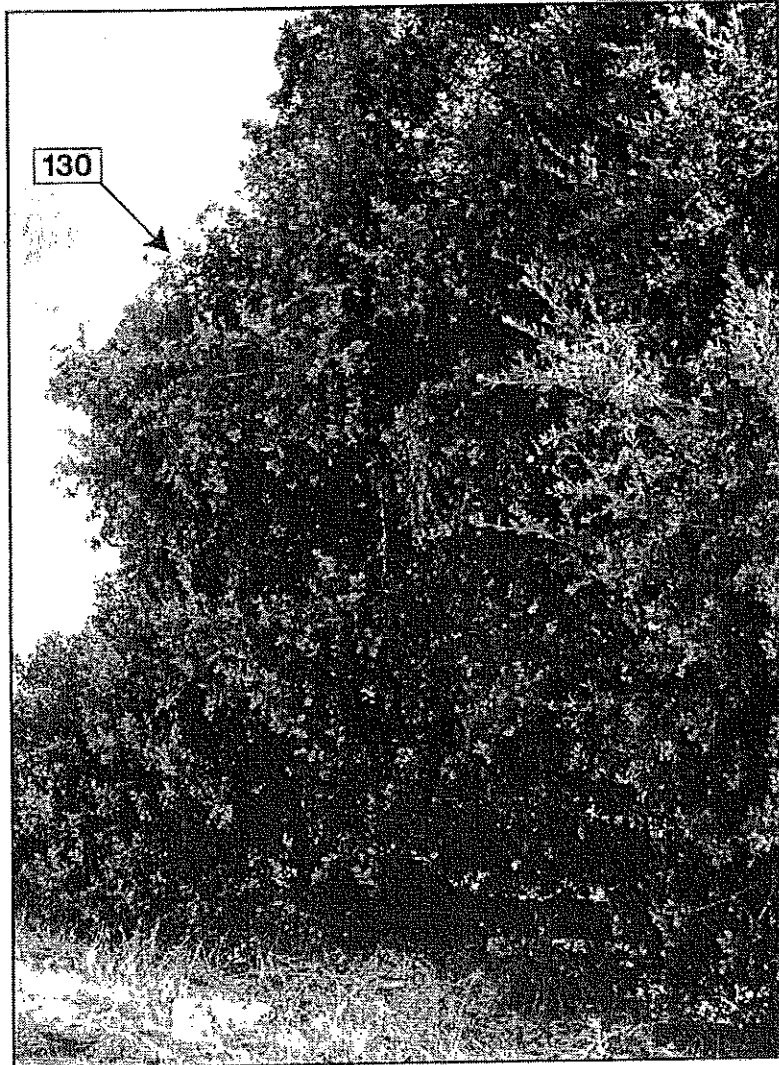
Tree 130
(Facing Southeast)

Tree #130 is a 14 foot tall Coast Live oak located within a cluster of four trees in the southern portion of the study area. Currently the tree has a health rating of "B" and an appearance rating of "C" (Plate 2). This tree is located under the canopy of tree #129 and is in direct competition. As a result the tree has started to develop a slight lean to

the north, away from tree #129. There is a need for minor structural pruning on the northwest side of the tree and the leaves show signs of pit-scale.

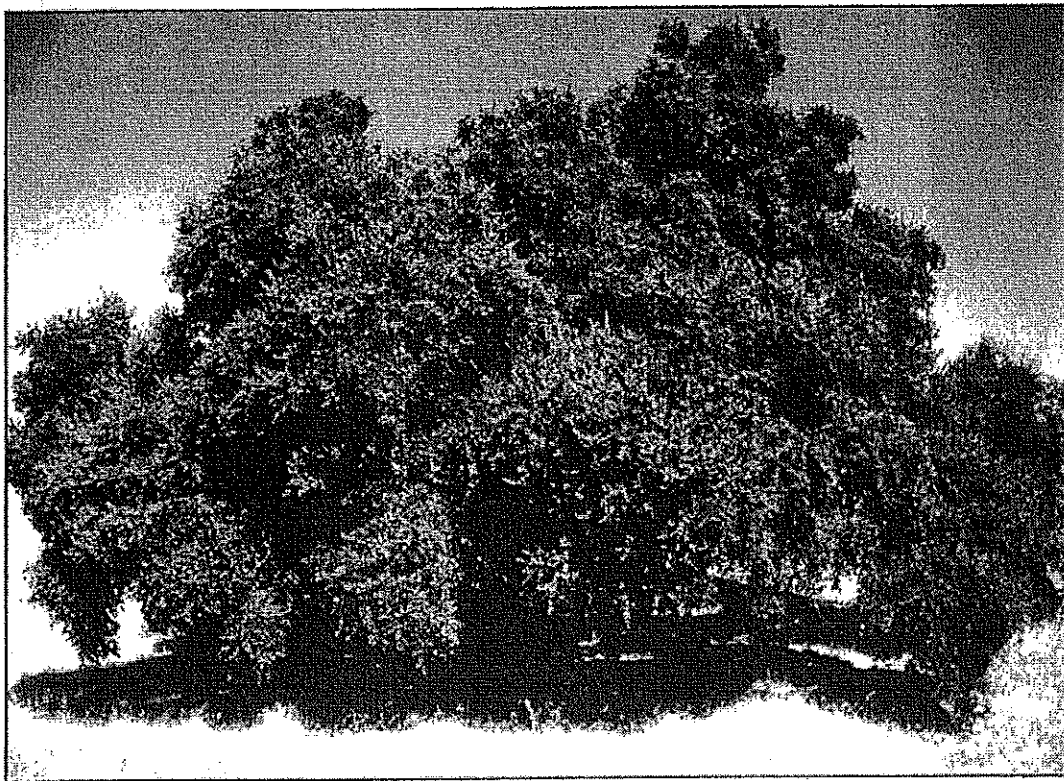
Tree 132
(Facing East)

Tree #132 is a 35-foot tall Coast live oak located within the cluster of four trees in the southern portion of the study area. Currently the tree has a health rating of "B" and an appearance rating of "B" (Plate 3). This tree is a larger oak that is in good shape for its size. There is some dead wood in the canopy, but no major limb failures. There is evidence of borers, ants and pit-scale in the tree. There is also soil buildup on the east side of the trunk. During the evaluation two raptors were observed fleeing from a nest in the top of the canopy. The species could not be identified due to visual obstructions.

Tree #132 is located approximately 110 feet south of the existing limits of pavement on Agoura Road. The proposed improvements would expand the pavement approximately 40 feet to the south require a cut slope between the location of tree #132 and Agoura Road. The proposed limits of the slope will daylight approximately 20 to 25 feet to the north of the canopy of tree #132. Therefore, no impacts are anticipated at this time.

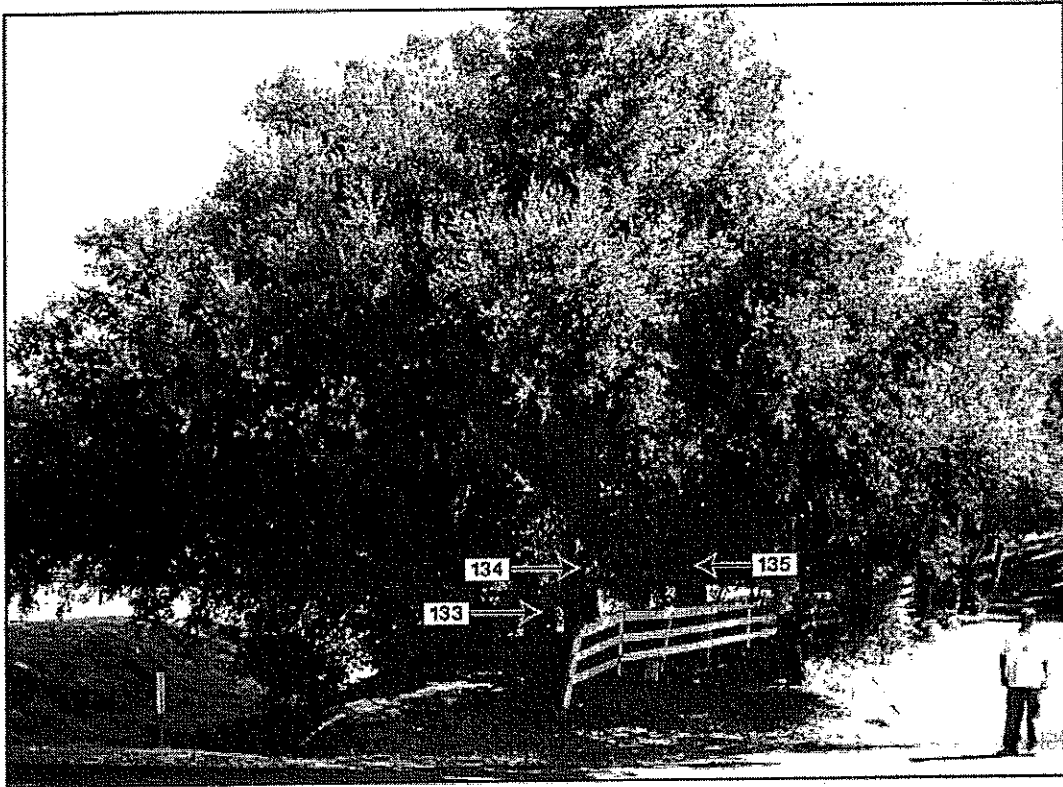
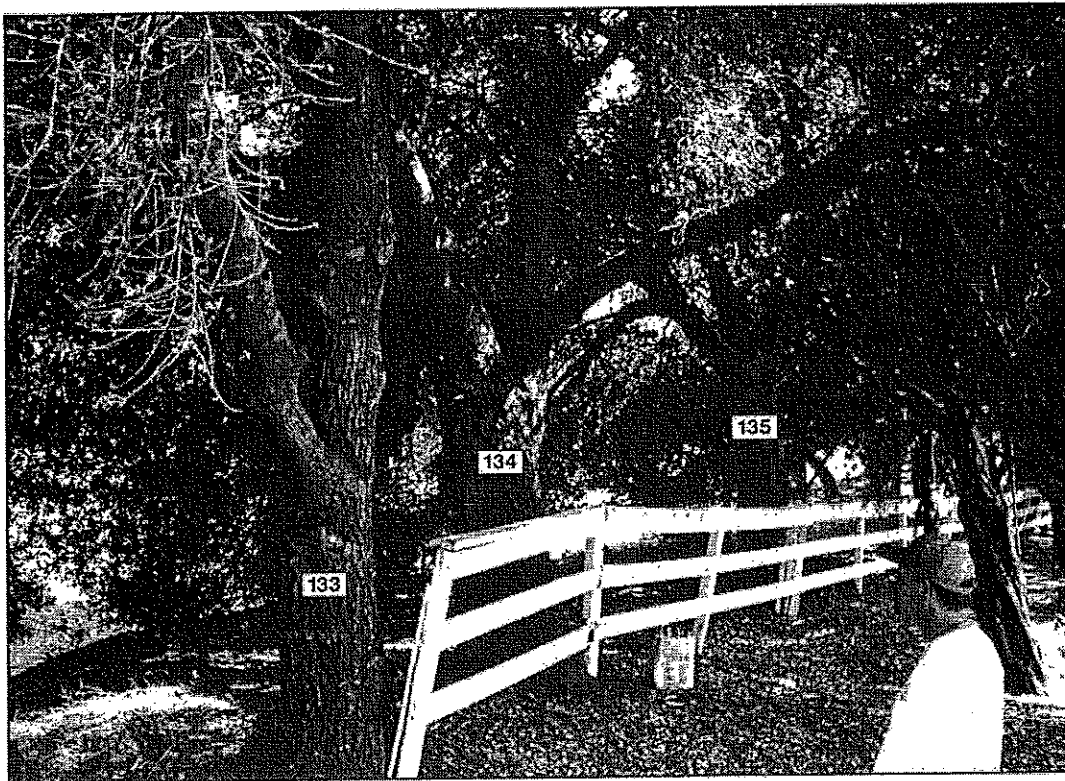
Trees 133, 134 & 135
(Facing South)

Tree #133 is a 28-foot tall Coast live oak located within a cluster of trees in the western portion of the study area, just south of the existing shoulder along the south side of Agoura Road. Currently the tree has a health rating of "B" and an appearance rating of "C" (Plate 4). This tree is in direct competition with tree #134 to the south. As a result the canopy of this tree is growing only in the northwest to east direction toward Agoura Road. The canopy contains a number of broken branches, and several instances of poor pruning. One of the branches extending to the northwest has been broken and torn from being struck by a high clearance vehicle. There is also a north trending branch that has epicormic growth and infestation from Witch's broom. At the base of the trunk there is a buildup of soil on the south side.

Tree #134 is a 40-foot tall Coast live oak located within a cluster of trees in the western portion of the study area, just south of the existing shoulder along the south side of Agoura Road. Currently the tree has a health rating of "B" and an appearance rating of "B" (Plate 4). This tree is the dominant tree within a cluster of three oaks. The canopy is healthy overall, but there is some deadwood, and evidence of minor twig dieback. Like tree #133, one of the branches has suffered mechanical damage and has been torn. The leaves of the tree exhibit some indications of chlorosis and pit-scale. Additionally, there is a buildup of soil on the southeast side of the trunk.

Tree #135 is a 40-foot tall Coast live oak located within a cluster of trees in the western portion of the study area, just south of the existing shoulder along the south side of Agoura Road. Currently the tree has a health rating of "B" and an appearance rating of "B"(Plate 4). This tree is within a cluster of three oaks that is dominated by tree #134. There is some low branching in this tree that trends to the east. The canopy has some broken branches and evidence of twig dieback. Also the leaves show evidence of pit-scale and there is soil buildup around the trunk.

- Minor structural pruning to remove inward oriented growth,
- Clean cut broken branches,
- Remove deadwood from canopy,
- Remove soil buildup around trunk.
