OAK TREE REPORT

Agoura Road Hotel

City of Agoura Hills, California

August 2015

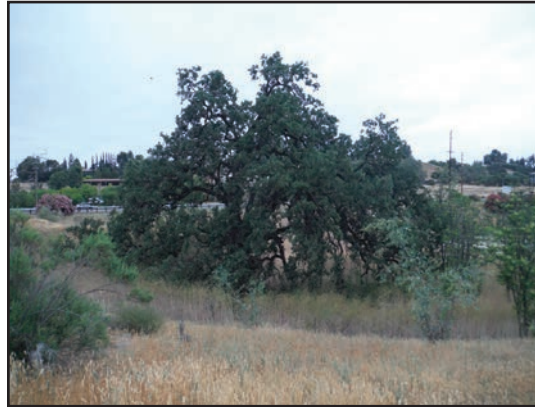
Tree #342

In accordance with Section 9657.5.C.3.c (c) of the Agoura Hills Municipal Code, in no case shall less than four (4) native oaks be provided for any oak tree removed or relocated. The subject tree was given a health rating of D and was deemed hazardous based on structural instability. Based on these conclusions we recommend replacement planting pursuant to the Oak Tree Planting and Replacement Program outlined in the City’s Oak Tree Preservation Guidelines (Section V.C.1.1). Accordingly, removal of a Dead or Hazardous Tree located on commercial property requires that one (1) 36-inch box tree shall be planted for each approved removal. As required by the City, the permittee shall ensure that the replacement trees live and maintain a healthy condition in perpetuity. The exact species, planting sizes, and planting locations shall be subject to review and approval by the City Oak Tree Consultant. **Table 4** identifies the mitigation offsets for the proposed removal.

1. All tree replacement, monitoring, and avoidance and minimization measures outlined in the Oak Tree Report shall be implemented. As stated in the Response to Memorandum (Envicom Corporation, November 24, 2015), four (4) 36-inch box valley oaks (*Quercus lobata*) will be planted onsite to offset the removal of tree #342.

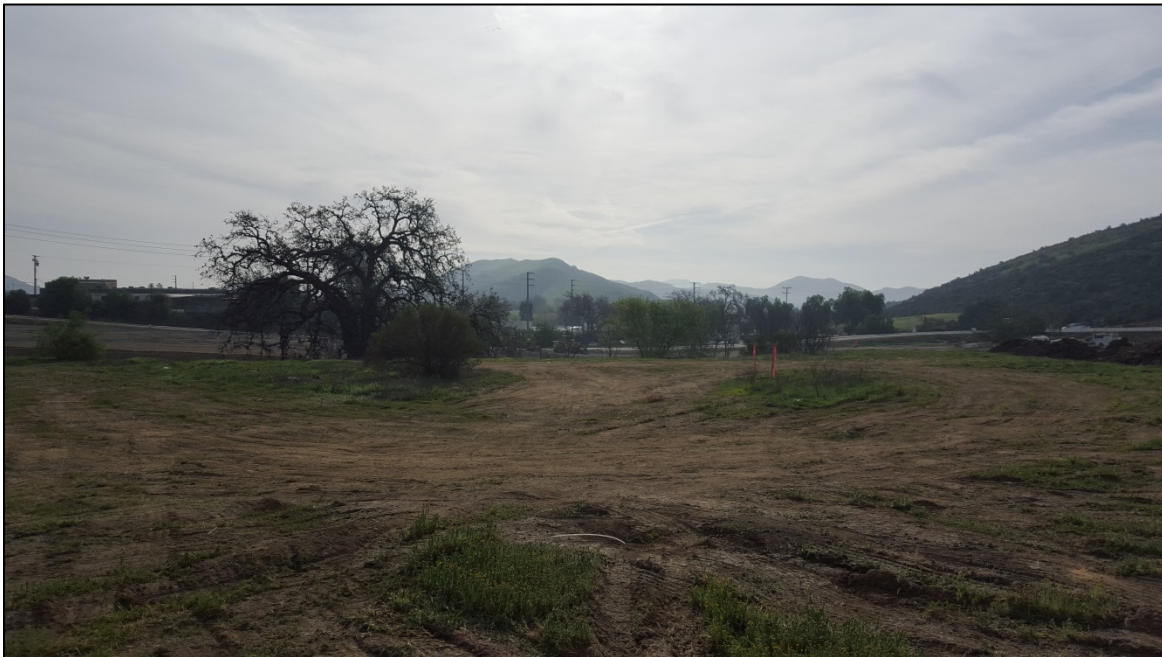
Photograph 1. Overview of the project site.

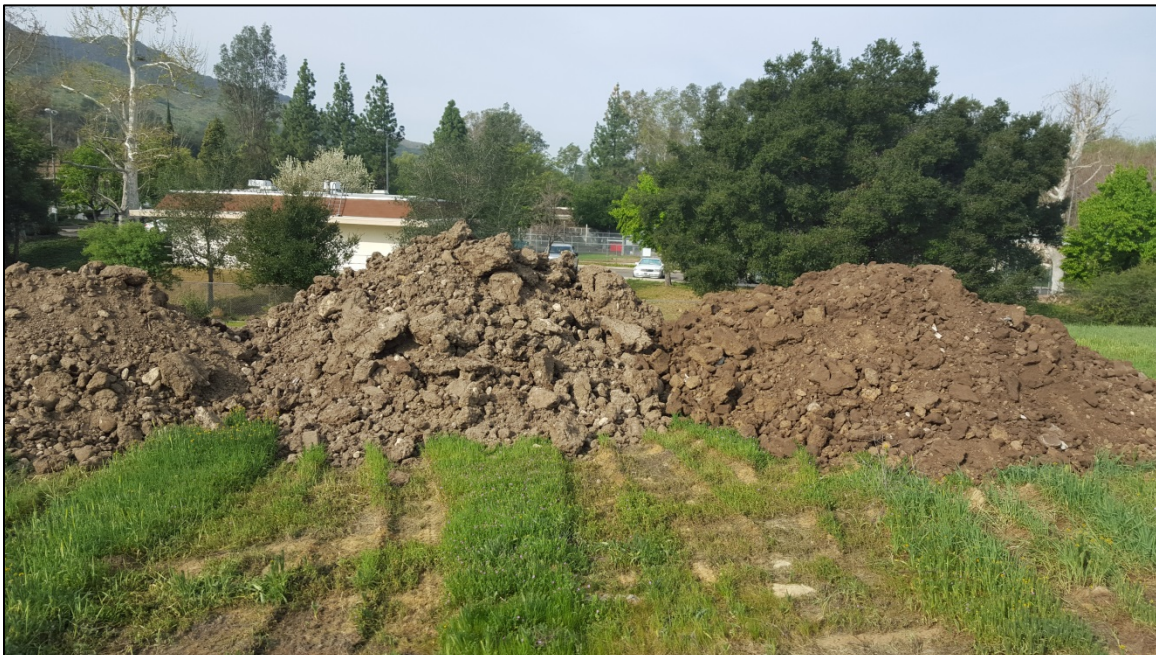
Photograph 2. Mound of fill material located on the project site.
