Appendix 3
Photographs of Surveyed Trees

Subj: Response to Memorandum: CUP-01150, VAR-01153-2015, OAK-01153-2015, SIGN-01152-2015 - Kruse Huntington Hotel Group - APN 2062-004-030

AGOURA ROAD HOTEL - OAK TREE REPORT

Tree Location and Project Impacts Map

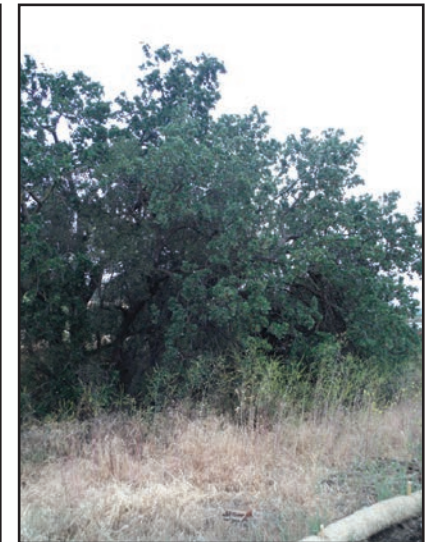
Tree #334

3. No encroachments will occur within the TPZ associated with Tree 335. Based on our conversation, I understand that your comment more specifically relates to whether the proposed development would provide adequate drainage for trees 334 - 341, 343, 346, and 348. As indicated on the revised Tree Location and Project Impacts Map, the existing grades and topography in the area surrounding the subject trees will be retained. The existing topography provides drainage to the northeast away from the trees to a low area outside the TPZs of the subject trees that is approximately four feet lower in elevation. Here, water will enter a storm drain located along the eastern edge of the property designed to convey flows away from the subject trees and into the existing Los Angeles County storm drain.

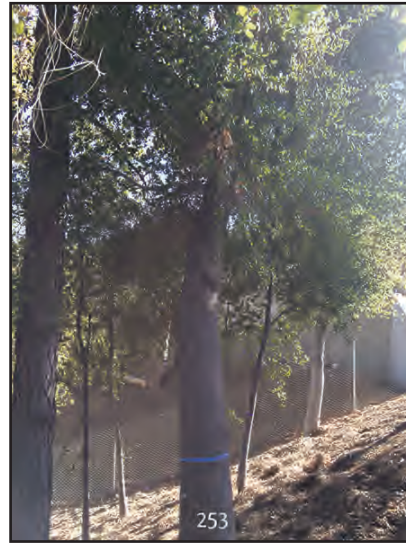
Tree #253

TREE NUMBER	251		252		253
SPECIES	<i>Quercus agrifolia</i>	X		X		X
	<i>Quercus lobata</i>					
	<i>Quercus berberidifolia</i>					
	Other					
FORM	TREE HEIGHT (~ FEET)	15.0		15.0		18.0
	LEAN	S		S		SE
	TRUNK DIAMETER / CIRCUMFERENCE (INCHES)	3.5/11.0		4.5/14.0		11.8/37.0
PHYSICAL CONDITION	TRUNK CAVITY					
	TRUNK EXUDATION					
	TRUNK DAMAGE					
	BURIED ROOT COLLAR					
	EXPOSED ROOTS					
	WEAK CROTCH					
	FUNGAL DISEASE					
	INSECT DAMAGE					
	FIRE DAMAGE (NEW/OLD)					
	BRANCH CAVITIES					
	MAINSTEM DIEBACK					
	TWIG/BRANCH DIEBACK					
	EPICORMIC GROWTH					
	THIN FOLIAGE	X		X		X
	DROUGHT STRESSED					
	UNBALANCED CROWN					
	EXC. HORIZONTAL BRANCH.					
VIGOR (GOOD/MOD/POOR)	GOOD		GOOD		GOOD	
TERRAIN (SLOPE/LEVEL)	SLOPE		SLOPE		SLOPE	
TREATMENT	REMOVE DEADWOOD					
	INSECT TREATMENT					
	DISEASE TREATMENT					
	SAFETY PRUNE					
RATING	HERITAGE					
	HEALTH	B		B		B
	AESTHETICS & CONFORMITY	B		B		C
			NOTES:		NOTES:	NOTES: Heavy lean

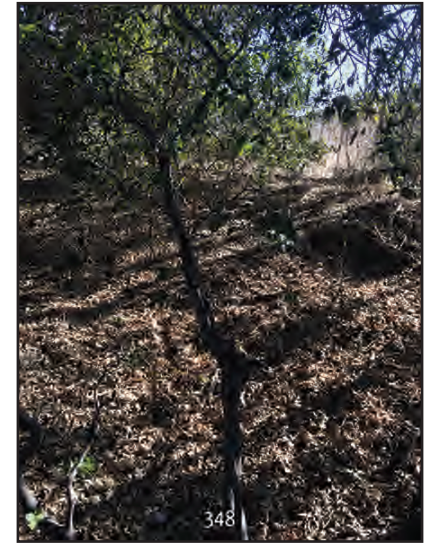
Tree #348

NOTES: Scale insects present on underside of leaves.				NOTES: Slight dieback of understory branches.	
						NOTES: Galls

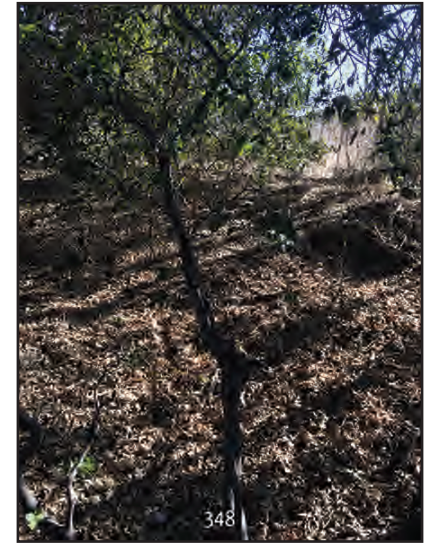
Tree #348

TREE NUMBER	348		349		350			
SPECIES	<i>Quercus agrifolia</i>	X	NOTES: Scale insects present on underside of leaves.	X	NOTES: Slight dieback of understory branches.	X	NOTES: Galls		
	<i>Quercus lobata</i>								
	<i>Quercus berberidifolia</i>								
	Other								
FORM	TREE HEIGHT (~ FEET)	8.0				20.0			14.0
	LEAN	SE				NE & N			N
	TRUNK DIAMETER / CIRCUMFERENCE (INCHES)	2.2/7.0				11.8/37.0			2.9/9.0
PHYSICAL CONDITION	TRUNK CAVITY								
	TRUNK EXUDATION								
	TRUNK DAMAGE								
	BURIED ROOT COLLAR								
	EXPOSED ROOTS								
	WEAK CROTCH								
	FUNGAL DISEASE								
	INSECT DAMAGE	X							X
	FIRE DAMAGE (NEW/OLD)								
	BRANCH CAVITIES								
	MAINSTEM DIEBACK								
	TWIG/BRANCH DIEBACK								
	EPICORMIC GROWTH								
	THIN FOLIAGE	X		X					
	DROUGHT STRESSED								
	UNBALANCED CROWN								
	EXC. HORIZONTAL BRANCH.								
VIGOR (GOOD/MOD/POOR)	MOD		GOOD		GOOD				
TERRAIN (SLOPE/LEVEL)	LEVEL		SLOPE		SLOPE

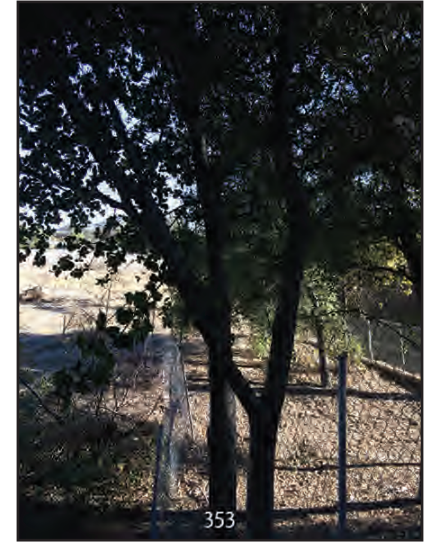
Tree #353

3.8/12.0		5.4/17.0	
				2.5/8.0			
PHYSICAL CONDITION	TRUNK CAVITY						
	TRUNK EXUDATION						
	TRUNK DAMAGE						
	BURIED ROOT COLLAR						
	EXPOSED ROOTS						
	WEAK CROTCH						
	FUNGAL DISEASE						
	INSECT DAMAGE	X		X			
	FIRE DAMAGE (NEW/OLD)						
	BRANCH CAVITIES						
	MAINSTEM DIEBACK						
	TWIG/BRANCH DIEBACK						
	EPICORMIC GROWTH			X			
	THIN FOLIAGE			X		X	
	DROUGHT STRESSED						
	UNBALANCED CROWN						
	EXC. HORIZONTAL BRANCH.						
VIGOR (GOOD/MOD/POOR)	GOOD		GOOD		GOOD		
TERRAIN (SLOPE/LEVEL)	SLOPE		SLOPE		LEVEL		
TREATMENT	REMOVE DEADWOOD						
	INSECT TREATMENT						
	DISEASE TREATMENT						
	SAFETY PRUNE						
RATING	HERITAGE						
	HEALTH	A		B		A	
	AESTHETICS & CONFORMITY	A		B		A	
		NOTES: Evidence of leaf miners.				NOTES: Scale insects present on underside of leaves.	
						NOTES:
