OAK TREE REPORT

Agoura Road Hotel

City of Agoura Hills, California

August 2015

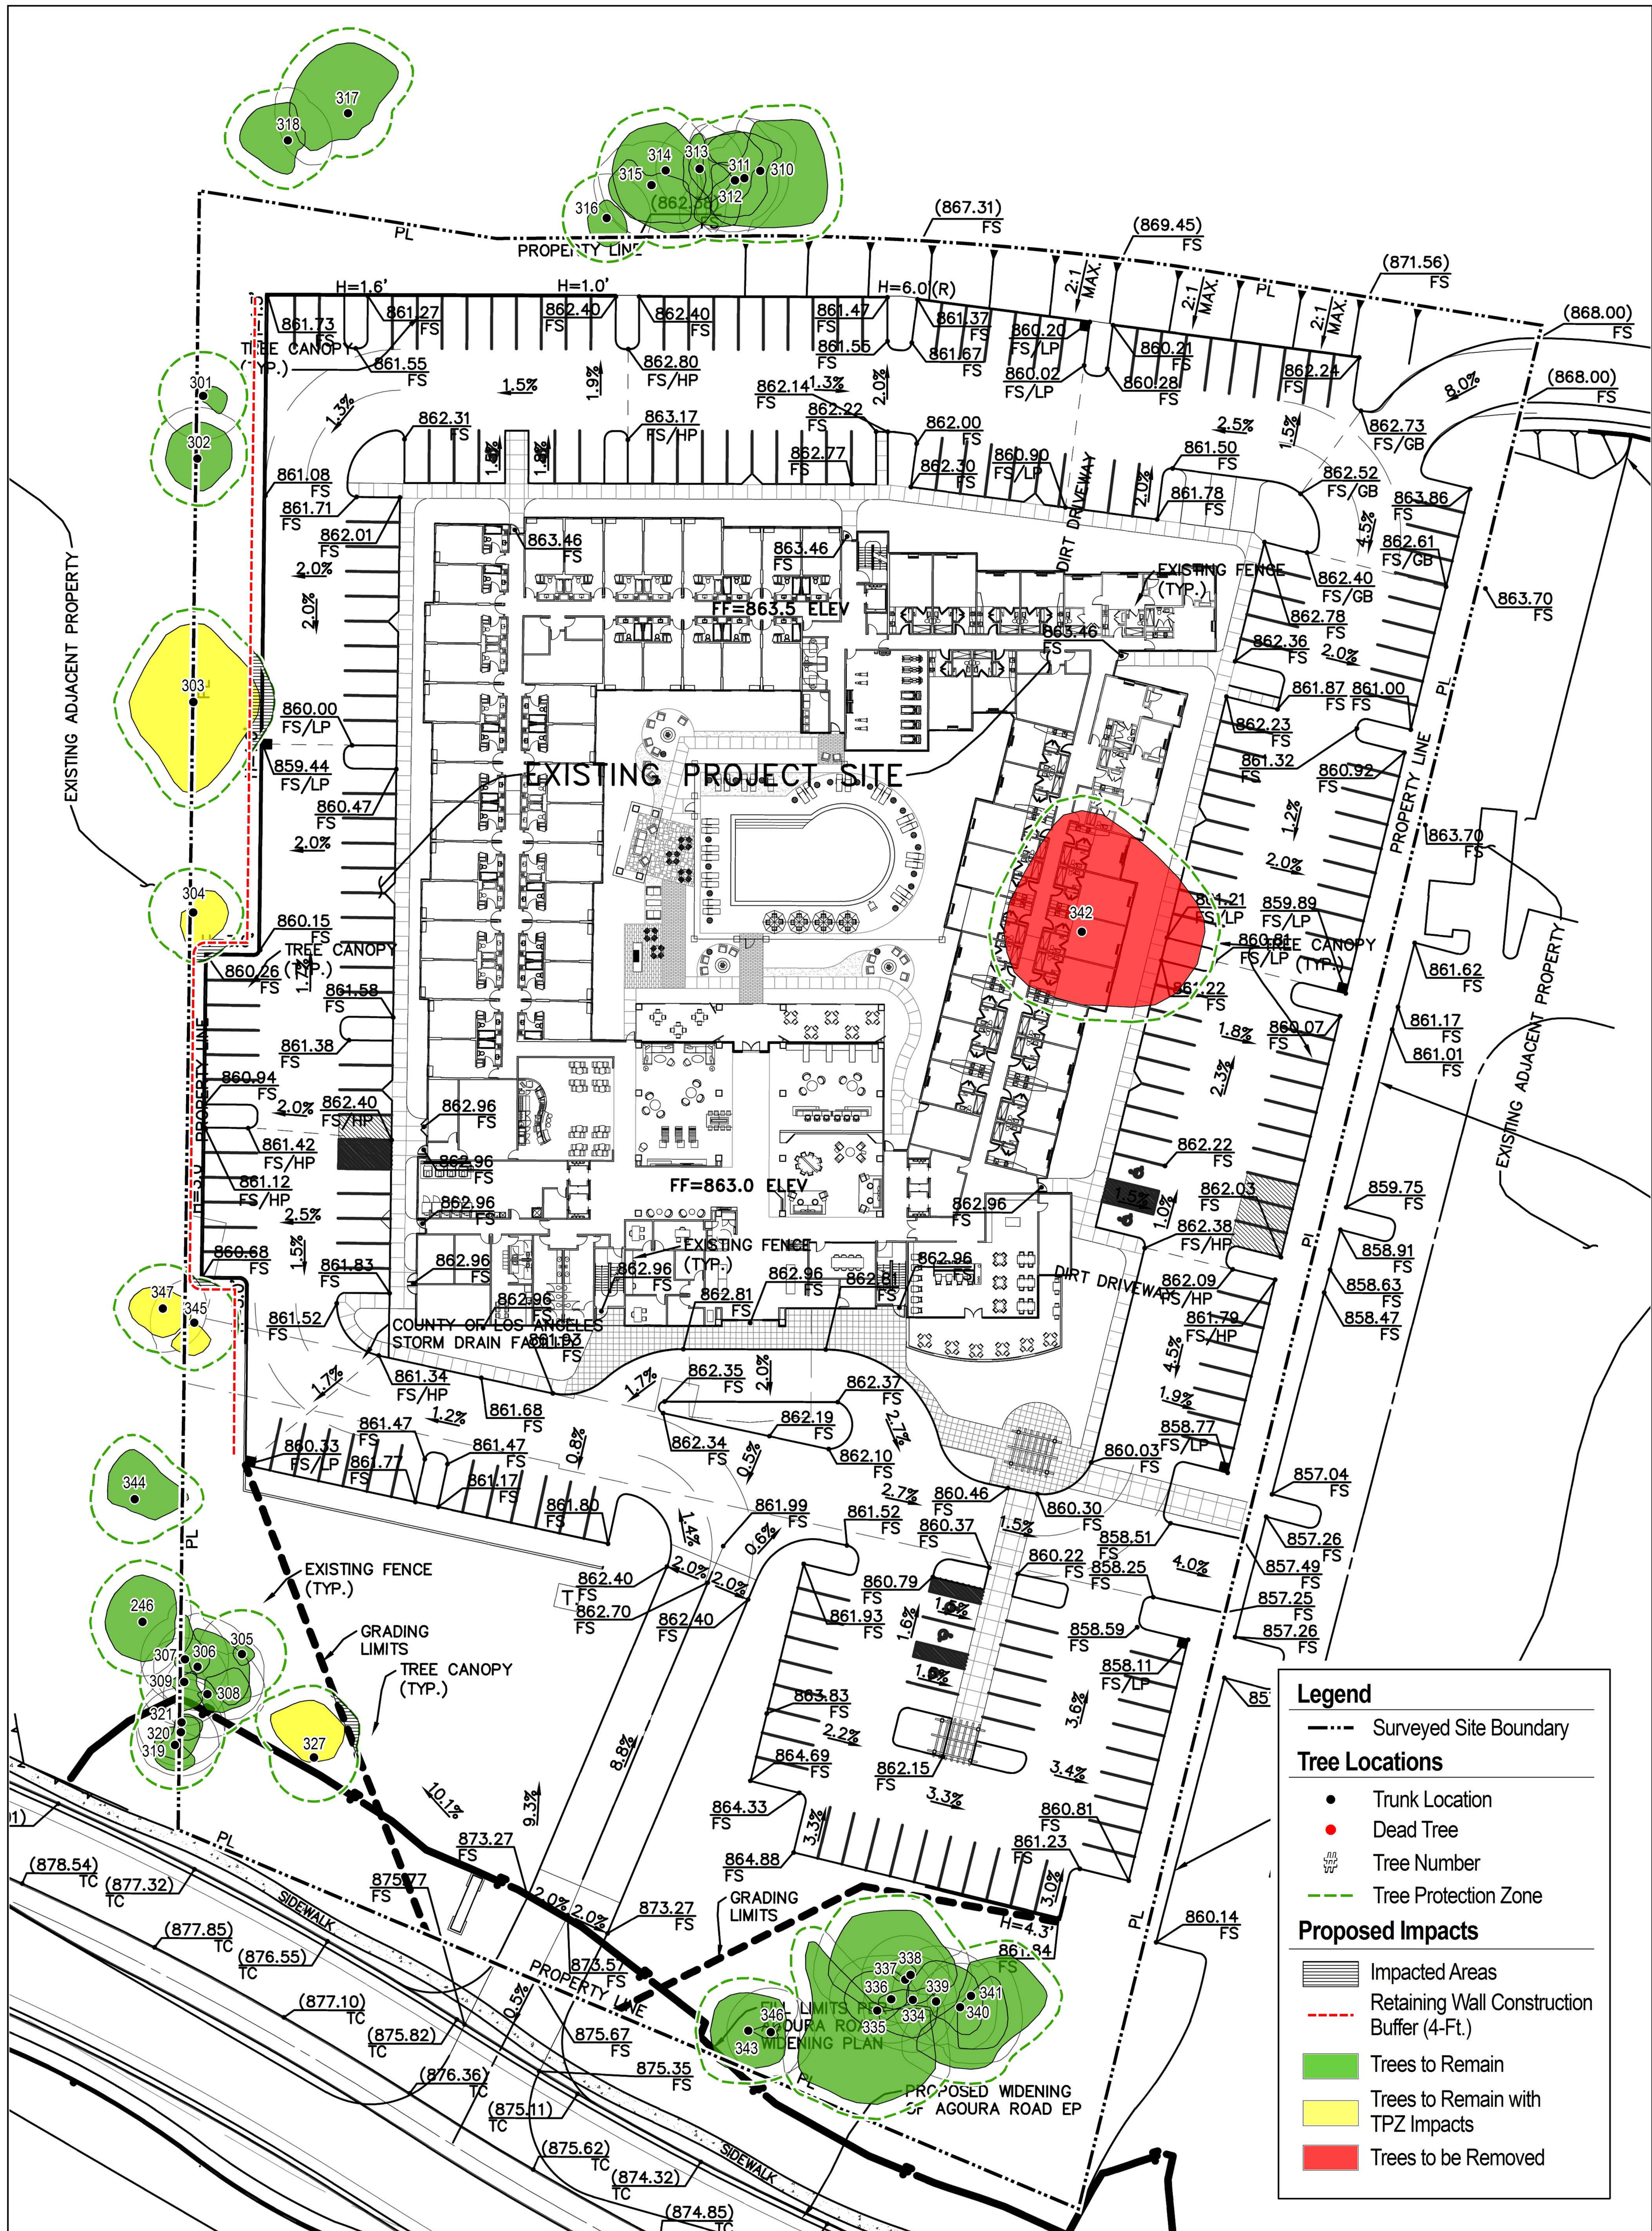
Tree Location and Project Impacts Map

Tree #	Species	Trunk Diameter (in.)	Landmark	Hazard	Health Rating	Reason for Disturbance
342	Ql	64.0	Yes	Yes	D	This tree is located in the central eastern portion of the site and is well within the proposed grading footprint. The project proposes to raise the grade at this location by approximately five feet and would be constructing the proposed hotel rooms over the areas currently occupied by the tree.

Five (5) trees will remain in place with TPZ impacts (Tree #s 303, 304, 327, 345, and 347). Proposed project activities will encroach into approximately 8% or less of the TPZ associated with each of these trees. Anticipated grading and construction activities will remain outside the dripline of four (4) trees (Tree#s 304, 327, 345, and 347) and encroach approximately 3.5 feet into the east edge of the canopy associated with Tree #303. These minor encroachments will allow the existing grade within the dripline and vertical height of the canopies for the subject trees to be maintained. Based on these assumptions it is not anticipated that these TPZ impacts will significantly affect the health or vigor of the subject trees. Trees anticipated to have TPZ impacts, including the reason for the disturbance, are listed in **Table 4**.
