PROTECTED OAK TREE REPORT

# Ladyface Vista

## Office Project

May 2021

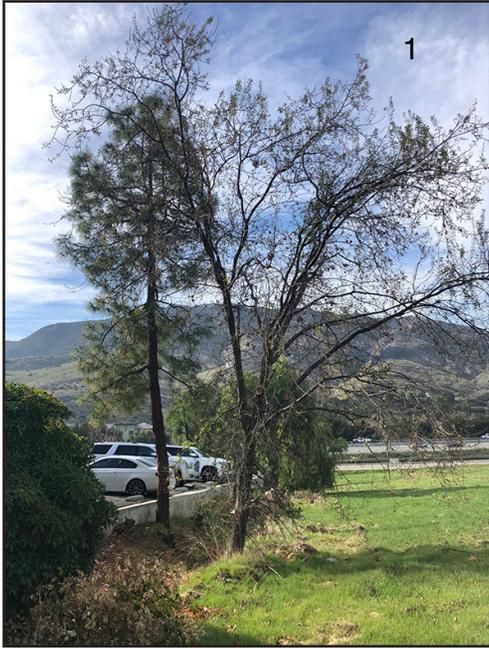
Tree 1

It is anticipated that proposed activities associated with construction of the retaining walls along the northern and eastern perimeter of the Project Site will encroach into the western portion of the canopy and PZ associated with Tree #1 and encroach into the southern portion of the canopy and PZ associated with Tree # 2.

To allow for these activities, it is anticipated less than 1 linear foot (0.05 percent) of canopy along the southwestern edge of Tree #1 will need to be raised to allow for equipment clearance during grading for the proposed retaining wall beneath this portion of the dripline. Because these activities will occur approximately 20 feet from the trunk, will impact less than 10 percent of the PZ, and allow for approximately 99 percent of the existing canopy and grade beneath the dripline to be retained, these resulting PZ impacts are not anticipated to significantly affect the health of Tree #1.

It is anticipated that proposed activities associated with construction of the retaining wall along the eastern perimeter of the Project will encroach into the western portion of the PZ associated with Tree #1. As previously reported, it is anticipated that less than 1 linear foot (0.05 percent) of the canopy along the southwestern edge of Tree #1 will need to be raised to allow for equipment clearance during grading for the proposed retaining wall beneath this portion of the dripline. Because these activities will occur approximately 20 feet from the trunk, will impact approximately 12.1 percent of the PZ, and allow for approximately 99 percent of the existing canopy and grade beneath the dripline to be retained, these resulting PZ impacts are not anticipated to significantly affect the health of Tree #1.

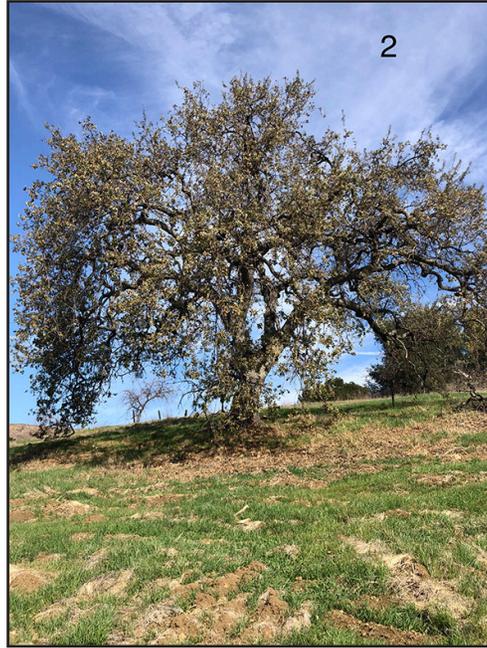
Tree 2

It is anticipated that proposed activities associated with construction of terraced retaining walls along the northern perimeter of the Project Site would encroach into approximately 0.9 percent of the southern edge of the PZ associated with Tree # 2. These will occur approximately 29 to 31 feet from the trunk and the design of the terraced retaining walls will allow for both the canopy and grade within the dripline to be retained and will not require the canopy to be trimmed. Based on these assumptions the resulting PZ impacts are not anticipated to significantly affect the health of Tree # 2.

2			30	35.3		N	X		X	X										X															scale insects on leaves; burl at trunk base; pit scales and lumpy lower stems	
3			9	2.9 1.9	N																															
4			10	7.0		N			X	X				X																						
5			18	11.1		N					X-					X-																			squirrel nest in canopy; trunk lean is slight; slightly sparse in canopy interior

It is anticipated that proposed activities associated with construction of terraced soil nail walls along the northern perimeter of the Project will encroach into 1 percent of the southern portion of the PZ associated with Tree #2. To construct each soil nail wall, 1- to 2-inch holes will be drilled at a 30-degree angle

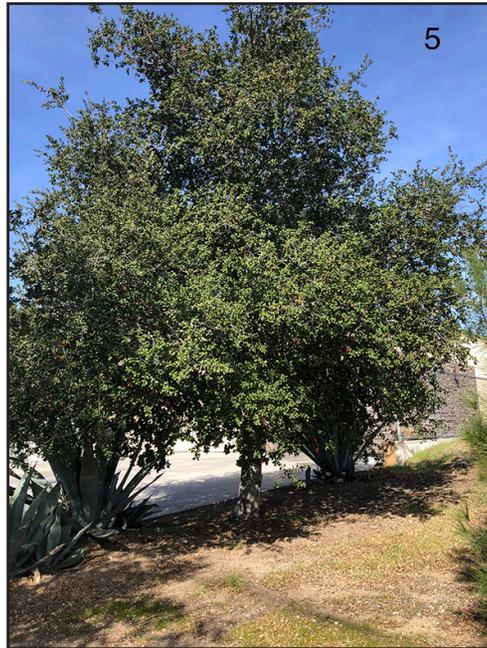
Tree 5

During Project grading activities, it is anticipated that approximately 2 linear foot (3.5 percent) of canopy along the eastern edge of Tree #5 will need to be removed or raised for equipment clearance to allow for grading beneath this portion of the dripline. Because these activities will occur approximately nine (9) feet east from the trunk, will impact less than 20 percent of the PZ, and allow for approximately 85 percent of the existing canopy and grade beneath the dripline to be retained, these resulting PZ impacts are not anticipated to significantly affect the health of Tree #5.

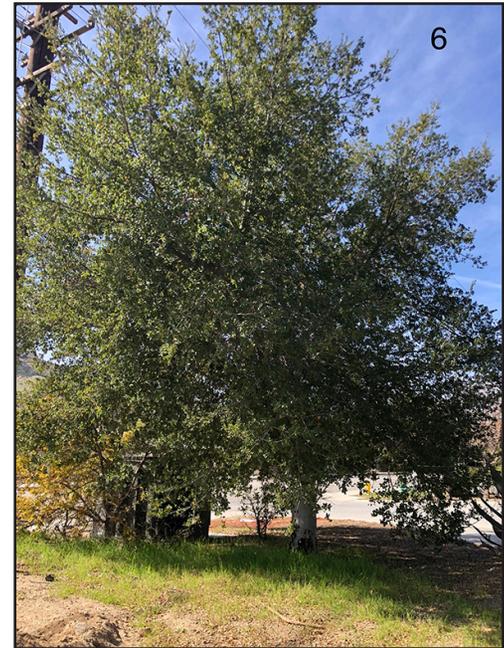
Tree 6

During Project grading activities, it is anticipated approximately 6 linear feet (14 percent) of canopy along the eastern edge of Tree #6 will need to be removed or raised to allow for equipment clearance beneath this portion of the dripline. Because Project grading will occur approximately 7 feet east from the trunk, and the impermeable materials used to construct the parking lot and sidewalks will be installed outside the dripline allowing for the porosity of the soils within the PZ to remain unaffected, it is anticipated that the resulting PZ impacts will not significantly affect the health of Tree # 6. However, to minimize impacts to these subject trees during construction, it is recommended that the Project arborist monitor canopy pruning and grading within the PZ.

Although the Project will impact greater than 20 percent of the PZ associated with Tree #6, it is anticipated that impermeable materials used to construct the parking lot and sidewalks will be installed outside the dripline allowing for the porosity of the soils within the PZ to be retained. Based on these assumptions, no mitigation offsets are recommended for encroachments to Tree #6. In conclusion, no mitigation offsets for Project Protected Tree impacts are recommended at this time.

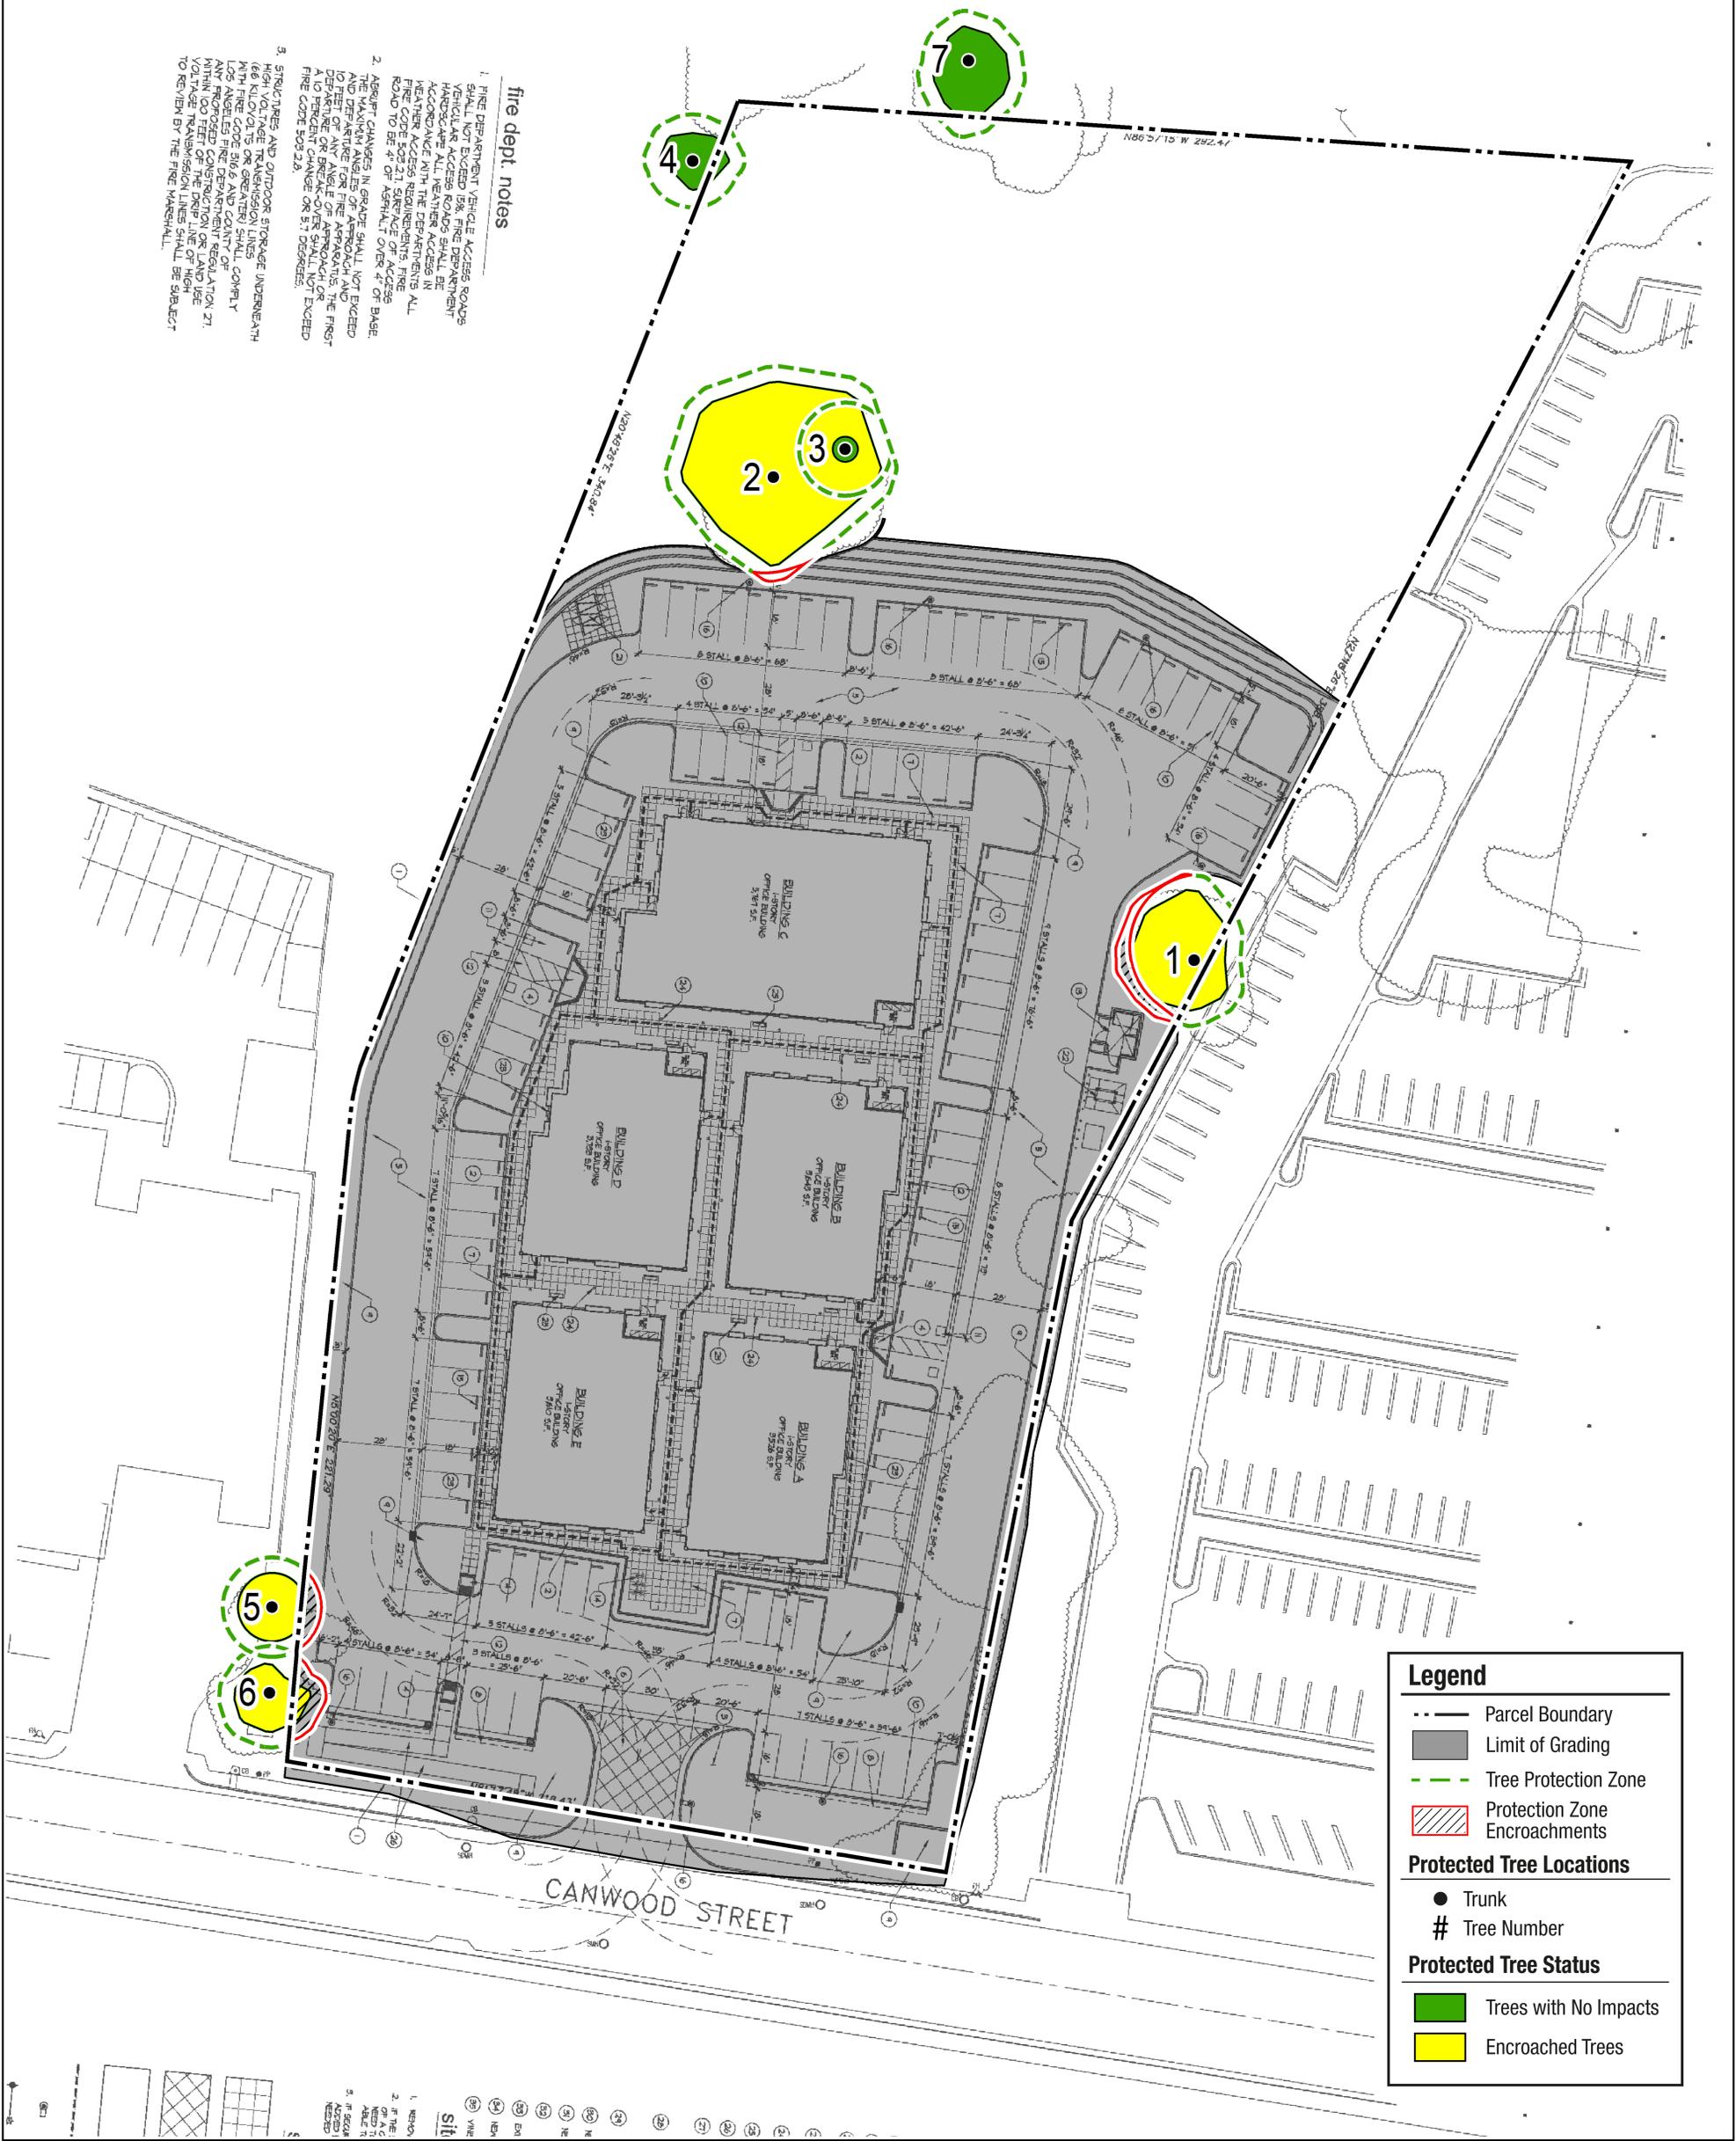
**Protected Tree Location and Project Impacts Map**

A total of four (4) Protected Trees would remain in place with PZ impacts, including two (2) valley oaks and two (2) coast live oaks. It is anticipated that Proposed Project activities would encroach into less than 20 percent of the PZ associated with these four (4) trees. A detailed discussion of anticipated PZ encroachments during Project construction is provided below and summarized in **Table 2, Trees to Remain with Protection Zone Impacts**.

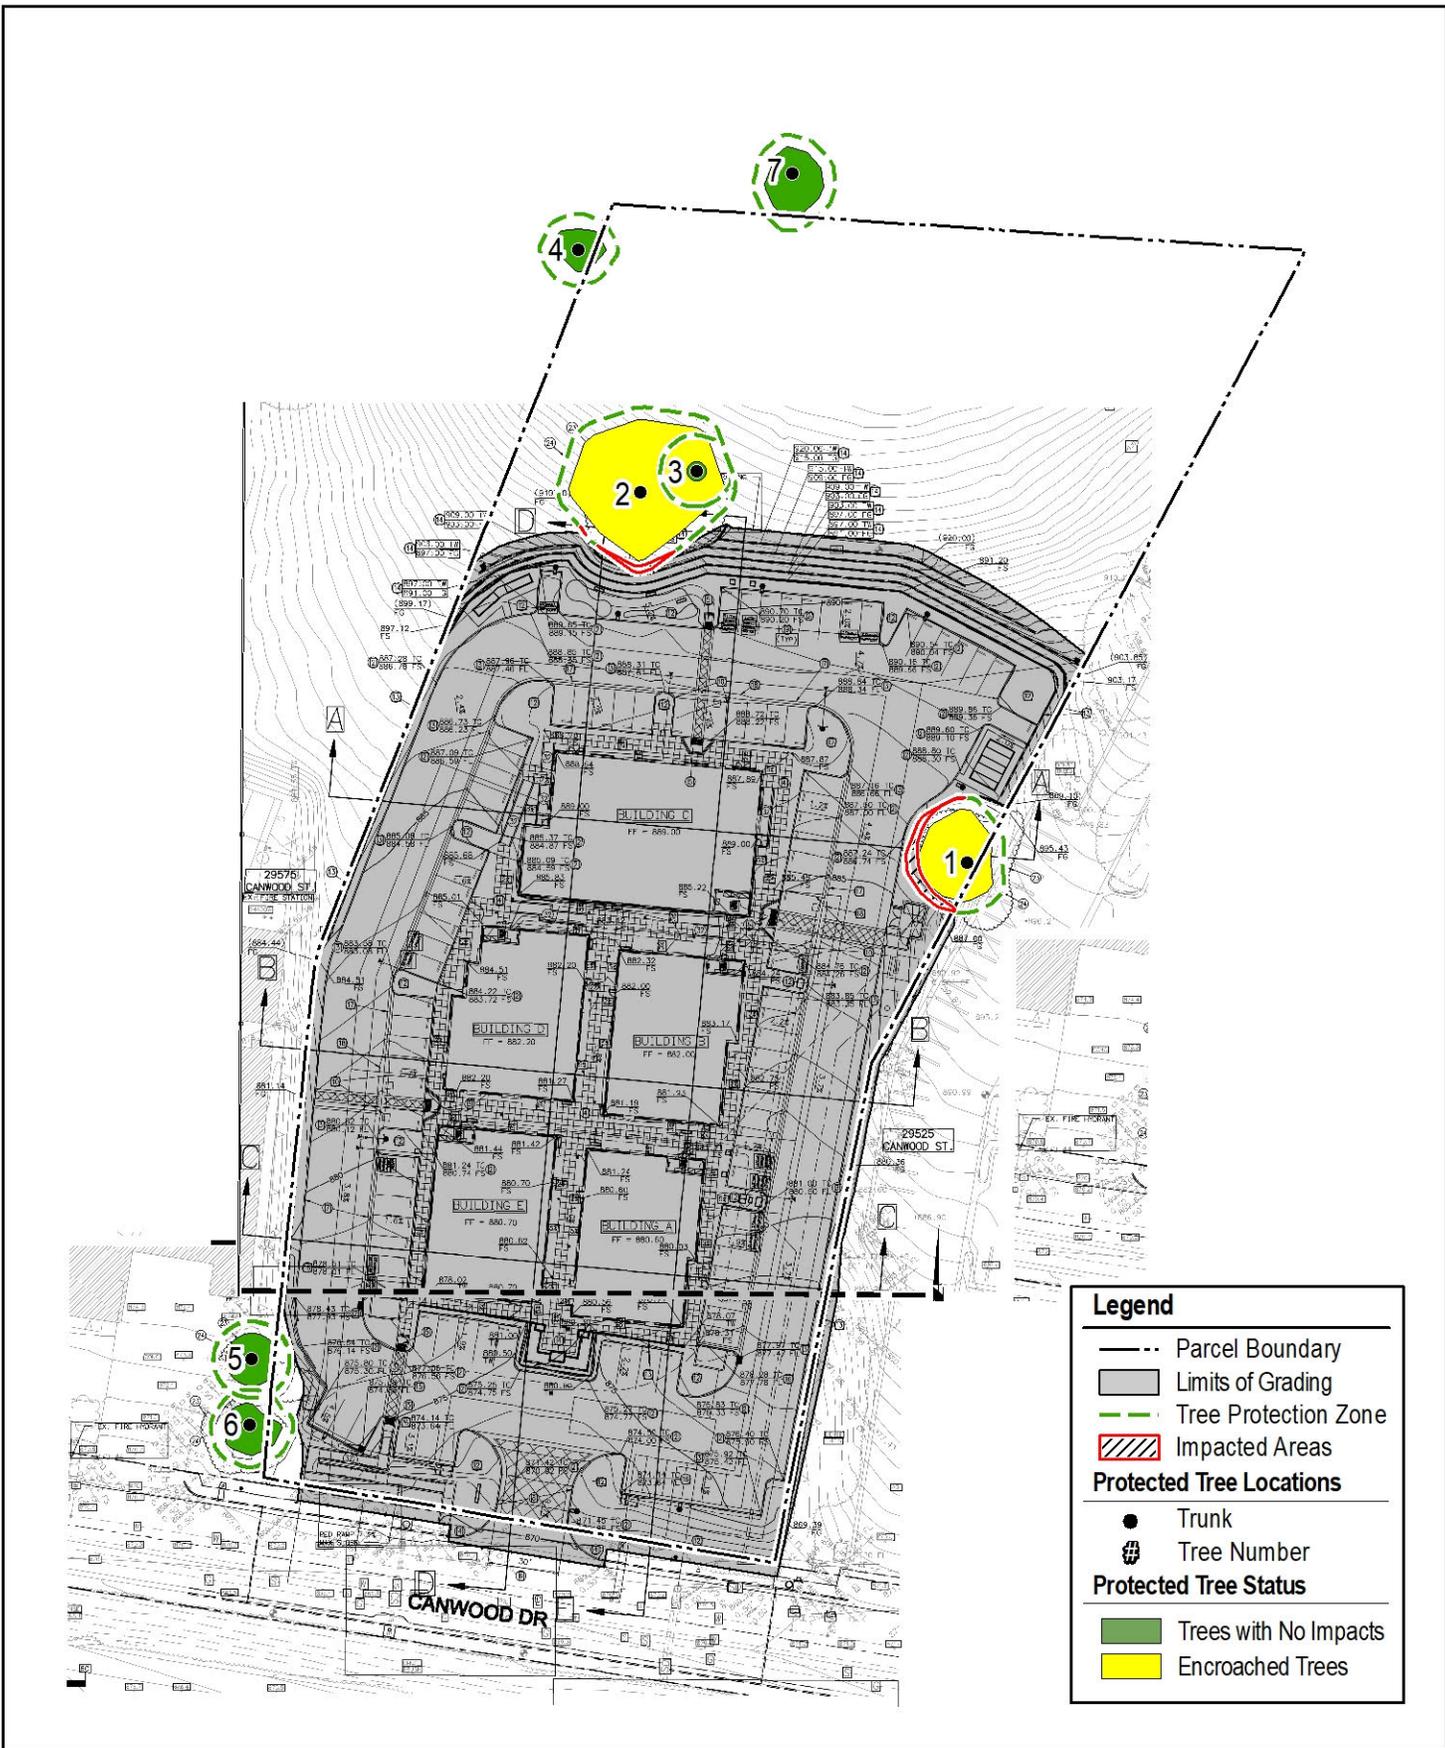
Attachment 1, Protected Tree Location and Project Impacts Map

Based on the May 17<sup>th</sup> grading plan, Project construction will encroach into the protection zone (PZ) associated with two (2) protected oak (Tree #s 1 and 2) and allow for five (5) protected oaks (Tree #s 3, 4, 5, 6, and 7) to remain in place without being impacted. No protected oaks will need to be removed to allow for the development of this Project. These anticipated impacts are consistent with those discussed in the November 2, 2021 letter. However, the portions of the grading plan that have been updated within the proximity of onsite protected oak trees include the removal of the masonry retaining wall east of Tree #s 5 and 6 and the replacement of the masonry retaining wall along the northern portion of the site with a soil nail wall. A detailed discussion related to the PZ encroachments associated with Tree #s 1 and 2 are provided below.
