Oak Tree Report Sunbelt Corporate Center II Agoura Hills. L. Newman Design Group. Revised June 17, 2009.

Oak Tree Report

**Canwood Street Offices
Agoura Hills**

**Date: June 27, 2007
3rd Revision Date: June 17, 2009**

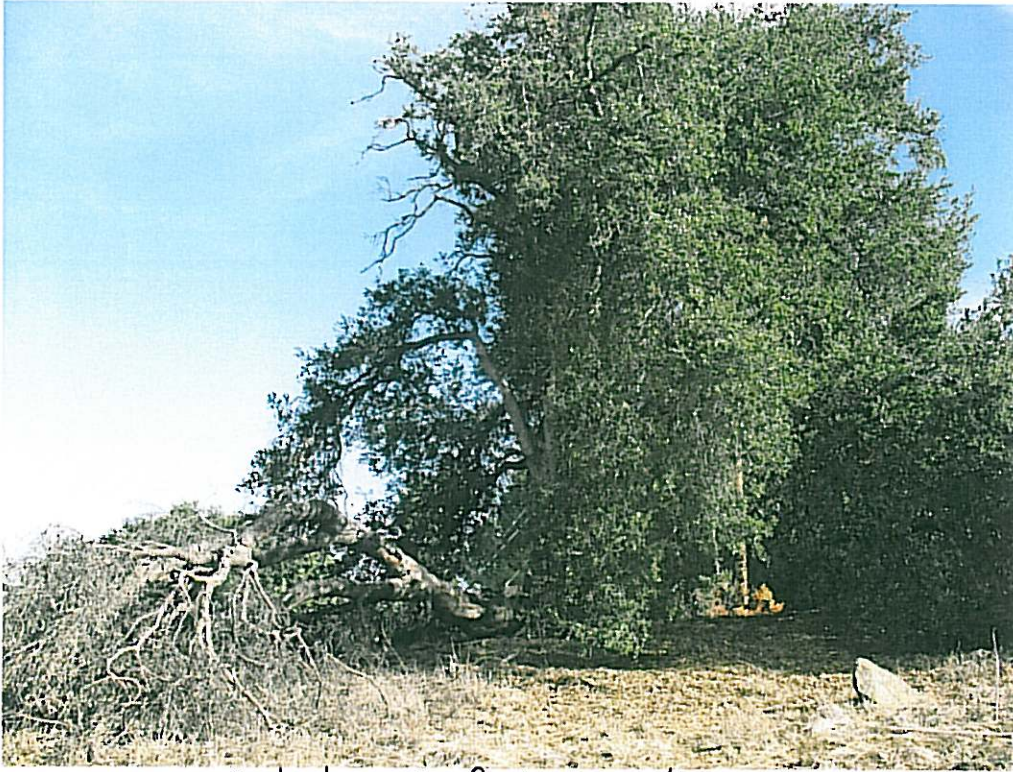
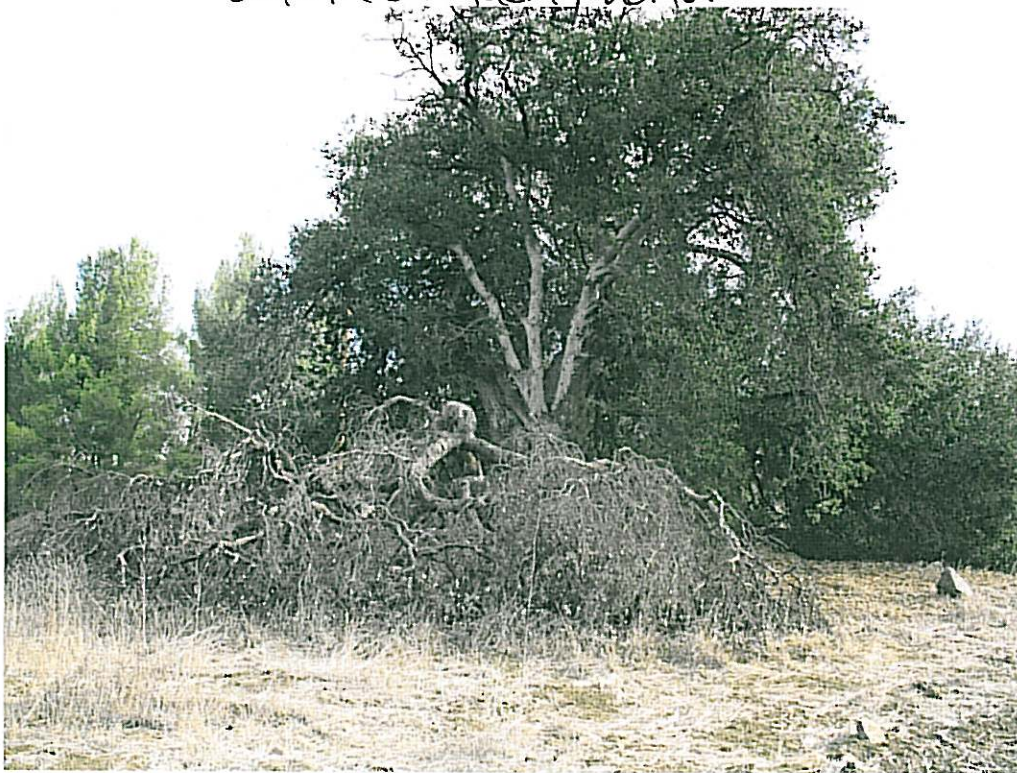
Oak tree 1 facing north

Oak tree 1 facing east

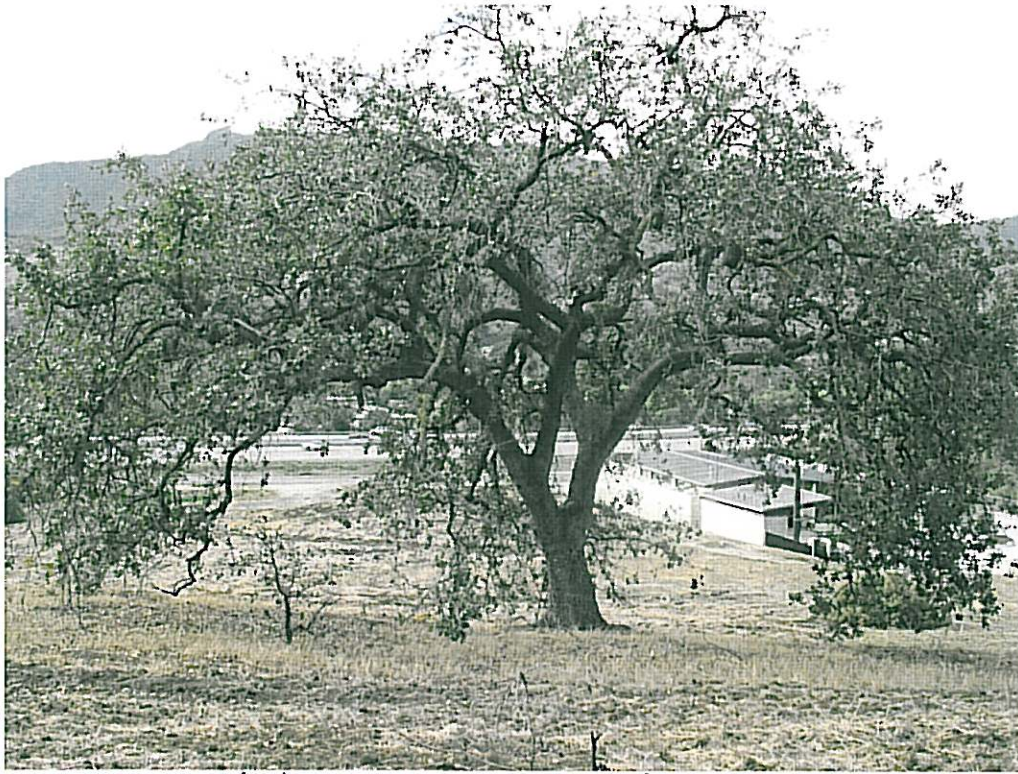
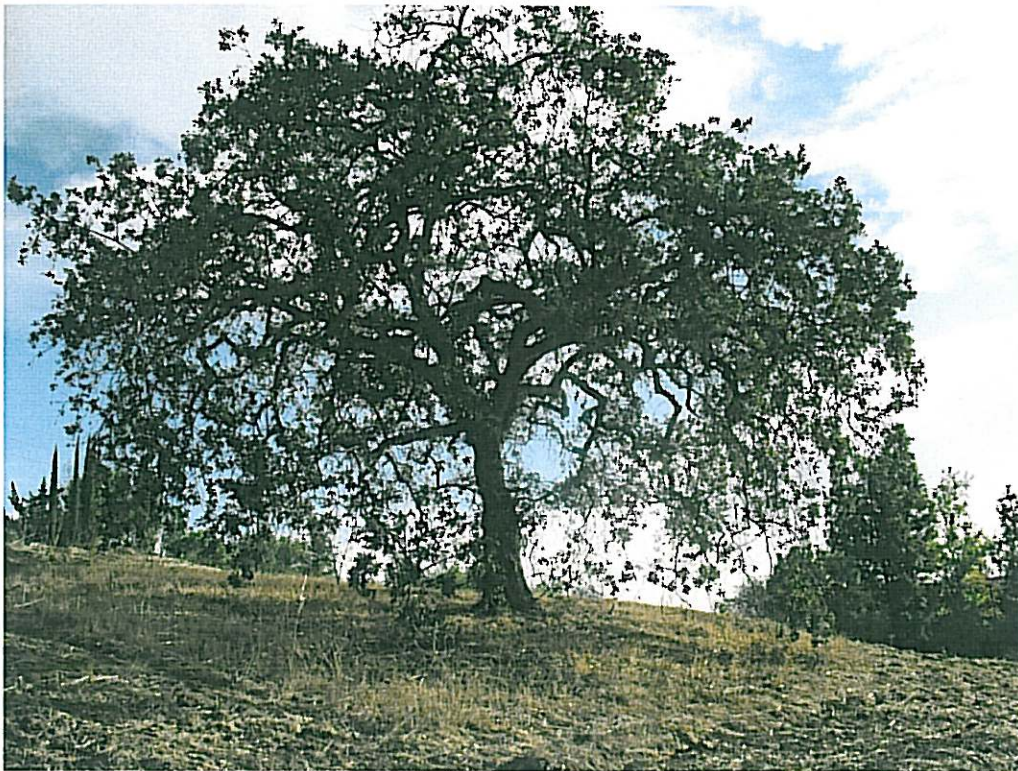
Tree No.	Encroachment
2	<p>On the west side (cross-section A), an ADA access ramp will be constructed 3 feet outside of the protected zone. The excavation for the footing shall stay outside of the protected zone. At this point, the ramp will be at grade and the retaining wall will be minimal. This will be an insignificant encroachment. No pruning shall be required.</p> <p>On the south side (cross-section B), the foundation of the building will be 3 feet outside of the protected zone. The limit of the over-excavation (as shown in the engineer's section A-A) will be 9 feet away from the edge of the building and 1 foot inside of the existing dripline. This will be a minor encroachment involving the pruning of small roots and should not harm the tree. Some minor pruning of branches less than 2 inches may be required for clearance but this should be avoided.</p>

On the east side (cross-section C), two retaining walls will be constructed just outside of the protected zone, the excavation for which shall be no closer than at the dripline, approximately 44 feet from the trunk, to allow the parking lot to be built outside of the protected zone. No pruning is required. This will be a minor encroachment and will not harm the tree.
--	--

- D. The only tree encroachments that will occur according to the current grading plan will be to tree 2. The percentage of encroachment to this tree will be approximately 1%. The plans have been modified to reduce the encroachments to insignificance.
- E. The other oak trees, trees 3 – 8 and trees 10 – 12, are well outside of grading, off property, and will not be impacted by the development of this site.

Oak tree 2 facing south

Oak tree 2 facing north
