Agoura Landmark Project

Addendum to the Agoura Oaks Plaza Final Initial Study/Mitigated Negative Declaration

October 2009

Oak Tree Survey

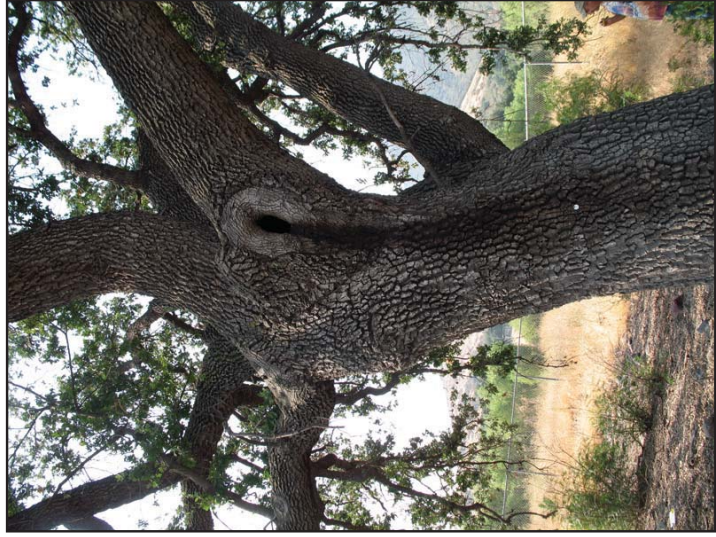
The lower trunk of the valley oak leans to the east. The oak has a weak main crotch, with included bark at the first branch union. There is a trunk cavity in the north side of the upper trunk structure at 13 feet in height, with an old exudation visible below the cavity from 6-12 feet in height. A broken cable was visible in the lower canopy. The cable had helped support a heavy horizontal-trending branch, linking it to another large branch. Horizontal-trending branches that extend to the edge of the canopy are not excessive, and lifting of the canopy for construction access should not be required. There are two collateral branches on the southwest side of the canopy, with one branch subdominant and sparse with foliage. There is a build-up of deadwood in the canopy that should be removed to invigorate the tree. Insect pests, including evidence of wood borers (exit holes) and California oak worm (*Phryganidia californica*, damaged leaves) are deemed to be at a tolerable level.

Oak #100 – showing trunk cavity and old exudation below cavity.

- Replace broken cable that supported heavy horizontal-trending branch
- Remove deadwood from oak canopy
- Remove exotic species growing inside oak's Protection Zone and control subsequent growth of re-sprouts and seedlings
- Remove concrete and other rubbish from under oak canopy
- Retain and supplement leaf mulch under oak canopy

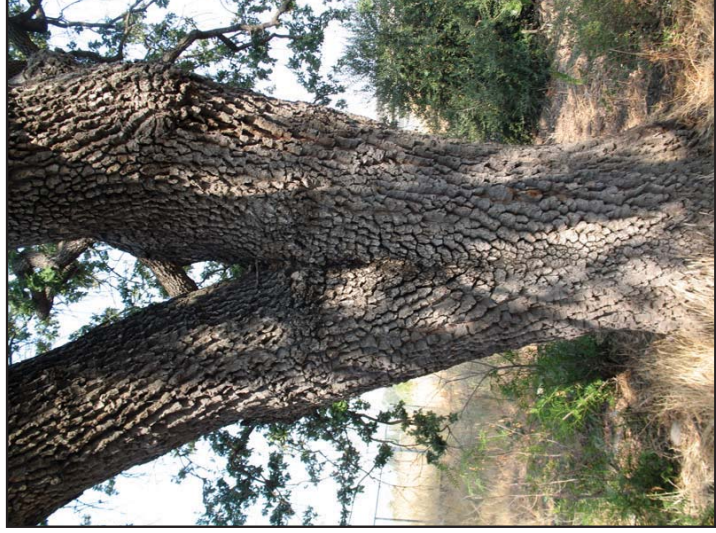
Oak #100 – showing weak main crotch with included bark.

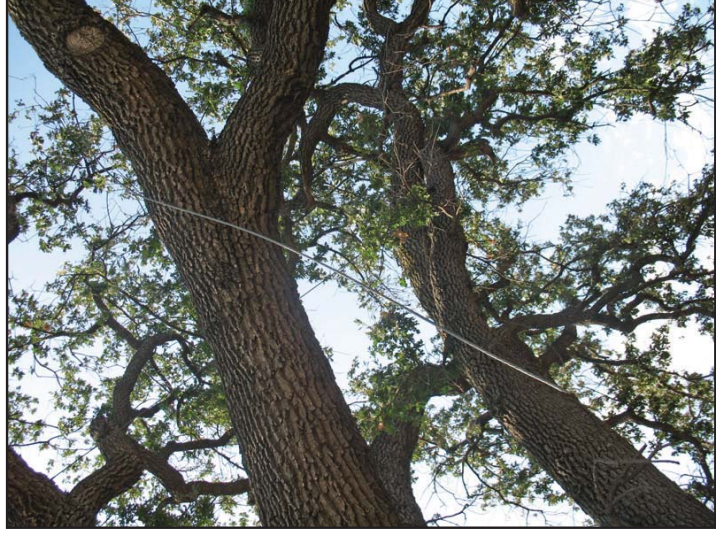
Oak #100 – showing broken cable in lower canopy.

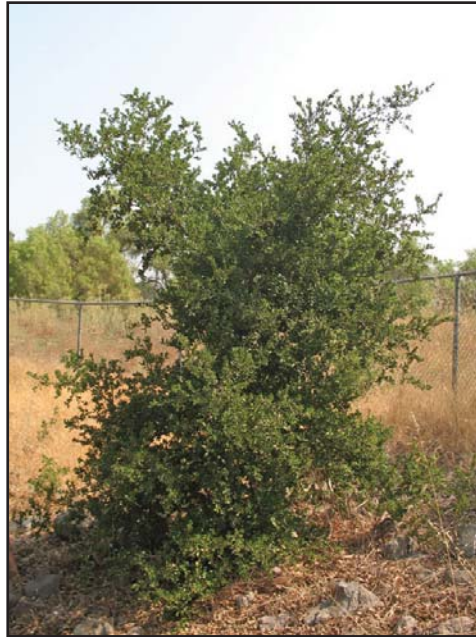
Oak #85 – View facing south-southeast.

Oak #85 is located at the eastern edge of the hollow associated with Oak #100. The proposed improvements will include a Keystone battered wall, which supports a pedestrian access, directly adjacent to the tree's location. The trunk of this coast live oak is located inside the grading footprint for the sidewalk curbing, thus, the oak will need to be removed, with standard tree replacement mitigation prescribed.

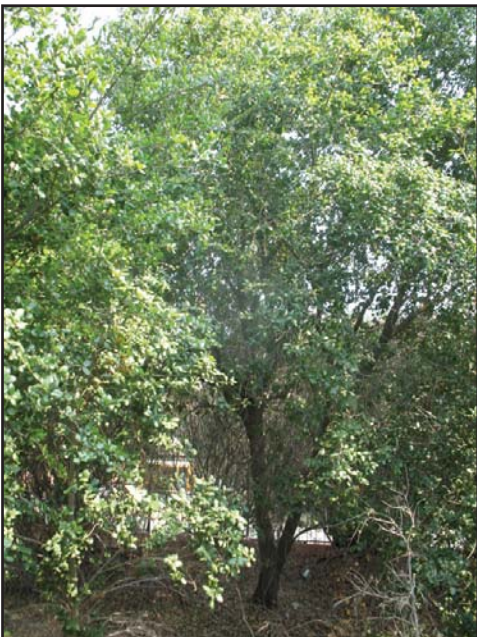
Oak #84 – View facing south-southeast.

Oak #84 is a 30-foot tall coast live oak located near the southwest corner of the property, in the vicinity of a storm drain structure. The oak was evaluated with an aesthetic rating of "C", a vigor rating of "C" and a health rating of "C" (**Plate 2, Appendix B**). There are multiple structural and health issues associated with this oak. The oak has a weak main crotch, with included bark at the first branch union. There are exfoliation cracks on the lower east trunk. There are two active exudations on the east trunk, a small seepage at four feet in height and a larger seepage at eight feet in height. Structural pruning is recommended to correct collateral and crossing branches in the upper trunk structure. There is a build-up of deadwood in the canopy that should be removed to invigorate the tree. Insect pests include Ehrhorn's oak scale, observed on the trunk and lower branches, and wood borers exit holes, observed at the base of the east trunk. Based on the presence of pupal cases observed in the exit holes, the borer may be carpenterworm (*Prionoxystus robiniae*). Control of wood borers is difficult, and would require proper timing and multiple applications of an insecticide recommended by a licensed pest control advisor. Removal of exotic shrubs (oleander) located inside the oak's Protection Zone would benefit the overall health of the oak.

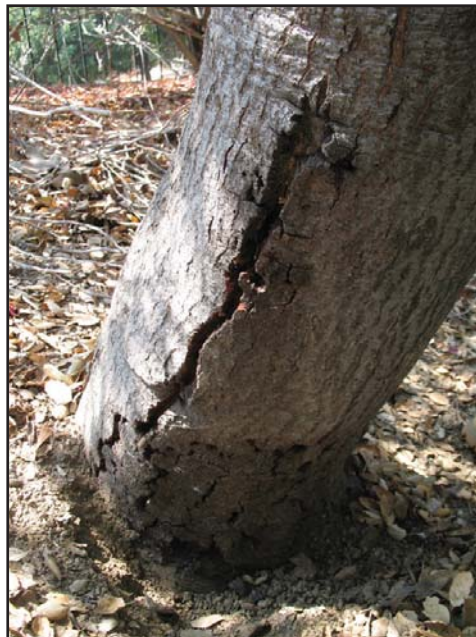
Oak #84 – Showing exfoliation crack and wood borer holes near base of trunk.

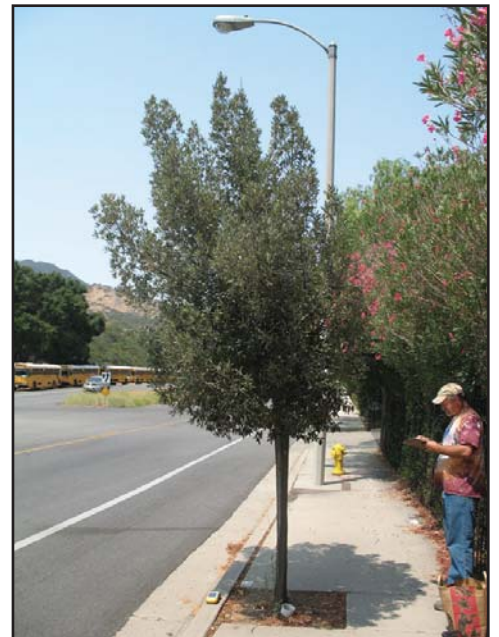
Oak #77 – View facing west.

Oak #77 is a 15-foot tall holly oak street tree installed along the southern edge of the subject property, along Agoura Road. The oak was evaluated with an aesthetic rating of "C", a vigor rating of "B" and a health rating of "B" (**Plate 2, Appendix B**). There is a crack along the lower trunk at 2-8 feet in height that may be indicative of a drought-stress condition in the tree. The vigor of the oak appeared to be satisfactory at the time of the survey. The tree tag has become embedded into the trunk, and should be re-attached and the wound treated with a fungicide. Insect pests were not found. Tree stakes supporting the oak were improperly installed, and the tree should be re-staked with two stakes installed a minimum one-foot from the trunk. Removal of exotic shrubs (oleander) located inside the oak's Protection Zone would benefit the overall health of the oak.

The holly oak street tree is located along Agoura Road, and its canopy and protection zone will be impacted by the installation of a new sidewalk. A total of 44-percent of the oak's protection zone is impacted by project grading. Although the percentage of protection zone impact is greater than 20-percent, grading impacts are considered less than significant. Replacement of the sidewalk should not significantly impact the root zone of the oak, and no tree replacement mitigation should be required.

The City of Agoura Hills recommends that, when the sidewalk is replaced, the new tree well be larger than the existing well. Since the width of the sidewalk prevents increasing its width, a linear well should be incorporated into the sidewalk design, with dimensions of two-foot by ten-foot (2' x 10'), running along the curb.

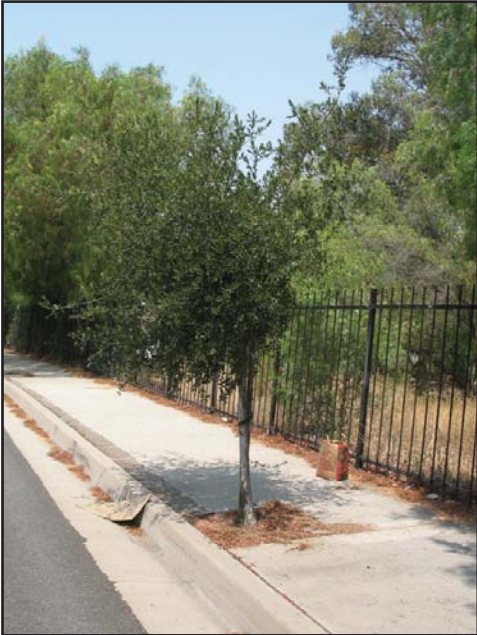
Oak #78 – View facing west.

Oak #78 is an 11-foot tall coast live oak street tree installed along the southern edge of the subject property, along Agoura Road. The oak was evaluated with an aesthetic rating of "C", a vigor rating of "C" and a health rating of "C" (**Plate 3, Appendix B**). Wounds and cracks were observed at the base of the trunk. Structural pruning is recommended to improve the branching structure of the upper canopy. The pruning cuts would involve branches less than two (2) inches in diameter. Tree stakes supporting the oak were improperly installed, and the tree should be re-staked with two stakes installed a minimum one-foot from the trunks. Removal of exotic shrubs (Peruvian pepper) located inside the oak's Protection Zone would benefit the overall health of the oak. Application of supplemental irrigation is recommended, as the oak appears drought-stressed.

The coast live oak is a street tree located along Agoura Road, and its canopy and protection zone will be impacted by the installation of a new sidewalk. A total of 38-percent of the oak's protection zone is impacted by project grading. Although the percentage of protection zone impact is greater than 20-percent, grading impacts are considered less than significant. Replacement of the sidewalk should not significantly impact the root zone of the oak, and no tree replacement mitigation should be required.

The City of Agoura Hills recommends that, when the sidewalk is replaced, the new tree well be larger than the existing well. Since the width of the sidewalk prevents increasing its width, a linear well should be incorporated into the sidewalk design, with dimensions of two-foot by ten-foot (2' x 10'), running along the curb.

- Structural pruning is recommended to improve branching structure of oak's upper canopy
- Re-stake tree with two stakes a minimum one foot from trunk
- Remove exotic species growing inside oak's Protection Zone
- Application of supplemental irrigation is recommended for drought-stressed oak

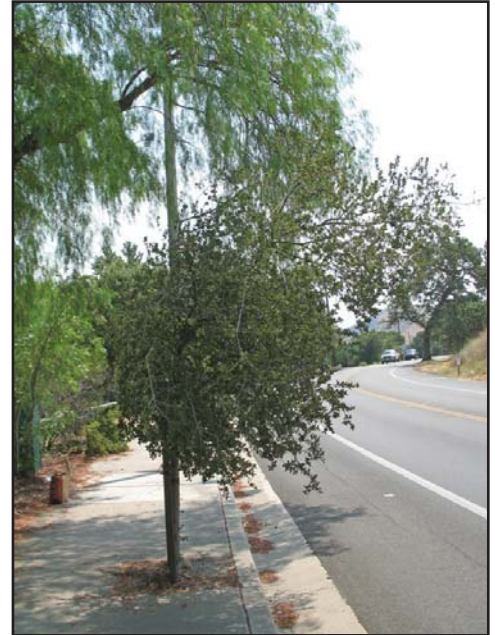
Oak #82 – View facing east.

Oak #82 is a nine-foot tall coast live oak street tree installed along the southern edge of the subject property, along Agoura Road. The oak was evaluated with an aesthetic rating of “D”, a vigor rating of “D” and a health rating of “D” (**Plate 3, Appendix B**). The upper trunk leans southwest. Structural pruning is recommended to remove portions of excessive horizontal branching and reestablish vertical growth. The pruning cuts would involve branches less than two (2) inches in diameter. Insect pests are minimal. The oak was planted too low, and soil should be removed that is covering the root crown. Removal of exotic shrubs (Peruvian pepper) located inside the oak’s Protection Zone would benefit the overall health of the oak. Application of supplemental irrigation is recommended, as the oak appears drought-stressed.

Given the health rating of “D” assessed in the 2008 oak tree report, The City of Agoura Hills’ oak tree consultant has recommended Oak #82 be replaced with 1 (24-inch box) coast live oak, to be included as a mitigation tree.

The City of Agoura Hills recommends that a new tree well be constructed that is larger than the existing well. Since the width of the sidewalk prevents increasing its width, a linear well should be incorporated into the sidewalk design, with dimensions of two-foot by ten-foot (2’ x 10’), running along the curb. Fill soil built-up around oak trunk should be removed with construction of new tree well.

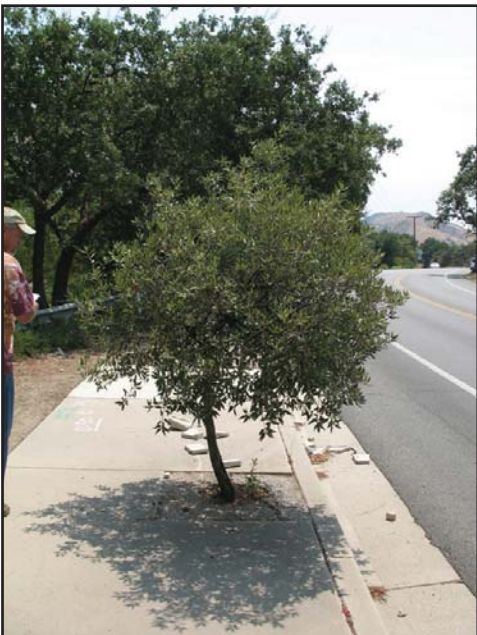
Oak #40 – View facing east.

Oak #40 is a seven-foot tall holly oak street tree installed along the southern edge of the subject property, along Agoura Road. The oak was evaluated with an aesthetic rating of “C”, a vigor rating of “B” and a health rating of “C” (**Plate 3, Appendix B**). The oak has an injury to the southwest side of the trunk at 0-2 feet in height. Blackened branches and exfoliation cracks along the branches may be damage resultant from a fire. Structural pruning is recommended to remove crossing branches and internal branches not contributing to the canopy. The pruning cuts would involve branches less than two (2) inches in diameter. Insect pests are minimal. A padlock has been closed on a branch and should be removed before the lock begins to girdle the branch.

The tree well for this oak is a circular opening only 18 inches in diameter, with asphalt covering the remainder of the original 3 foot x 3 foot well. The City of Agoura Hills recommends that a new tree well be constructed that is larger than the existing well. Since the width of the sidewalk prevents increasing its width, a linear well should be incorporated into the sidewalk design, with dimensions of two-foot by ten-foot (2' x 10'), running along the curb.

- Structural pruning is recommended to remove crossing branches and internal branches not contributing to oak canopy.
- Cut-off padlock attached to oak branch

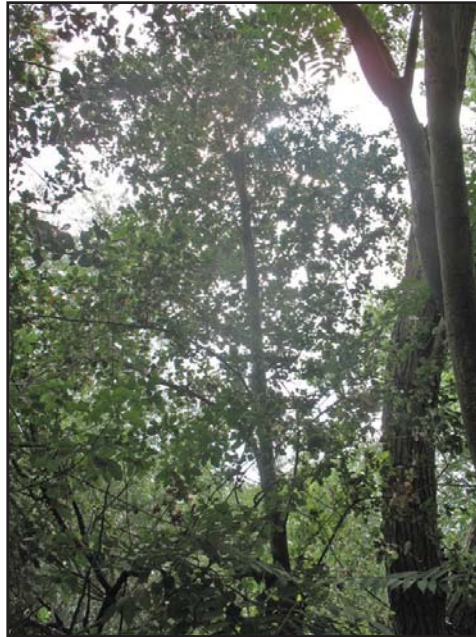
Oak #60 – View facing east-southeast.

Oak #60 is a 30-foot tall coast live oak located near the northeast corner of the subject property. The trunk of the off-site oak is located east of the property boundary on the County of Los Angeles Animal Center property, and the trunk is growing through the existing fencing positioned along or near the eastern property boundary. The oak was evaluated with an aesthetic rating of "B", a vigor rating of "C" and a health rating of "C" (**Plate 4, Appendix B**). The oak has a straight trunk than leans to the north. Insect pests, including evidence of California oakworm (damaged leaves) and tent caterpillar (silken mats) are deemed to be at a tolerable level. Soil and plant debris covering the root crown should be removed. Removal of exotic trees (tree of heaven) located inside the oak's Protection Zone would benefit the overall health of the oak.

The young oak has a strong vertical growth pattern, and, due to the sandy soils in this area, the oak's structural roots are likely concentrated downward. The distance between the wall and the trunk is estimated at 4.5 feet, which should provide room for construction of the wall without impacting the integrity of the trunk, branching structure and root structure. However, due to unknown factors such as width and depth of the wall footing, and required changes in grade near the oak trunk, standard tree replacement mitigation is prescribed for this oak.

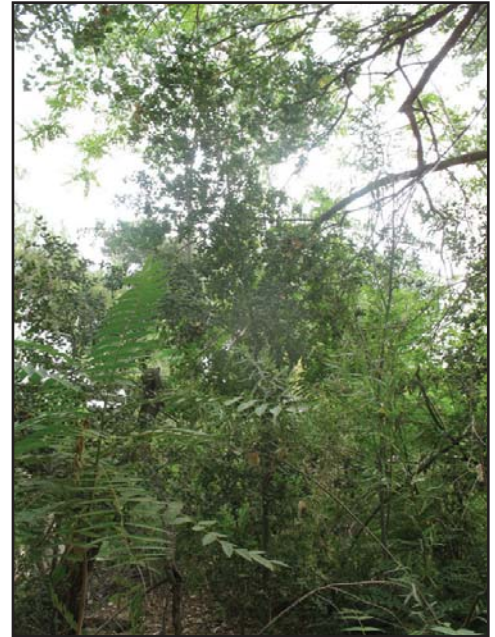
Oak #61 – View facing north-northeast.

Oak #61 is an 18-foot tall coast live oak located near the northeast corner of the subject property. The oak was evaluated with an aesthetic rating of "C", a vigor rating of "C" and a health rating of "C" (**Plate 4, Appendix B**). The trunk of this oak leans to the north-northwest, and the oak canopy is over-topped by exotic trees. Insect pests, including evidence of California oak worm (damaged leaves) and tent caterpillar (silken mats) are deemed to be at a tolerable level. Removal of exotic trees (tree of heaven, Peruvian pepper) located inside the oak's Protection Zone would benefit the overall health of the oak.

The trunk of this coast live oak is located within the grading footprint for the sidewalk curbing for the eastern edge of parking facilities, thus, the oak will need to be removed, with standard tree replacement mitigation prescribed.

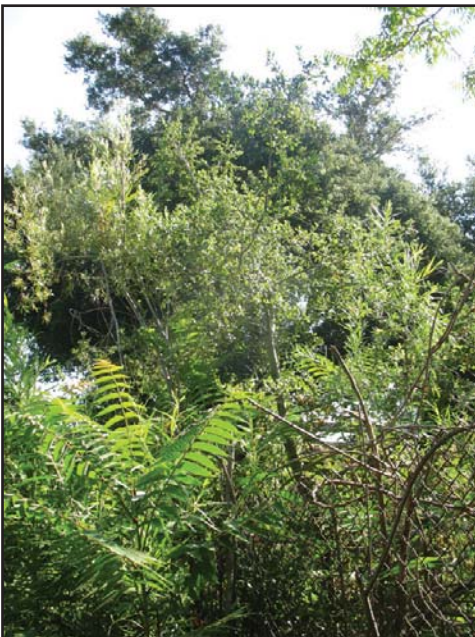
Oak #62 – View facing north-northeast.

Oak #62 is a 15-foot tall coast live oak located near the northeast corner of the subject property. The trunk of the off-site oak is located a few feet east of the property boundary, on the County of Los Angeles Animal Center property. The oak was evaluated with an aesthetic rating of "C", a vigor rating of "C" and a health rating of "B" (**Plate 4, Appendix B**). Insect pests, including evidence of California oakworm (damaged leaves) are deemed to be at a tolerable level. Soil and plant debris covering the root crown should be removed. Removal of exotic trees (tree of heaven) located inside the oak's Protection Zone would benefit the overall health of the oak.

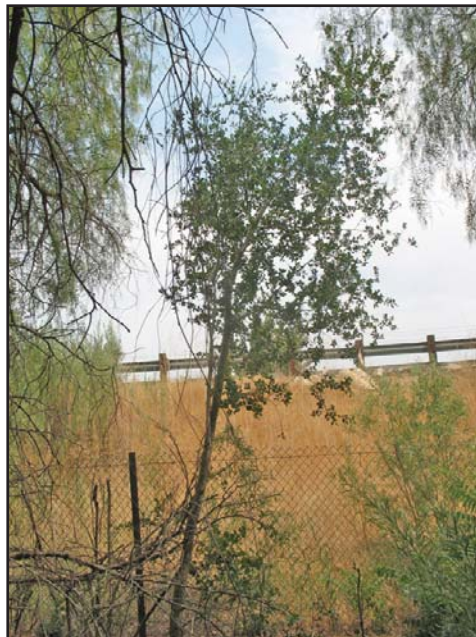
Oak #63 – View facing north.

Oak #63 is a 17-foot tall coast live oak located near the northeast corner of the subject property. The trunk of the oak is located a few feet south of the fencing along the northern property boundary. The oak was evaluated with a health rating of "C", a vigor rating of "C" and an aesthetic rating of "C" (**Plate 4, Appendix B**). There are exfoliation cracks along the trunk from 0-5 feet in height. Insect pests, including Ehrhorn's oak scale (observed along the trunk and branches), crown whitefly (observed on the undersides of leaves), and evidence of California oakworm (damaged leaves) are deemed to be at a tolerable level. Removal of exotic trees (tree of heaven, Peruvian pepper) located inside the oak's Protection Zone would benefit the overall health of the oak.
