Roadside Drive Bridge Widening	Project No. 101480-2000
		6/21/2013

Subject: Response to Geotechnical Review
Geotechnical and Foundation Report
Roadside Drive and Bridge Widening Over Medea Creek
Agoura Hills, California
Willdan Geotechnical Project No. 101480-4000

**ROADSIDE DRIVE BRIDGE
WIDENING PROJECT
CITY OF AGOURA HILLS**

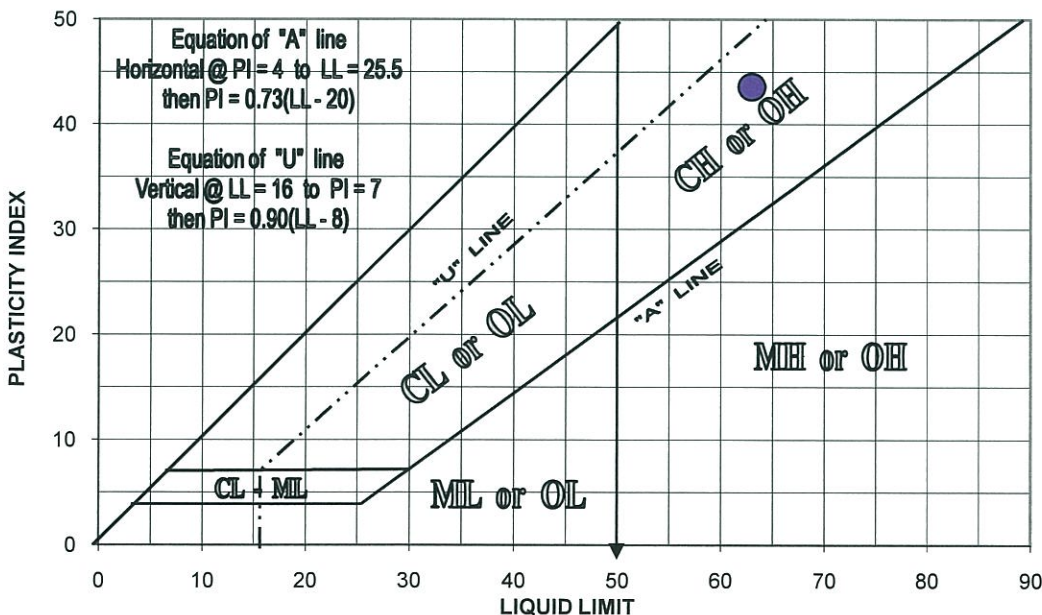
FLOW CURVE

PLASTICITY CHART

NATURAL MOISTURE CONTENT, (%)	_____
LIQUID LIMIT (LL)	63
PLASTIC LIMIT (PL)	19
PLASTICITY INDEX (PI)	44
SYMBOL FROM PLASTICITY CHART	CL

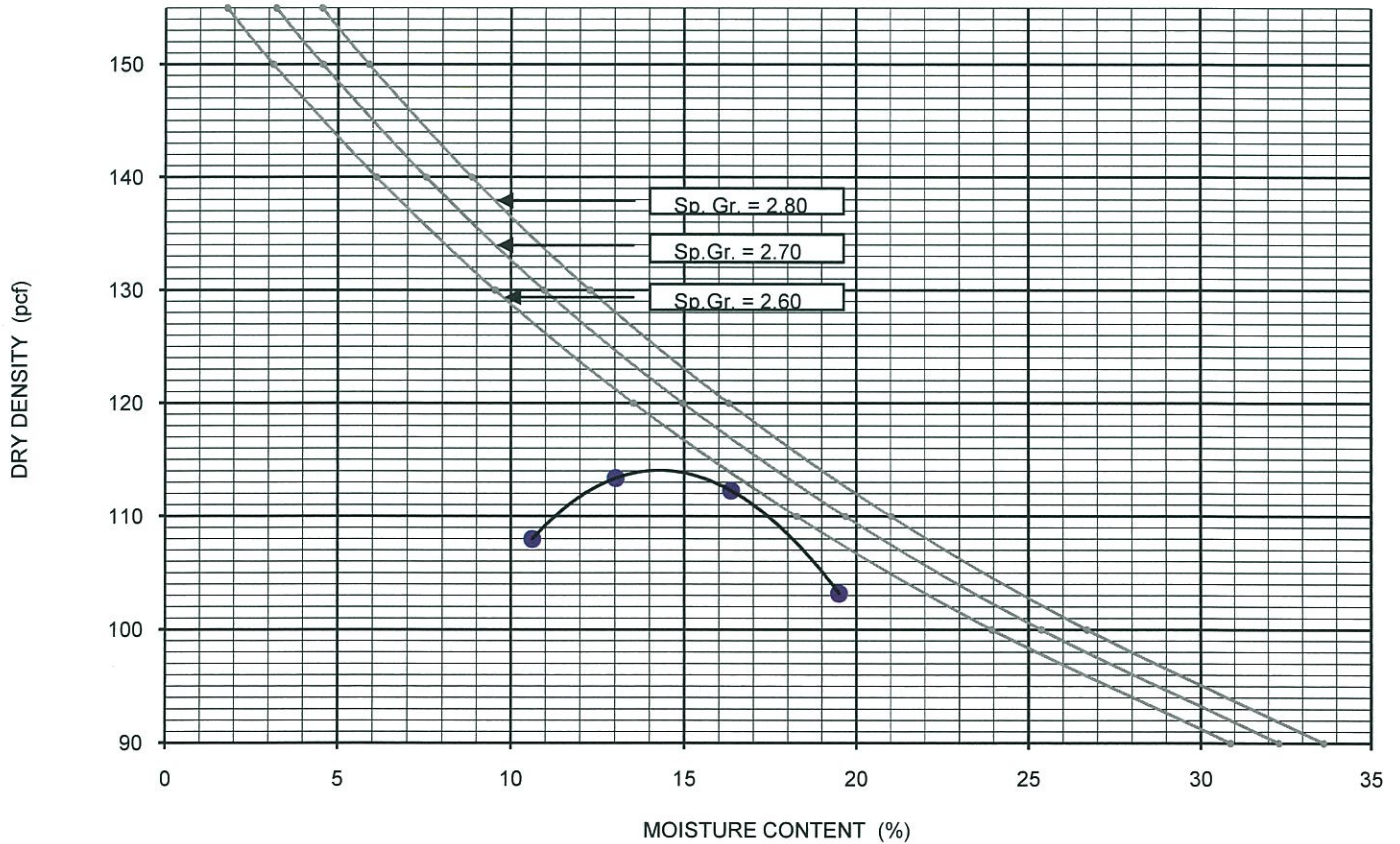
COMPACTION TEST

TEST STANDARD METHOD	ASTM D 698 - 07			ASTM D 1557- 07		
	A	B	-	A	B	C
TRIAL NUMBER	1	2	3	4	5	
WATER ADDED, (ml)	-2%	0%	2%	4%		
WT. OF SOIL + MOLD, (g)	3849.4	3980.5	4018	3907.5		
WT. OF MOLD, (g)	2045	2045	2045	2045		
WT. OF WET SOIL, (g)	1804.4	1935.5	1973	1862.5		
WET DENSITY, (pcf)	119.5	128.1	130.6	123.3		
CAN NUMBER	A48	A133	A139	A135		
WET SOIL + TARE, (g)	510.80	395.20	774.70	779.00		
DRY SOIL + TARE, (g)	471.60	361.60	679.30	667.50		
TARE, (g)	102.70	103.80	96.20	96.00		
DRY SOIL, (g)	368.90	257.80	583.10	571.50		
WATER, (g)	39.20	33.60	95.40	111.50		
MOISTURE CONTENT, (%)	10.6	13.0	16.4	19.5		
DRY DENSITY, (pcf)	108.0	113.4	112.3	103.2

DIAMETER OF MOLD :	<u>4</u>	in.
VOLUME OF MOLD :	<u>0.0333</u>	ft. ³
SCALPED ON SIEVE SIZE / NO. :	<u>No.4</u>	
PERCENT RETAINED, (%) :	<u><1.0</u>	
MAXIMUM DRY DENSITY :	<u>114.0</u>	pcf.
OPT. MOISTURE CONTENT :	<u>14.5</u>	%

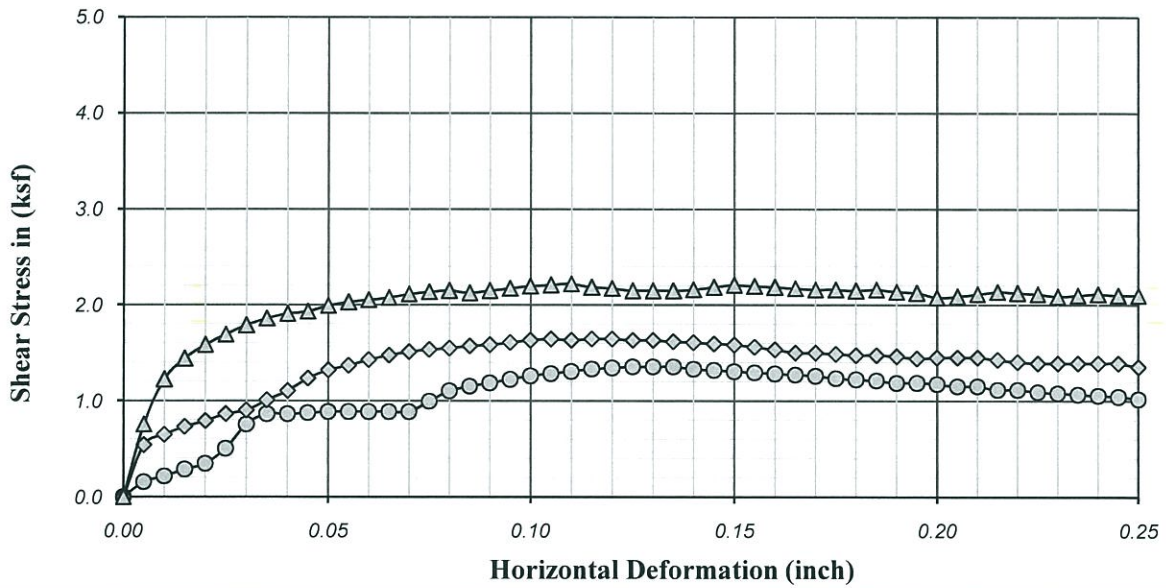
Direct Shear Test

Ultimate : ○ Shear Type : Saturated Undisturbed Peak : ●

Boring No. :	A-13-002	Strength Intercept (C) :	1.07	(ksf)	Peak	0.64	(ksf)	Ultimate		
Sample No. :	R-5		51.14	(kPa)		30.45	(kPa)			
Depth (ft/m) :	20.0	Friction Angle (Ø) :	16	Degree		20	Degree			
Description :	Brown Fat Clay (CH)				Shear Rate (inch/min.):	0.01				
SYMBOL	MOISTURE CONTENT (%)	DRY DENSITY		VOID RATIO	NORMAL STRESS		PEAK STRESS		ULTIMATE STRESS	
		(pcf)	(kN/m ³)		(ksf)	(kPa)	(ksf)	(kPa)	(ksf)	(kPa)
○	30.80	90.52	14.25	0.86	1.00	47.88	1.36	64.93	1.00	47.69
◇	30.25	91.69	14.43	0.84	2.00	95.76	1.64	78.71	1.36	64.93
△	30.92	92.08	14.50	0.83	4.00	191.52	2.22	106.29	2.08	99.40
Remark

Response: Shear tests have been performed on four selected samples including A-13-001 at 20 feet bgs (sample 1), A-13-002 at 20 feet bgs (sample 2), A-13-003 at 36 feet deep bgs (sample 3), and A-13-004 at 35 feet bgs (sample 4). Samples 1 and 2 are representative of fill material, and samples 3 and 4 are representative of bedrock layer. Due to high disturbance of the samples obtained from sandy layer, no shear test was performed on the samples from this layer. The relevant parameters for sandy layer have been assumed based on the soil condition and engineering judgment, as well as using the presumptive values provided in acceptable references.
