***Existing Conditions and  
Constraints Report for  
Medea Creek Restoration  
Project, City of Agoura  
Hills, California***

***Kelly Fisher  
City of Agoura Hills  
30001 Ladyface Court  
Agoura Hills, CA 91301***

***Questa Engineering Corporation  
1220 Brickyard Cove Road  
Suite 206  
Pt. Richmond, California 94807  
(510) 236-6114***

*August 2013*

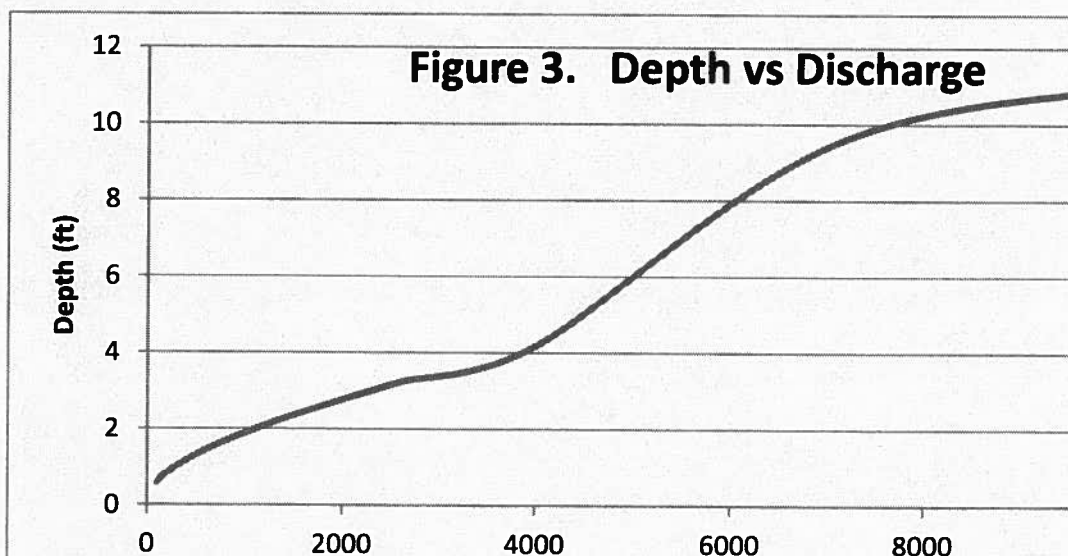
*Channel Capacity.* The existing channel is very efficient. The graph below shows a depth versus discharge curve for the channel (**Figure 3**). The channel is approximately 10 feet high from the channel bottom to the top of the bank. The existing conditions hydraulic model predicts a maximum depth of 9 to 10 feet within the channel at 100-year flow listed in the current FIS of 7,200 cfs. Thus, there is not much of extra depth under the 100 year discharge rate. Extra capacity in the channel that would allow the incorporation of vegetation planting will have to be gain from channel cross section enlargements and structures to prevent flooding outside of current flood control ROW. Initial modeling indicates that restoring the channel with fully matured vegetation would cause water surface elevations to rise above the current top of bank elevations although they would still be far below all of improvements on adjacent properties.

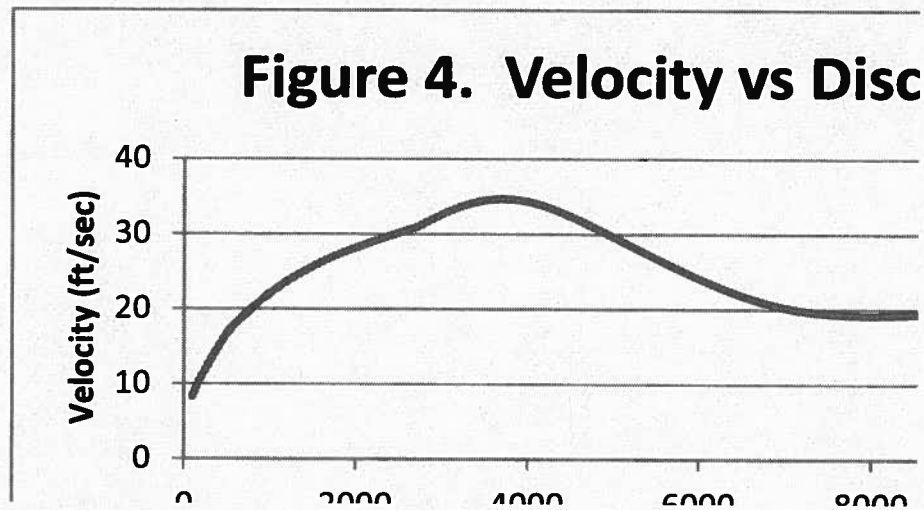
*Channel Velocities.* Existing flow velocities within the channel are very high due to the low frictional resistance within the concrete-lined trapezoidal channel and the steep slope. **Figure 4** shows average channel velocity versus discharge for the three different scenarios. These high velocities are an important constraint because the erosion potential of the channel can be linked to the velocity of the water moving through the channel. Once the channel is planted with or colonized by vegetation, velocities will be reduced. The design of the restoration project has to take into account that prior to this vegetation being established the channel will have lower frictional resistance, thus making channel erosion a serious concern during the establishment period.

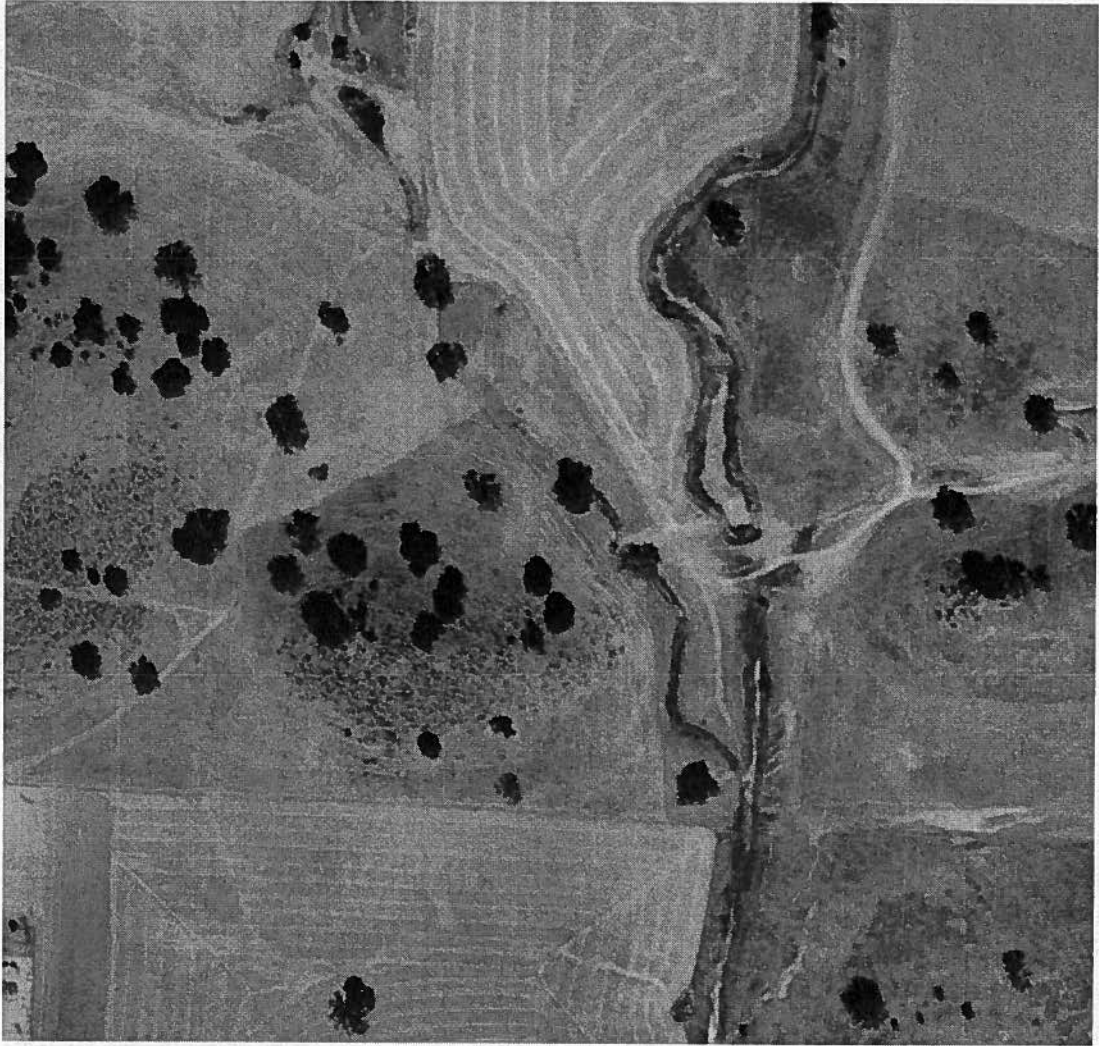
**Figure 5. Medea Creek Air Photo 1959**

The geomorphology of Medea Creek has highly been affected by anthropogenic activities. The air photo sequence shown below highlights the human development that has taken place within the watershed.
