**FLOW MONITORING SITE: GRAPHS, FIGURES & TABLES**

# Temporary Flow Monitoring Study

## Sanitary Sewer Collection System

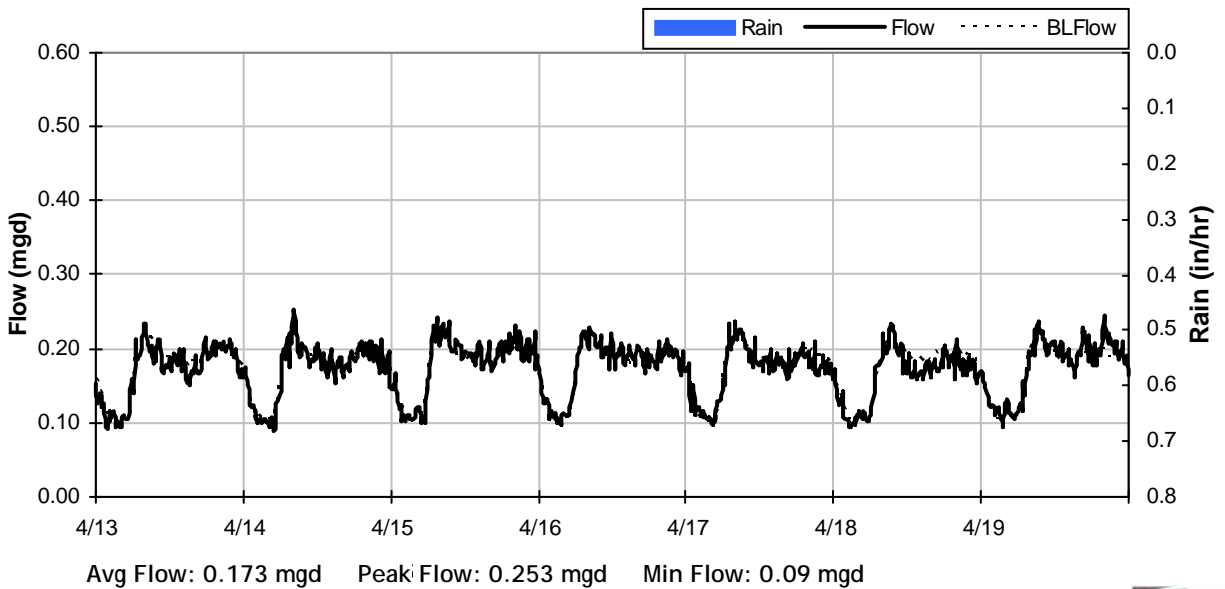
# Level, Velocity and Flow

From 4/13/2009 to 4/20/2009

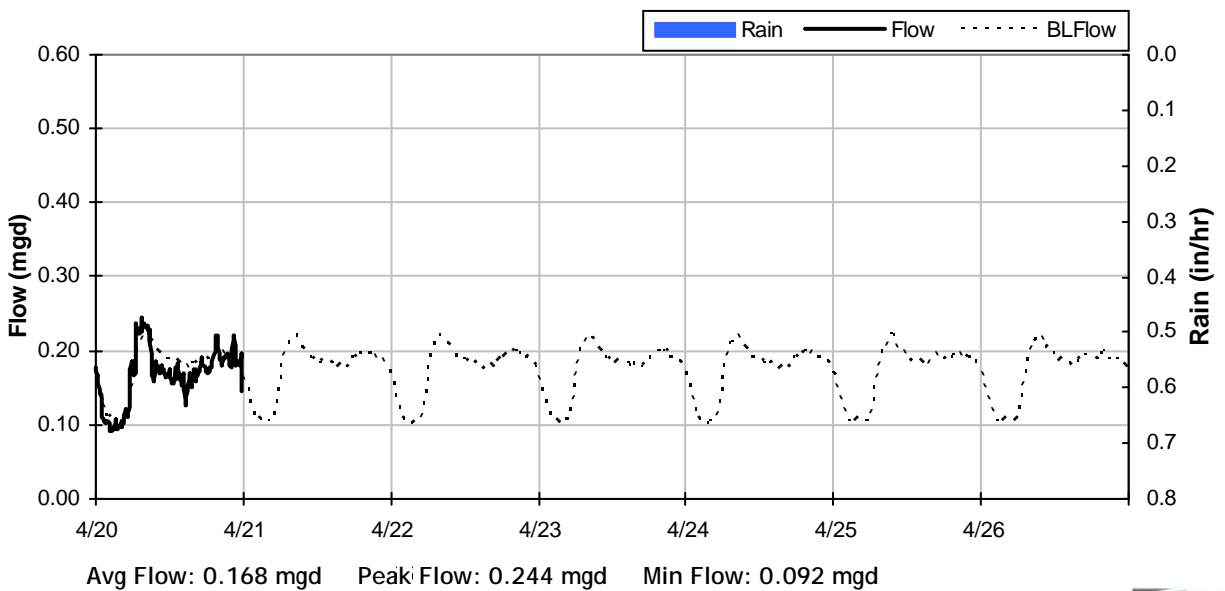
# Level, Velocity and Flow

From 4/20/2009 to 4/27/2009

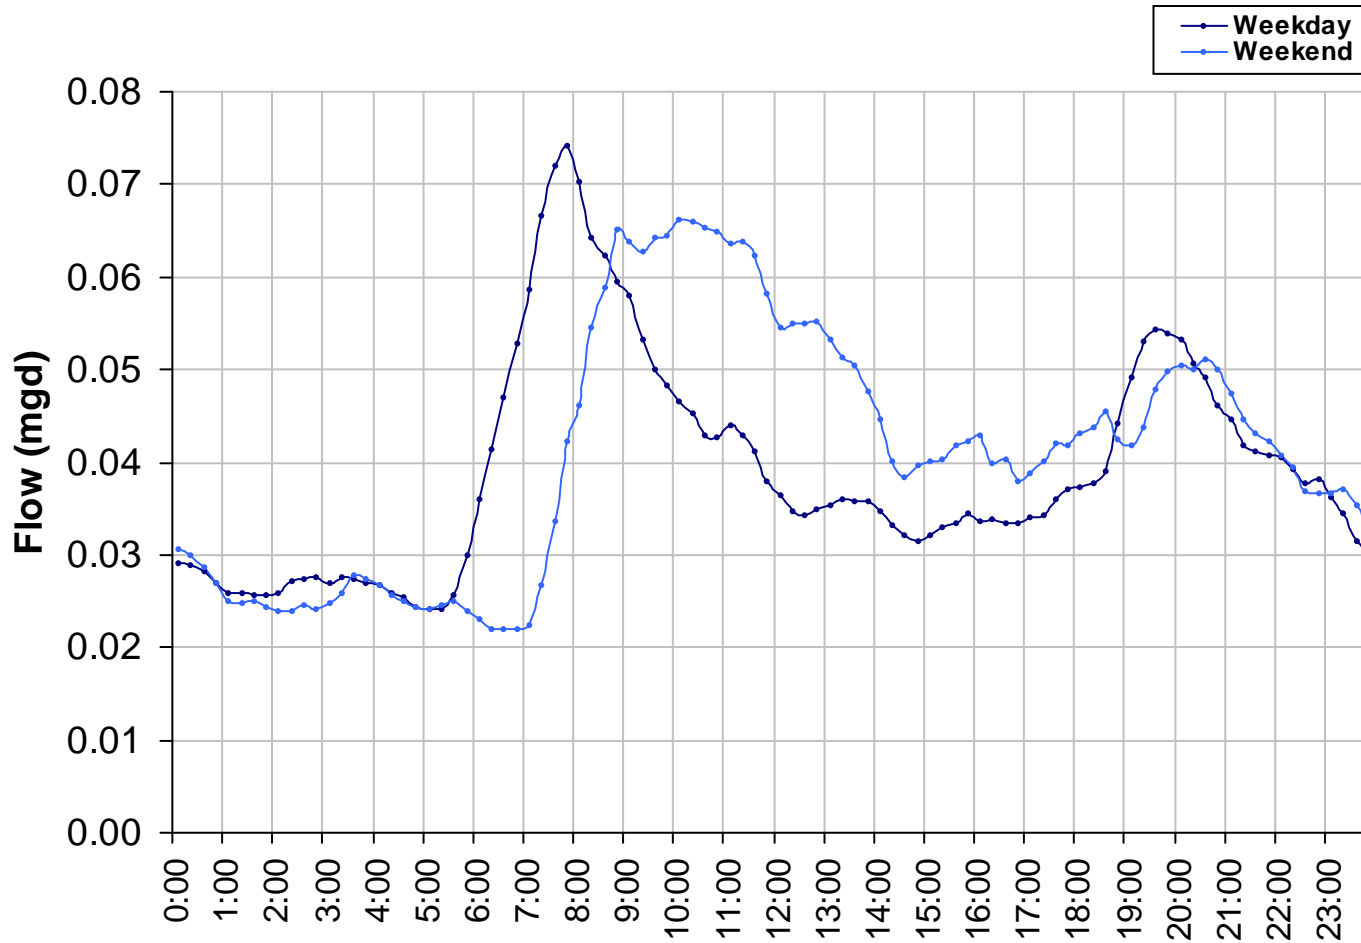
# Average Dry Weather Flow

Peak Measured Flow:  
0.13 mgd

Average Dry Weather Flow:  
0.04 mgd
