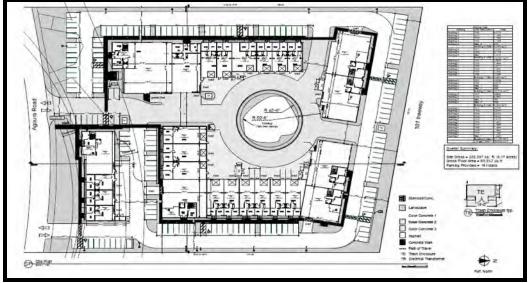
Figure 5: Proposed Site Plan Looking West

Figure 5 illustrates a proposed site plan, which includes office buildings, parking and associated landscaping features.

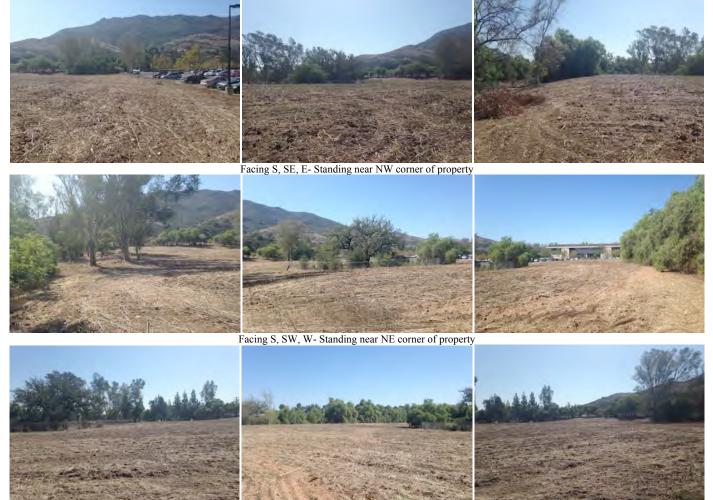
Plate 1: Selected Views of the Subject Property

The results of the Phase 1 archaeological study yielded no indications of prehistoric or historic archaeological resources within the surveyed area. Plate 1 illustrates selected views of the property.

Facing E, NE, SE- Standing along the western perimeter of the property, parallel to the Bank of America parking lot

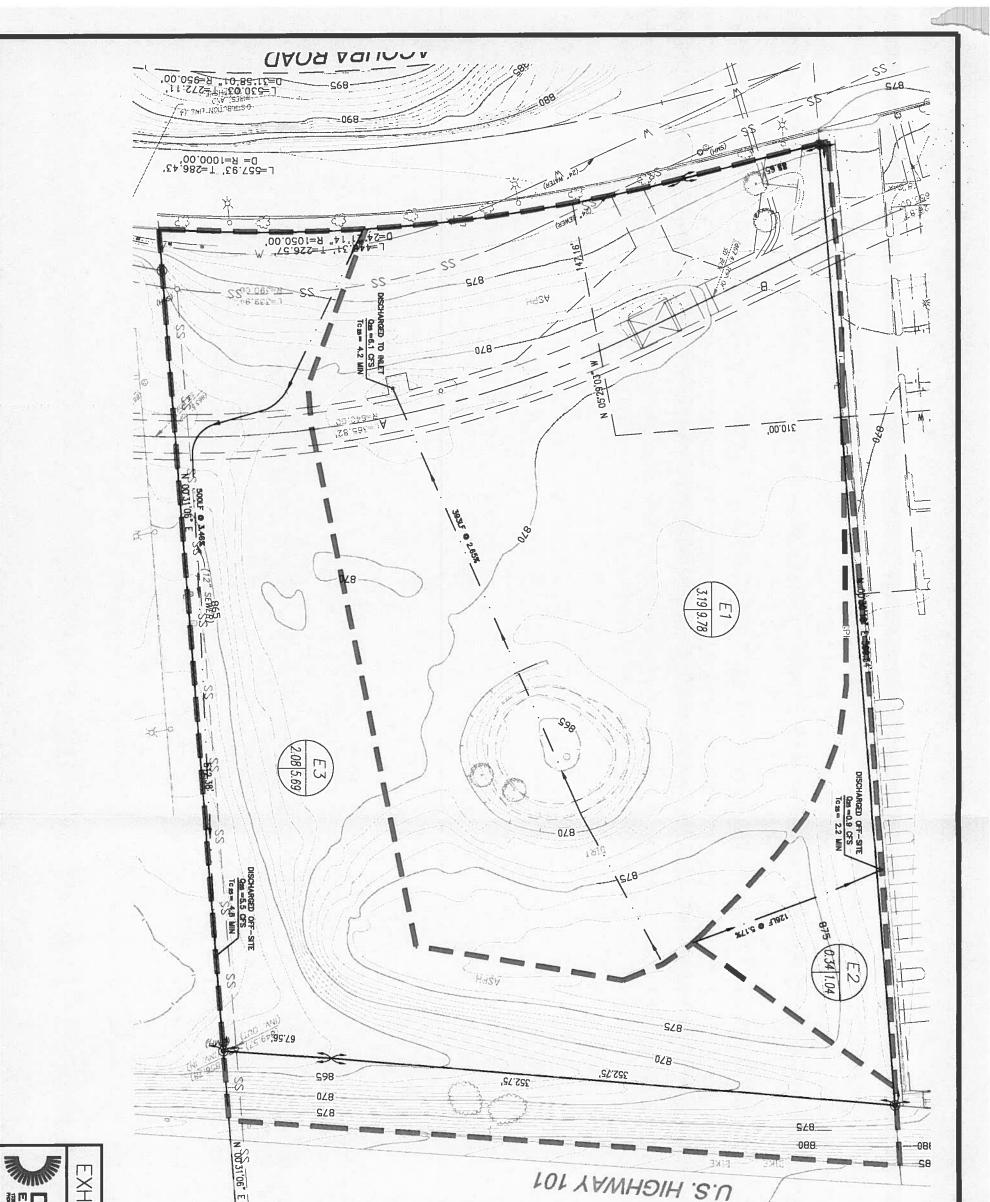
m	
DRN BY:		EGEND
FING CONDITION HYDROLOGY MAP		SUB-AREA BOUNDARY SUB-AREA DESIGNATION AREA (AC) FLOW DIRECTION

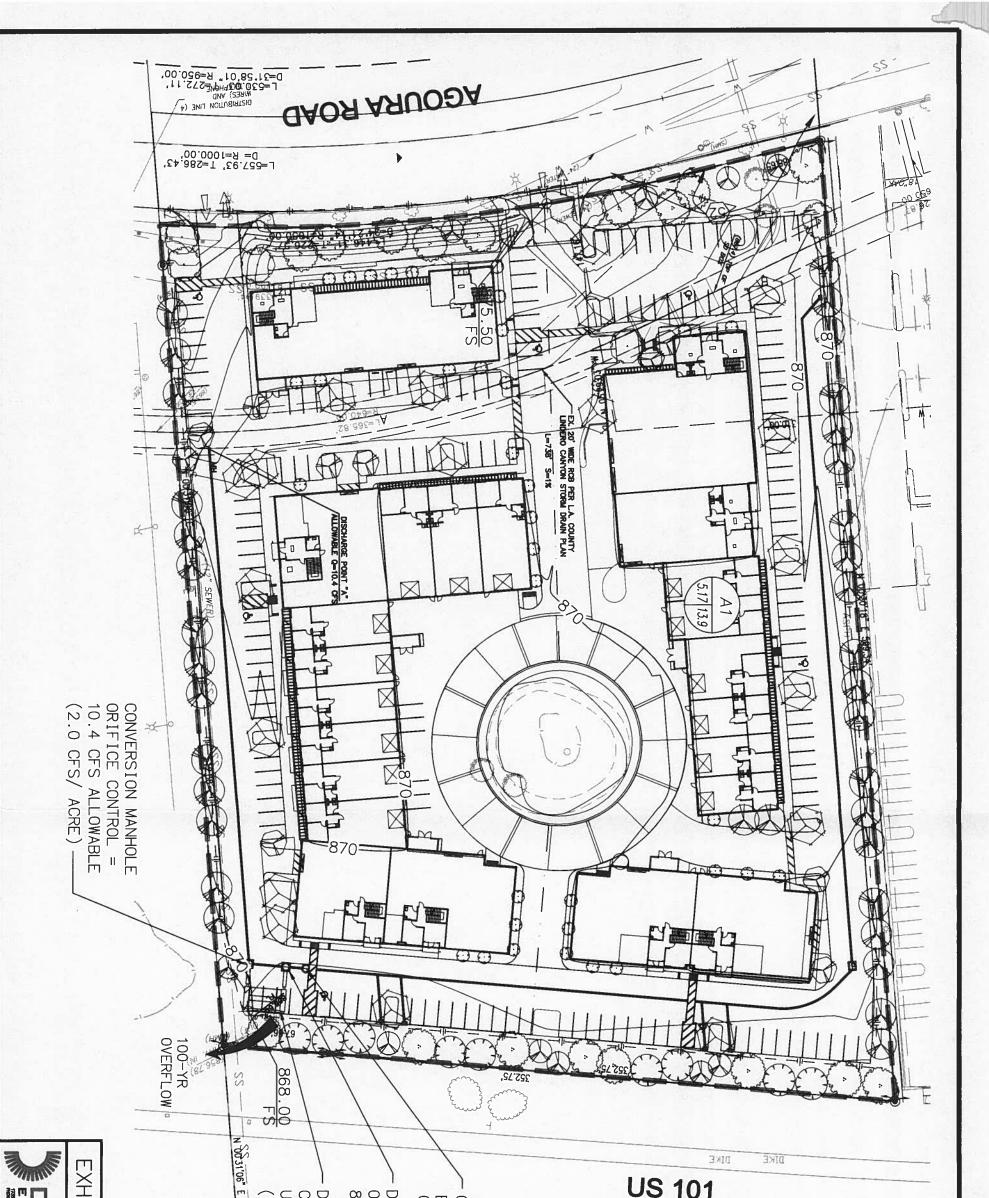
THE WGINEERING DRN BY: CS DES BY: SU/CS CK'D BY: SU 1	DELANE HYDROLOGY MAP	HIBIT B: PROPOSED CONDITION	DIVERSION MANHOLE ORIFICE CONTROL = 8.5 CFS ALLOWABLE DETENTION BASIN CONTECH: CHAMBER MAX UG DETENTION SYSTEM (1,684 CF)	CDS UNIT (SUSMP BMP) = 0.23 CFS Qpm	FLOW DIRECTION	LEGEND
	IAP	NO		-	CTION	Ž

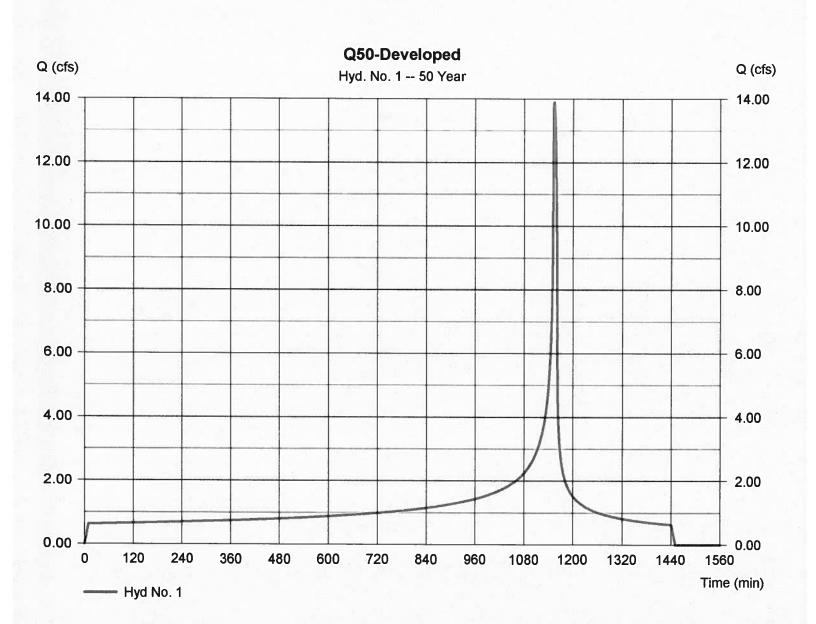
Q50-Developed

Hydrograph type	= Manual	Peak discharge	= 13.89 cfs
Storm frequency	= 50 yrs	Time to peak	= 1154 min
Time interval	= 1 min	Hyd. volume	= 103,471 cuft

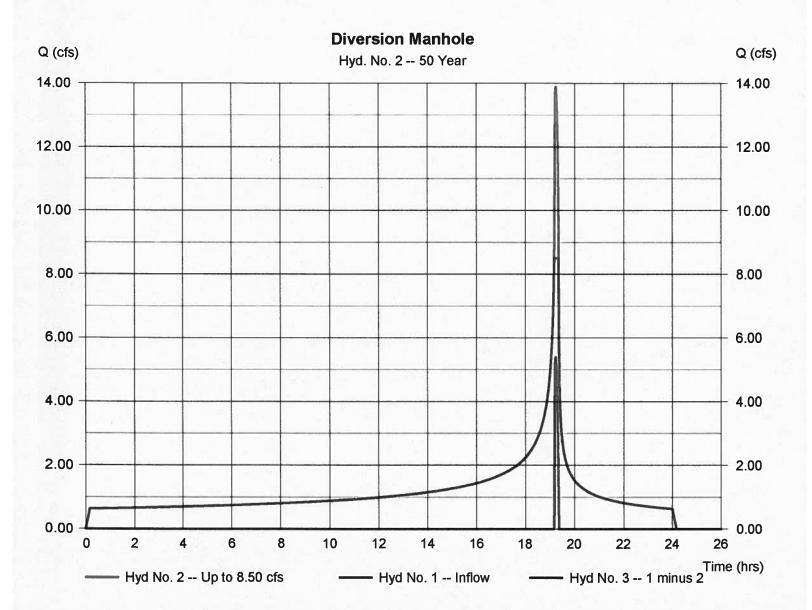
Diversion Manhole

Hydrograph type	= Diversion1	Peak discharge	= 8.500 cfs
Storm frequency	= 50 yrs	Time to peak	= 19.18 hrs
Time interval	= 1 min	Hyd. volume	= 100,996 cuft
Inflow hydrograph	= 1 - Q50-Developed	2nd diverted hyd.	= 3
Diversion method	= Constant Q	Constant Q	= 8.50 cfs

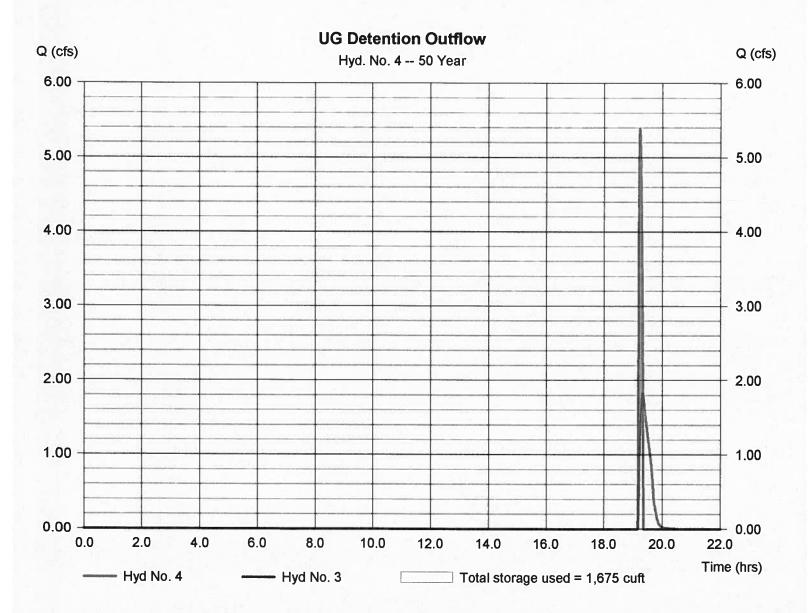
Hydrograph type	= Reservoir	Peak discharge	= 1.824 cfs
Storm frequency	= 50 yrs	Time to peak	= 19.33 hrs
Time interval	= 1 min	Hyd. volume	= 2,472 cuft
Inflow hyd. No.	= 3 - To UG Detention	Max. Elevation	= 863.00 ft
Reservoir name	= Underground Detention	Max. Storage	= 1,675 cuft

Storage Indication method used.

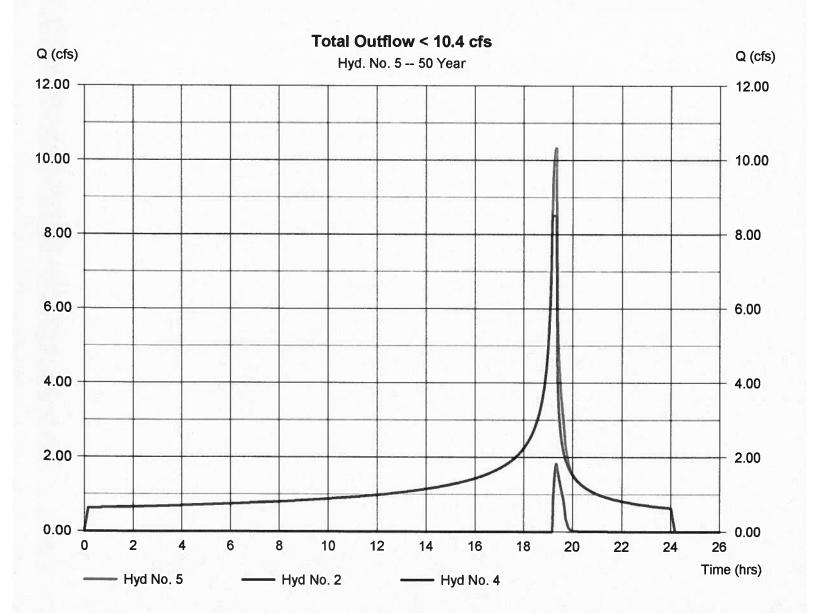
Total Outflow < 10.4 cfs

Hydrograph type Storm frequency	= Combine = 50 yrs	Peak discharge Time to peak	= 10.32 cfs = 19.33 hrs
Time interval	= 1 min	Hyd. volume	= 103,469 cuft
Inflow hyds.	= 2, 4	Contrib. drain. area	= 0.000 ac
