Project: **Agoura Landmark**
29621 Agoura Rd.
Agoura, CA 93023

Sheet Title: **Building B - Exterior Elevations**

Agoura Landmark Light Industrial Project

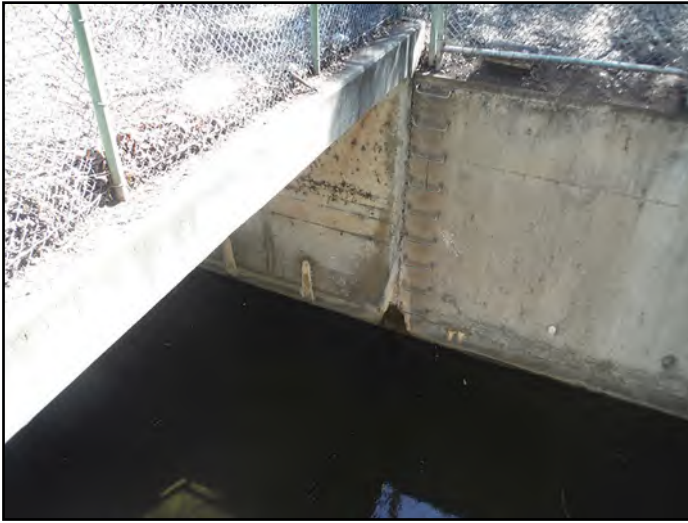
Photo 2A – Lindero Creek flows in a closed and an open concrete box culvert beneath the site. The open section of Lindero Creek in the southwestern portion of the site is shown.

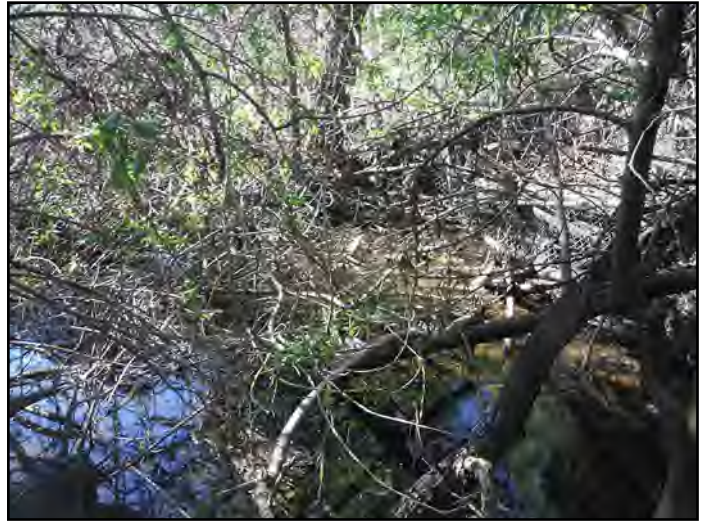
Photo 2B – The jurisdictional stream and riparian habitat located near the northeastern corner of the site is shown. The western margin of this stream wetland and the canopies of riparian willows and a cottonwood extend into the site.

The jurisdictional areas at the project site include a stream bank, a stream wetland, and a patch of riparian habitat in the northeastern corner of the site. Other jurisdictional areas include Lindero Creek, which passes from west to east through the site in a buried open and closed 20-foot wide concrete box culvert. There is also a buried jurisdictional lateral storm drain, which discharges to the 20' closed box culvert. A map of the jurisdictional areas at the site is provided as **Figure 3, Jurisdictional Delineation Map**. Photos relevant to the jurisdictional delineation are provided on **Plate 2** and **Plate 3**, and wetland determination data forms are provided in Appendix 3.

The project would also permanently impact 0.036 acres of riparian habitat under the jurisdiction of CDFW in the northeastern corner of the site, which is associated with a jurisdictional tributary to Lindero Creek. The extent of the riparian habitat that would be impacted by the project is shown on Figure 3. The riparian habitat is comprised of the Red Willow Woodland Alliance natural community, which in addition to being jurisdictional habitat is also a CDFW Natural Community of Special Concern. Impacts to the jurisdictional riparian habitat and the Red Willow Woodland Alliance would consist of trimming the canopies of a small number of large mature native willow and cottonwood trees. The trees would not be removed, as while the canopies of the trees extend into the property the main trunks are located off-site. The trees would be trimmed and then maintained such that the canopies would not extend into the developed portion of the project site. Impacts to 0.036 acres to CDFW jurisdictional riparian habitat and the Red Willow Woodland Alliance natural community would be a significant, but mitigable impact.

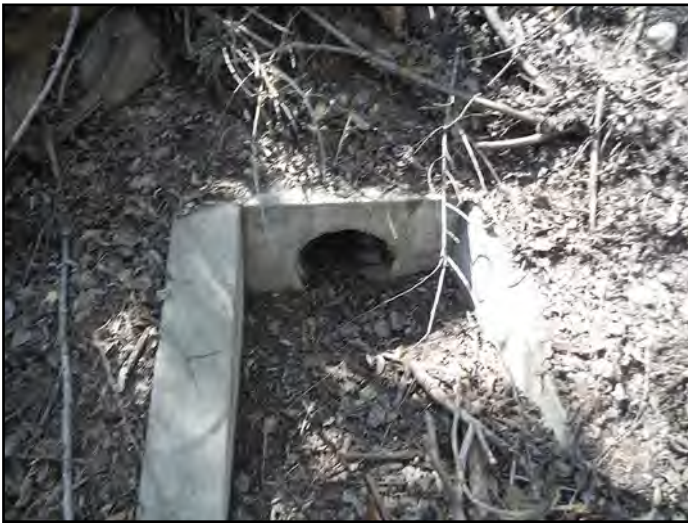
Photo 2C – This small on-site culvert inlet discharges to the jurisdictional stream wetland located near the northeastern site boundary.

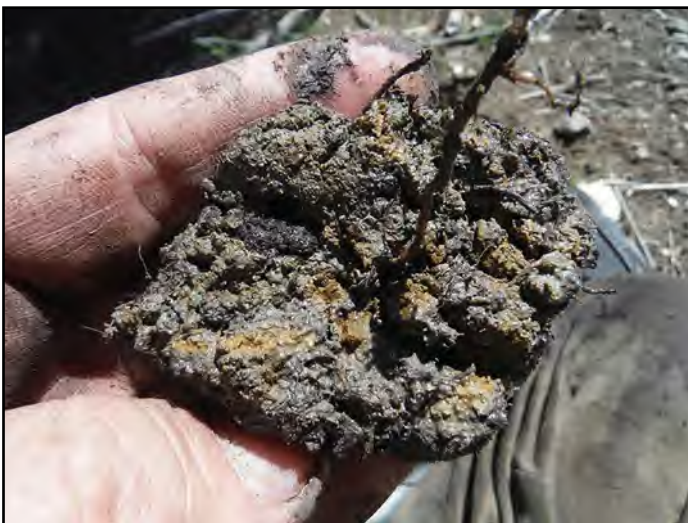
Photo 2E – Soils in Test Pit 1 met the hydric soil indicator F3 Depleted Matrix. A soil sample taken from Test Pit 1 is shown.

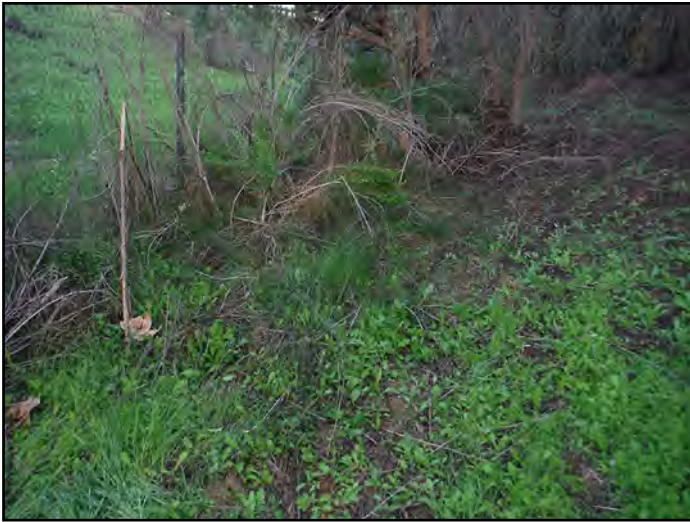
Photo 3A – Sample Plot 3 is shown, which evaluated a patch of Mexican rush (*Juncus mexicanus*) [FACW] and narrowleaf willow (*Salix exigua*) [FACW] located at the northern site boundary. This area receives runoff from the side-slope of US 101, and it may also be irrigated, but it did not meet three-parameter wetland criteria.

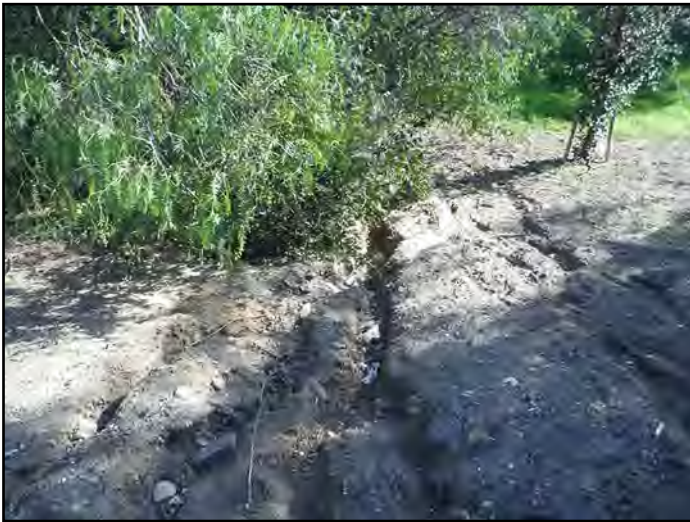
Photo 3C – Erosional features on the south facing side-slope of US 101 are shown. Runoff from this slope drains to a topographically low area along the northern property boundary, resulting in mesic but not wetland conditions.

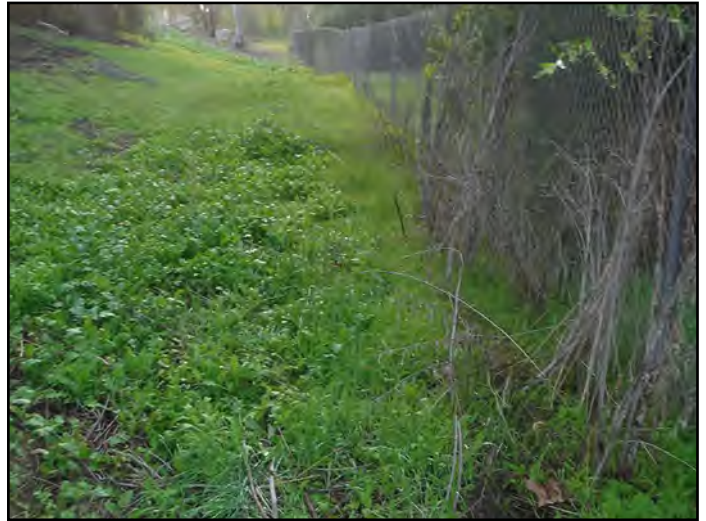
Photo 3D – Sample Plot 4 is shown, which evaluated a patch of Italian thistle (*Carduus pycnocephalus*) [UPL], black mustard (*Brassica nigra*) [UPL], and red brome (*Bromus madritensis*) [UPL] and narrowleaf willow (*Salix exigua*) [FACW]. This area receives some runoff from the side-slope of US 101, and it may also be irrigated, but it does not meet three-parameter wetland criteria.

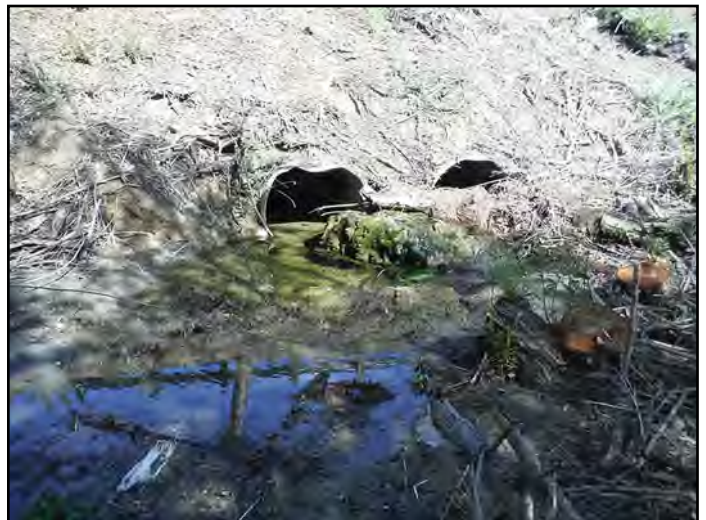
Photo 3F – A tributary to Lindero Creek located east of the site flows beneath US 101 in the culverts shown in this photo. When flows are absent, or minimal, small or medium-sized animals could use these culverts to pass through the US 101 corridor.
