OAK TREE REPORT

LIBERTY CANYON OFFICES

LIBERTY CANYON OFFICES OAK TREE EVALUATION SUMMARY (50 TREES)

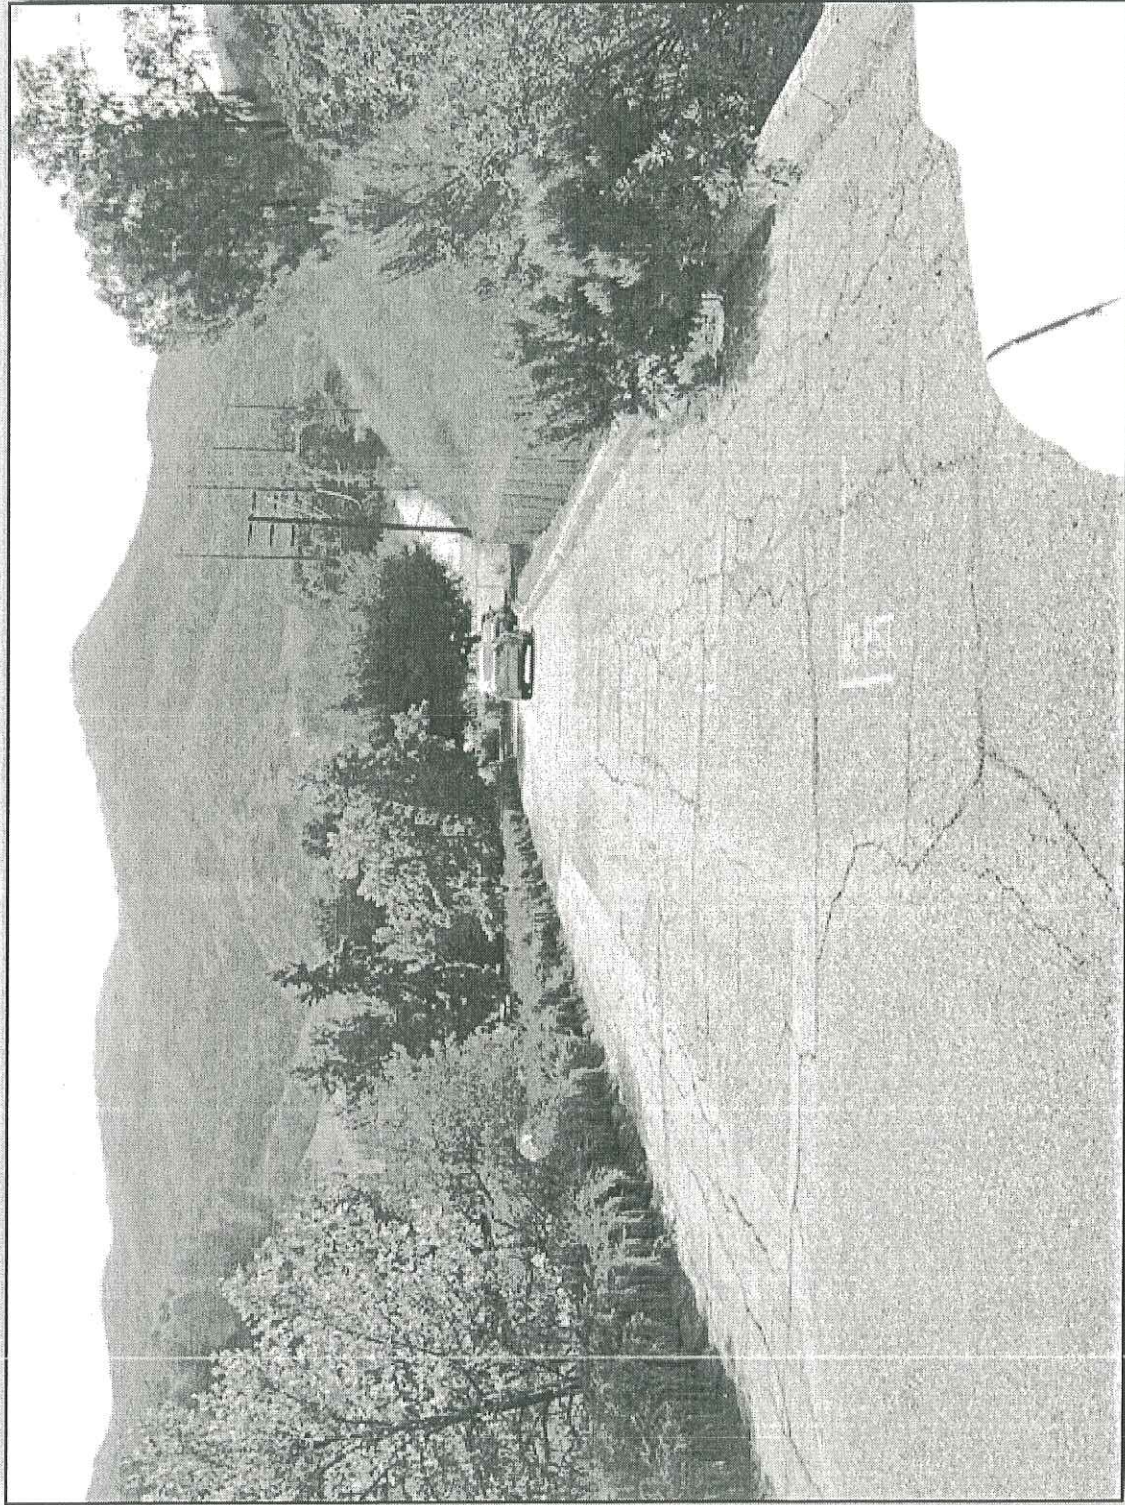
FIGURE 4

Facing west on Vendell Road, with Santa Monica Mountains in background and embankment of Highway 101 on right.

corridor. One camera was positioned on Vendell Road, facing to the west, and a second camera was faced towards the south side of the existing building at the culvert. The potential for Vendell Road to serve as a wildlife movement corridor is described in more detail below in Section 5.2, Wildlife Movement Corridors.

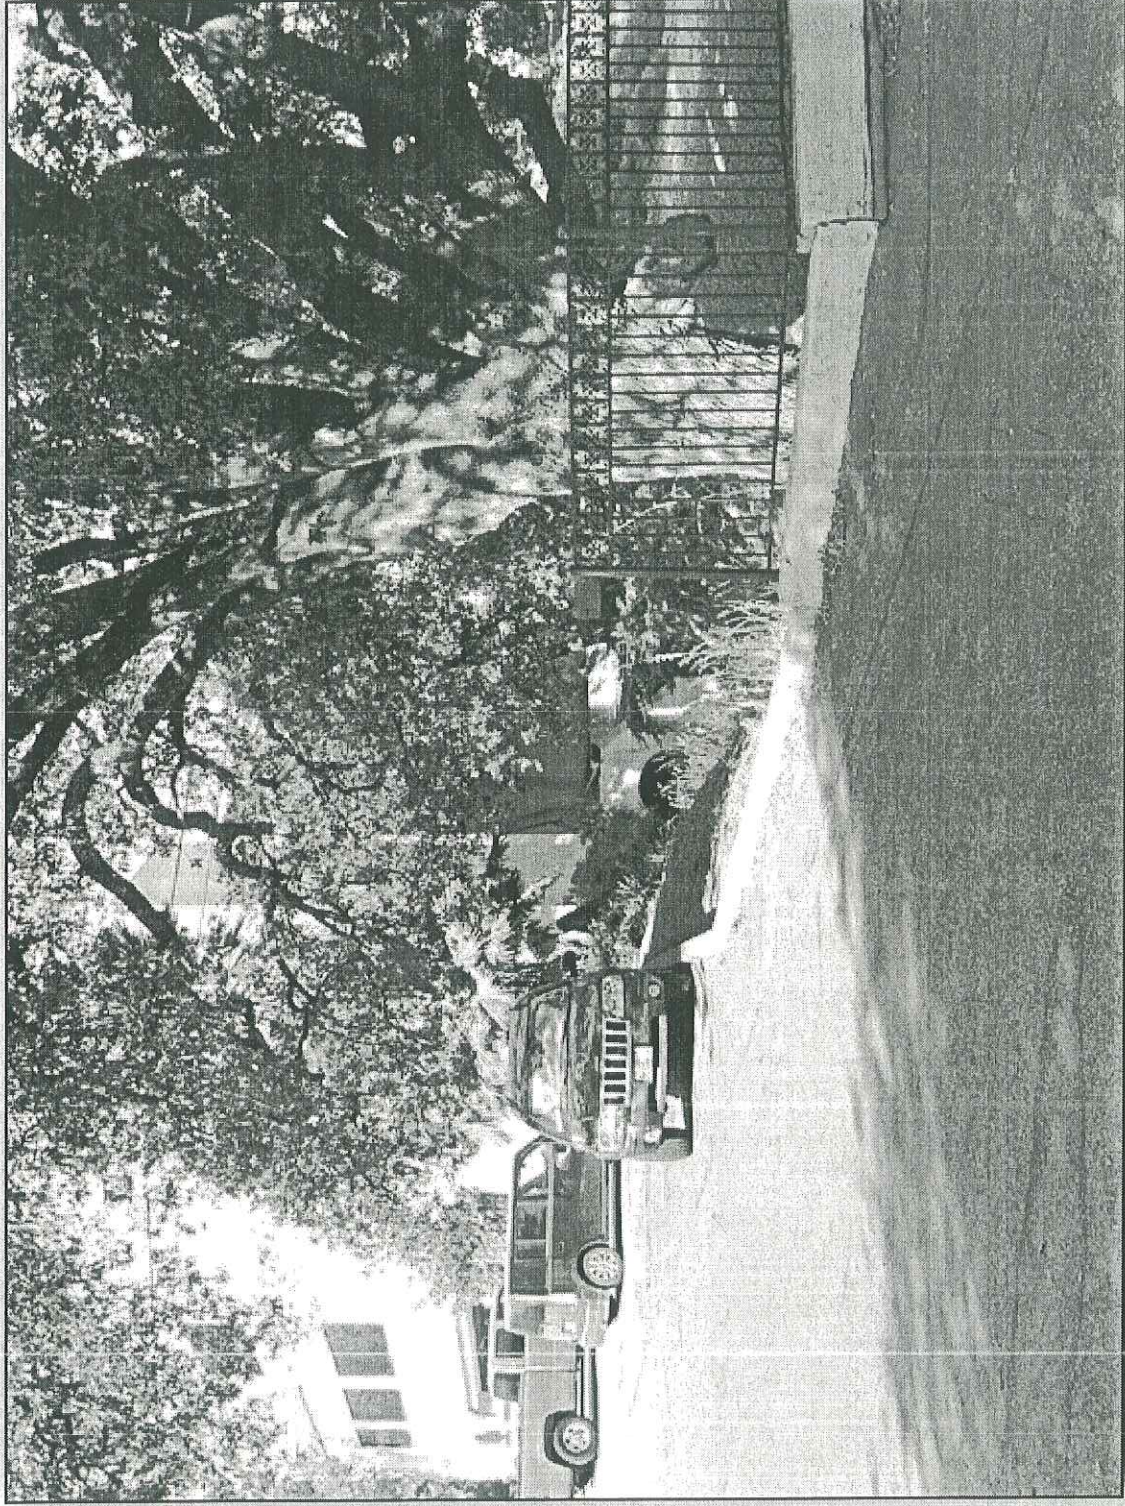
FIGURE 5

View of south-side of existing building, parking lot, and culvert with oak tree in foreground.

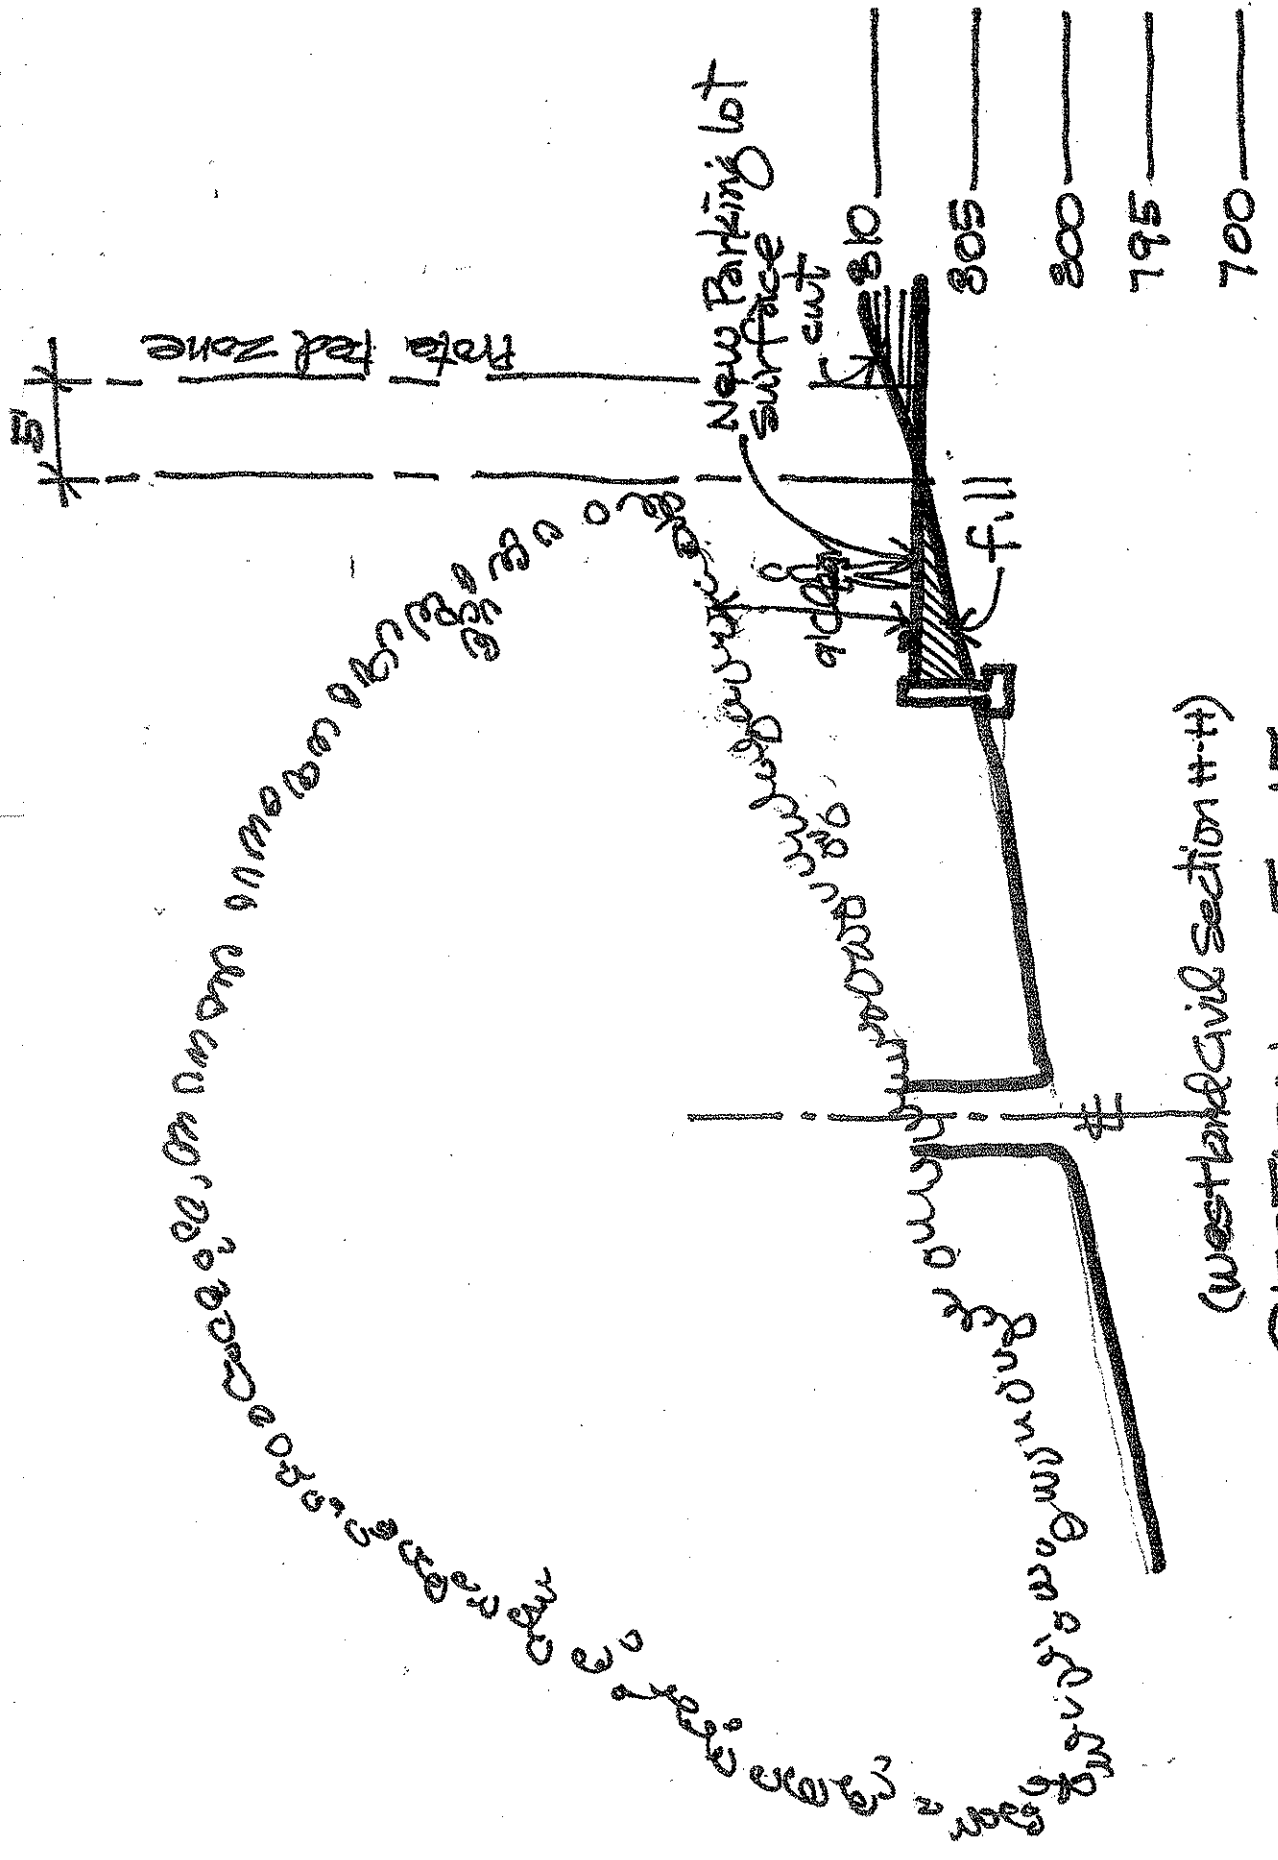
SECTION T-17a

(westland civil section #11)

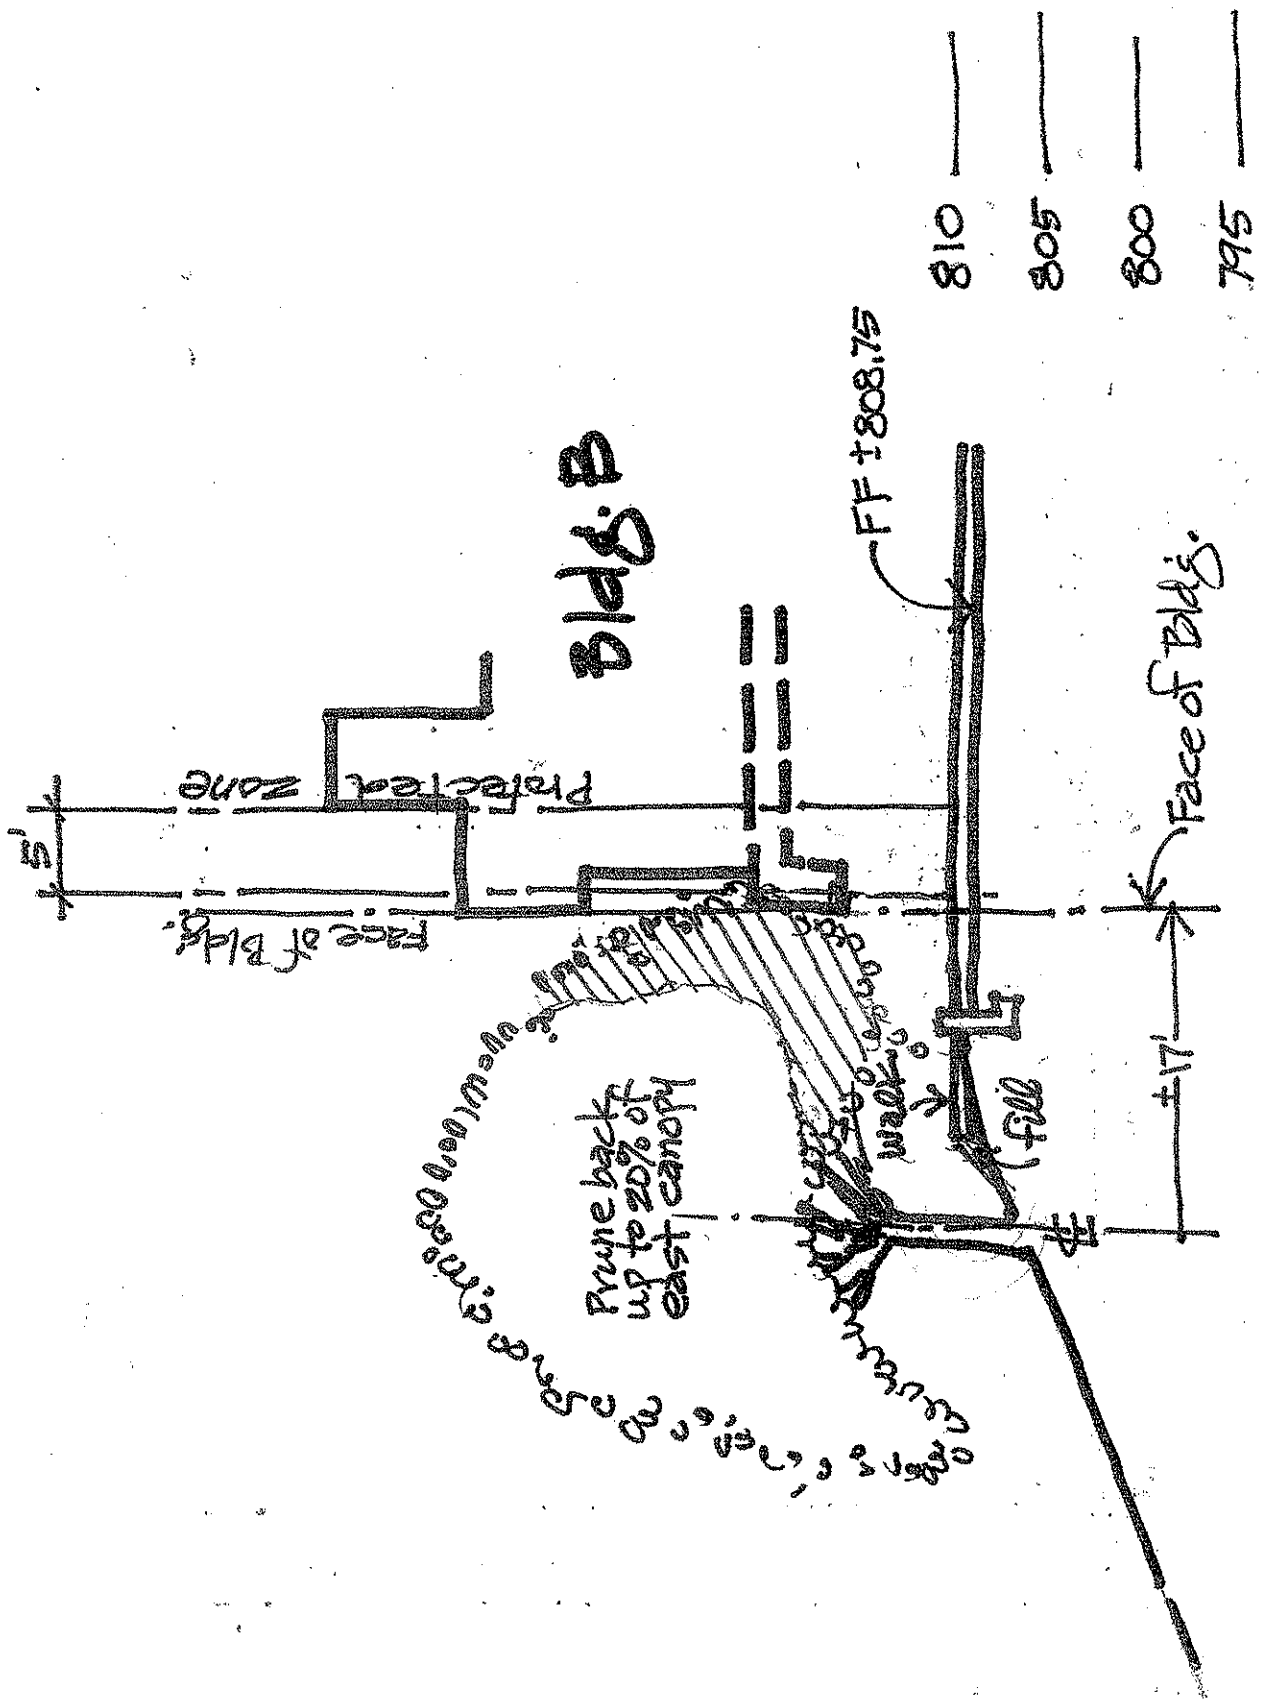
SECTION T-19

LOOKING NORTH

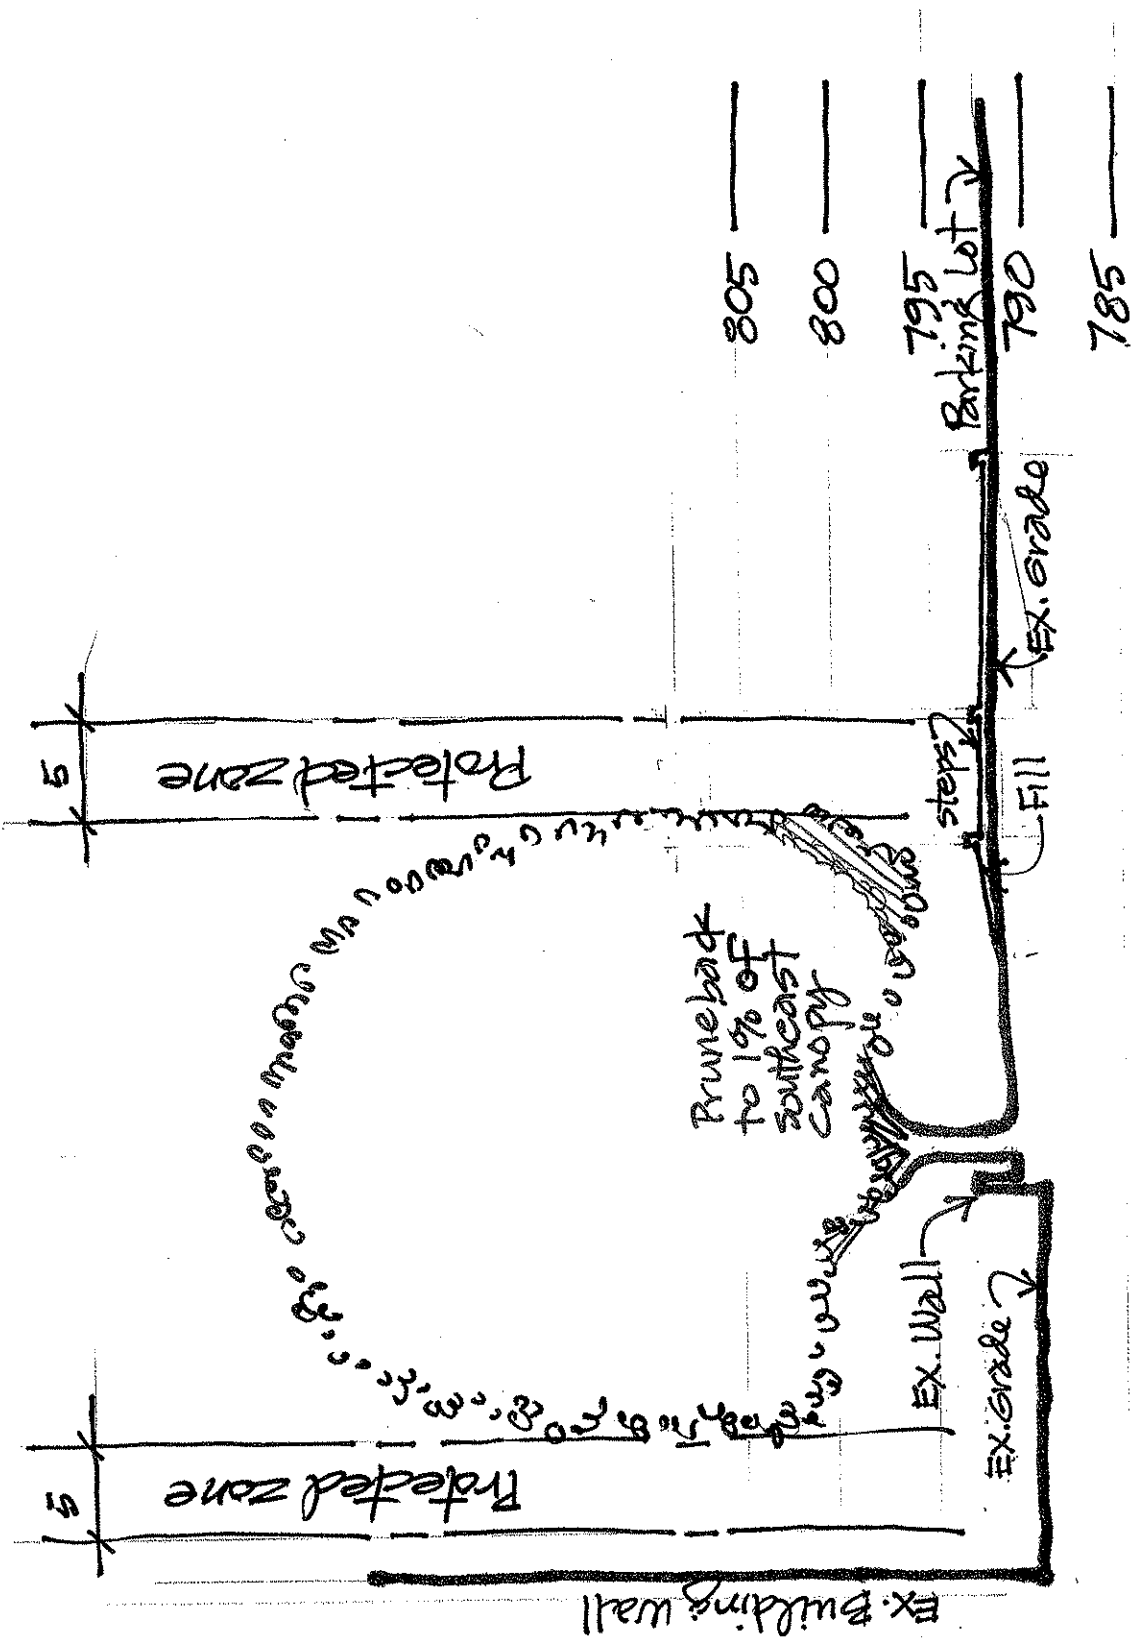
SECTION T-30a

LOOKING NORTHEAST

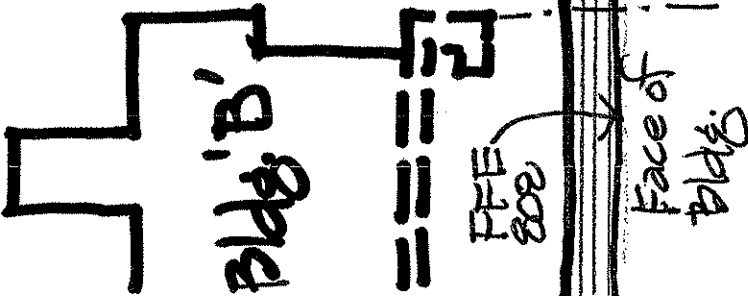
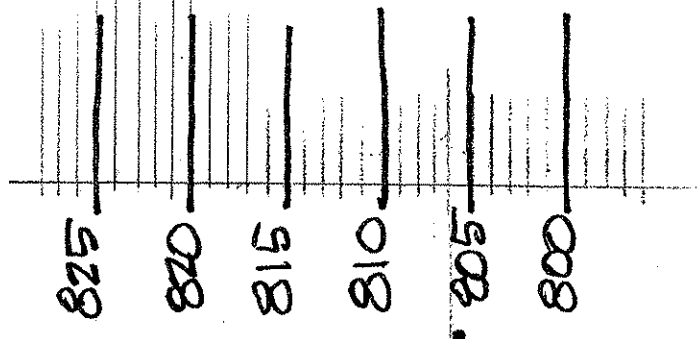
SECTION T-33

(Westland Civil Section A-A)

THE PROPOSED REMOVAL OF OAK TREES T-11, T-19, T-33, T-47, T-48 AND T-50, TOTALING 110.5" IN TRUNK DIAMETERS, SHOULD BE REPLACED WITH A MIXTURE OF 3/4 QUERCUS AGRIFOLIA AND 1/4 QUERCUS LOBATA TO EQUAL 110.5 INCHES OF DIAMETER IN REPLACEMENT BOXED OAK TREE SPECIMENS; AND, SHOULD BE SHOWN ON THE LANDSCAPE PLANS. THE MUNICIPAL CODE REQUIRES THAT A 4:1 MINIMUM RATIO OF THE REPLACEMENT, BEGINNING WITH TWO 24" BOX, ONE 36" BOX AND ONE 15 GALLON OAK TREES. IN THIS CASE, IT WAS AGREED TO A 1:1 REPLACEMENT OF DIAMETER INCHES. FOR EACH DEAD, MISSING OR HAZARDOUS OAK TREES (T-29 AND T-41), ONE 36" BOX OAK TREE IS REQUIRED FOR REPLACEMENT ON COMMERCIAL PROPERTIES.

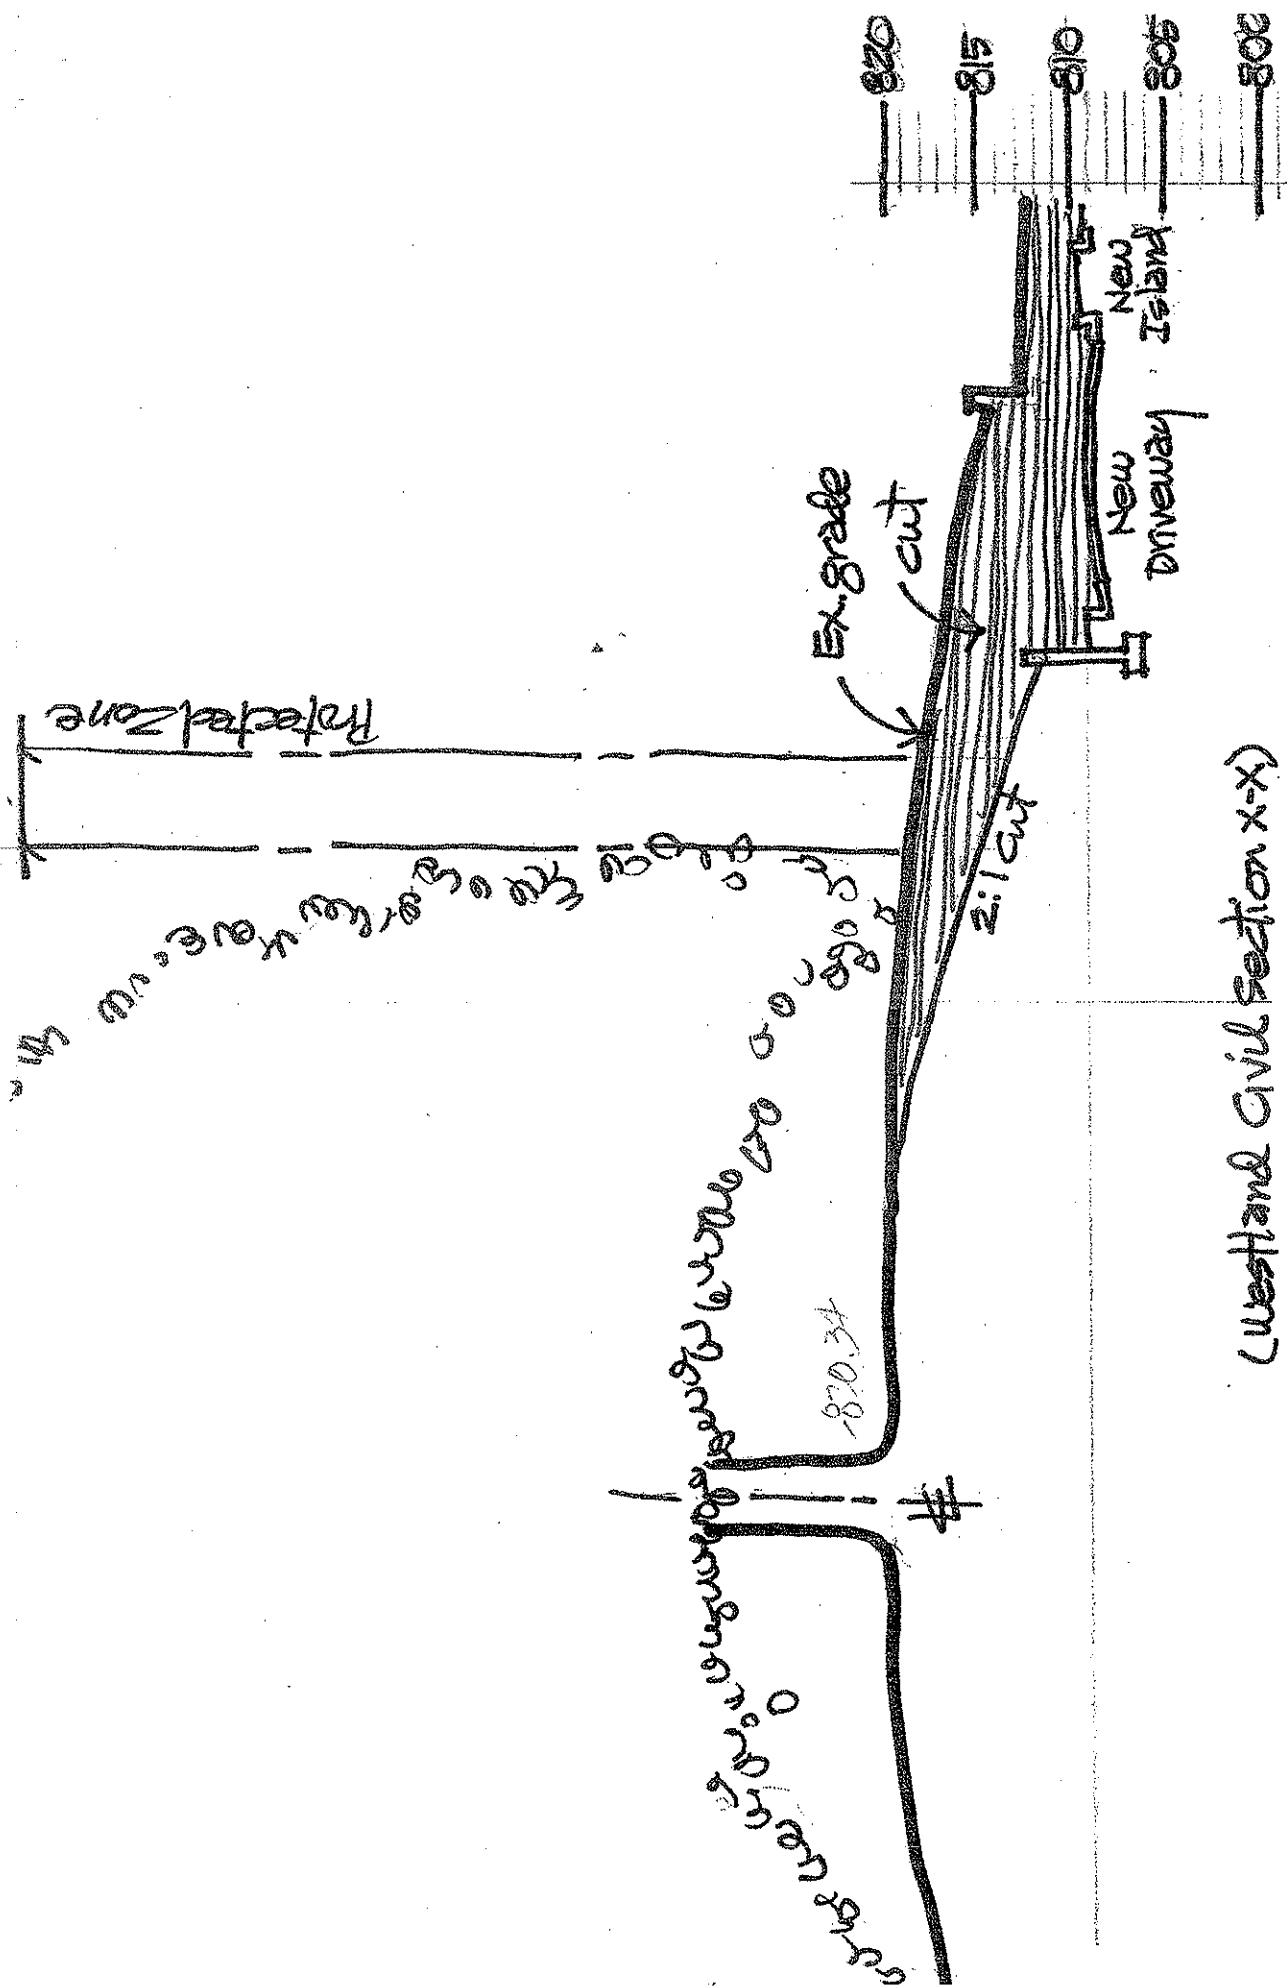
SECTION T-33a
LOOKING

(Westland Civil Section X-X)

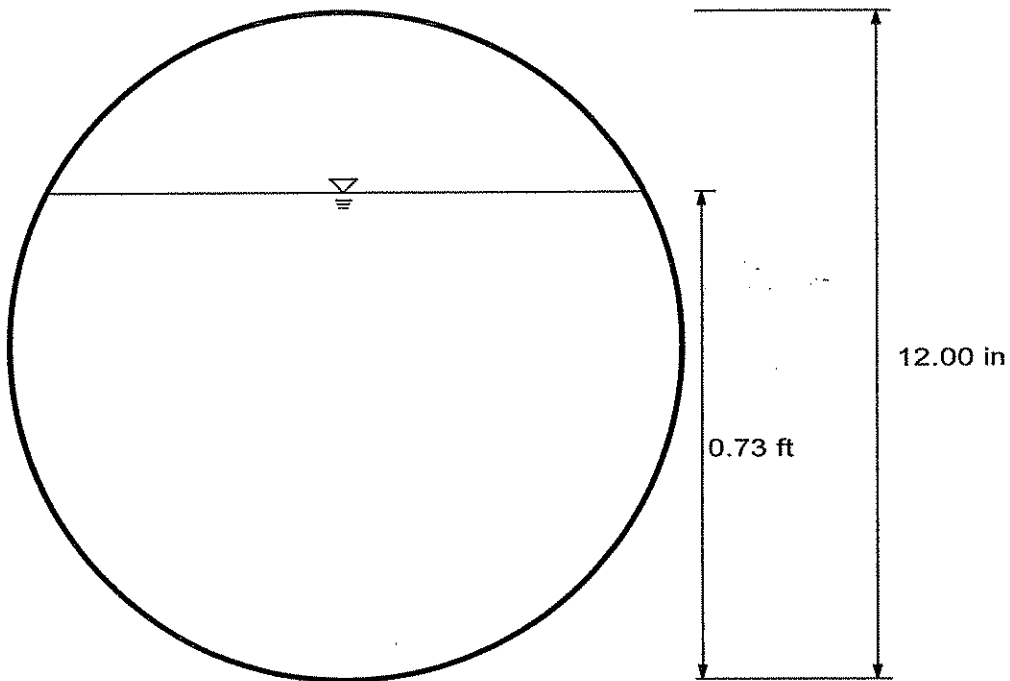
Project Description	
Project File	c:\haestad\fmw\lagourllc.fm2
Worksheet	LINE "A" (STA 1+00 TO 1+20)
Flow Element	Circular Channel
Method	Manning's Formula
Solve For	Channel Depth

Section Data	
Mannings Coefficient	0.013
Channel Slope	0.056000 ft/ft
Depth	0.73 ft
Diameter	12.00 in
Discharge	7.41 cfs

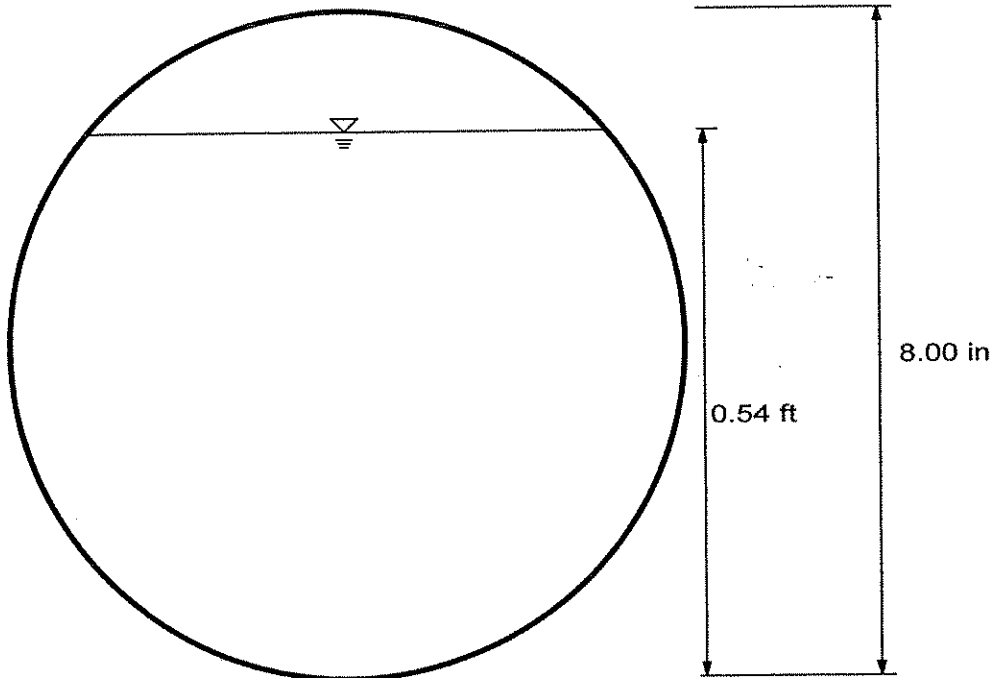
Project Description	
Project File	c:\haestad\fmw\lagourllc.fm2
Worksheet	LINE "A" (STA 1+20 TO 3+40)
Flow Element	Circular Channel
Method	Manning's Formula
Solve For	Channel Depth

Section Data	
Mannings Coefficient	0.013
Channel Slope	0.056000 ft/ft
Depth	0.54 ft
Diameter	8.00 in
Discharge	2.85 cfs

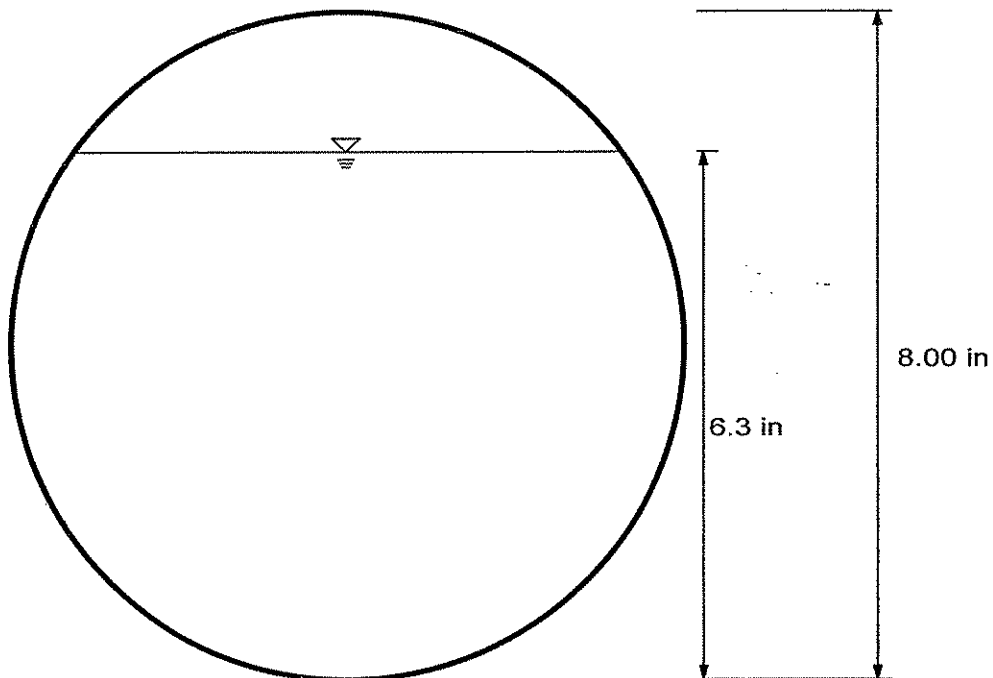
Project Description	
Project File	c:\haestad\fmw\lagourllc.fm2
Worksheet	LINE "A" STA 3+40 TO 5+00
Flow Element	Circular Channel
Method	Manning's Formula
Solve For	Channel Depth

Section Data	
Mannings Coefficient	0.013
Channel Slope	0.050000 ft/ft
Depth	6.3 in
Diameter	8.00 in
Discharge	2.60 cfs

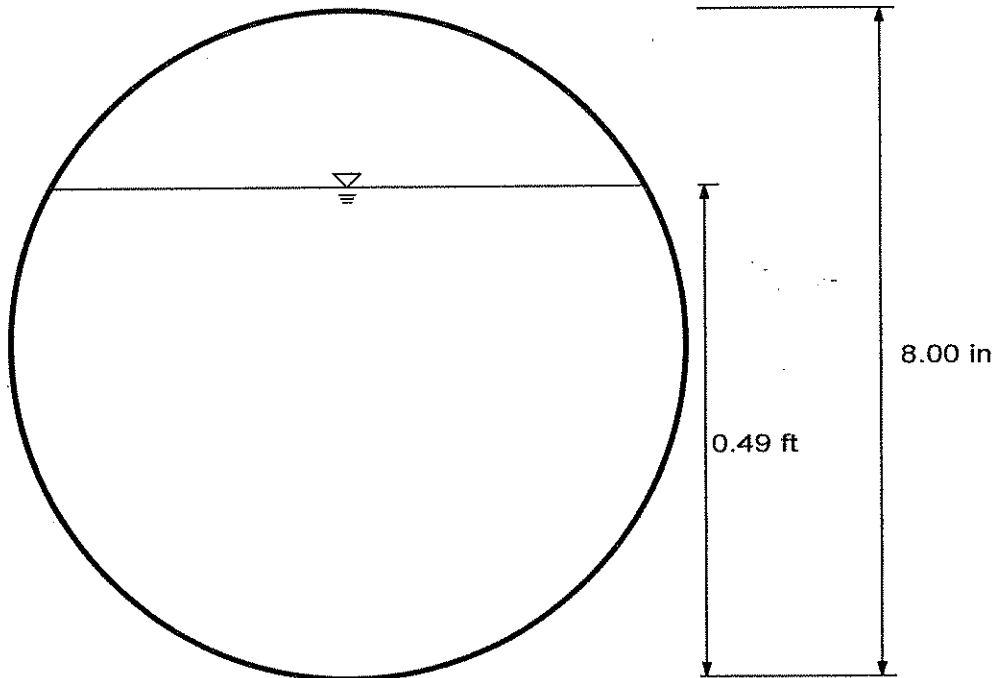
Project Description	
Project File	c:\haestad\fmw\lagourllc.fm2
Worksheet	LINE "B"
Flow Element	Circular Channel
Method	Manning's Formula
Solve For	Channel Depth

Section Data	
Mannings Coefficient	0.013
Channel Slope	0.010000 ft/ft
Depth	0.49 ft
Diameter	8.00 in
Discharge	1.07 cfs

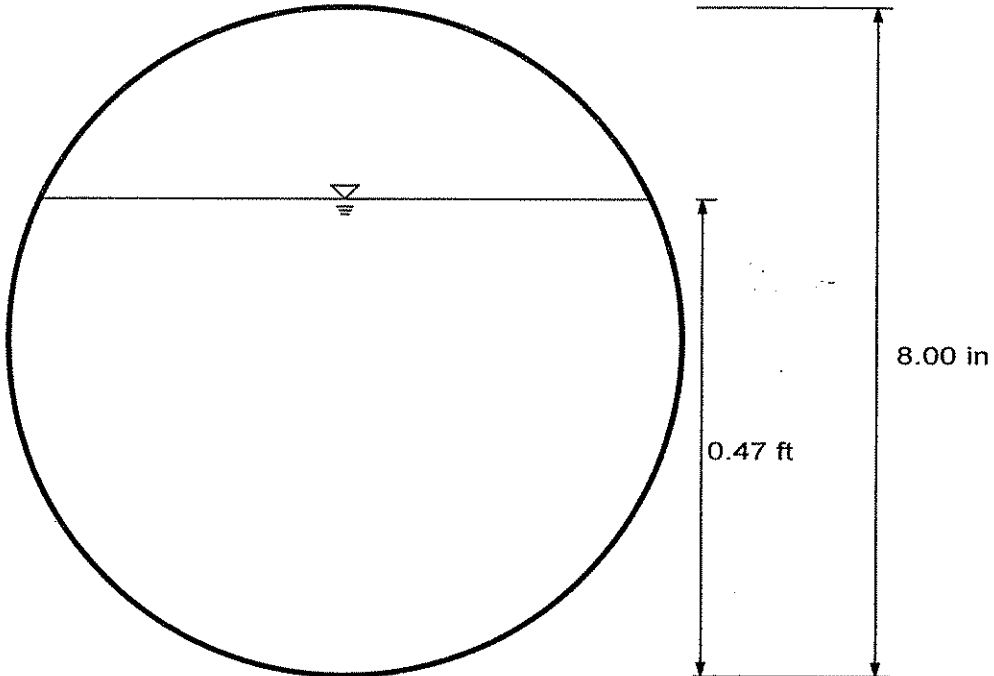
Project Description	
Project File	c:\haestad\fmw\lagourllc.fm2
Worksheet	LINE "C"
Flow Element	Circular Channel
Method	Manning's Formula
Solve For	Channel Depth

Section Data	
Mannings Coefficient	0.013
Channel Slope	0.010000 ft/ft
Depth	0.47 ft
Diameter	8.00 in
Discharge	1.03 cfs

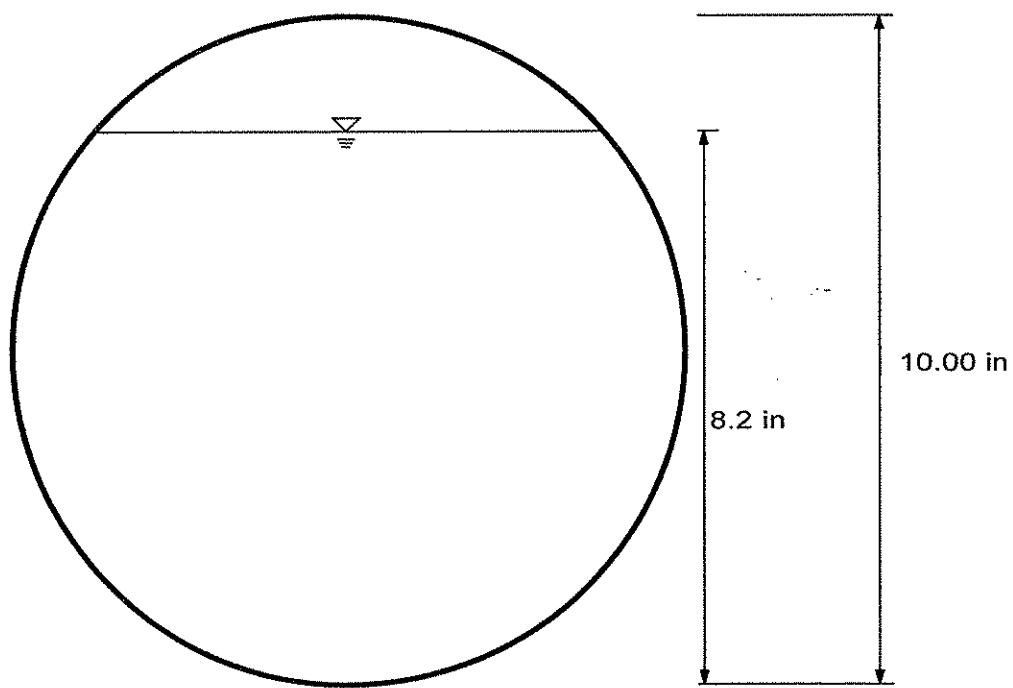
Project Description	
Project File	c:\haestad\fmw\agourllc.fm2
Worksheet	LINE "D"
Flow Element	Circular Channel
Method	Manning's Formula
Solve For	Channel Depth

Section Data	
Mannings Coefficient	0.013
Channel Slope	0.010000 ft/ft
Depth	8.2 in
Diameter	10.00 in
Discharge	2.20 cfs

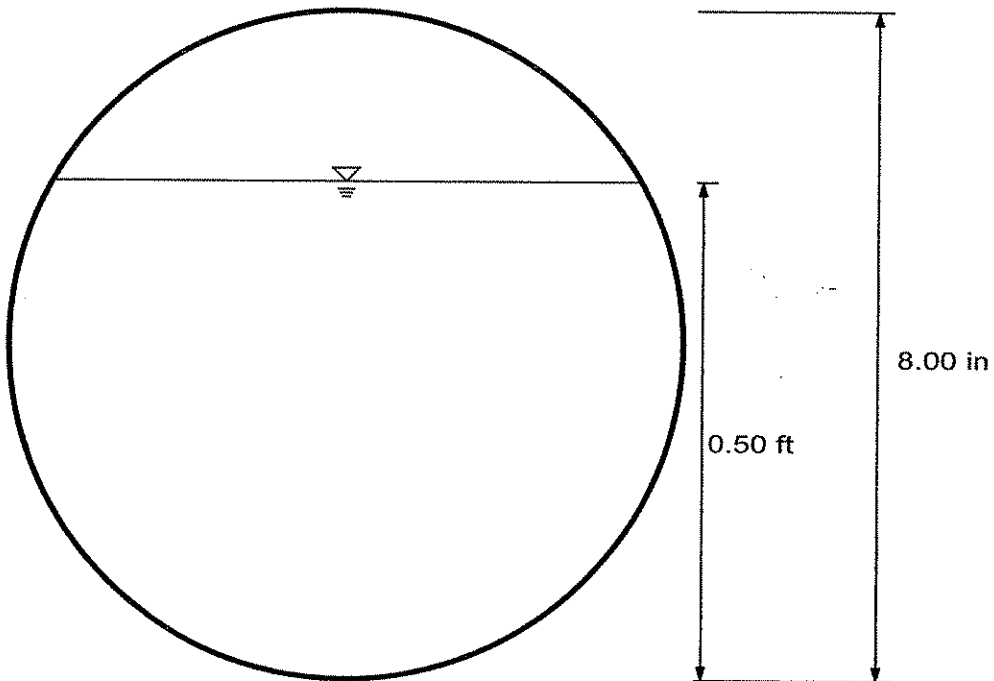
Project Description	
Project File	c:\haestad\fmw\lagourllc.fm2
Worksheet	LINE E
Flow Element	Circular Channel
Method	Manning's Formula
Solve For	Channel Depth

Section Data	
Mannings Coefficient	0.013
Channel Slope	0.020000 ft/ft
Depth	0.50 ft
Diameter	8.00 in
Discharge	1.54 cfs

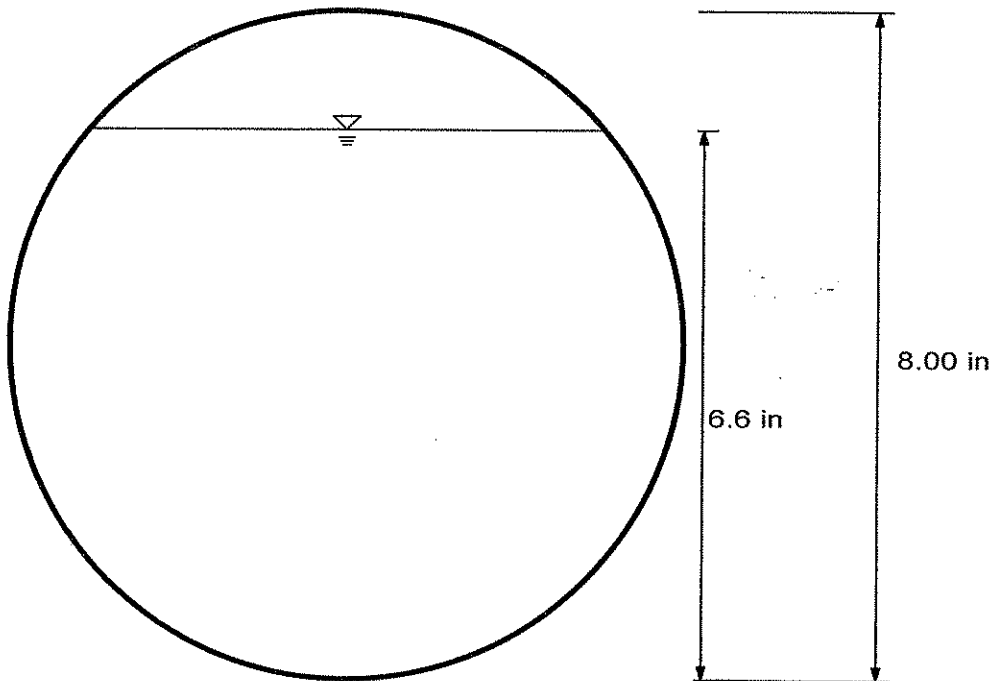
Project Description	
Project File	c:\haestad\fmw\agour\lc.fm2
Worksheet	LINE F
Flow Element	Circular Channel
Method	Manning's Formula
Solve For	Channel Depth

Section Data	
Mannings Coefficient	0.013
Channel Slope	0.027395 ft/ft
Depth	6.6 in
Diameter	8.00 in
Discharge	2.00 cfs
