**Preliminary
CDFW and ACOE
Jurisdictional
Delineation**

Oakmont of Agoura Hills

Preliminary CDFW/ACOE Jurisdictional Delineation

Oakmont of Agoura Hills Project

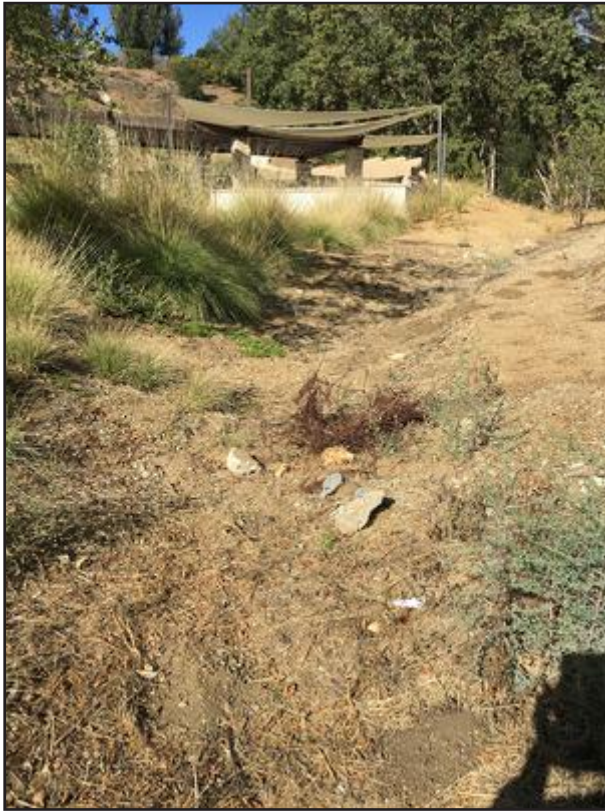
Photo 1 – View to the north illustrating the ephemeral drainage south of the oak-willow riparian woodland. Non-native bristly-ox tongue (*Helminthotheca echinoides*), tumbleweed (*Salsola australis*), and planted deergrass (*Muhlenbergia* sp.) line the drainage.

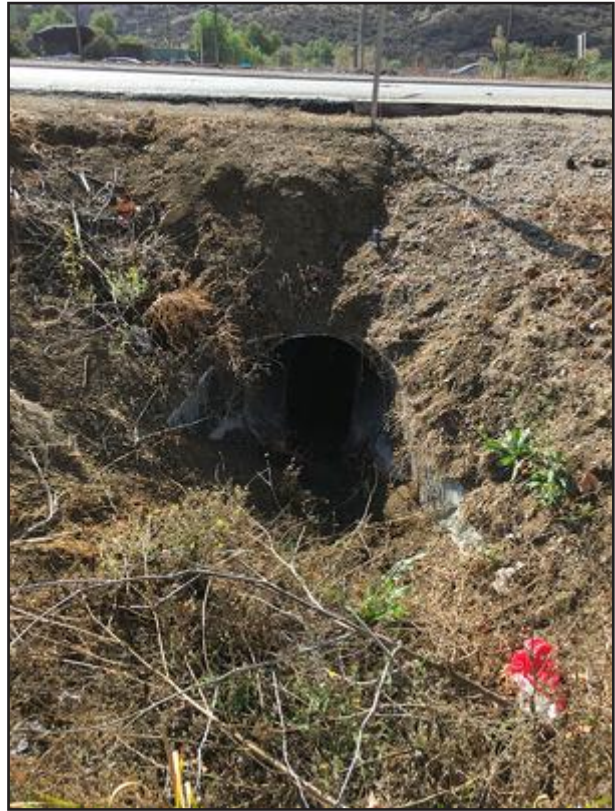
Photo 2 – View to the south of the culvert under Canwood Street at the southern terminus of the ephemeral drainage. The drainage is supplemented by irrigation runoff from the adjacent medical plaza.

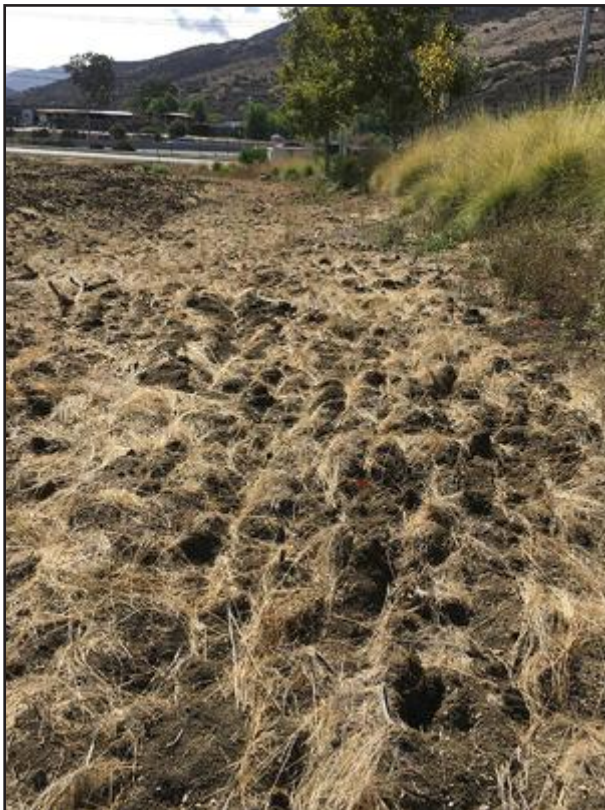
Photo 3 – View to the south illustrating the disced overland sheet flow area where the drainage is poorly defined. Facultative bristly-ox tongue dominates the western drainage limit at the toe of the manufactured slope.

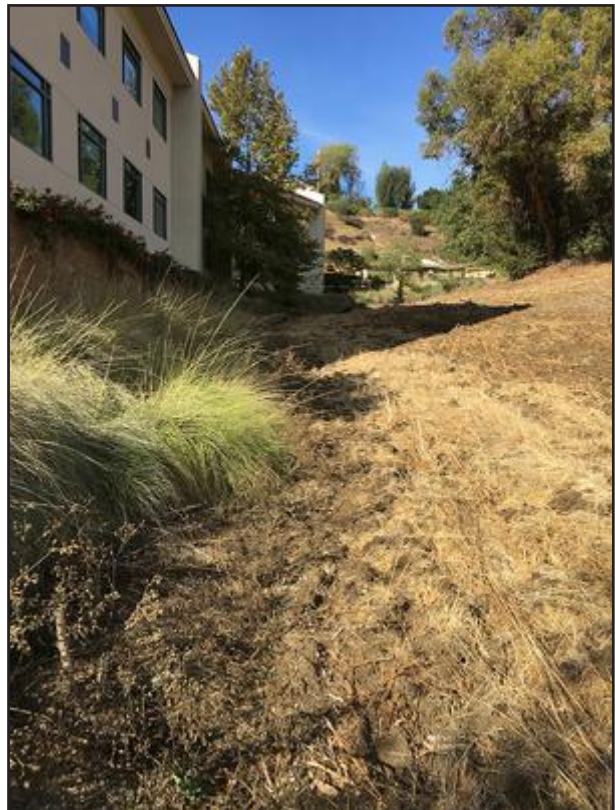
Photo 4 – View to the north illustrating the poorly defined channel and the adjacent (west) medical plaza with landscape plantings.

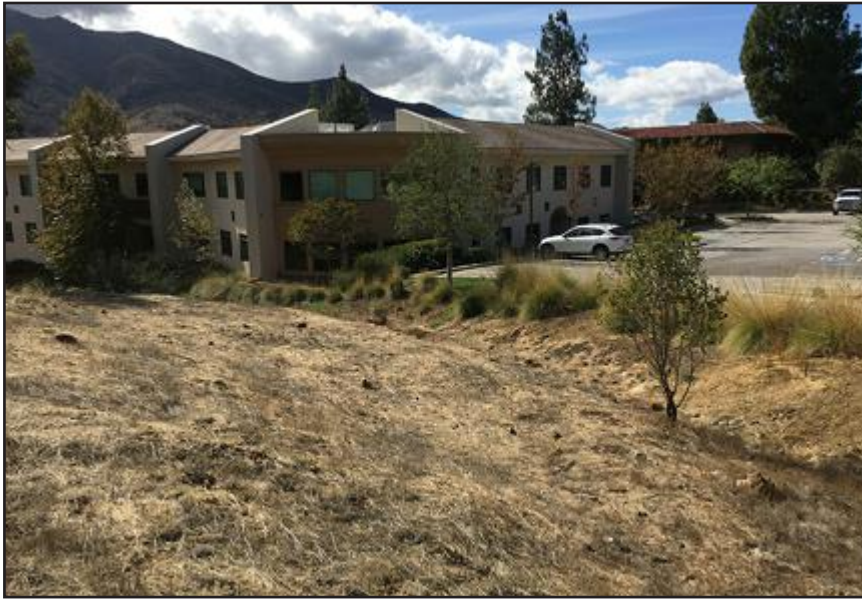
Photo 5 – View to the southwest illustrating the southernmost portion of the Baltic rush (*Juncus balticus*) patch and the northern portion of the drainage.

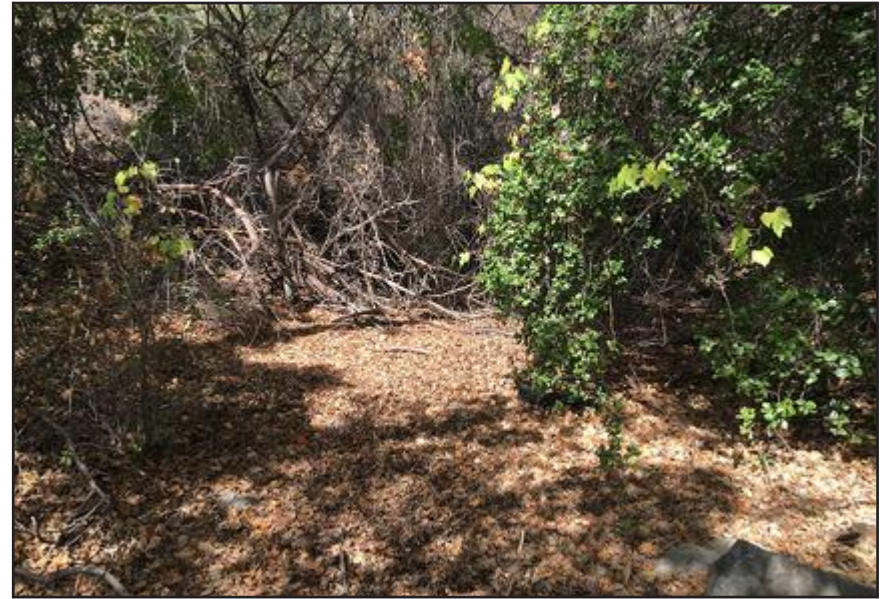
Photo 6 – Photo to the north illustrating the understory of the oak-willow riparian woodland.

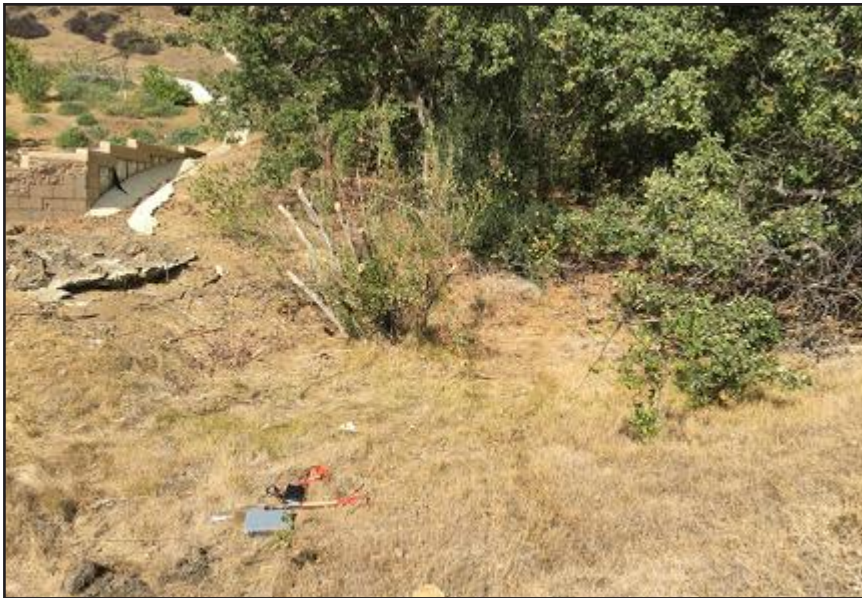
Photo 7 – Photo to the northwest illustrating the drought-stress remains of a previously robust rush wetland area. The area is transitioning to a drier ecotype as evidenced by the emergence of valley oak and coast live oak saplings.

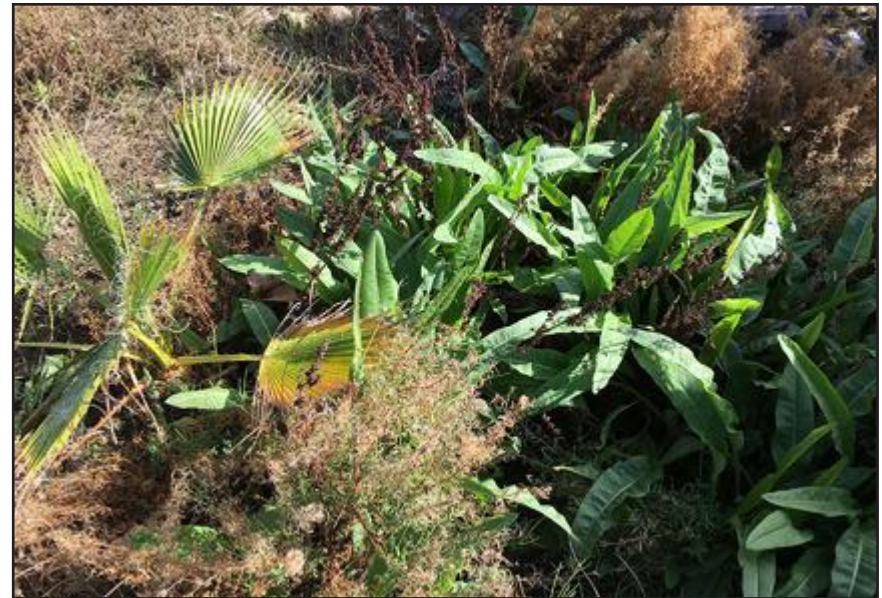
Photo 2D – Photo of the wetland area associated with the medical plaza culvert outfall. This area had standing water and supported a robust collection of hydrophytic vegetation including non-native dock (*Rumex* sp.) and willow herb (*Epilobium ciliatum* ssp. *ciliatum*).

Two (2) small wetted areas were observed within the study area just north of the culvert and adjacent to a culvert outfall from the adjacent Center Court Medical Plaza. These areas supported hydrophytic species including southern cattail (*Typha domingensis*) (OBL) and a non-native dock (*Rumex* sp.) (OBL). The presence of these species appears to be directly attributable to irrigation and landscape practices from the adjacent development.

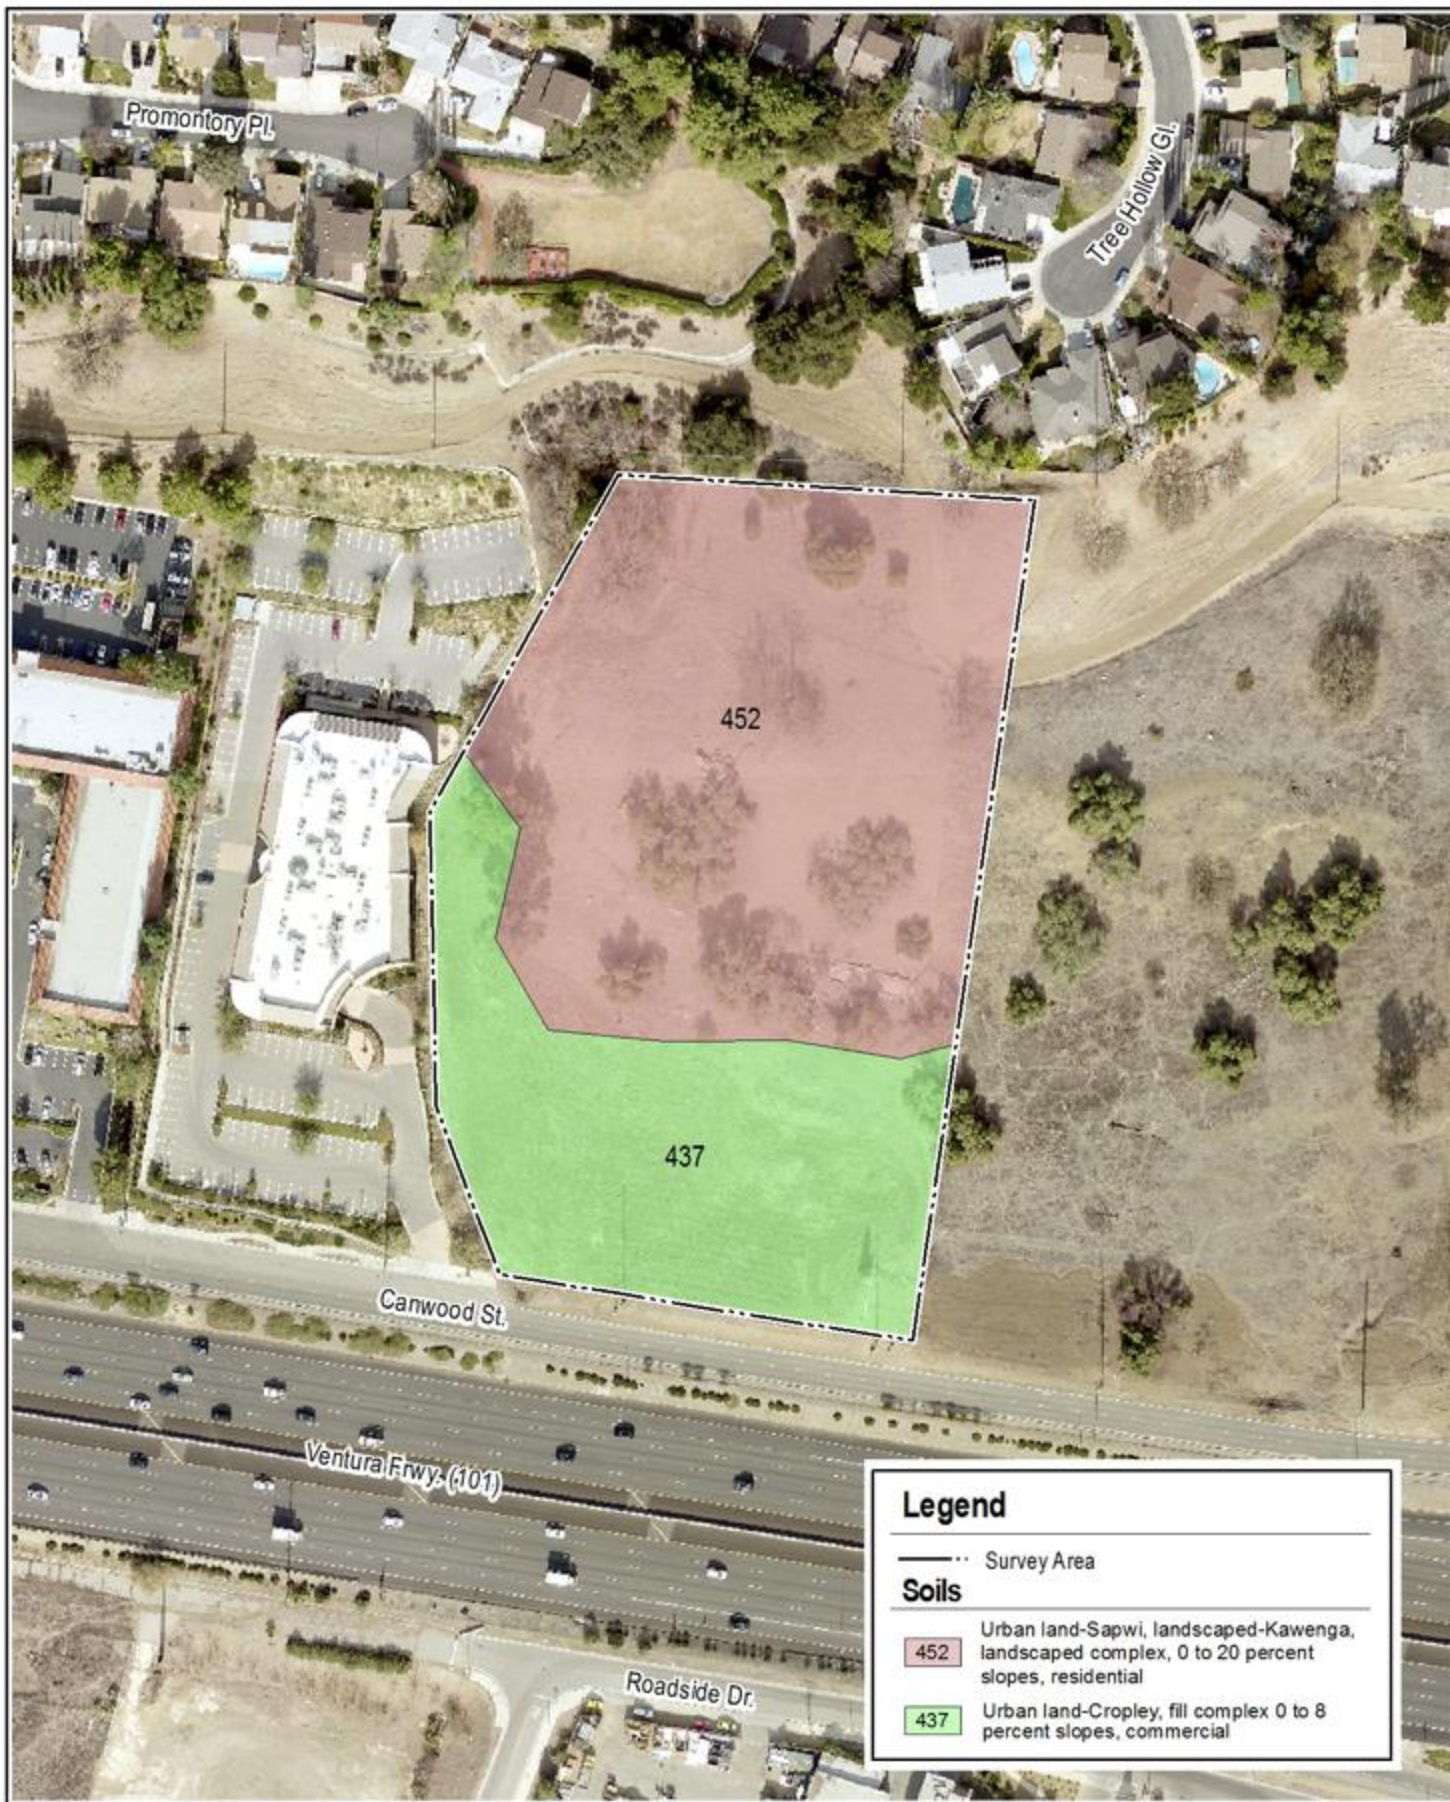
Aerial Source: USGS High Resolution Orthoimagery; <http://viewer.nationalmap.gov/basic>. Data Source: NRCS Soils; <http://websoilsurvey.sc.egov.usda.gov/App/WebSoilSurvey.aspx>.

The survey area is characterized by two (2) soil type that primarily consist of loams and sandy/silt loams (Figure 5). A brief description of the soil type is given below:

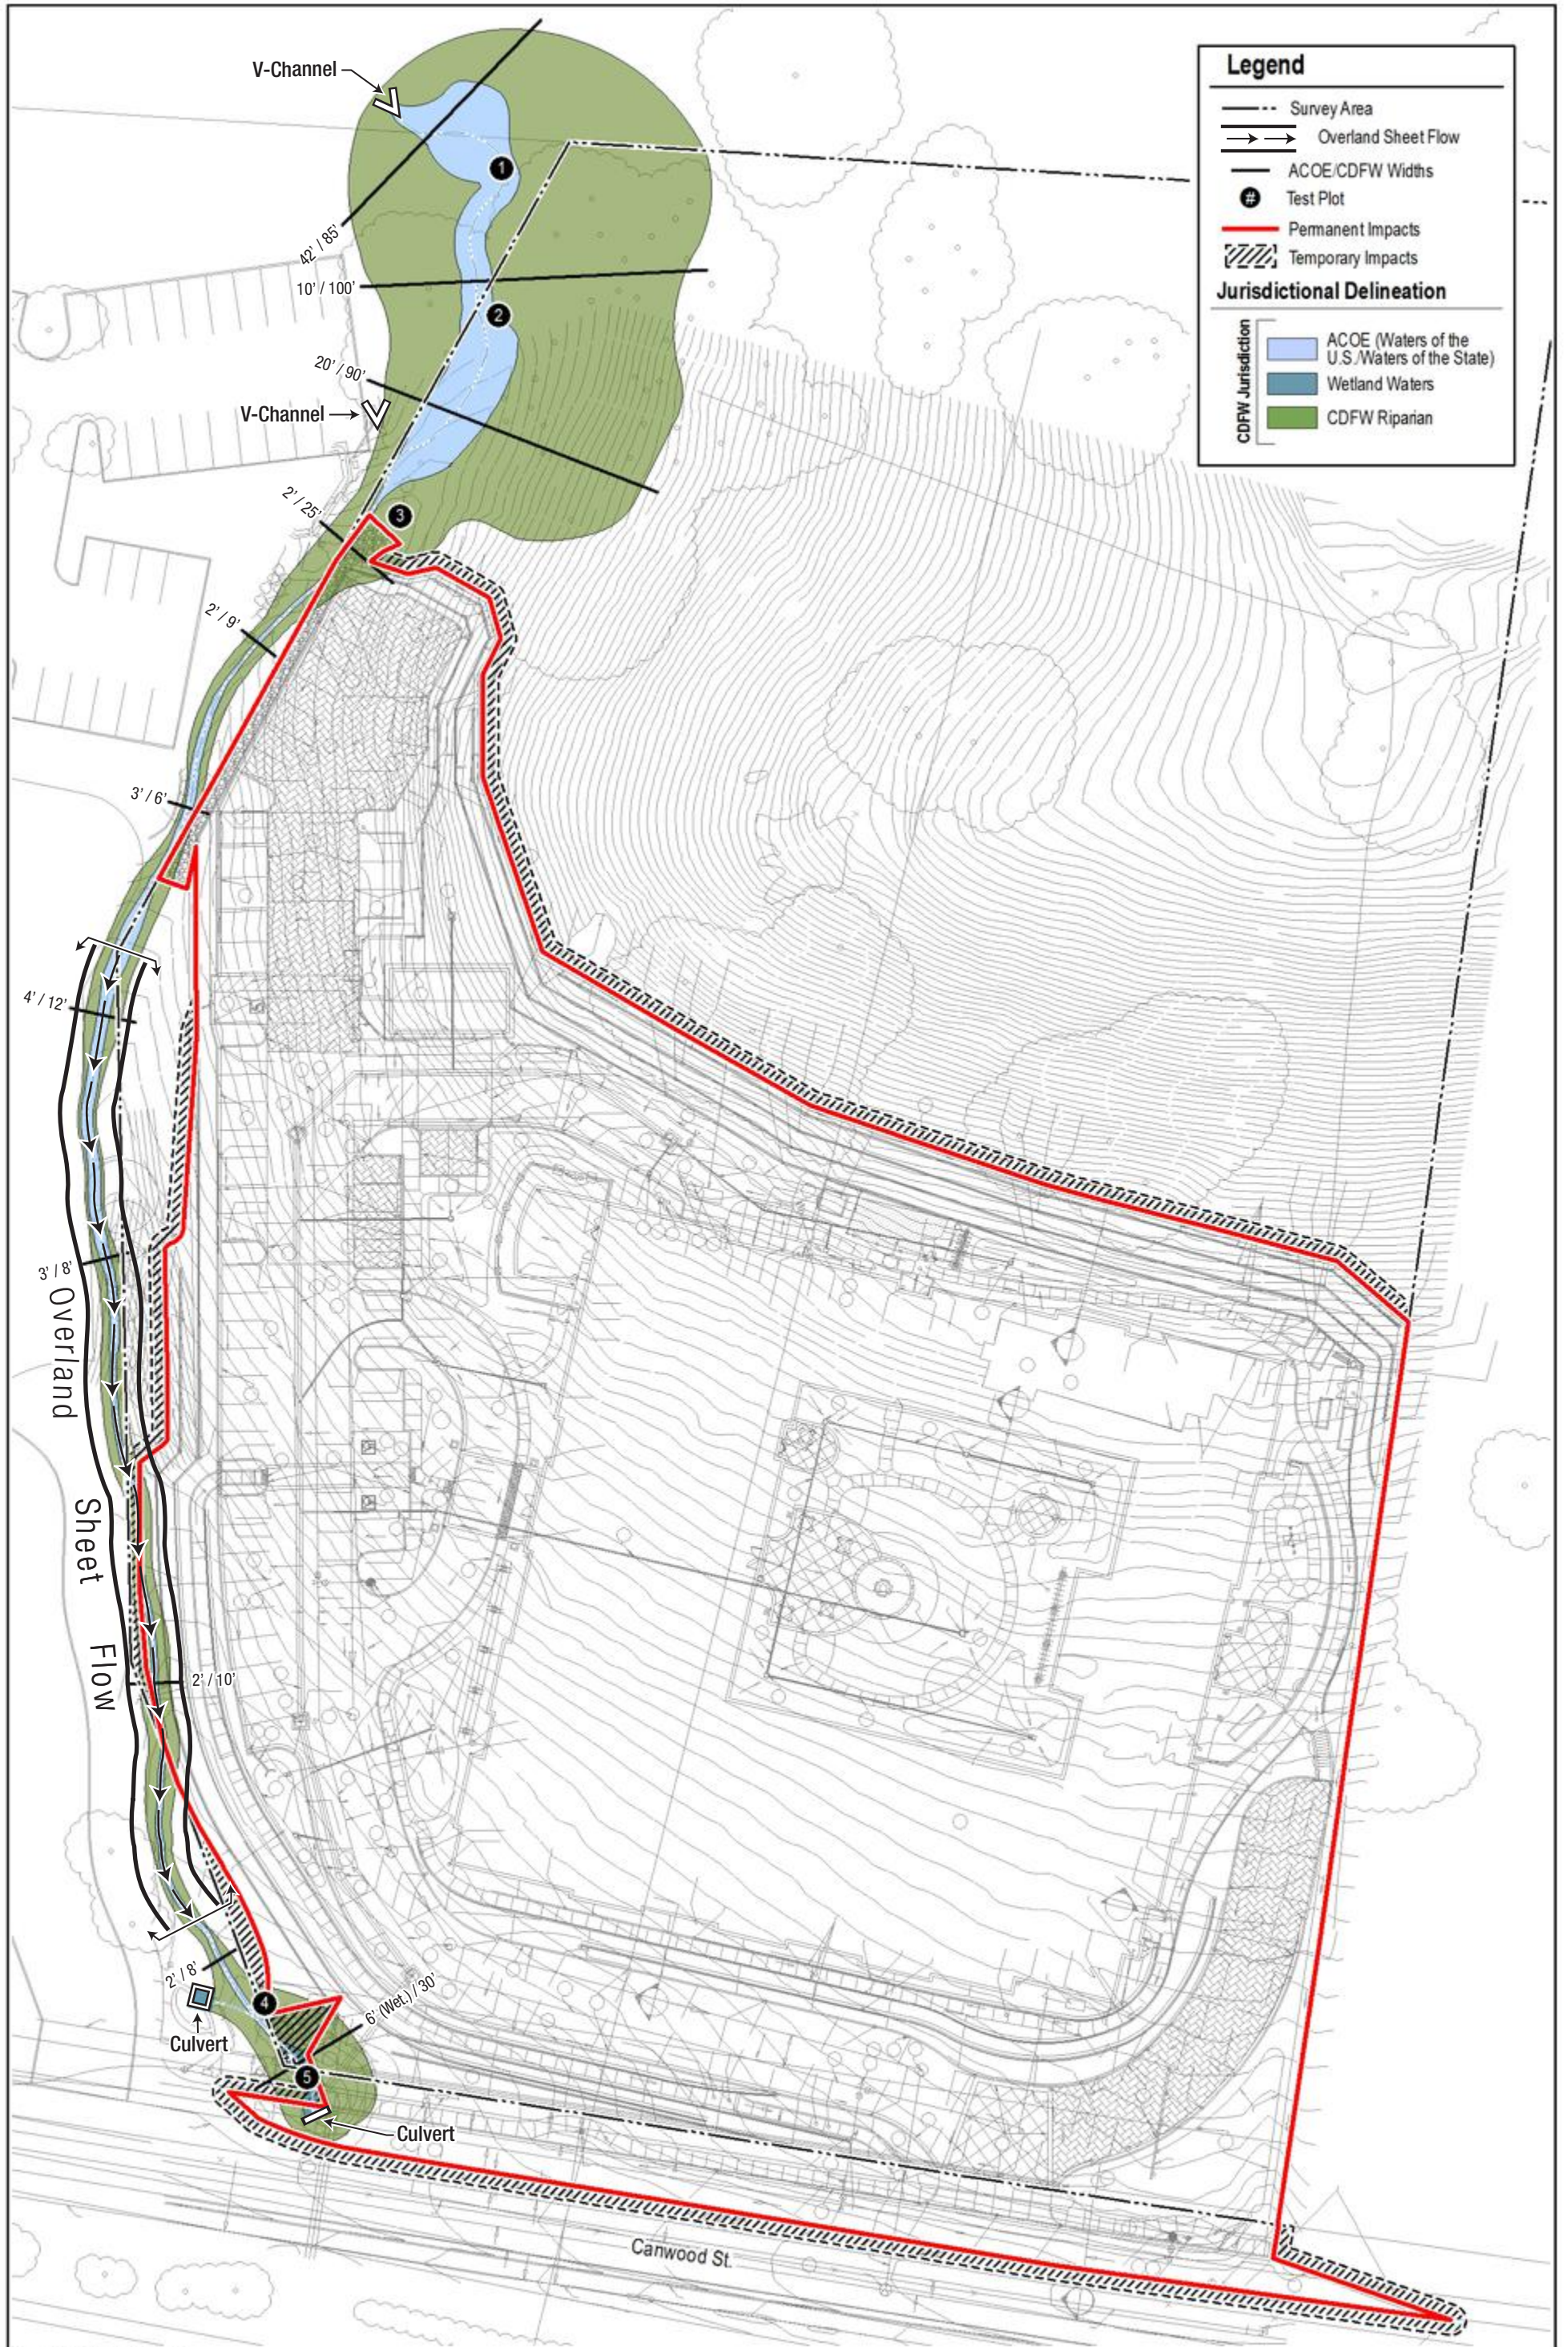
Source: Hutt-Zollars, Aug. 8, 2017.

Wetland ACOE Waters of U.S. (Acres / Linear Feet)		Non-wetland ACOE Waters of U.S. (Acres / Linear Feet)		CDFW (Acres / Linear Feet)	
	Temporary	Permanent	Temporary	Permanent	Temporary	Permanent
DR1	0.002/87	0.001/44	0.002/87	0.004/174	0.013/566	0.034/1,481

The proposed project's impacts to potential jurisdictional areas would be subject to the review and approval of the Trustee Resource Agencies. Impacts to jurisdictional areas would be considered a significant impact. Implementation of Mitigation Measure (MM) BIO-1 would reduce potentially significant impacts to a less-than-significant level.

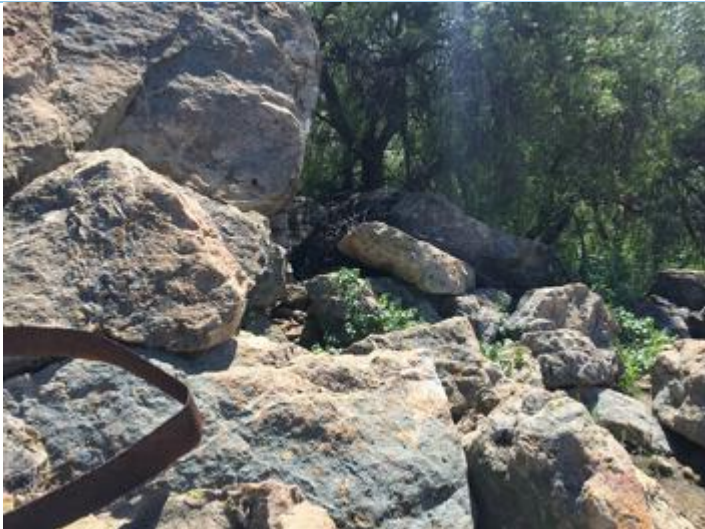
Photograph 3: Rock area potential pallid bat habitat

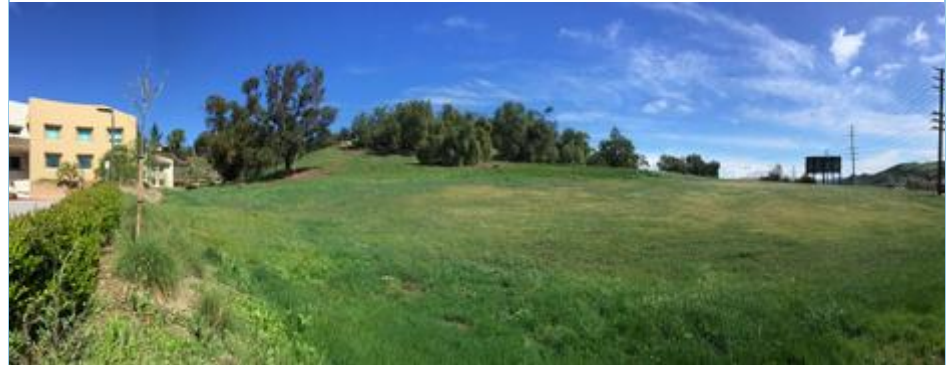
Photograph 4: Overview 1

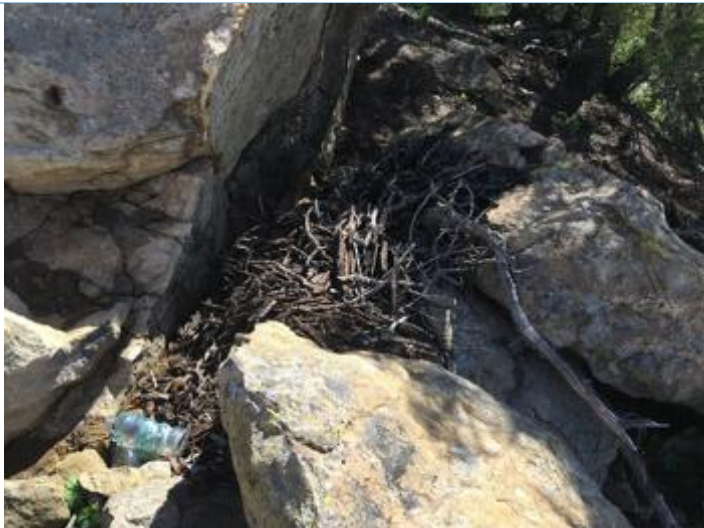
Photograph 7: Woodrat midden
