**LIMITED ASBESTOS AND LEAD BASED PAINT SURVEY  
U.S. 101/PALO COMADO CANYON ROAD INTERCHANGE PROJECT  
CITY OF AGOURA HILLS, CALIFORNIA  
GDC PROJECT NUMBER LA1143**

Subject: Limited Asbestos and Lead Based Paint Survey  
U.S. 101/Palo Comado Canyon Road Interchange Project  
City of Agoura Hills, California,  
Group Delta Project No. LA1143

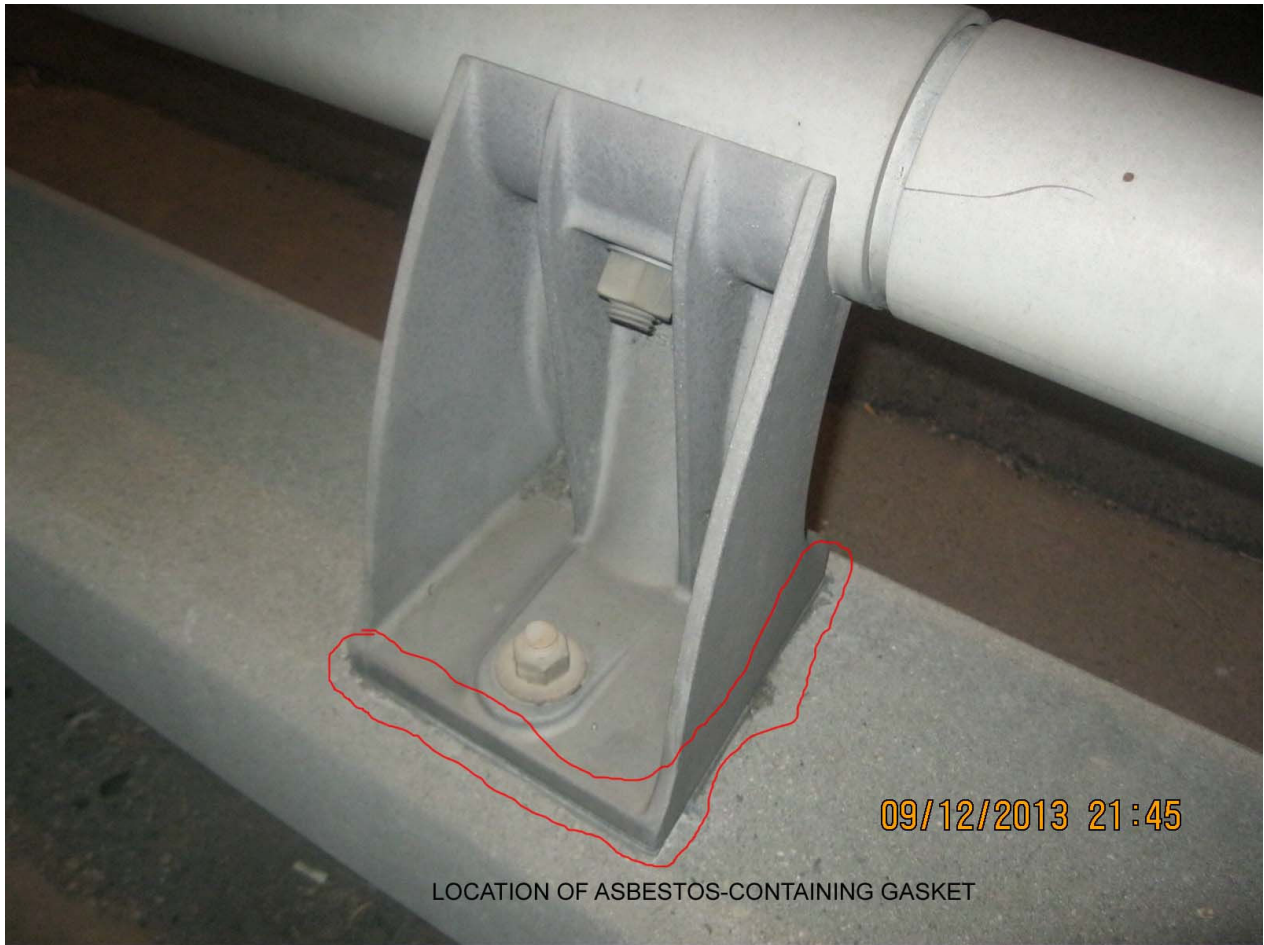
Asbestos (80% chrysotile) was found in the gray gasket that was sampled. It is the CACs professional opinion that the sampled material is homogeneous and represents the material that composes at least nine other gaskets on the structure. These gaskets are located between the concrete walls and the bridge railing supports on either side of the overcrossing. ACM was not detected in the overcrossing concrete, expansion joint material, and black gaskets located under washers on the railing supports.

The ACM materials were observed to be non-friable and in good condition. If ACM remains in good condition and is not disturbed, exposures to asbestos are expected to be negligible. However, when ACM deteriorates, is disturbed or damaged, such as during removal or demolition operations, asbestos fibers may be released creating a potential health hazard for the public and construction personnel.

LOCATION OF ASBESTOS-CONTAINING GASKET

If bridge railing including the gray ACM gaskets must be removed during construction, a State-certified asbestos abatement contractor should remove the ACM gaskets. GDC recommends that the following steps be taken:

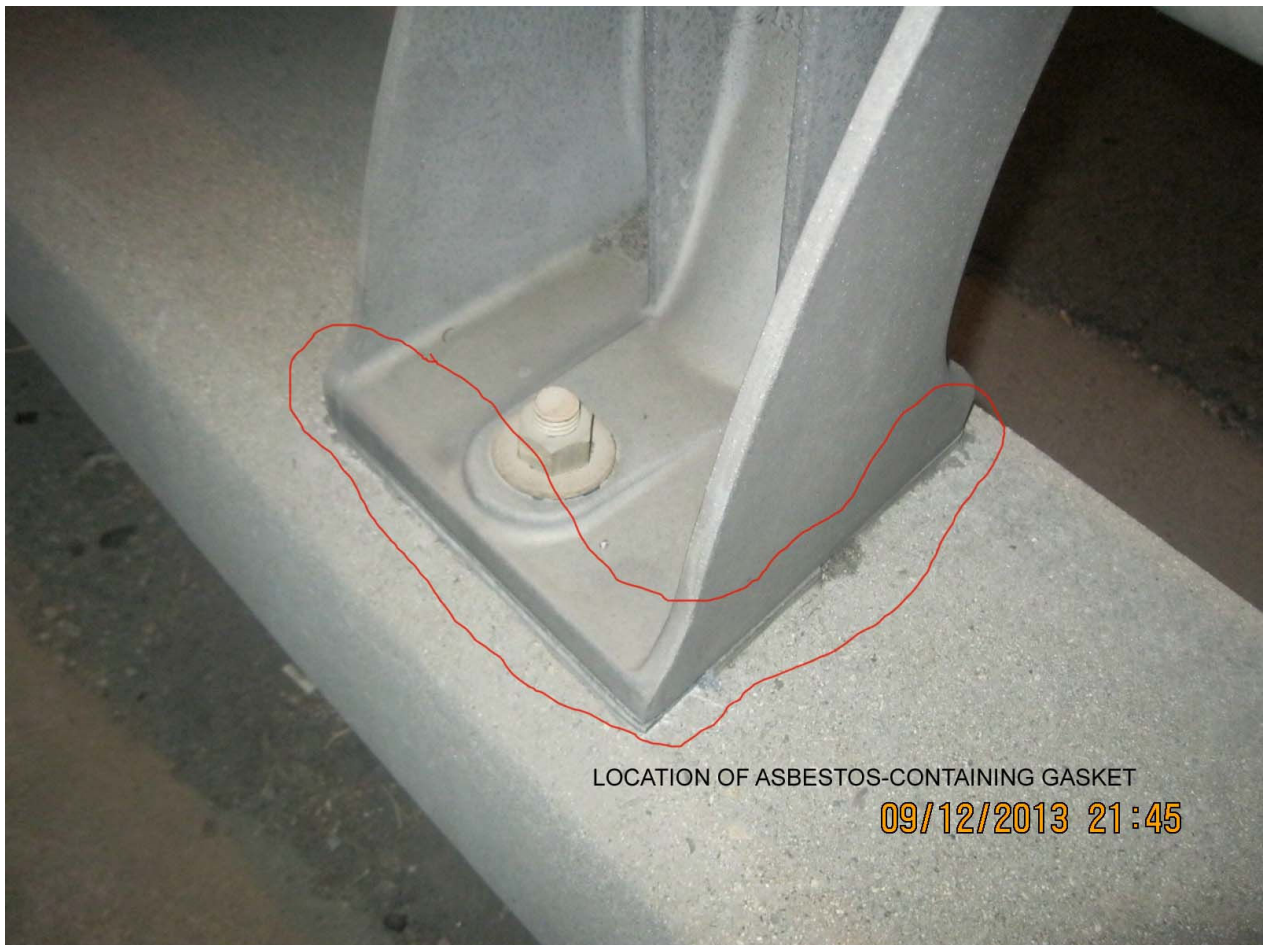
LOCATION OF ASBESTOS-CONTAINING GASKET
