Based on the information provided in the project's Application, we understand the project includes the construction of a senior living facility. A site plan prepared by Huitt-Zollars dated August 8, 2017 is provided as Appendix 1.

Project/Site: Oakmont Senior / CANWOOD City/County: AGORA HILLS Sampling Date: 10/31/16
 Applicant/Owner: OAKMONT SENIOR LIVING State: CA Sampling Point: FP2 TPI
 Investigator(s): T. BAKS Section, Township, Range: Los Virgenes Civil Land Grant
 Landform (hillslope, terrace, etc.): depression Local relief (concave, convex, none): concave Slope (%): 1-2
 Subregion (LRR): LARC Lat: 34.14885092 Long: -118.7660653 Datum: NAD83
 Soil Map Unit Name: Urban land-Saguai, landscaped-Kawonga, landscaped complex, 0-20% res. NWI classification: N/A
 Are climatic / hydrologic conditions on the site typical for this time of year? Yes No (If no, explain in Remarks.)
 Are Vegetation N, Soil N, or Hydrology N significantly disturbed? Are "Normal Circumstances" present? Yes No
 Are Vegetation N, Soil N, or Hydrology N naturally problematic? (If needed, explain any answers in Remarks.)

**Biological Resources Assessment Report
Oakmont of Agoura Hills
City of Agoura Hills, Lo

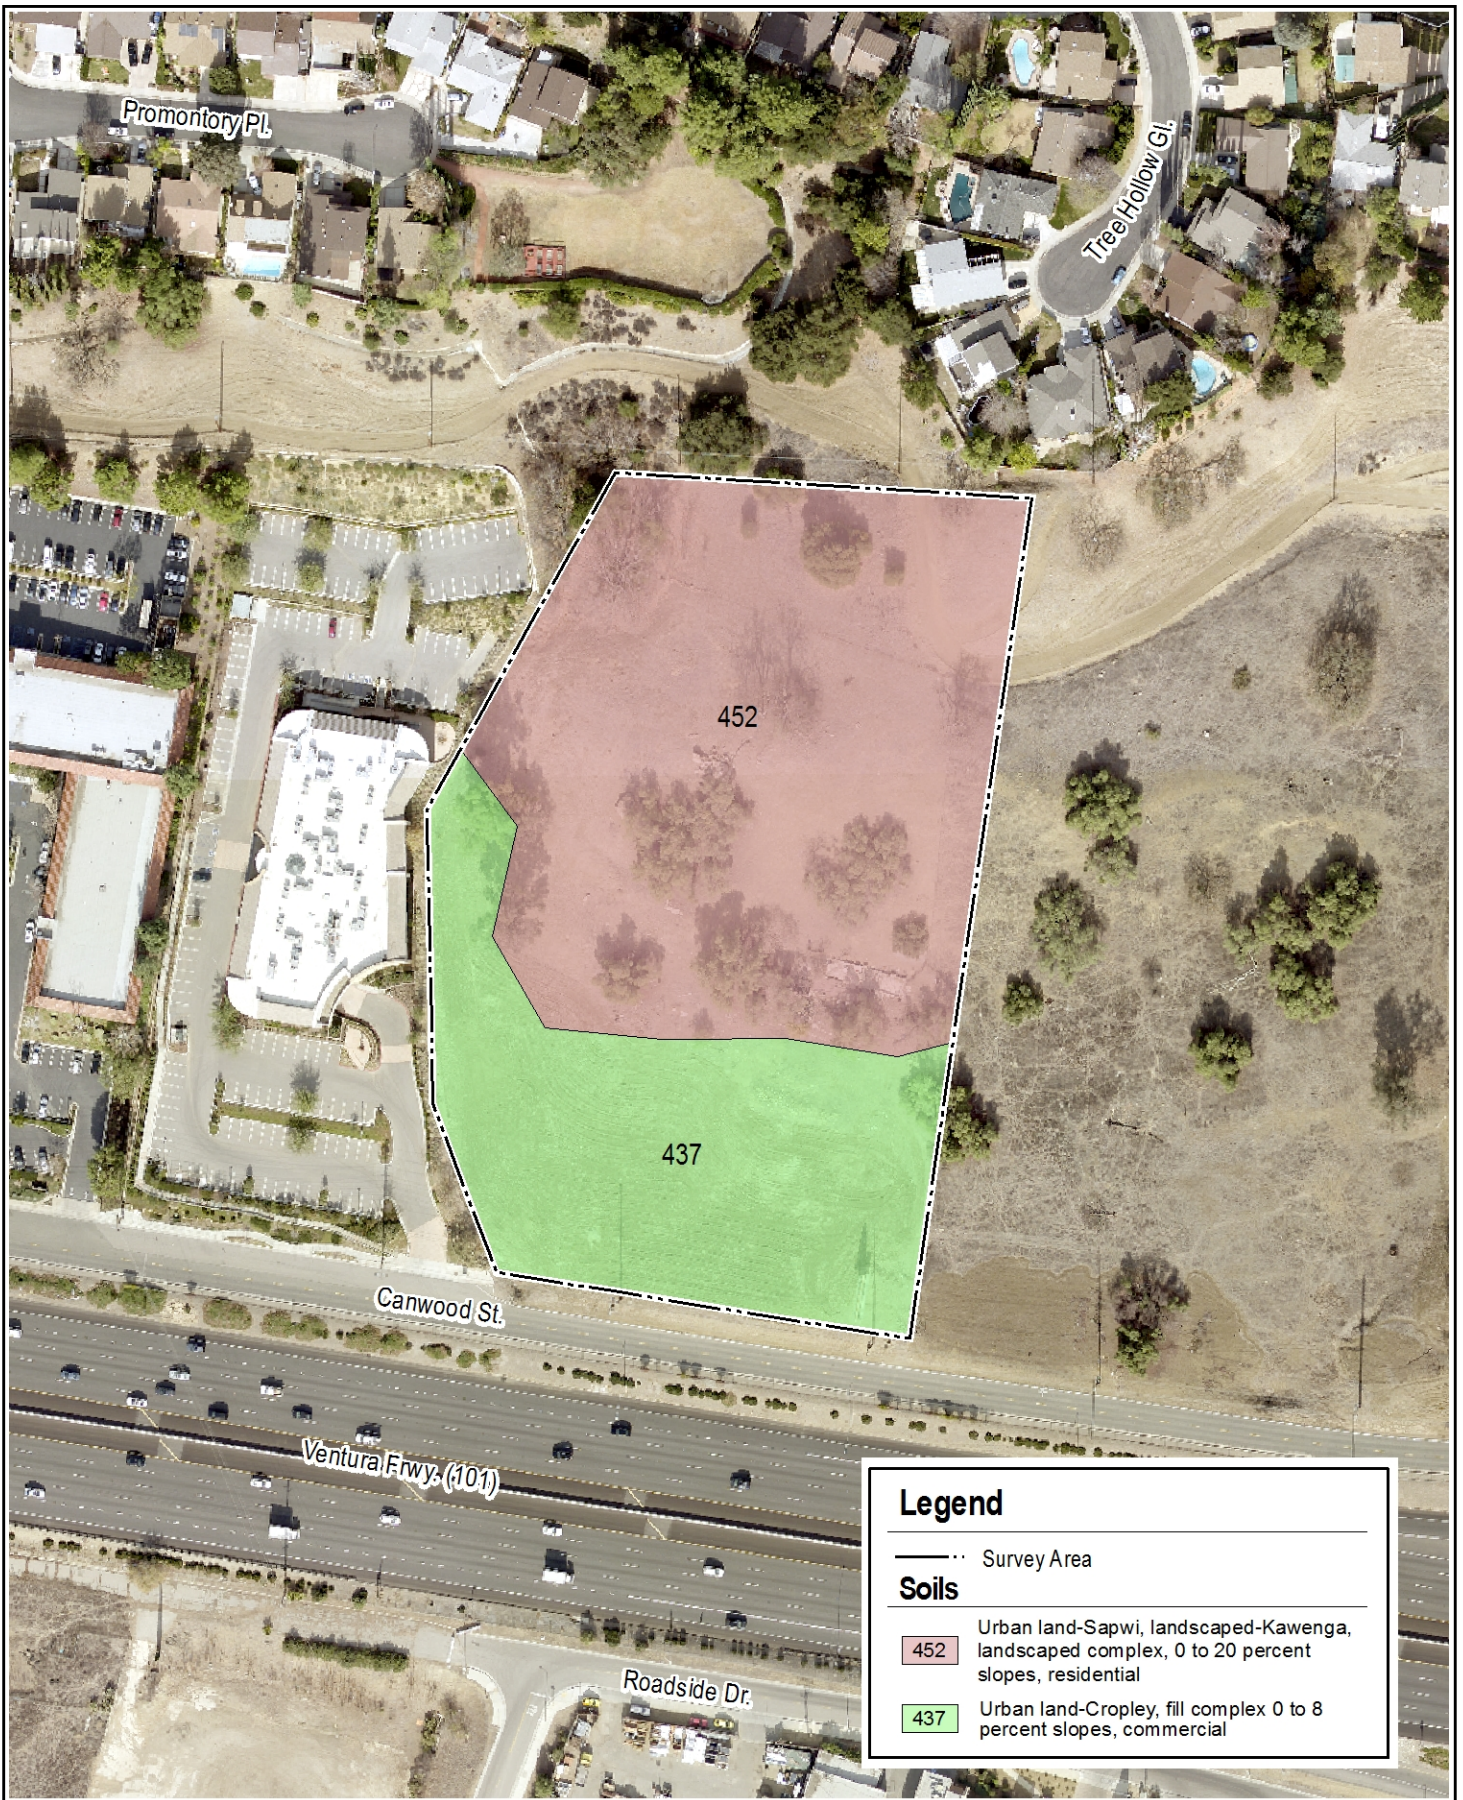
Aerial Source: USGS High Resolution Orthoimagery: <http://viewer.nationalmap.gov/basic>. Data Source: NRCS Soils: <http://websoilsurvey.sc.egov.usda.gov/App/WebSoilSurvey.aspx>.

The survey area is characterized by two (2) soil type that primarily consist of loams and sandy/silt loams (Figure 5). A brief description of the soil type is given below:

- URBAN LAND-CROPLEY, FILL COMPLEX 0 TO 8 PERCENT SLOPES, COMMERCIAL (437) - The Cropley series consists of very deep, moderately well and well drained soils that formed in alluvium from mixed rock sources. Cropley soils are on alluvial fans, floodplains and in small basins. Slopes range from 0 to 15 percent. This soil association does not meet hydric criteria.
- URBAN LAND-SAPWI, LANDSCAPED-KAWENGA, LANDSCAPED COMPLEX, 0 TO 20 PERCENT SLOPES, RESIDENTIAL (452) - The Kawenga and Sapwi series consists of moderately deep to bedrock, well drained soils that formed in residuum and colluvium derived from sandstone. Sapwi soils are on hills and mountains. Slopes are 15 to 75 percent. This soil association does not meet hydric criteria.

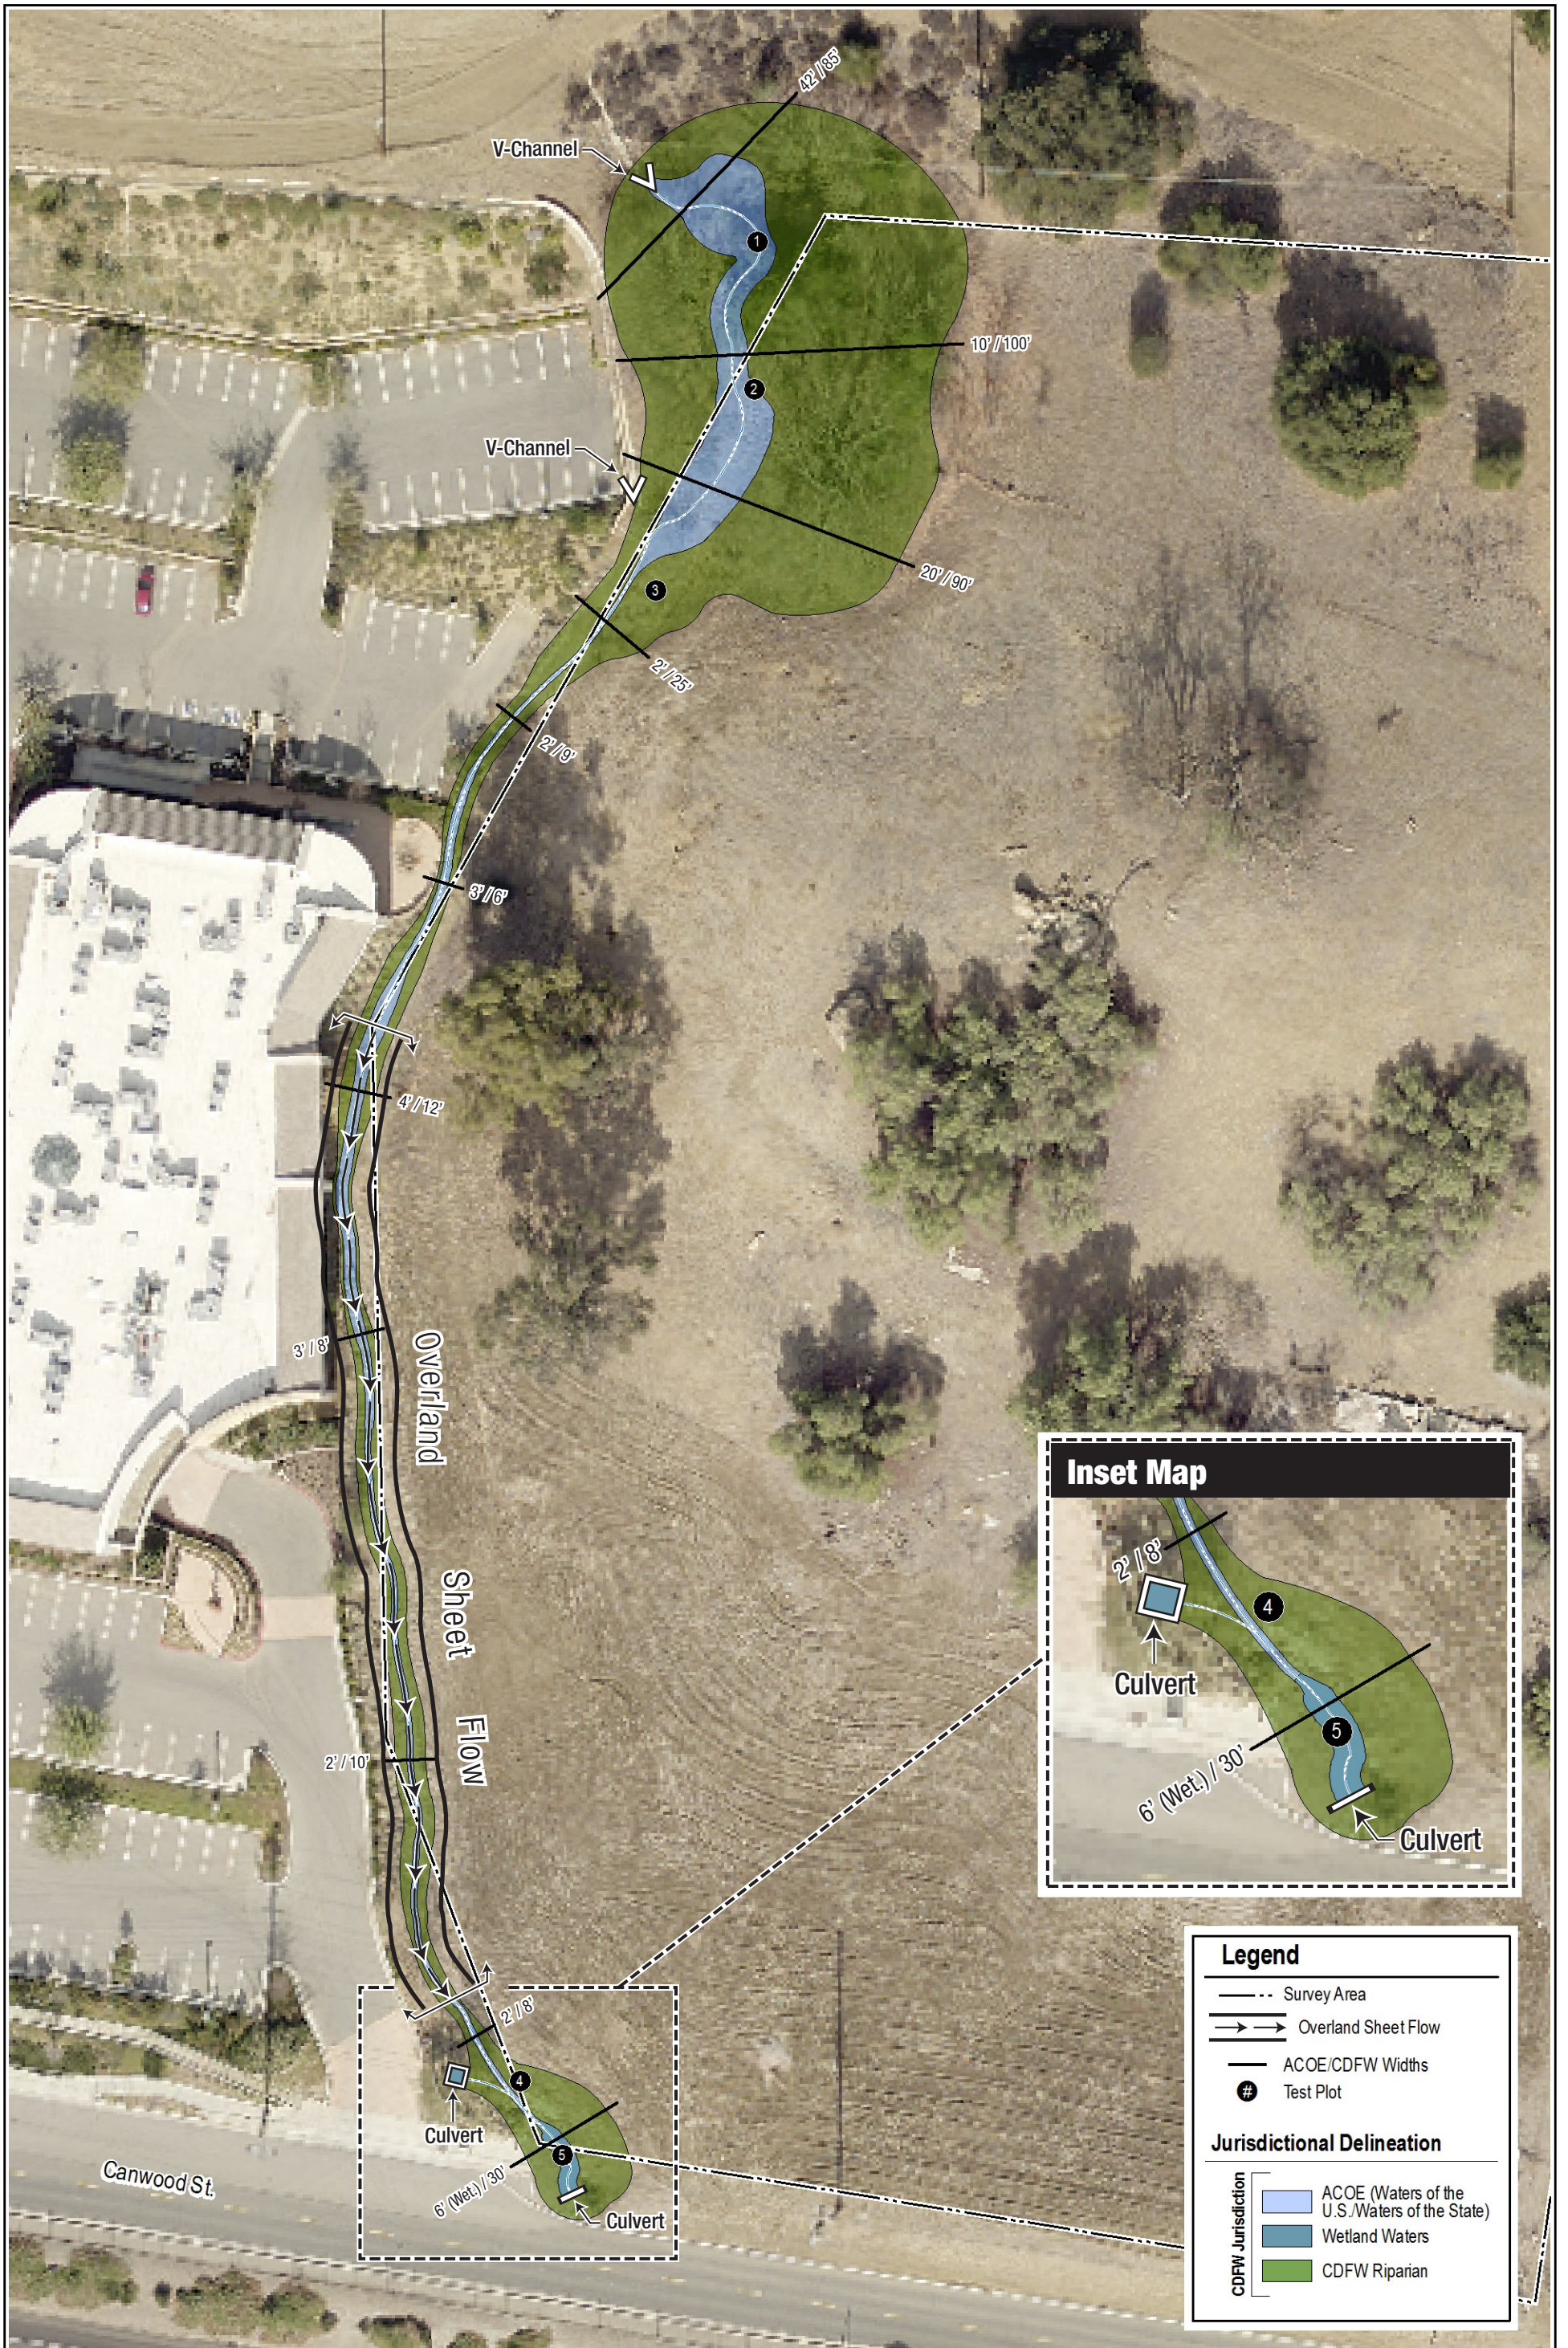
The ephemeral drainage would be regulated as a federal and state jurisdictional feature (**Table 2, Potential Jurisdictional Feature in Survey Area** and **Figure 8**). The drainage (DR1) appears to be hydrologically connected to the Pacific Ocean, which is navigable water. Therefore, the drainage is subject to both federal and state jurisdiction. Thus, all features observed were recorded per both ACOE and CDFW guidance. Within the survey area, data for five (5) soil test points were collected using ACOE methodology described above to delineate wetlands. One (1) area within the drainage met all three (3) ACOE wetland parameters (hydrophytic vegetation, hydric soils, and hydrology) to be classified as a wetland. Based on the results of the test plots, the remainder of the drainage does not meet wetland criteria and is classified as non-wetland waters, a significant departure from the previous 2005 report.

The drainage is incised in the northern portion of the site and conveys water from upland areas to the south and off-site via a culvert under Canwood Street. Here, the drainage has a discernible bed and OHWM indicators. Upland environs were determined based on the limits of upland indicators including breaks in the bank, drainage pattern, woody debris, and the development of soil. Riparian habitat associated with drainage includes the contiguous tree canopy, which is dependent on the perennial spring and irrigation flow. As the drainage trends to the south, including areas of mechanical discing, the channel flattens out and water is conveyed across the site through a loosely defined channel along the western margins of the property, bounded by fill from the adjacent site and landscape plantings. A box culvert from the adjacent development that drains into the project site had standing water and a well-established hydrophytic plant community. This water source drains into the main channel and provides a supplemental source that supports a wetland depression area just north of the culvert under Canwood Street.

Based on the delineation, a total of approximately 0.094 acres (740 linear feet) are considered potential jurisdictional WOUS by the ACOE and WOS by the RWQCB and 0.41 acres (760 linear feet) are potential CDFW jurisdiction. Activities that affect the delineated features within the survey area would potentially be subject to requirements under Section 404 and 401 of the CWA and California Fish and Game Code section 1600 *et seq.*

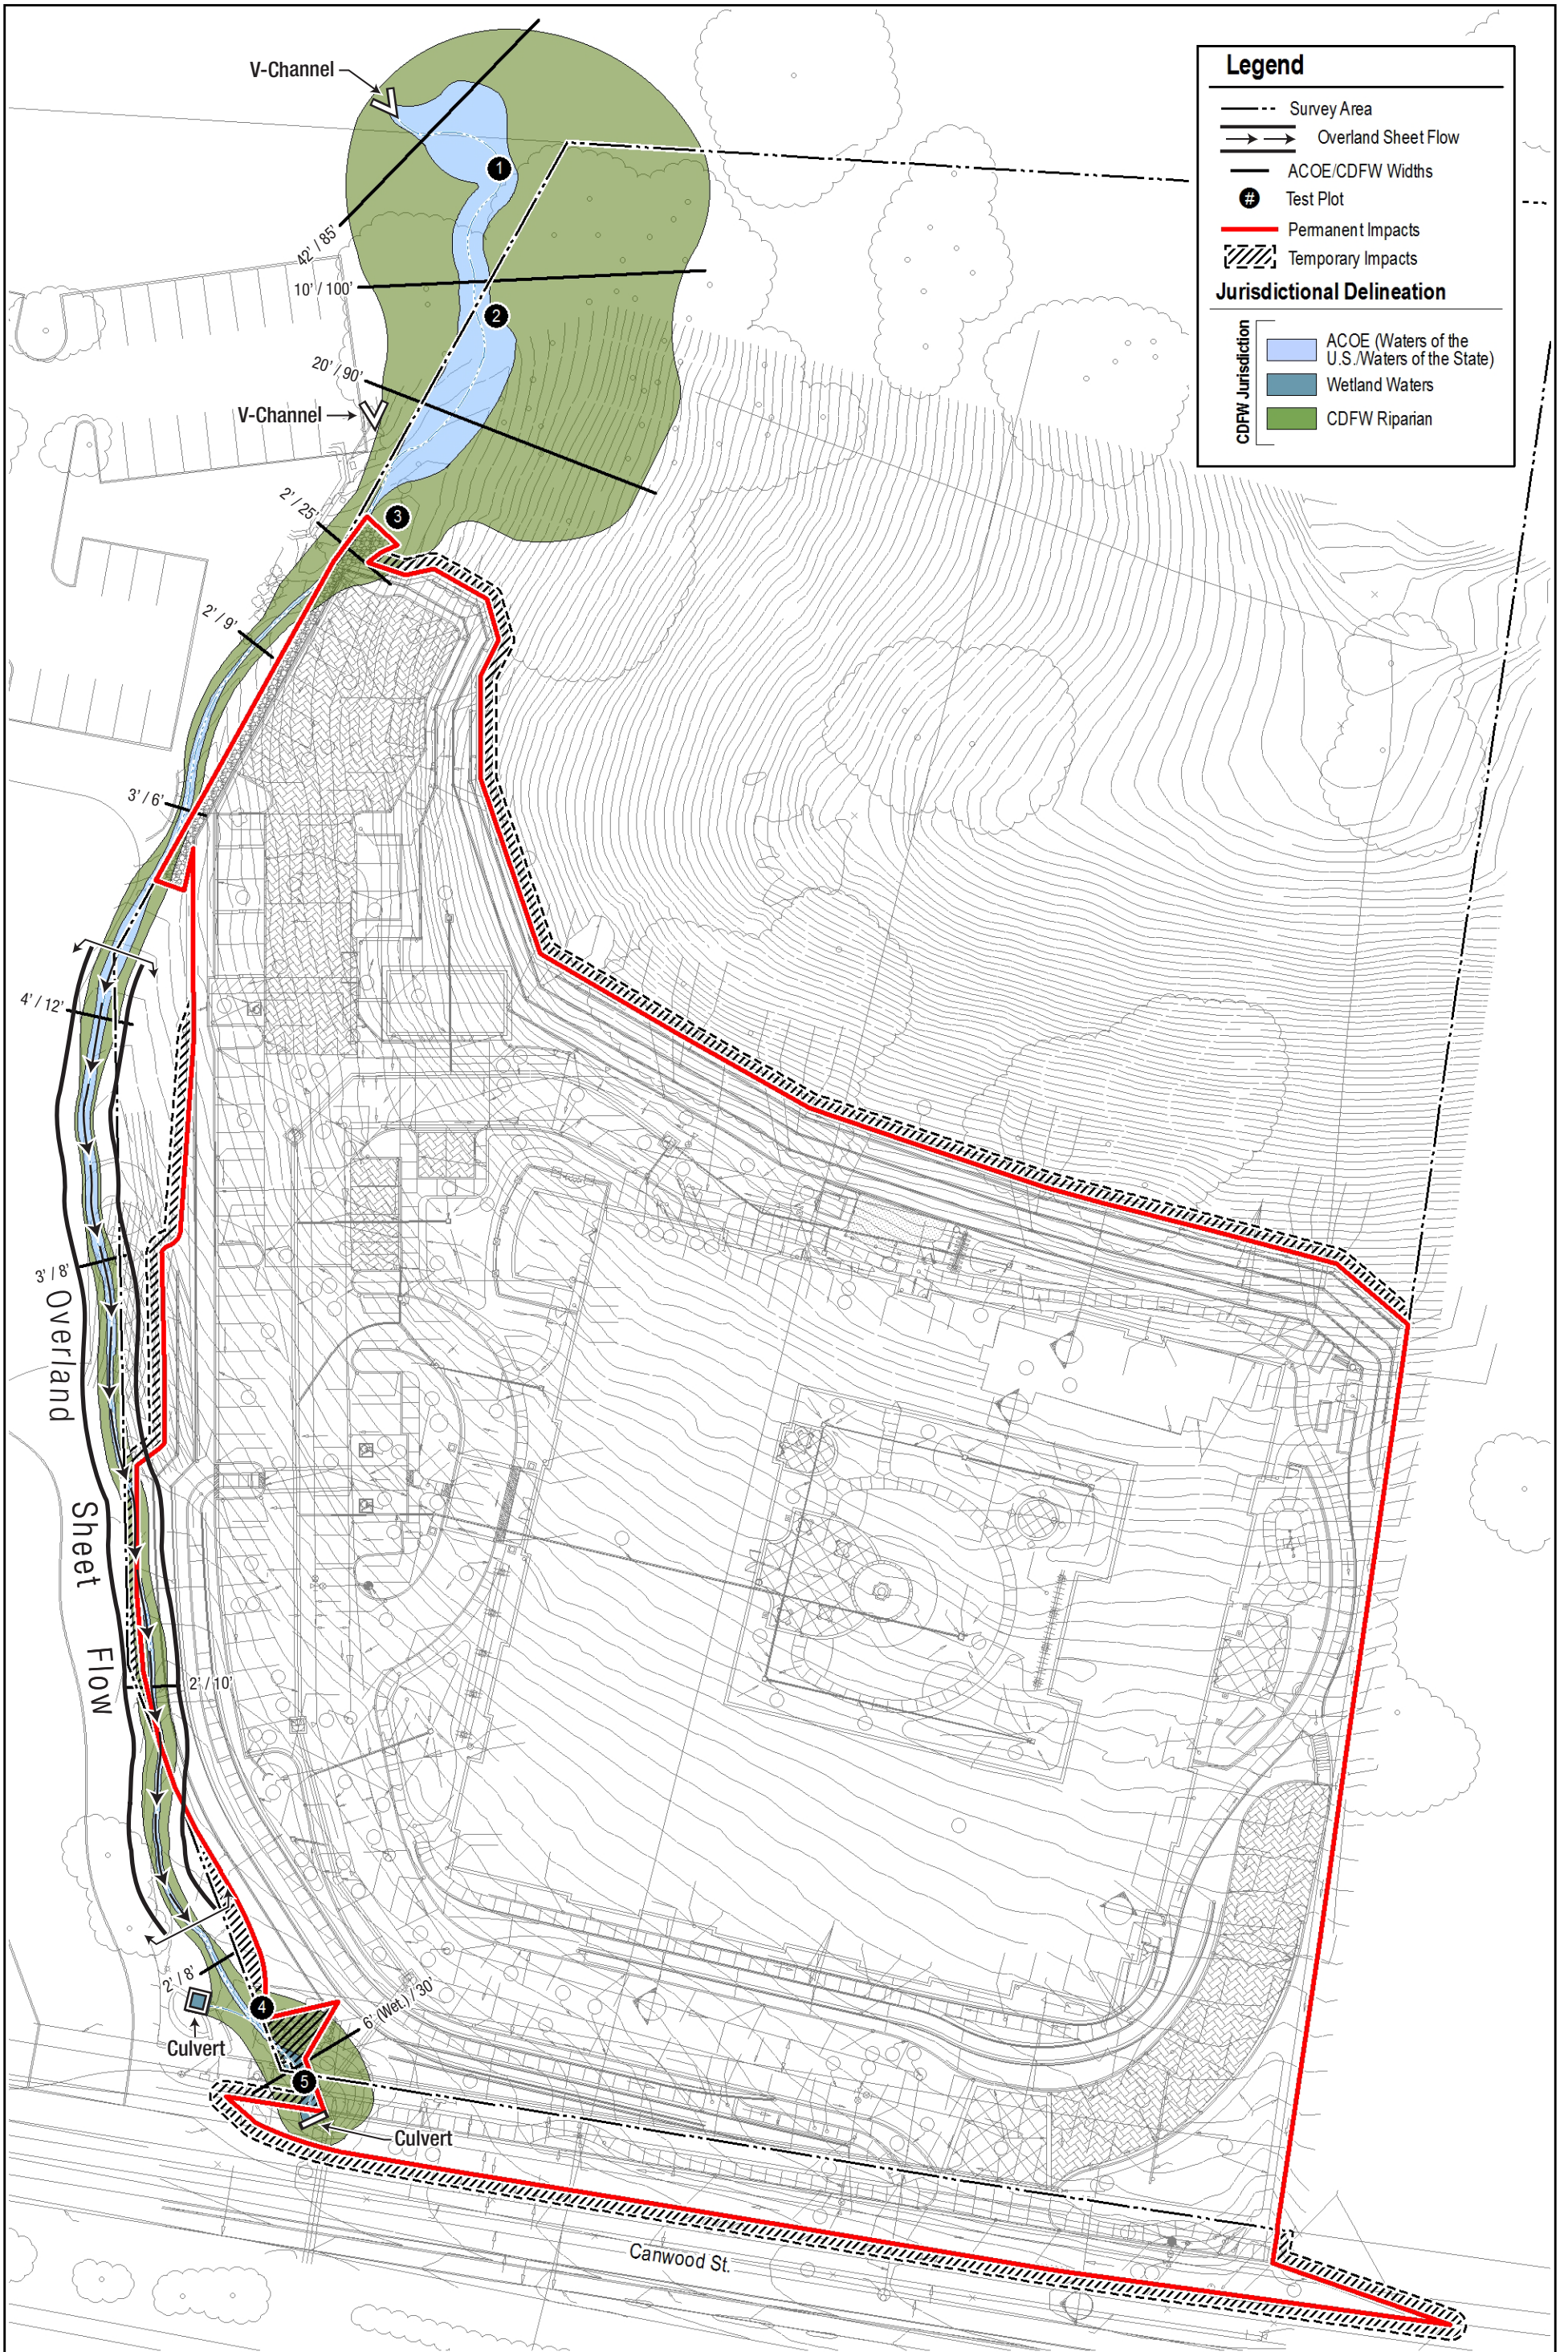
Source: Huitt-Zollars, Aug. 8, 2017.

As described above, Envicom conducted a jurisdictional delineation within the survey area. One (1) feature was identified within the survey area and delineated in accordance with the ACOE Wetlands Delineation Manual and the Regional Supplement. The project limits of disturbance are based on the limits of disturbance overlaid on potential jurisdictional areas as illustrated in **Figure 9, Jurisdictional Delineation Impacts Map**. Temporary impacts associated with the construction process include a five-foot buffer from the edge of the planned retaining walls and hydraulic energy dissipators on the western edge of the development. The jurisdictional acreage within the drainage that would be impacted by the project is provided in **Table 3**.
