**PALO COMADO RANCH**  
**(Shuken Residence, 6511 Chesebro Road)**  
**Addendum to the Environmental Impact Report**

**CITY OF AGOURA HILLS**  
30001 Ladyface Court  
Agoura Hills, CA 91301  
Valerie Darbouze, Associate Planner

**ENVICOM CORPORATION**  
4165 E. Thousand Oaks Blvd. Suite 290  
Westlake Village, CA 91362  
Tim Rosenstein, Environmental Analyst

October 2021

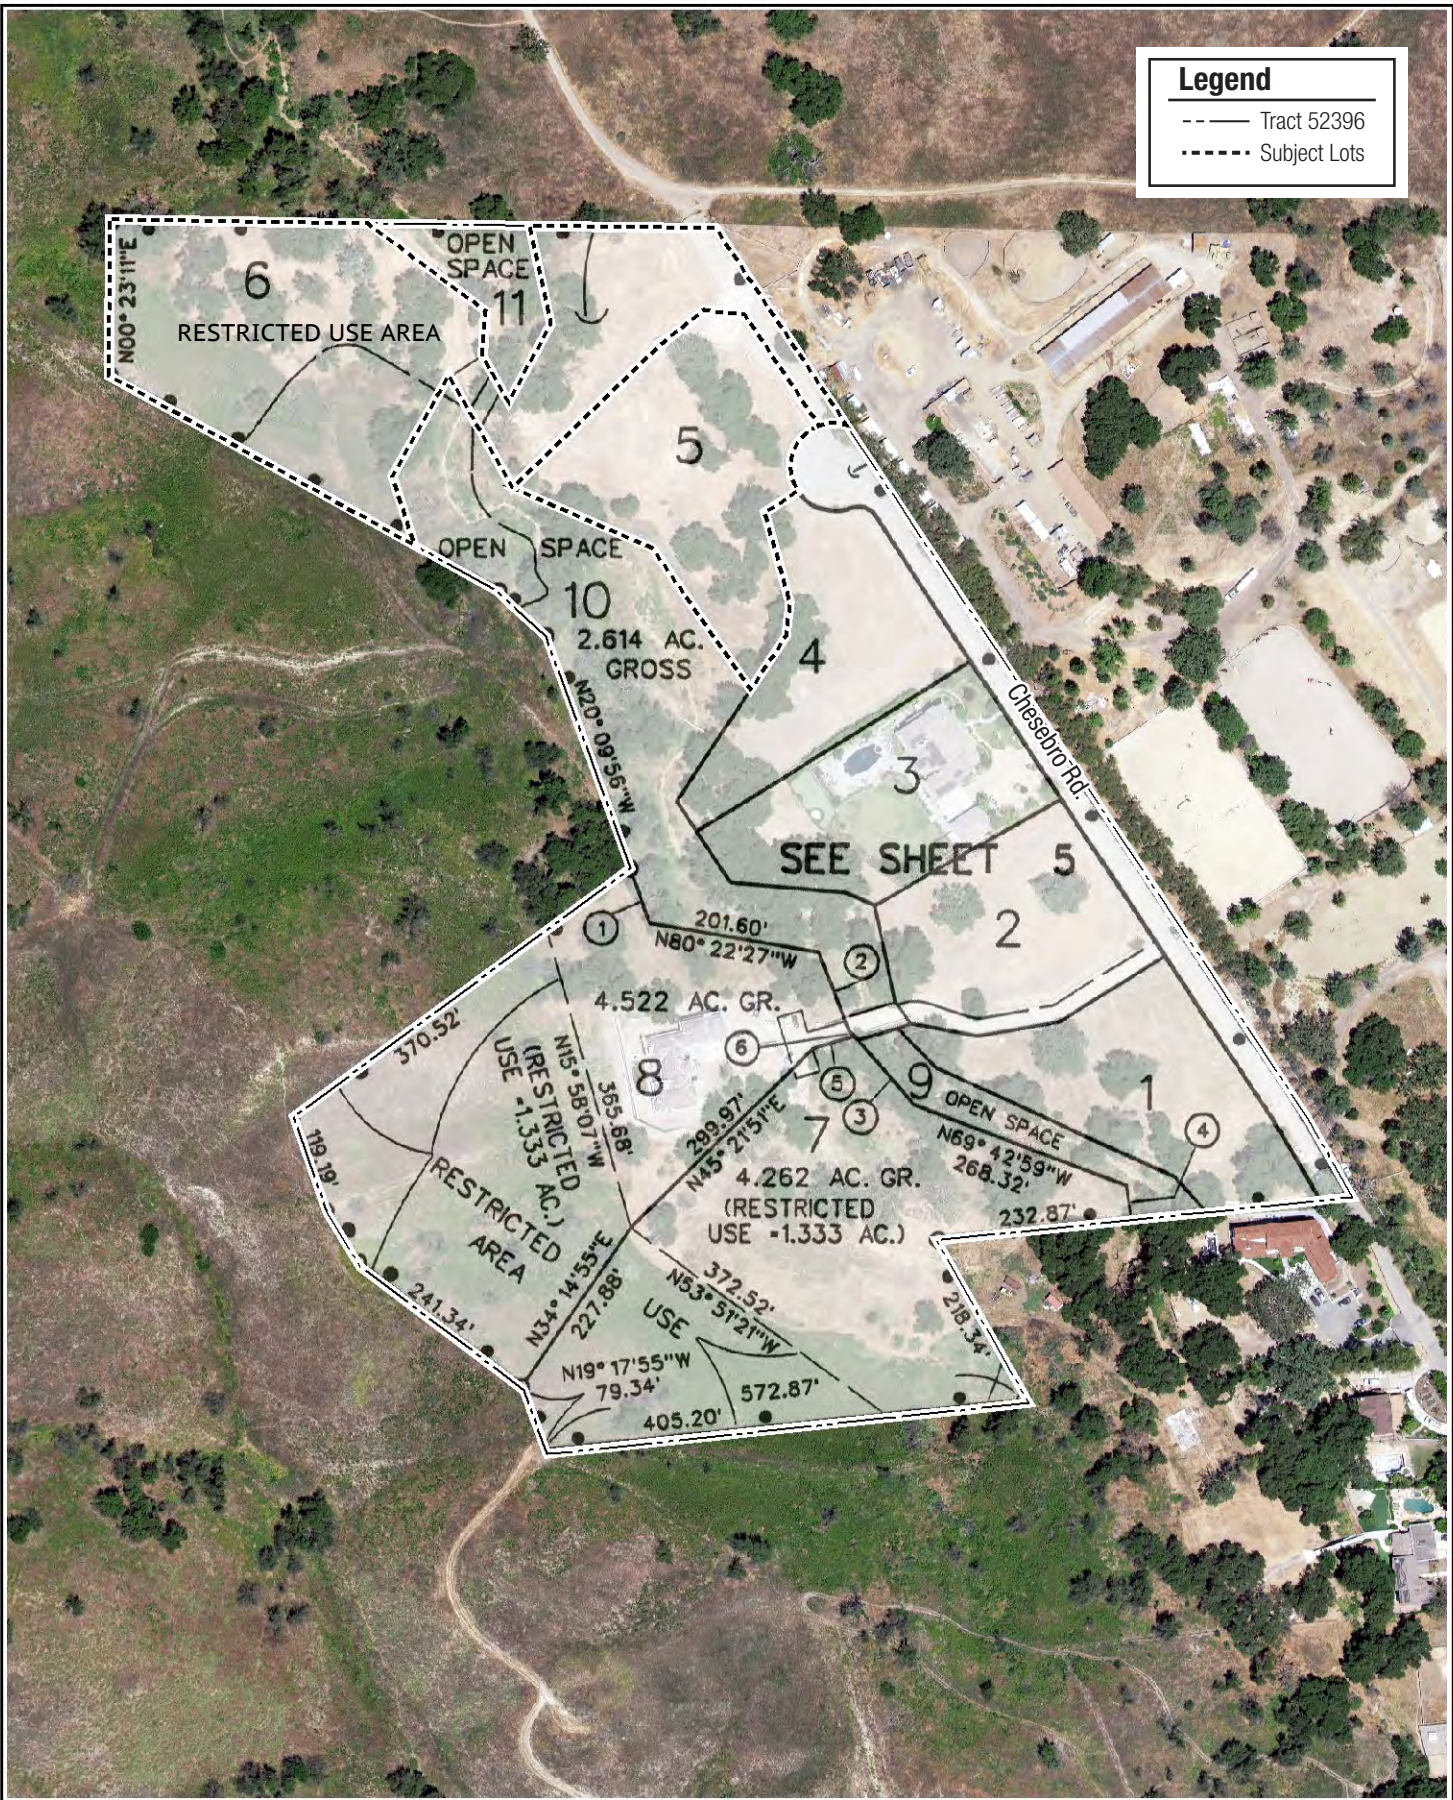
Source: Valtus Imagery Services: Hexagon Imagery Program (HxIP), 2020. Site Plan Source: Palo Comado Ranch EIR, Tract No. 52396.

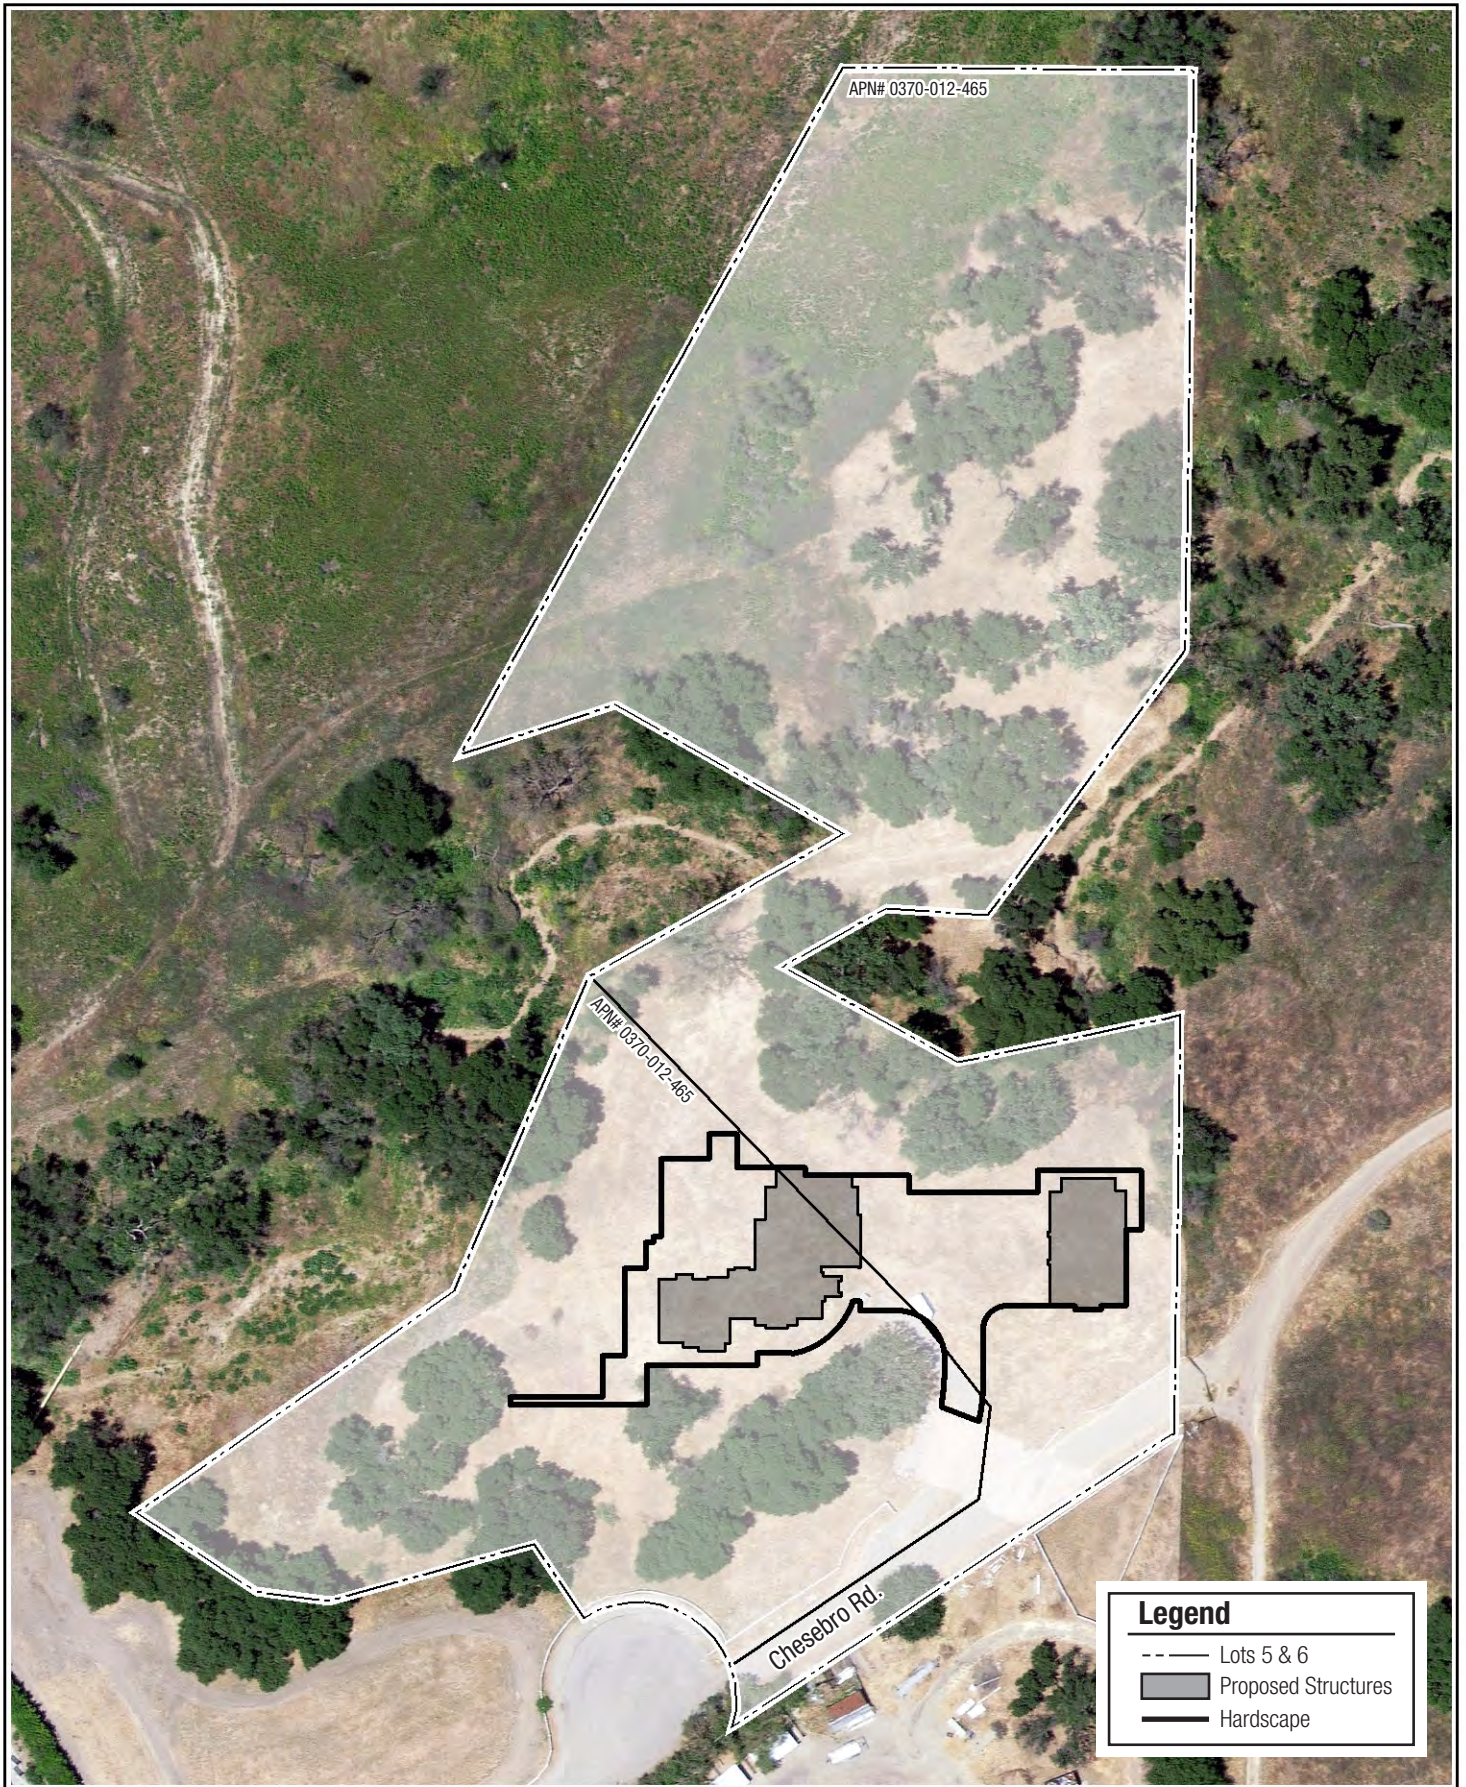
Source: Valtus Imagery Services: Hexagon Imagery Program (HxIP), 2020. Site Plan Source: Wallace Mason & Associates, March 31, 2021.

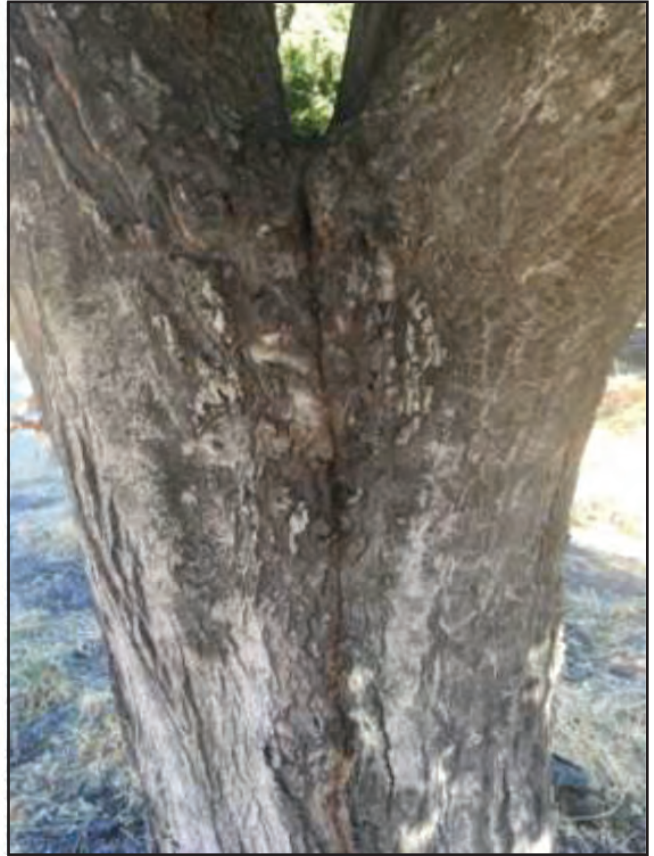
Photo 2 - South side of Trunk #23

- ii. The Project proposes to remove only one coast live oak tree, No. 23, as referred to in the Oak Tree Report, because it has a cavity dividing the trunk and is in structural decline, making it at risk of splitting and falling onto the residence. The Project would also encroach into the protected zone of 3 oak trees, though as explained in the Oak Tree Report the encroachments are at the edge of the trees' protected zone and would amount to only 3.2% of the cumulative protected zone area being encroached upon, and therefore impacts from encroachment are less than significant. The Oak Tree Report recommends mitigation for the removed oak tree. However, the City's Oak Tree Permit process already contains approved standard mitigation measures for removal of an oak. The removed oak tree will be replaced at a rate determined by the City pursuant to the Oak Tree Permit, which will reduce the impact to less than significant. In addition, the Oak Tree Preservation Guidelines, Appendix A of the Municipal Code, implemented via the Oak Tree Permit process, will ensure proper treatment of oaks on the property during construction. Therefore, impacts to oaks will not exceed those assumed by the Certified EIR. The location of tree No. 23 and photos are provided in **Figure 6, Location of Tree #23**.

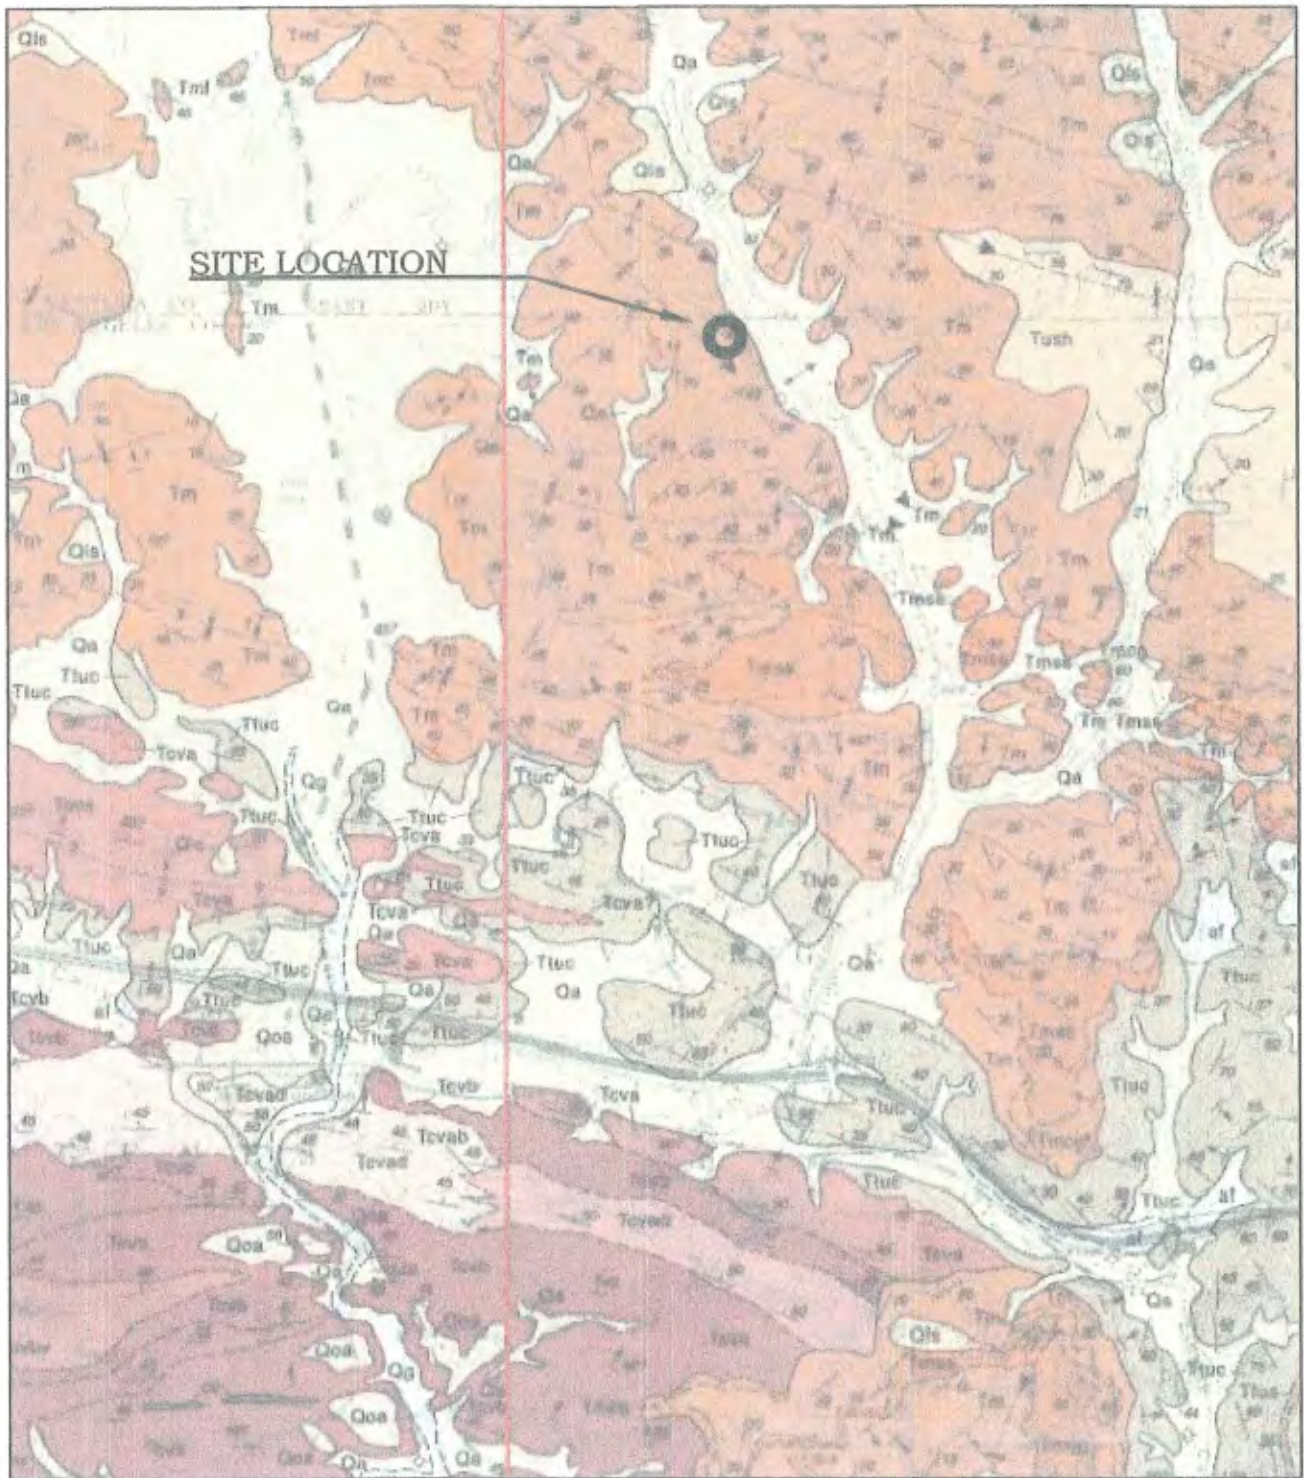
REGIONAL GEOLOGIC MAP  
SHUKEN

Lots 5 and 6 earth materials consist of Modelo Formation marine sediments (bedrock) overlain by topsoil, colluvium, recent alluvium, and non-marine, older alluvium or terrace deposits.

Recent alluvium is found in the creek bottom just southwest of Lots 5 and 6; however, this has no impact on the proposed development.

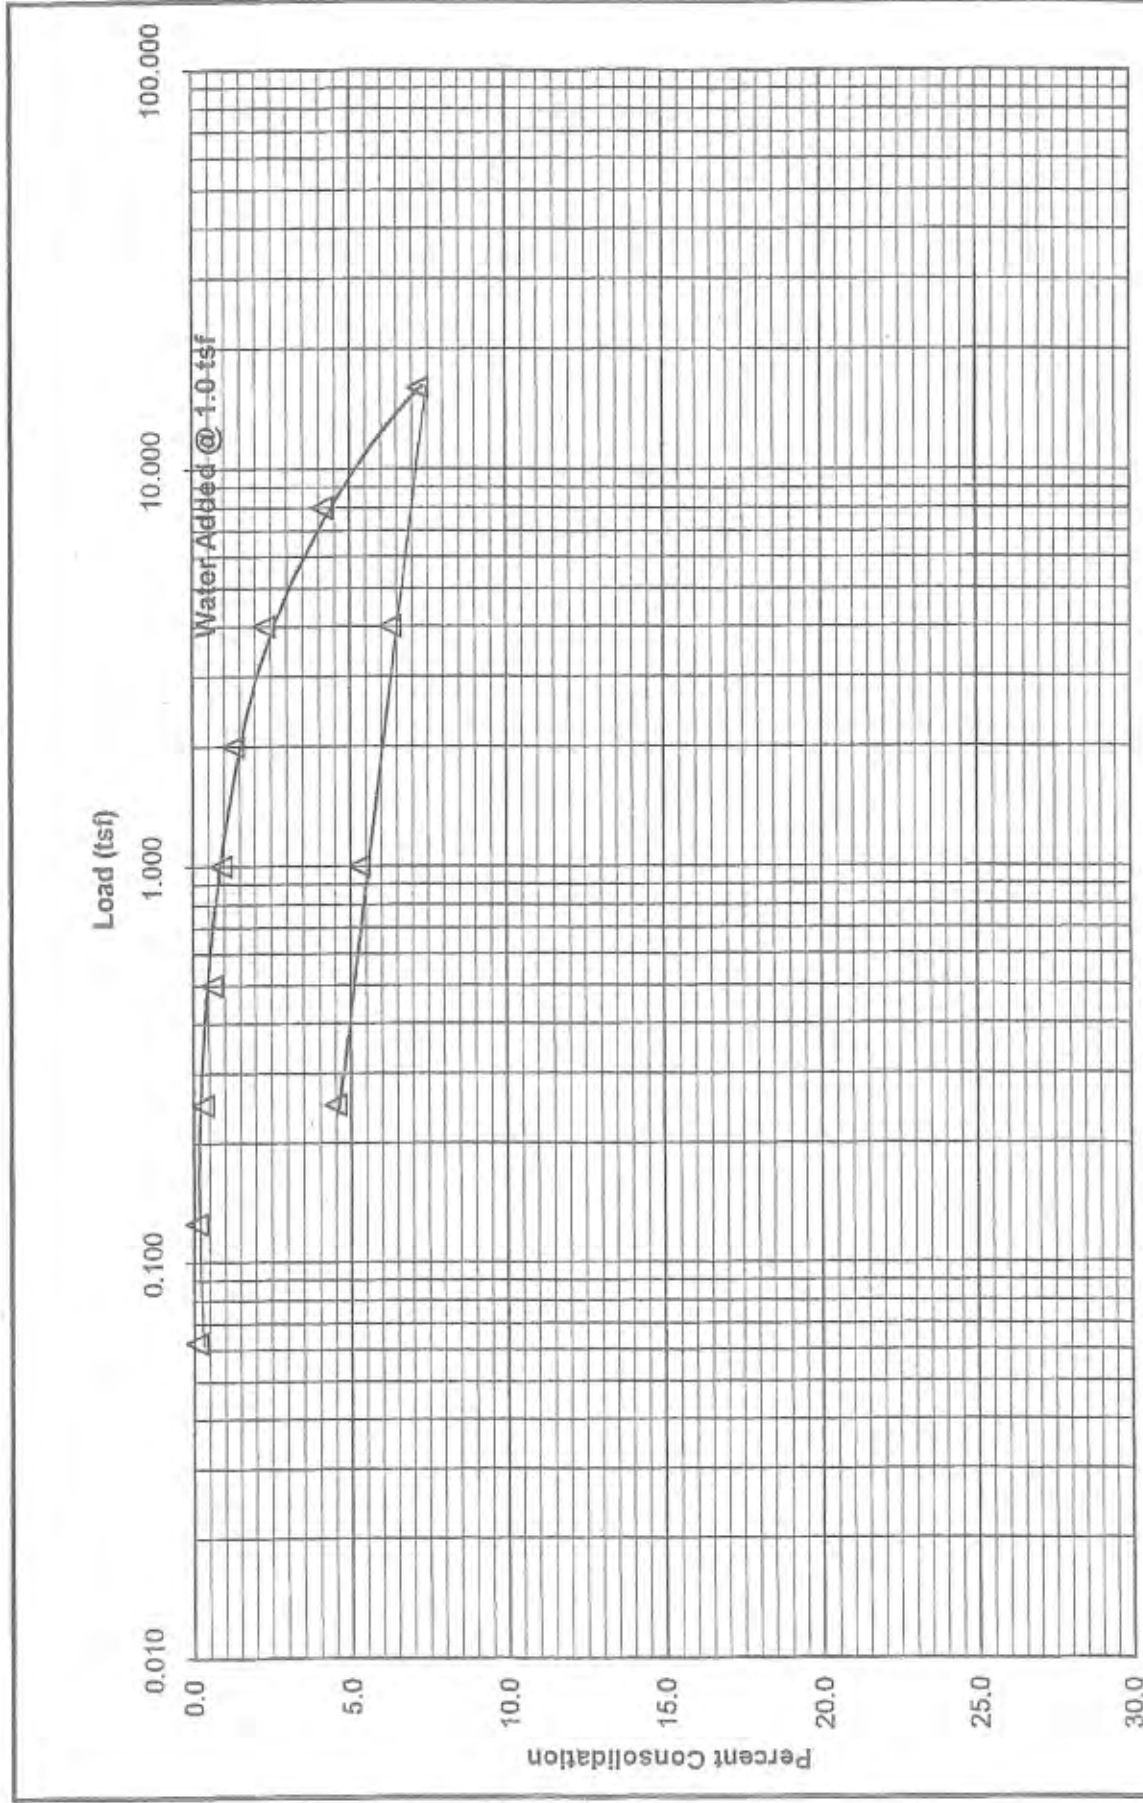
C3079A.1

Sample (in.)  
Height: 1.00 Diameter: 2.36

Consolidation Diagram

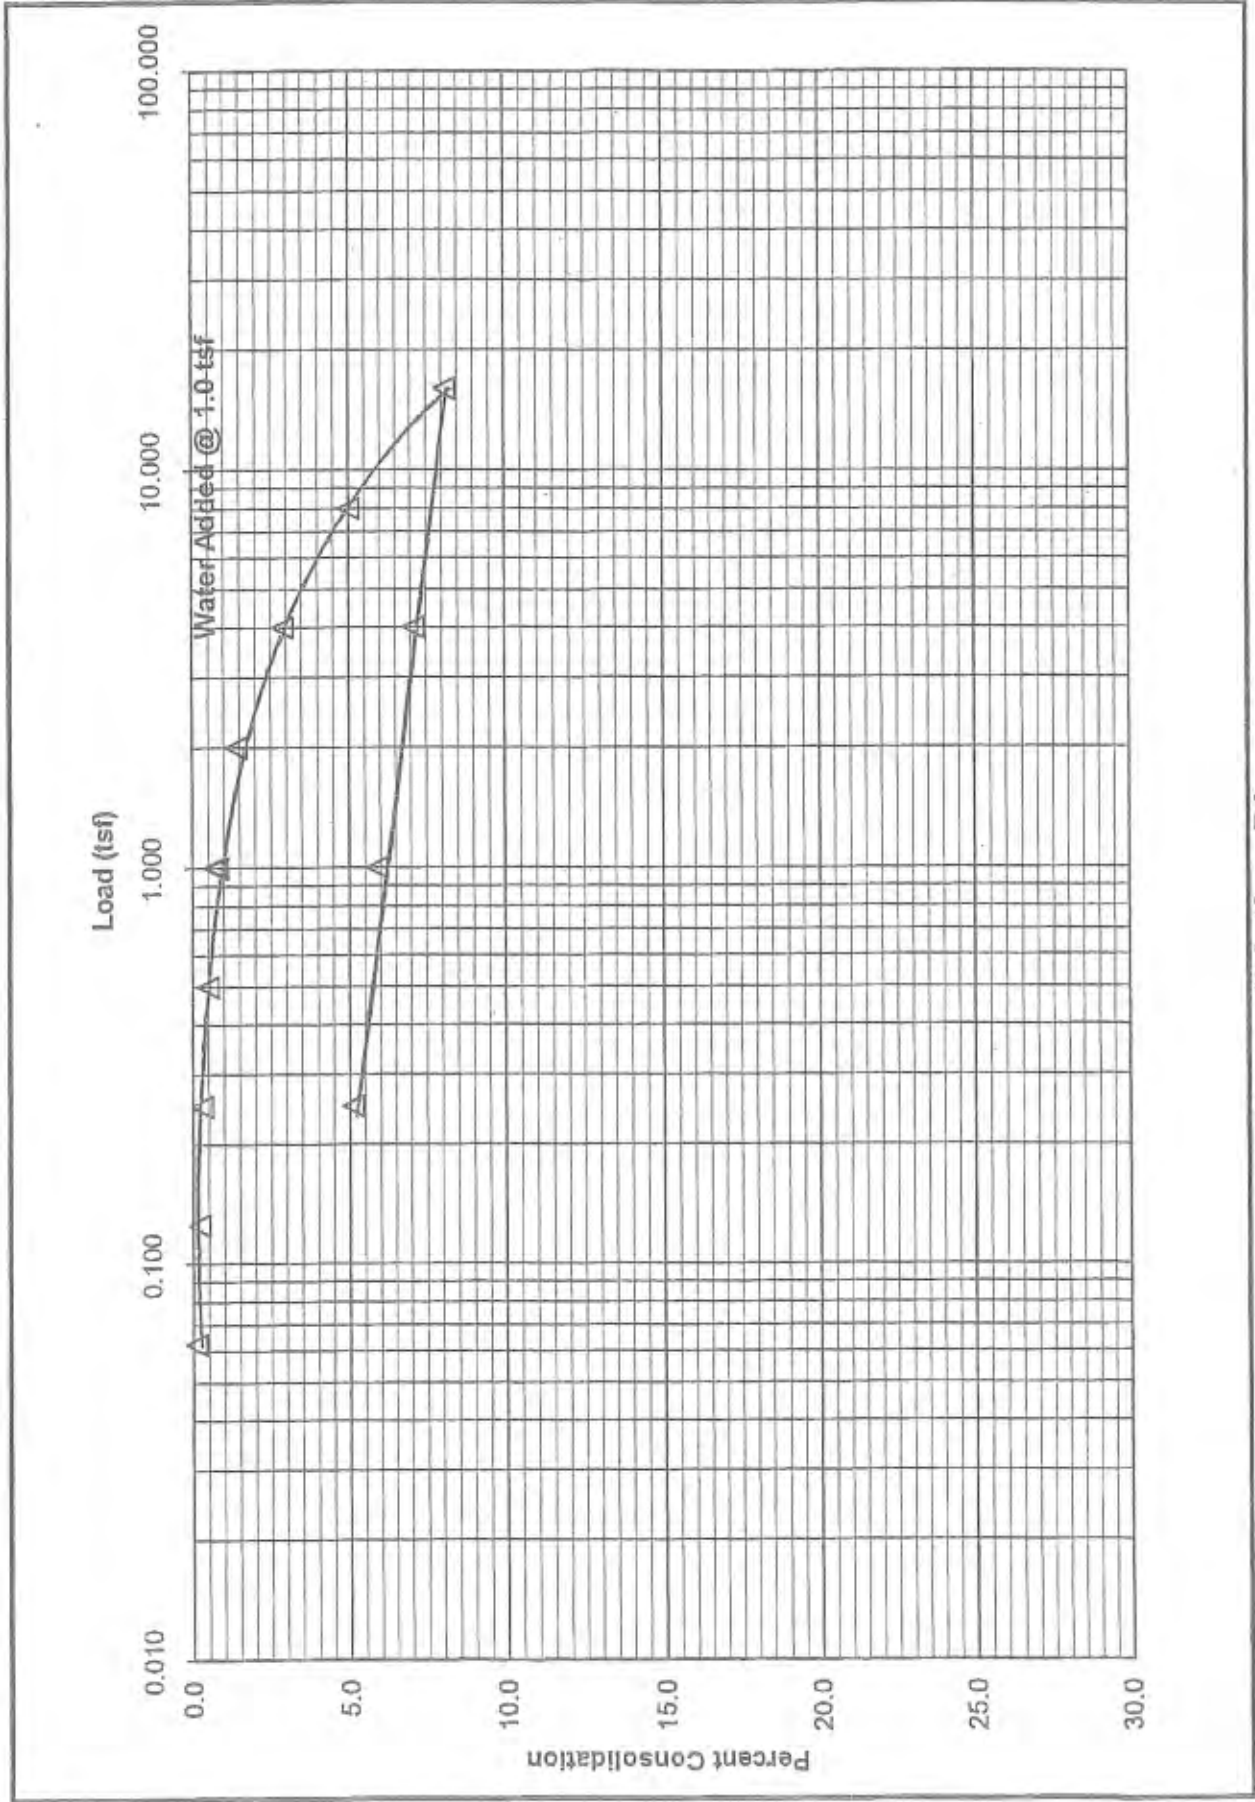
C3079A.2

Sample(m.)  
Height: 1.00 Diameter: 2.36

Consolidation Diagram

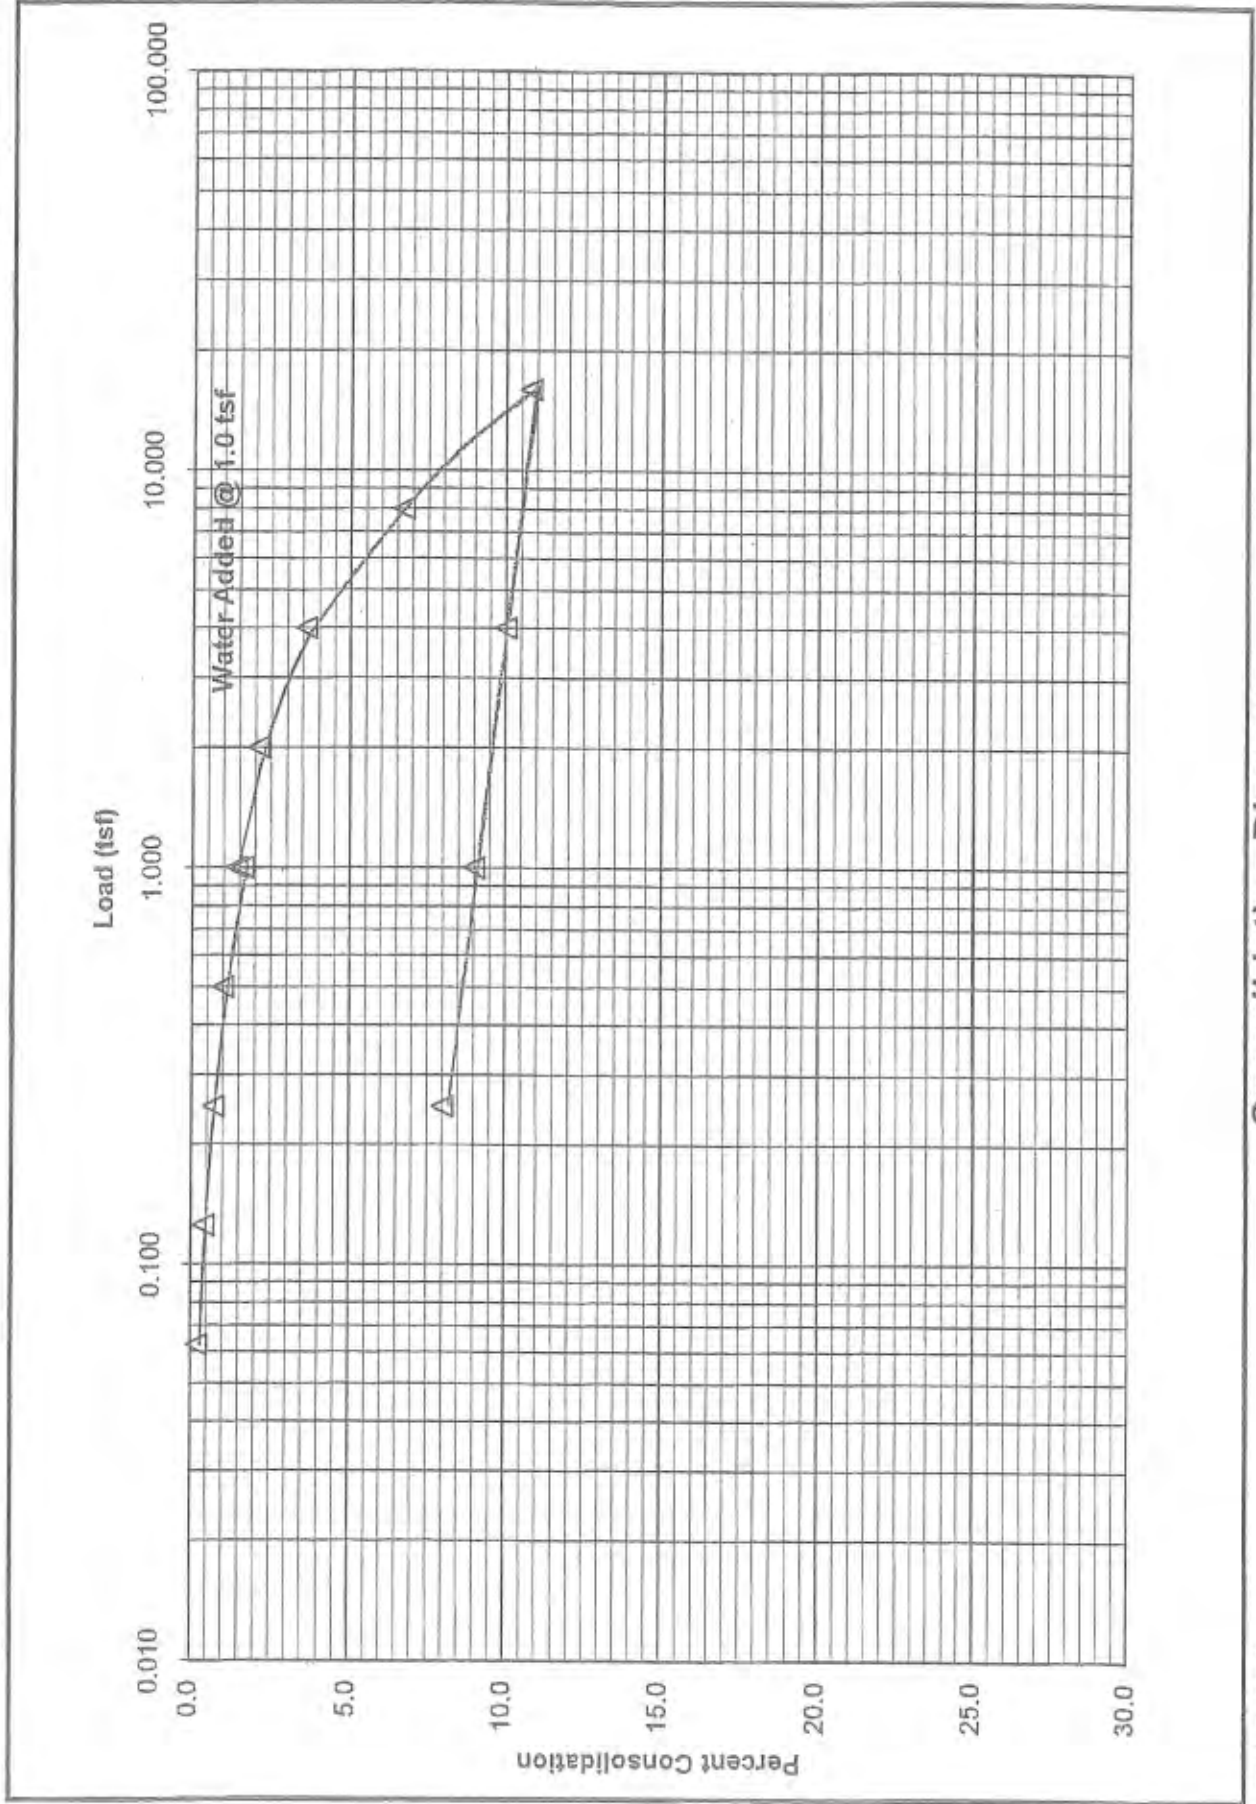
B-2 @ 11.0'

Sample(in.)  
Height: 1.00 Diameter: 2.36

Dark-brown, slightly sandy, silty CLAY.

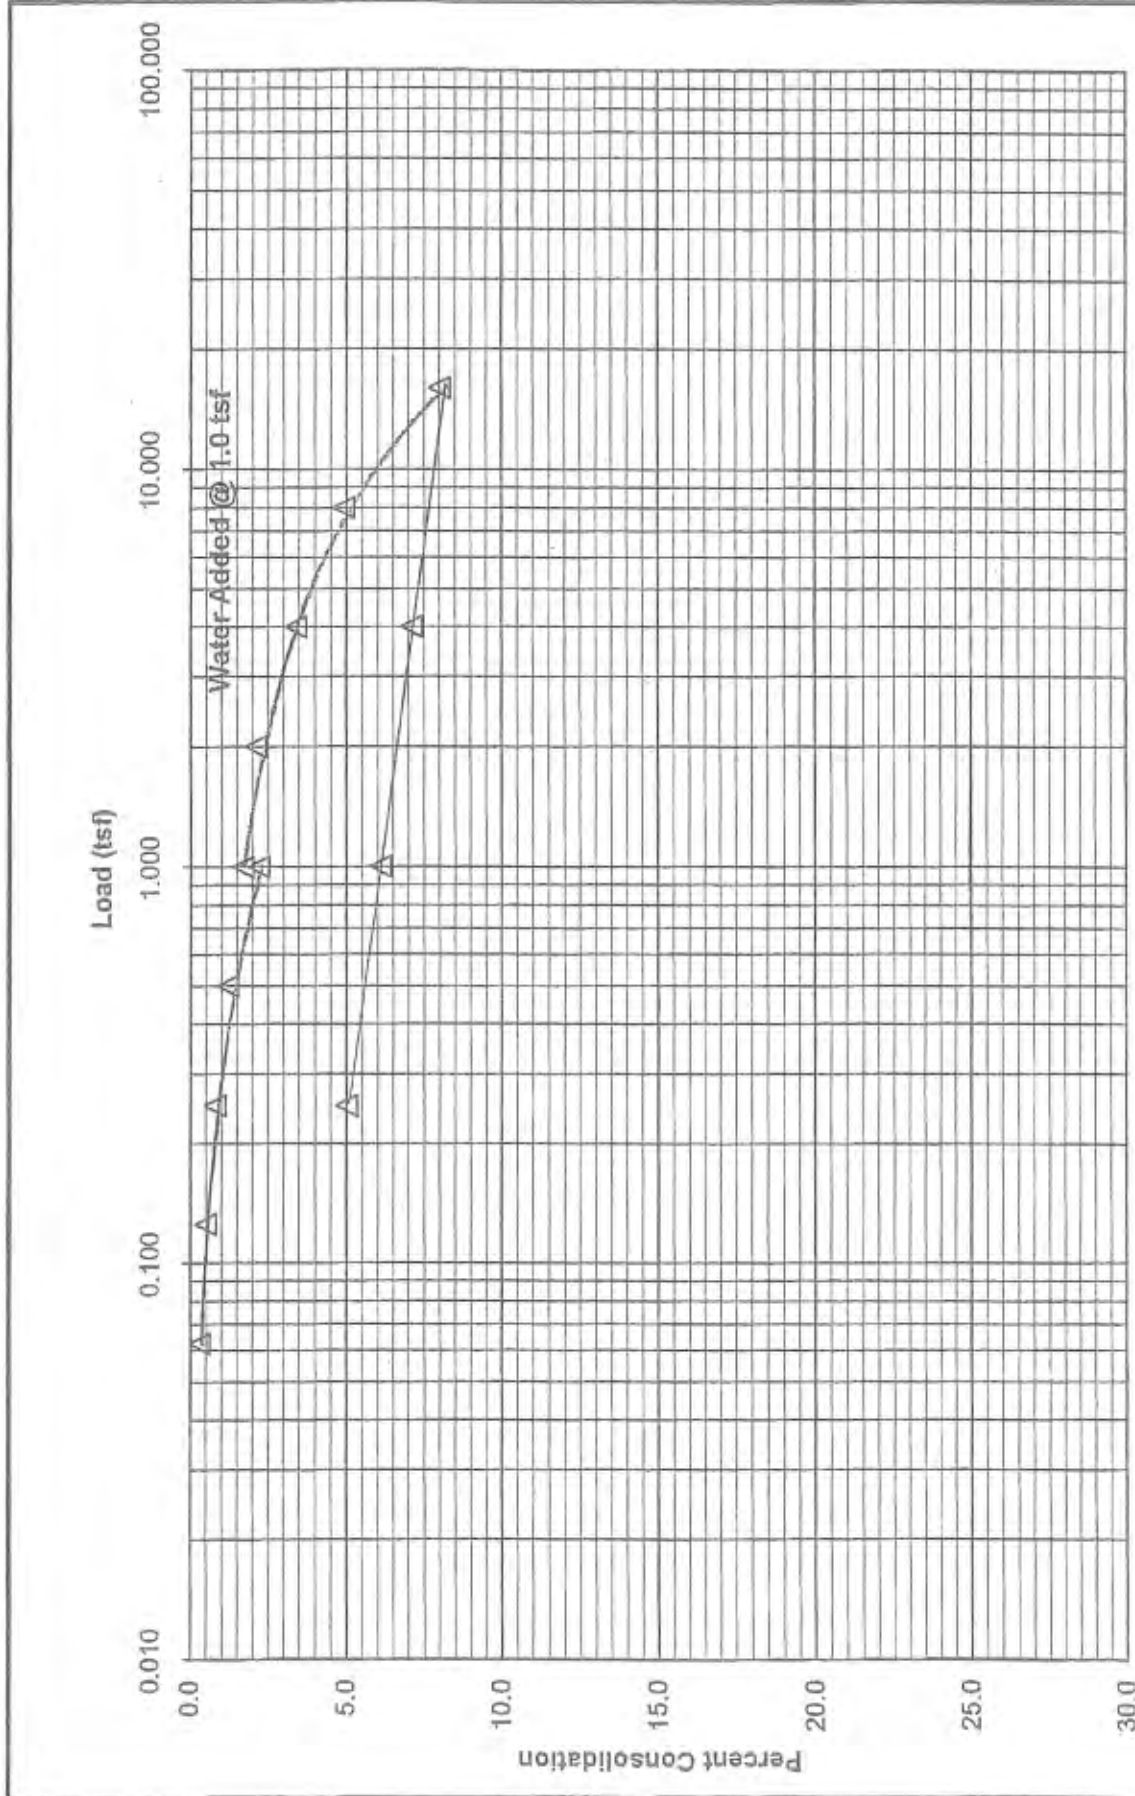
B-2 @ 15.0'  
Dark-brown, sandy CLAY, w/ rock fragments.

## Consolidation Diagram

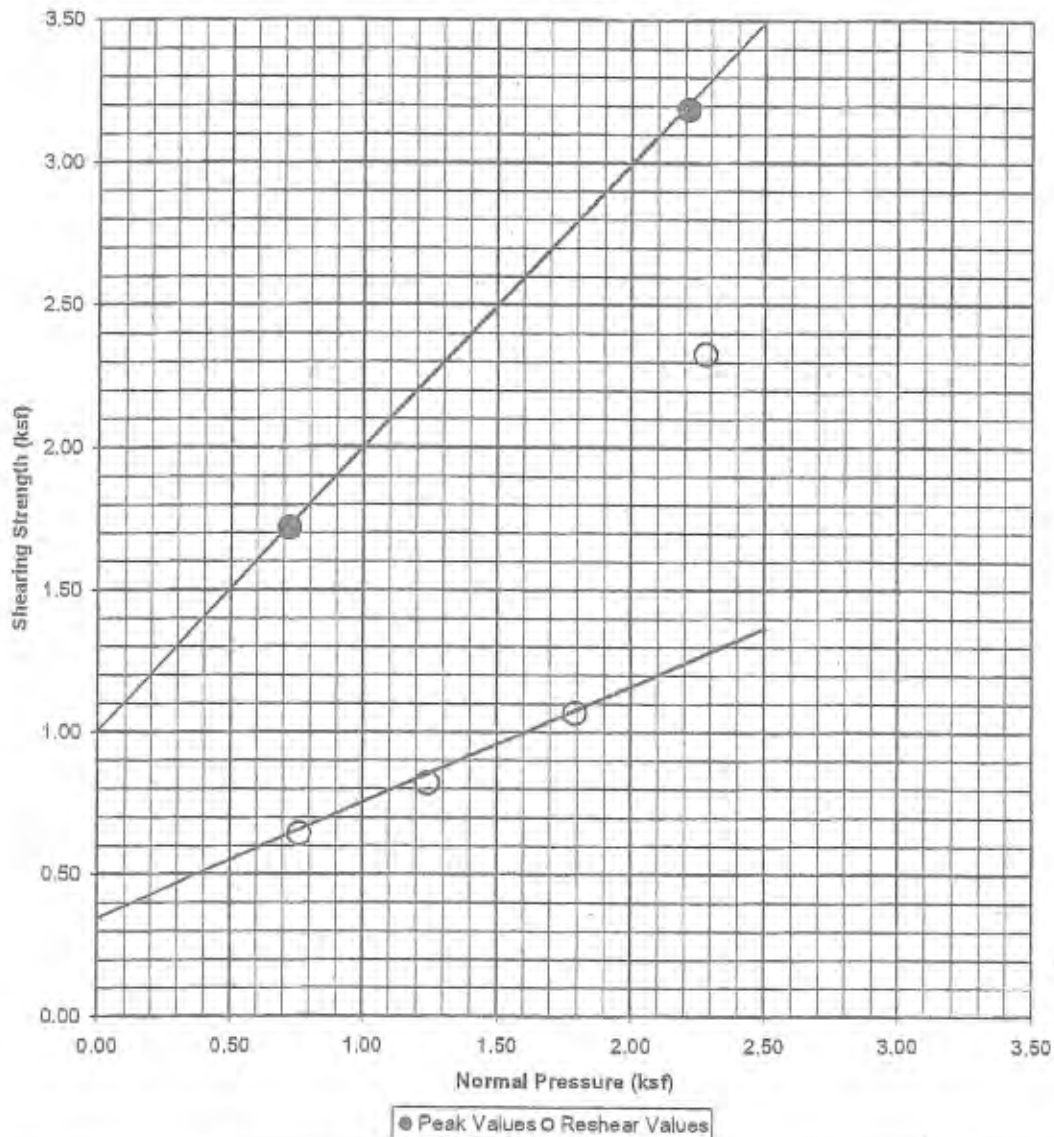
C(psf): 340 Phi (degrees): 23.5

Undisturbed Natural Shear-Saturated

Dark-brown, slightly sandy, CLAY, w/ rock fragments.

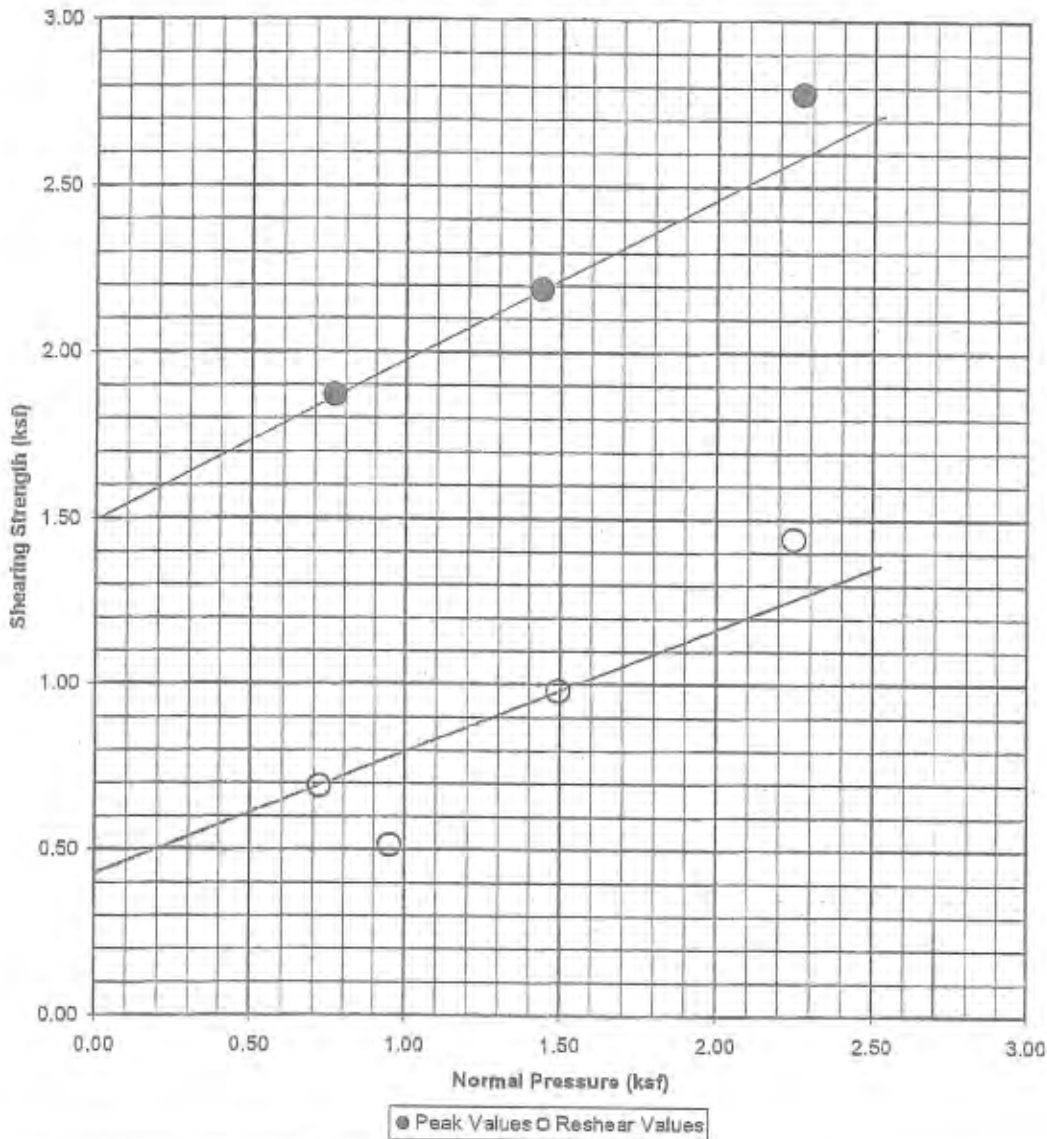
C(psf): 430 Phi (degrees): 21.5

Undisturbed Natural Shear-Saturated

Dark-brown, sandy CLAY.

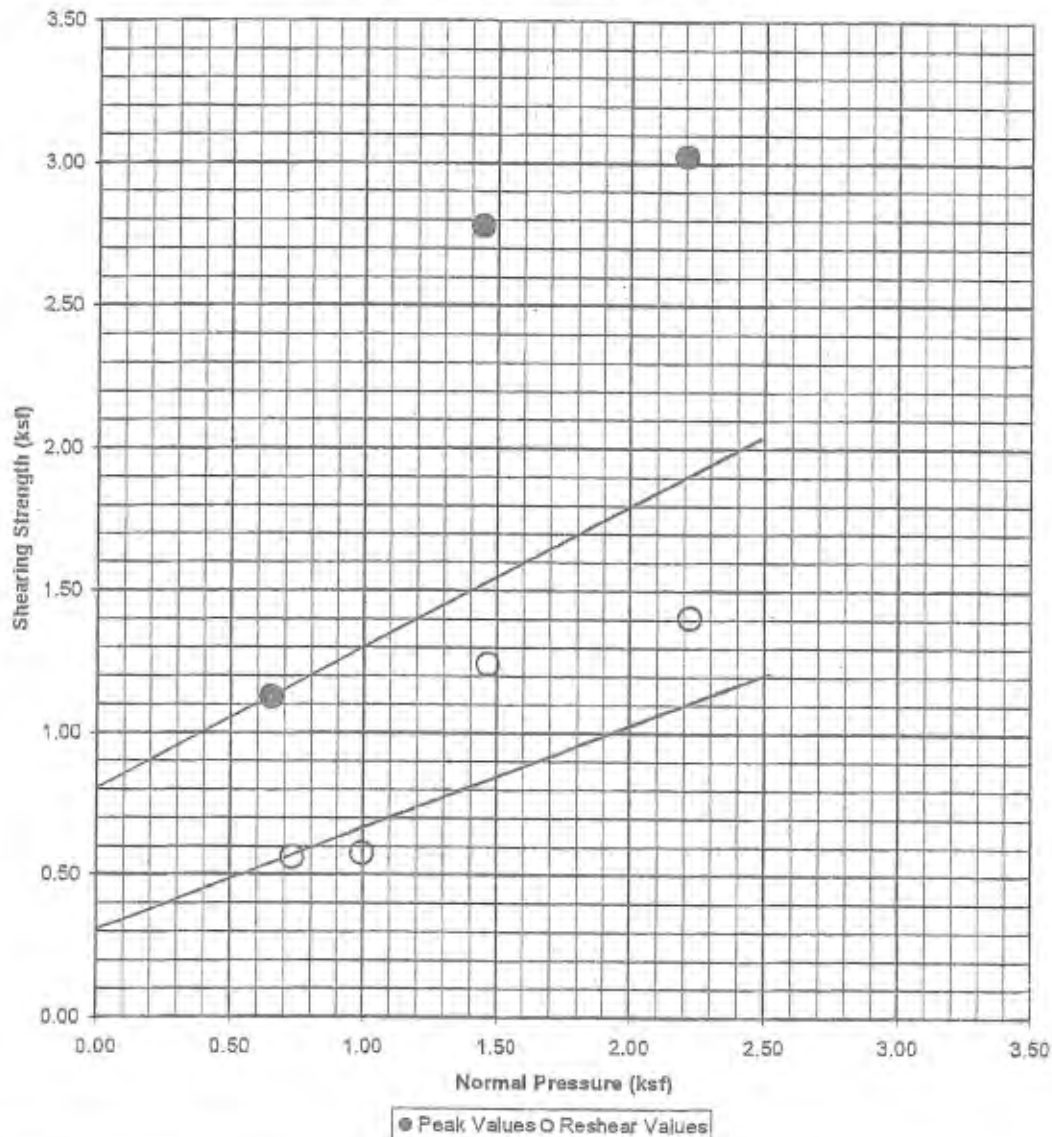
C(psf): 300 Phi (degrees): 21.0

Undisturbed Natural Shear-Saturated

Orange-brown, silty CLAY W/ sandy SILT layers.

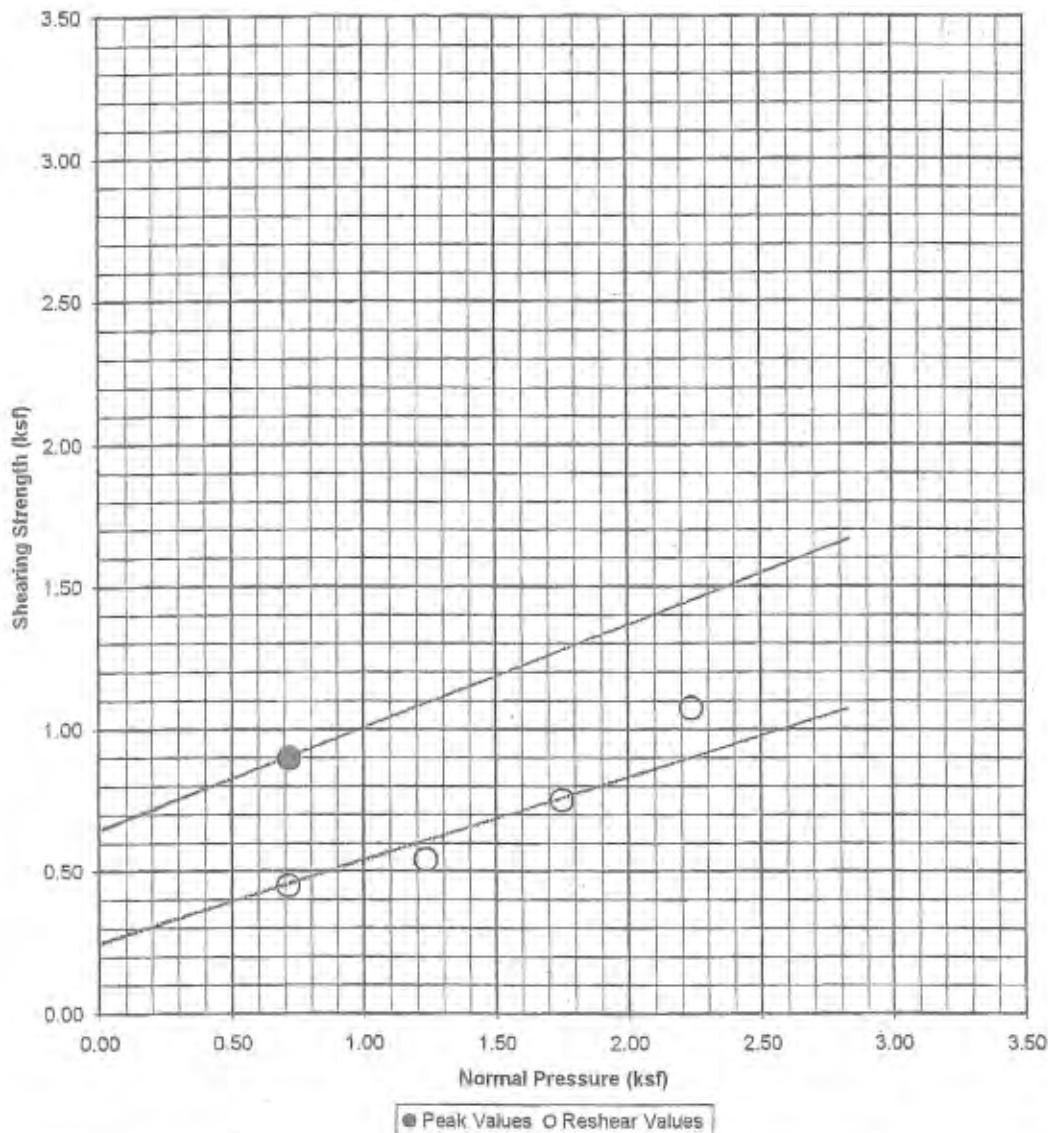
C(psf): 250 Phi (degrees): 17.0

Undisturbed Natural Shear-Saturated

Dark-brown, slightly sandy, CLAY, w/ rock fragments.

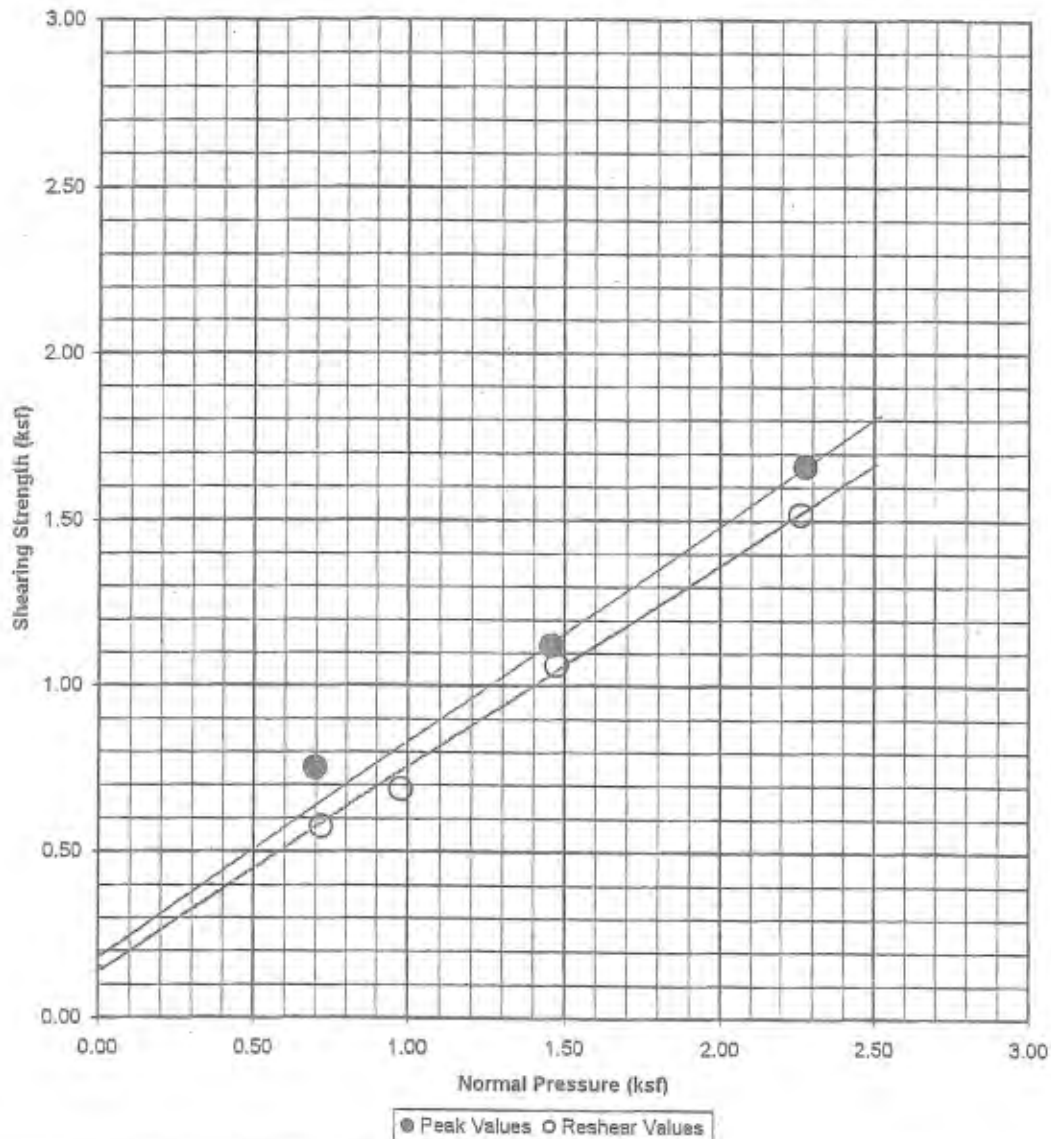
C(psf): 150 Phi (degrees): 33.0

Sample Remolded to 90% Relative Density, Saturated.  
Remolded Dry Density = 92.7 PCF

Dark-brown, sandy CLAY.
