**PALO COMADO RANCH**  
**(Shuken Residence, 6511 Chesebro Road)**  
**Addendum to the Environmental Impact Report**

**CITY OF AGOURA HILLS**  
30001 Ladyface Court  
Agoura Hills, CA 91301  
Valerie Darbouze, Associate Planner

**ENVICOM CORPORATION**  
4165 E. Thousand Oaks Blvd. Suite 290  
Westlake Village, CA 91362  
Tim Rosenstein, Environmental Analyst

October 2021

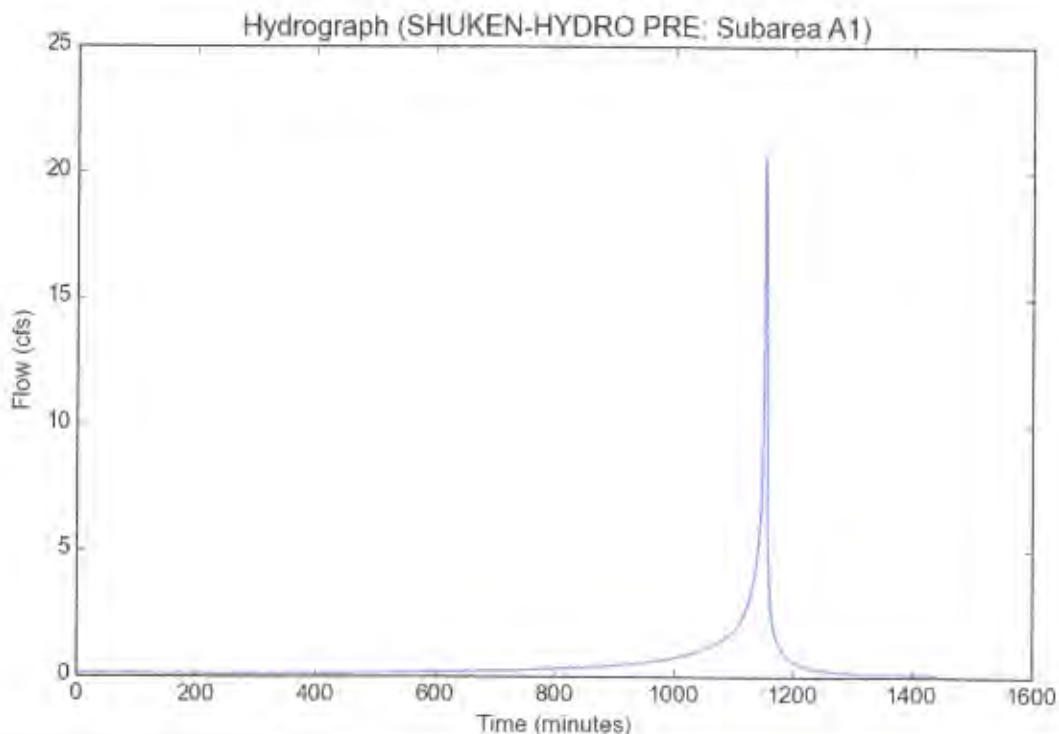
Modeled (50-yr) Rainfall Depth (in)	7.2
Peak Intensity (in/hr)	4.2957
Undeveloped Runoff Coefficient (Cu)	0.8893
Developed Runoff Coefficient (Cd)	0.8894
Time of Concentration (min)	5.0
Clear Peak Flow Rate (cfs)	20.632
Burned Peak Flow Rate (cfs)	20.632
24-Hr Clear Runoff Volume (ac-ft)	0.9912
24-Hr Clear Runoff Volume (cu-ft)	43177.4997

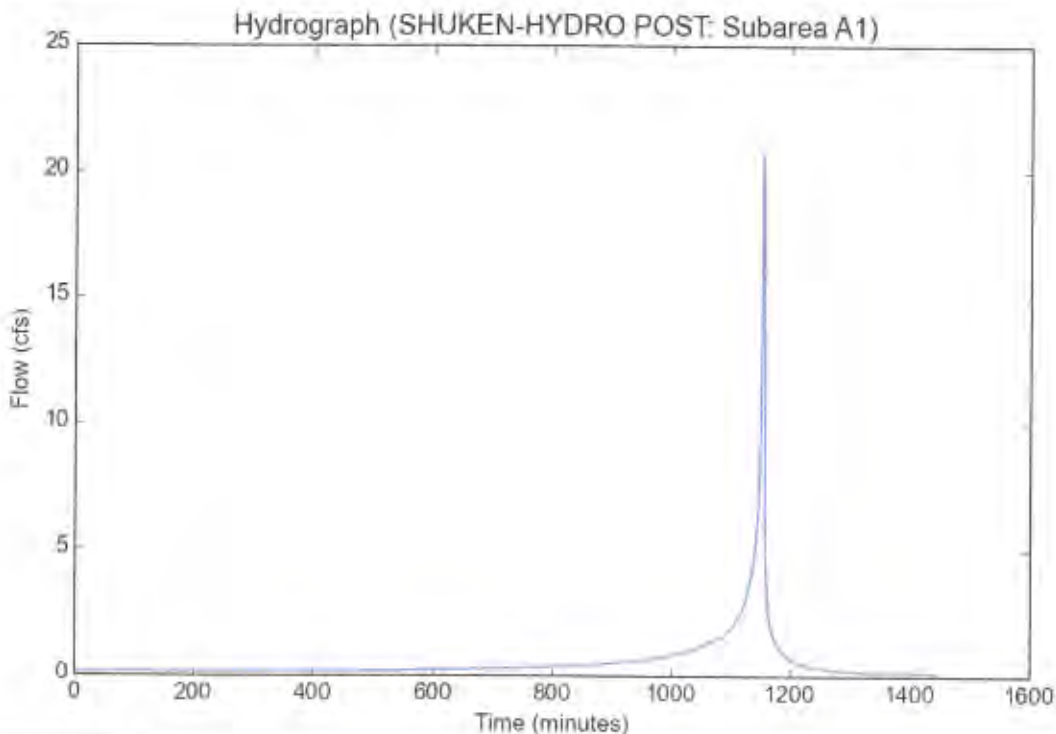
## Peak Flow Hydrologic Analysis

Modeled (50-yr) Rainfall Depth (in)	7.2
Peak Intensity (in/hr)	4.2957
Undeveloped Runoff Coefficient (Cu)	0.8893
Developed Runoff Coefficient (Cd)	0.8899
Time of Concentration (min)	5.0
Clear Peak Flow Rate (cfs)	20.6434
Burned Peak Flow Rate (cfs)	20.6434
24-Hr Clear Runoff Volume (ac-ft)	1.0795
24-Hr Clear Runoff Volume (cu-ft)	47024.4815

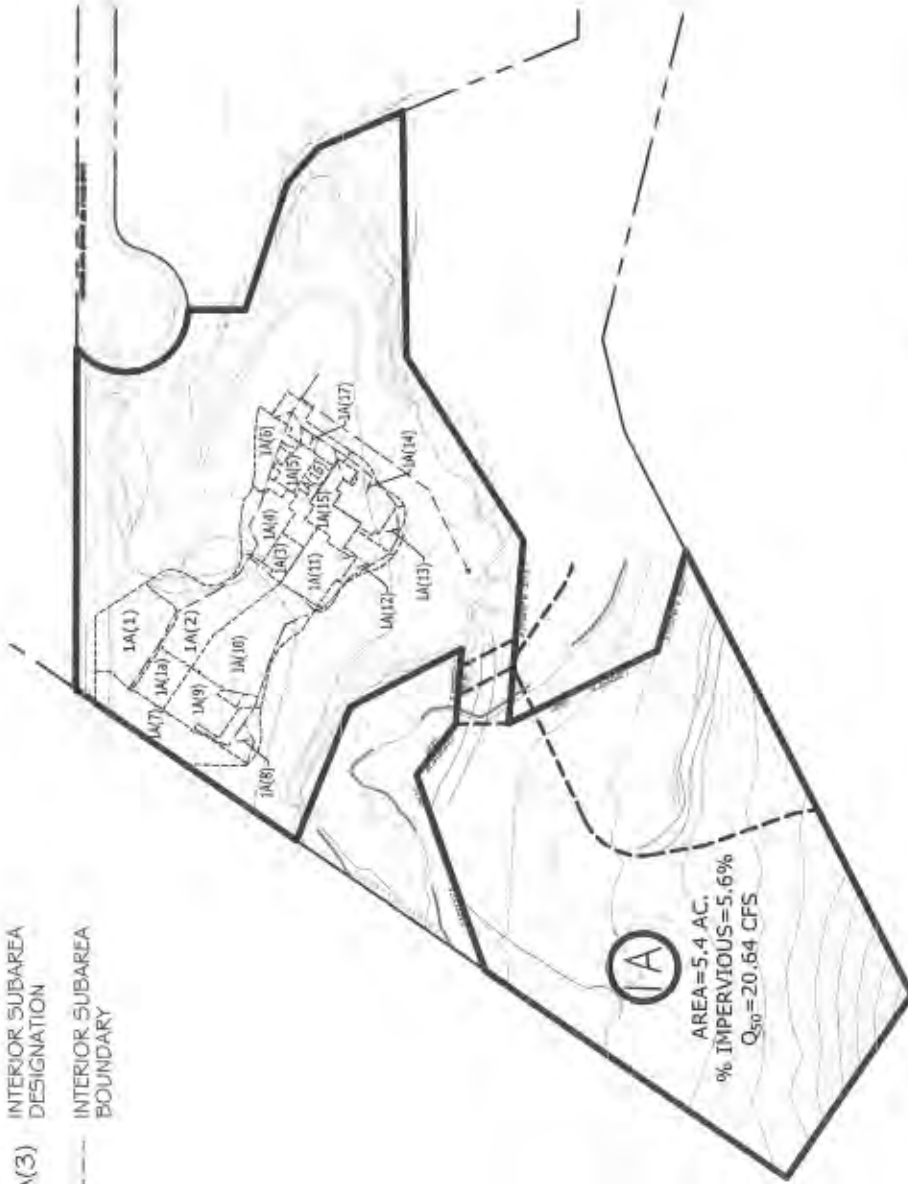
INTERIOR SUBAREA BOUNDARY

AREA=5.4 AC.  
% IMPERVIOUS=5.6%  
 $Q_{50} = 20.64$  CFS

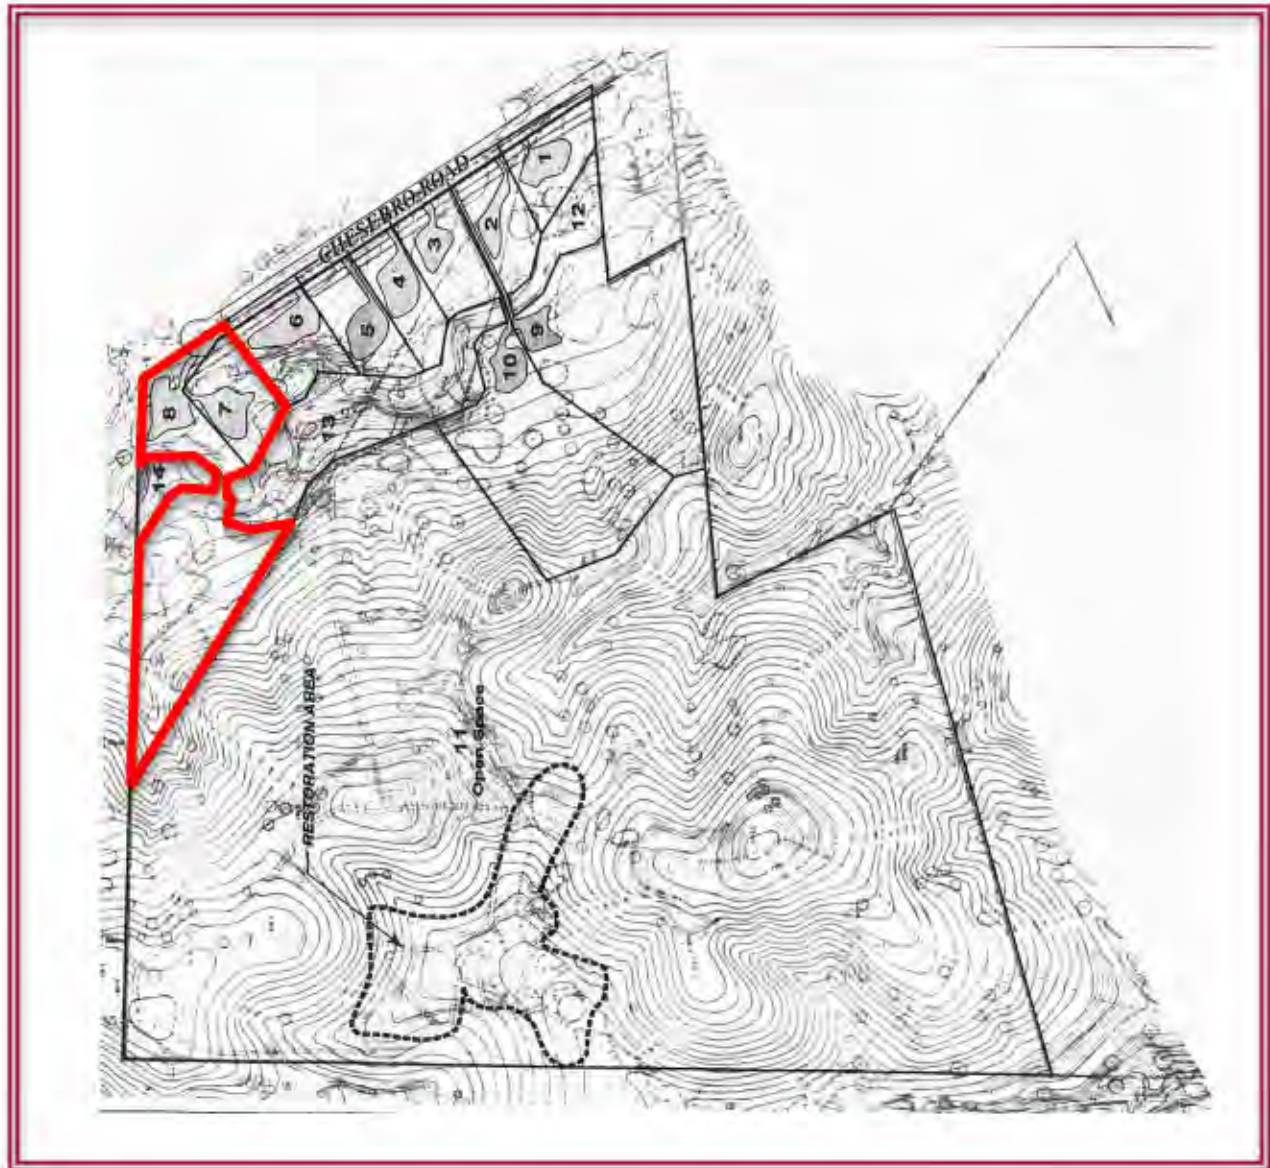
The proposed project is located within Lots 7 and 8 (outline red) as identified by the Palo Comado Ranch EIR. The proposed development appears to roughly correspond to the pad areas that are highlighted.

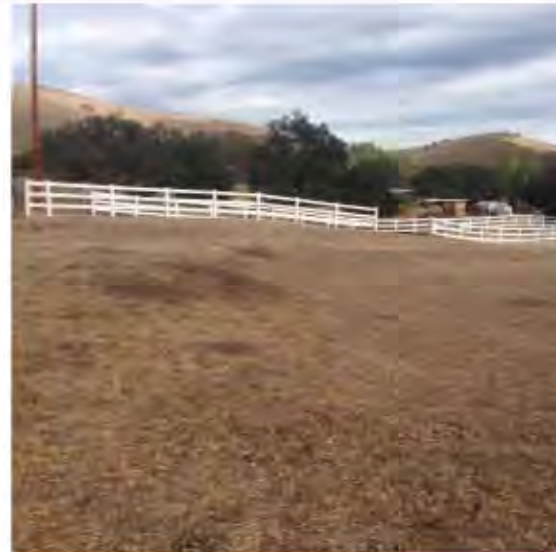
Photo 1  
Description: Development Envelope/Ruderal Habitat  
View: Southeast

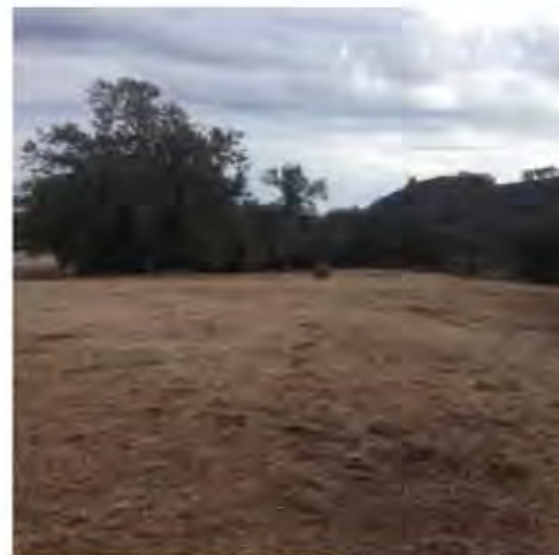
Photo 2  
Description: Development Envelope/Ruderal Habitat (Foreground)  
Southern Coast Live Oak Forest (background)  
View: South

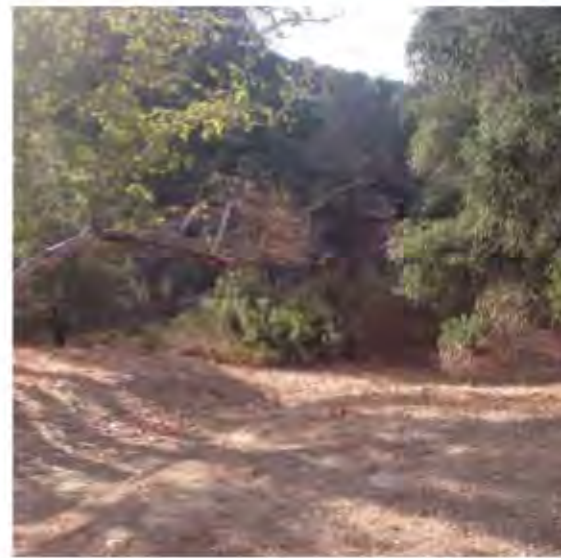
Photo 3

Description: Ruderal Habitat (foreground)  
Southern Coast Live Oak Forest (midground)  
Coastal Sage Scrub (center, background)

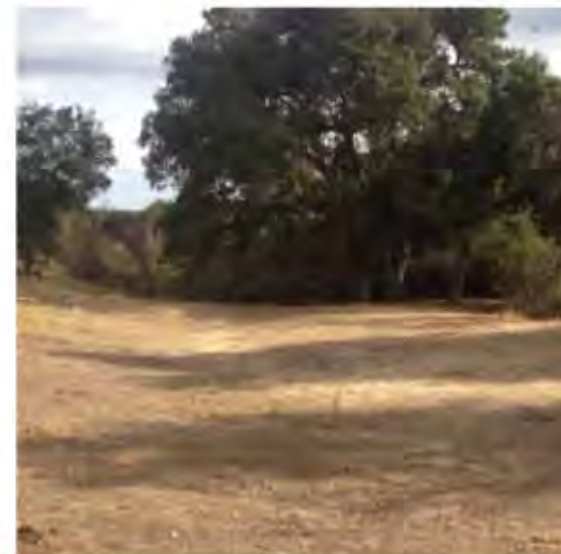
Photo 4

Description: Ruderal Habitat (foreground)  
Southern Coast Live Oak Forest  
(background)

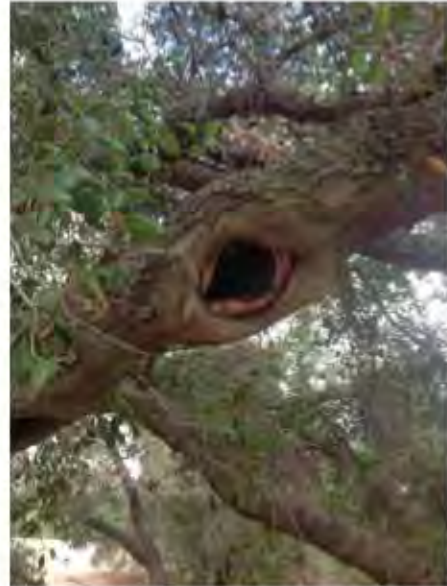
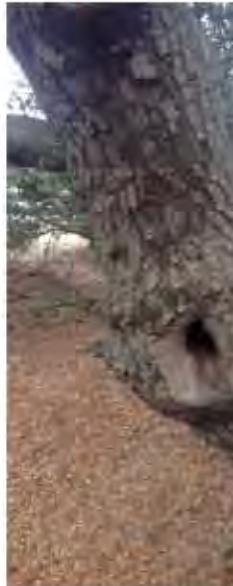
Photo 7 & 8

Description: Cavities suitable for nesting birds and roosting bats

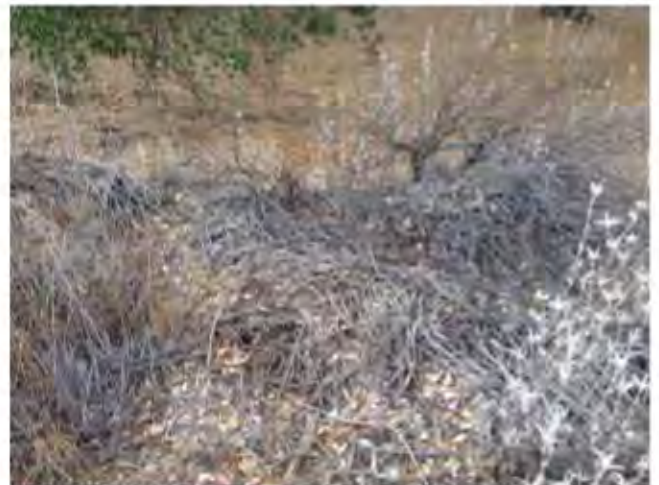
Photo 9

Description: Woodrat House

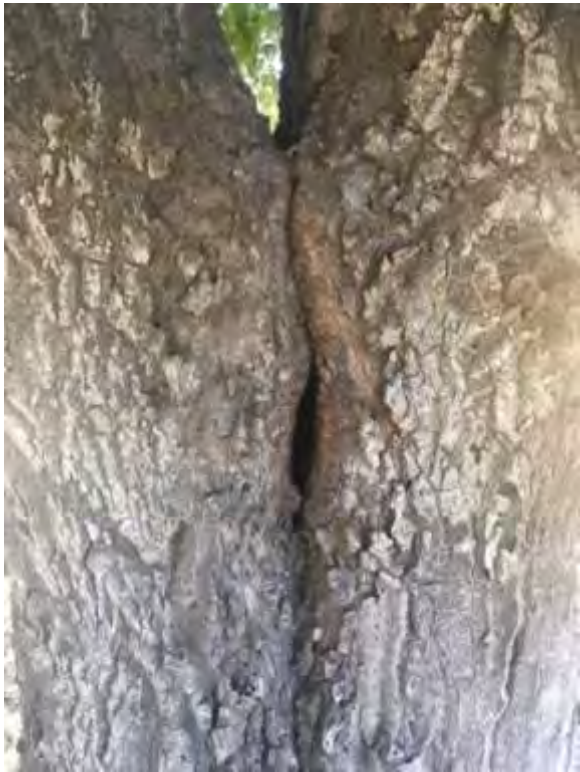
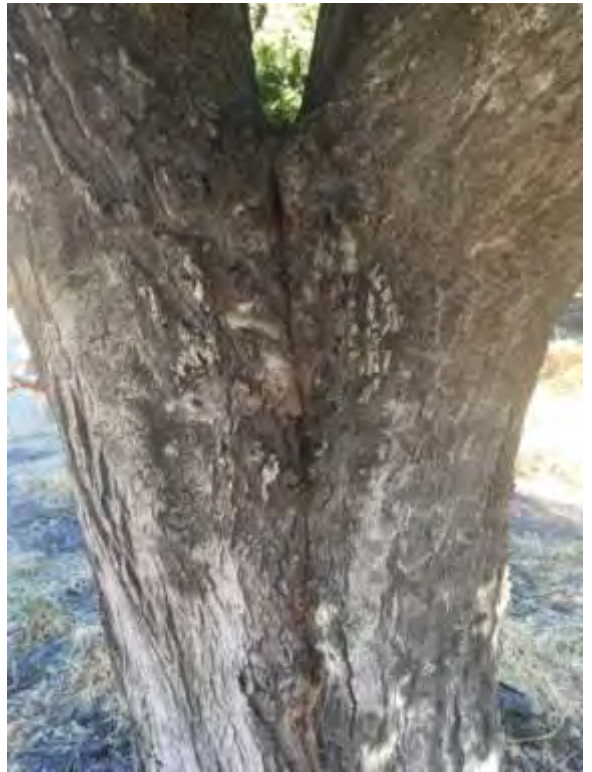
Oak tree 23 – north and south sides of the trunk.

- ii. The Project proposes to remove only one coast live oak tree, No. 23, as referred to in the Oak Tree Report, because it has a cavity dividing the trunk and is in structural decline, making it at risk of splitting and falling onto the residence. The Project would also encroach into the protected zone of 3 oak trees, though as explained in the Oak Tree Report the encroachments are at the edge of the trees' protected zone and would amount to only 3.2% of the cumulative protected zone area being encroached upon, and therefore impacts from encroachment are less than significant. The Oak Tree Report recommends mitigation for the removed oak tree. However, the City's Oak Tree Permit process already contains approved standard mitigation measures for removal of an oak. The removed oak tree will be replaced at a rate determined by the City pursuant to the Oak Tree Permit, which will reduce the impact to less than significant. In addition, the Oak Tree Preservation Guidelines, Appendix A of the Municipal Code, implemented via the Oak Tree Permit process, will ensure proper treatment of oaks on the property during construction. Therefore, impacts to oaks will not exceed those assumed by the Certified EIR. The location of tree No. 23 and photos are provided in **Figure 6, Location of Tree #23**.

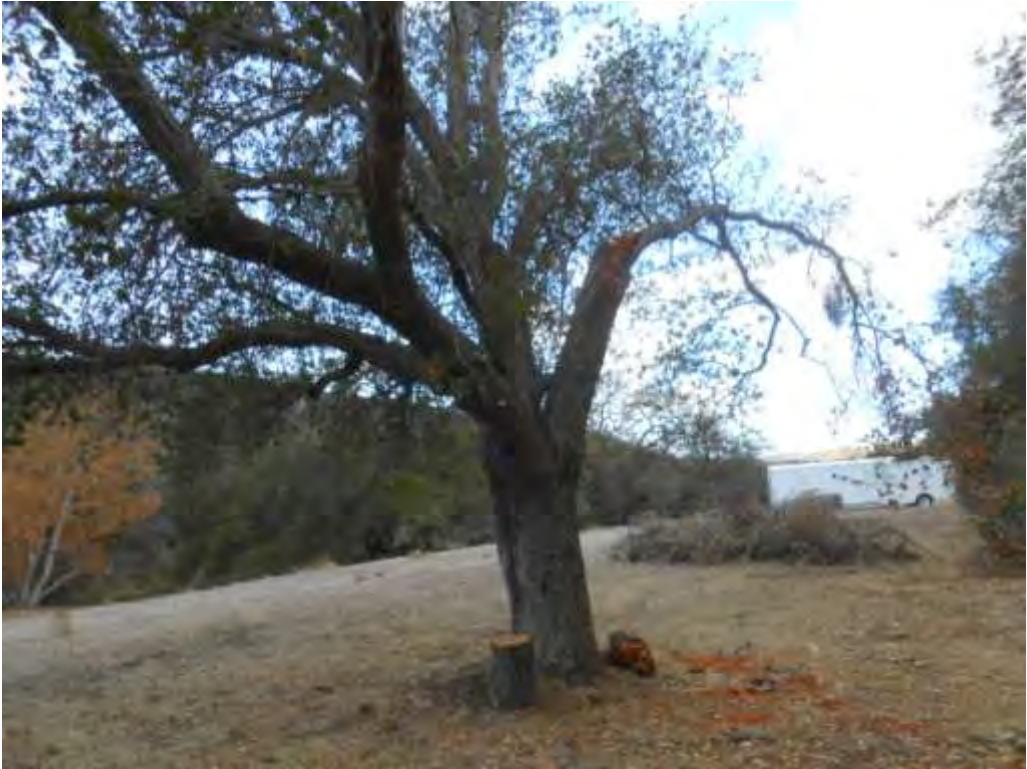
Oak tree 23 – has recovered because of recent rains but remains structurally weak and risky. Photo taken 11/1/19.

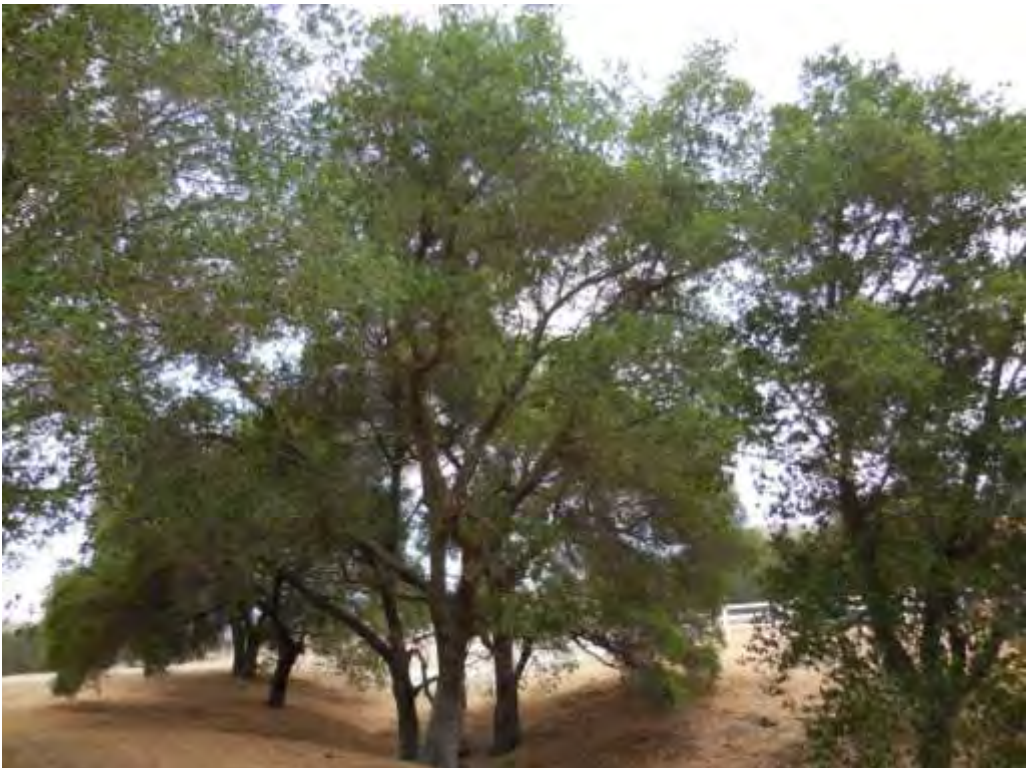
Oak tree 23 – photo taken on July 11, 2014. Large branch spontaneously broke as it had been declining due to drought stress.

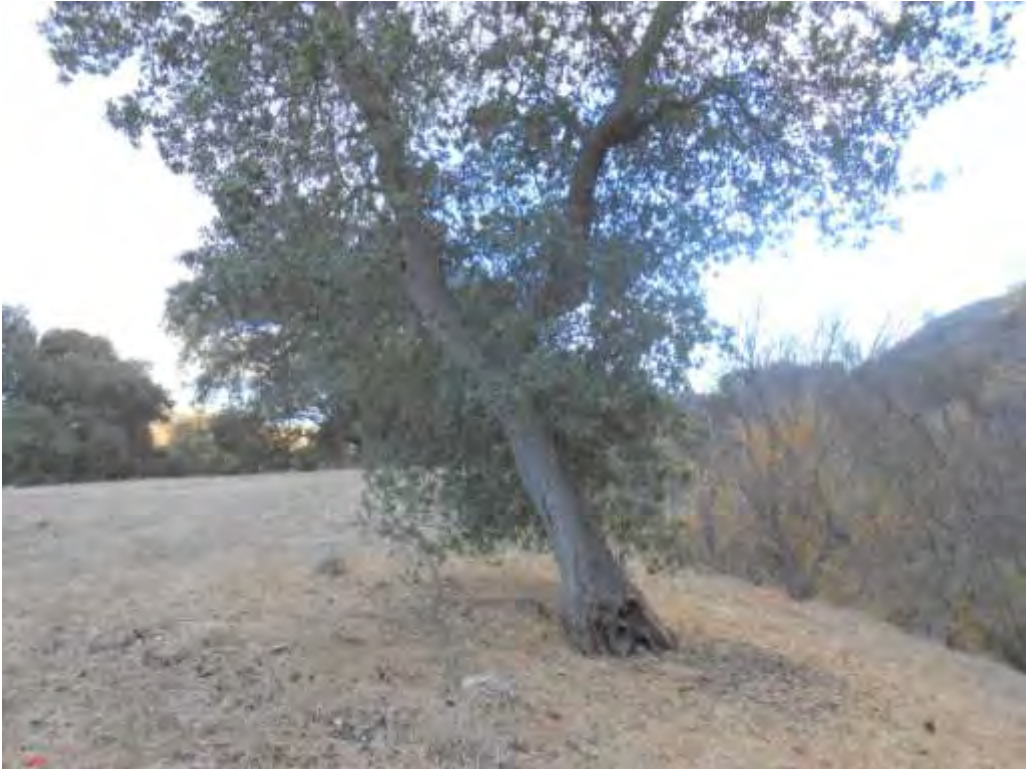
Oak tree 30 – This photo was taken on July 11, 2014. As of 2015, the tree was dead. The tree to its right was not tagged because it was dead when this photo was taken.

REMARKS: Badly damaged. DEAD AS OF 2015.

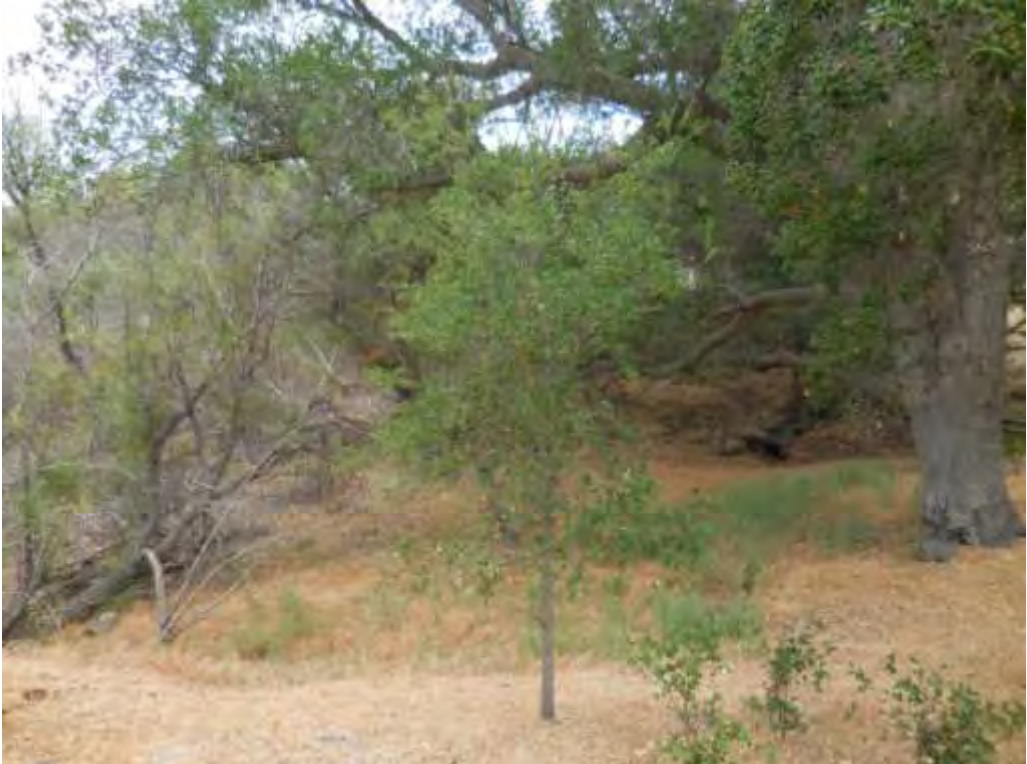
Oak tree 31 – This photo was taken in December of 2015 and shows the large cavity at the base of the trunk.

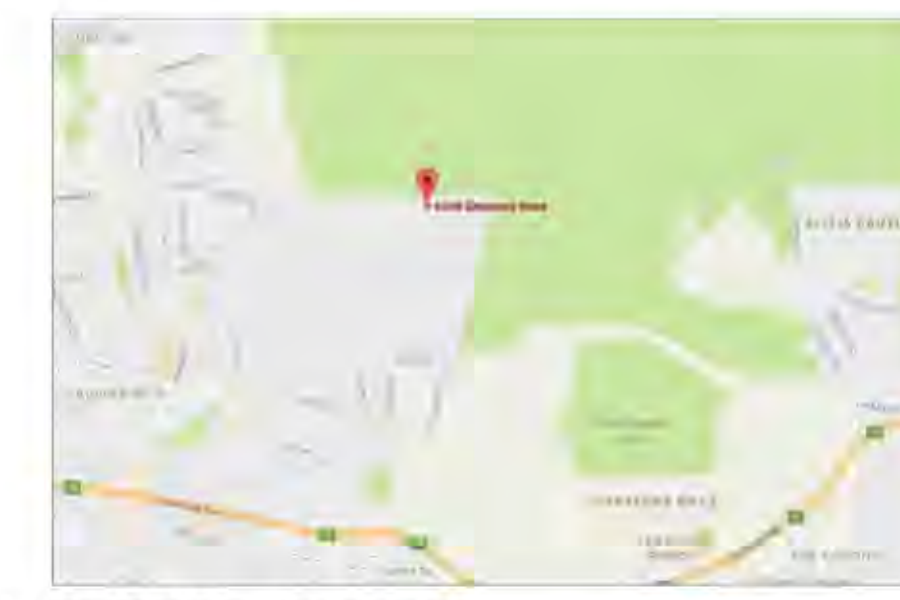
# OAK TREE LOCATION MAP

**SITE PLAN**

SCALE: 1/32" = 1'-0"

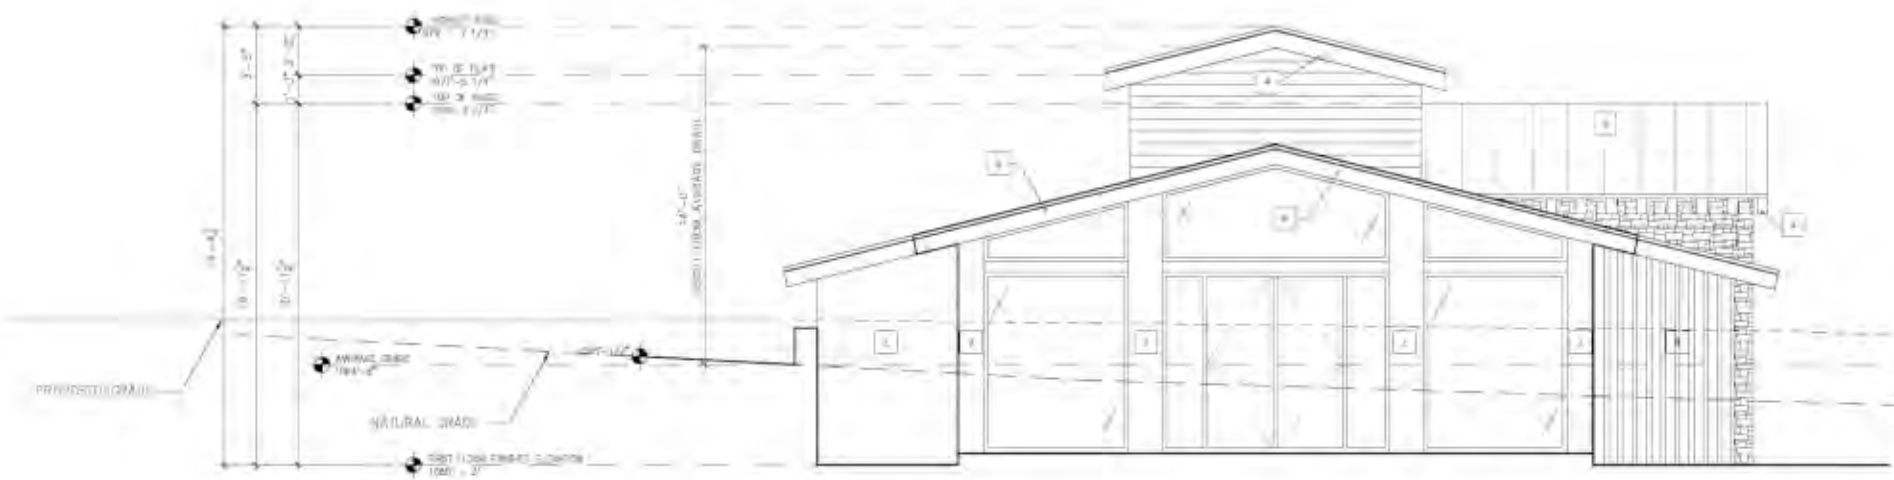
**WEST GARAGE ELEVATION**

- 1. STUCCO
- 2. 1/2" GYPSUM BOARD
- 3. 1/2" GYPSUM BOARD
- 4. 1/2" GYPSUM BOARD
- 5. 1/2" GYPSUM BOARD
- 6. 1/2" GYPSUM BOARD
- 7. 1/2" GYPSUM BOARD
- 8. 1/2" GYPSUM BOARD

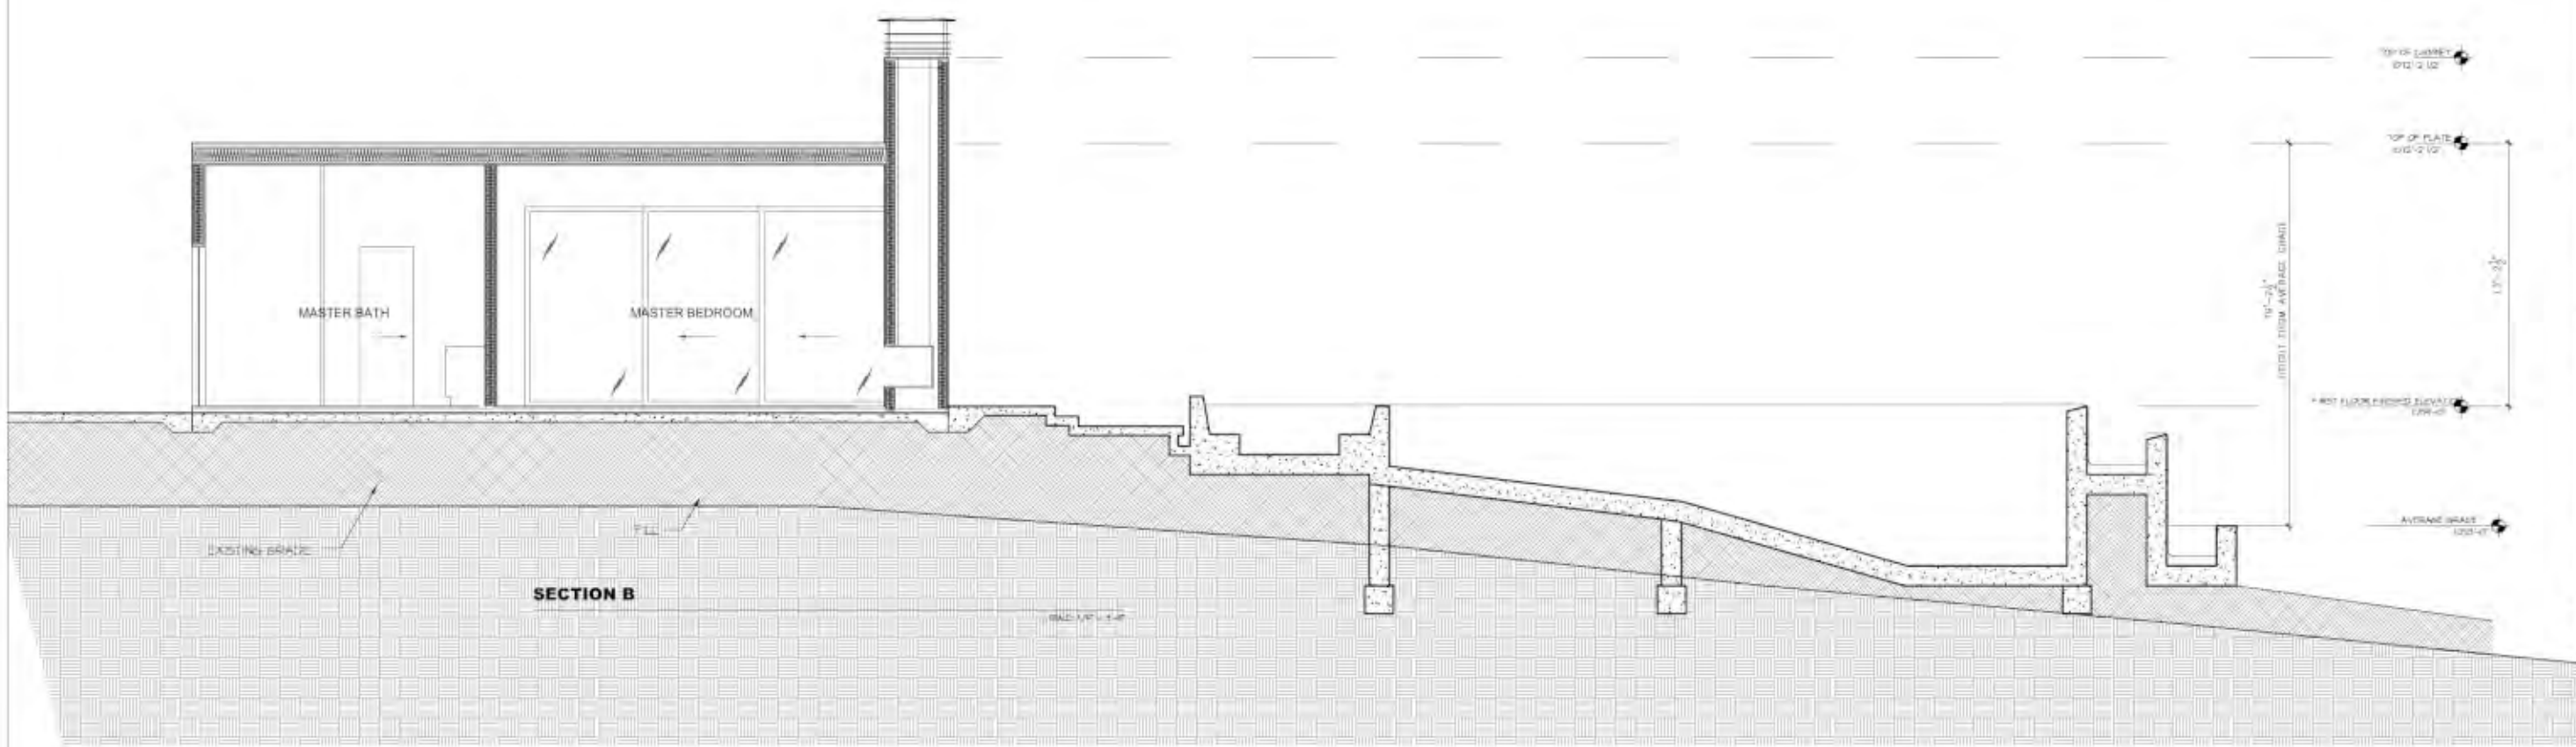
SECTION B

SCALE: 1/4" = 1'-0"

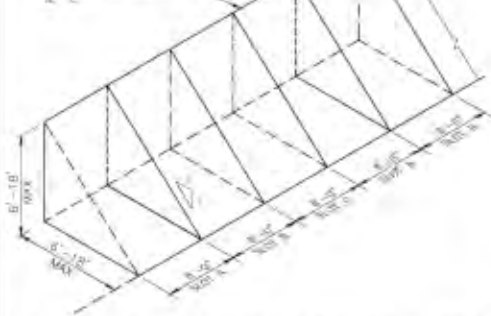
DETAIL NO. 12 ABC SLOT CUT DETAIL AND NOTES. N.T.S.

NOTE: SLOT "A" SHORING SHALL BE COMPLETED BEFORE PROCEEDING TO SLOTS "B" & "C".

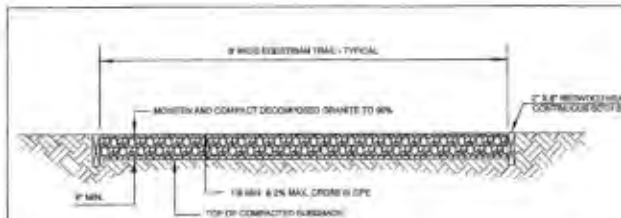
DETAIL NO. 11 CITY OF AGOURA HILLS STANDARD - EQUESTRIAN TRAIL DETAILS. N.T.S.

NOTE: NO PESTICIDES OR HERBICIDES TO BE USED TO TREAT TOP OR SUBGRADE SURFACES. TRAIL SURFACE DETAIL - RAILING IS SHOWN HERE UNDER IN TWO VIEWS.
