## **Appendix E**

Cultural Resources Phase I Assessment

**Subj: Cultural Resources Phase I Assessment for Ladyface Vista Office Project  
(Envicom Project # 2021-038-01)**

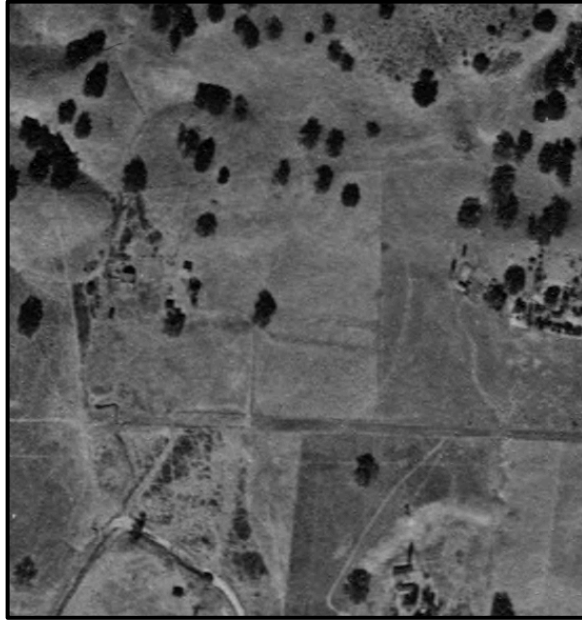
*Figure 5: The Project area in 1945 image, showing the Project property (center) (UCSB Historic Aerial Image Database).*

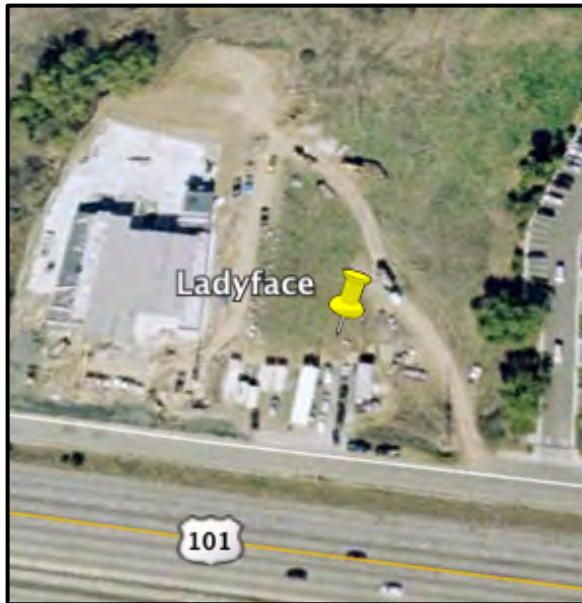
*Figure 6: Google Earth Image of the Project property in 2006, showing impacts from the construction of the fire station to the west.*

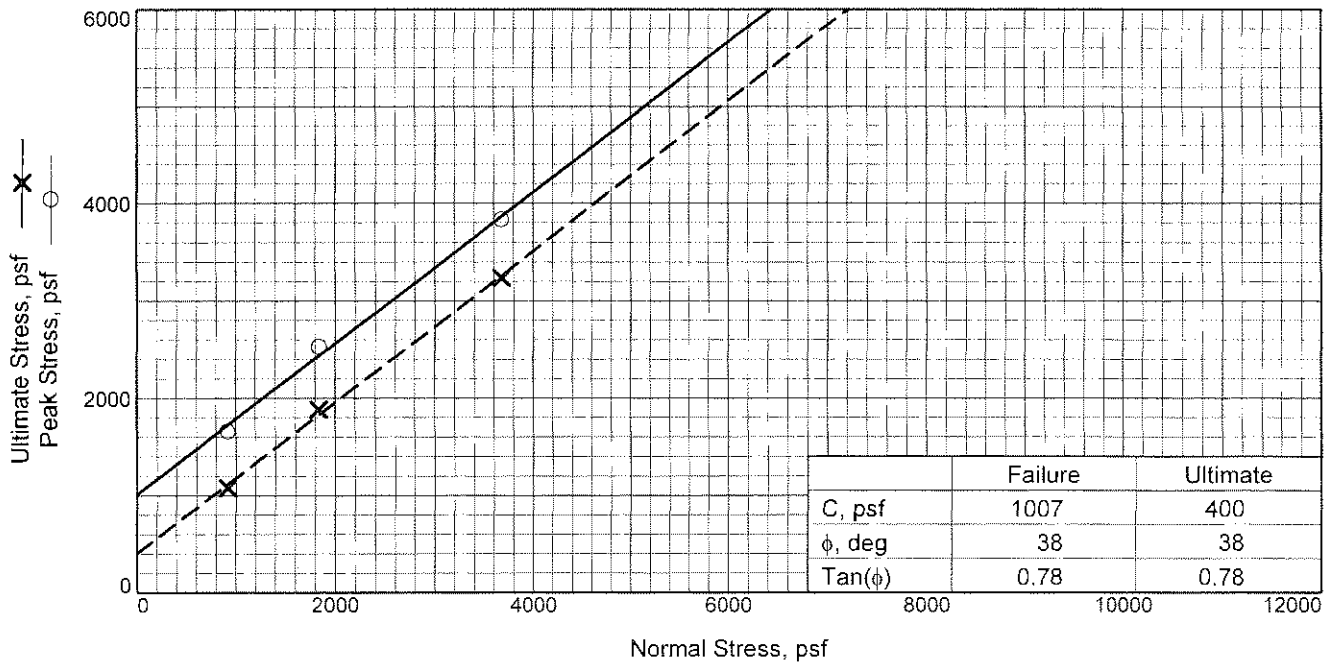
Sample No.	1	2	3	
Initial	Water Content, %	25.3	25.3	25.3
	Dry Density, pcf	93.9	94.5	94.5
	Saturation, %	88.0	89.2	89.2
	Void Ratio	0.7619	0.7514	0.7514
	Diameter, in.	2.62	2.62	2.62
	Height, in.	1.00	1.00	1.00
At Test	Water Content, %	30.5	28.3	24.2
	Dry Density, pcf	93.9	94.5	94.5
	Saturation, %	106.1	99.9	85.3
	Void Ratio	0.7619	0.7514	0.7514
	Diameter, in.	2.62	2.62	2.62
	Height, in.	1.00	1.00	1.00
Normal Stress, psf	920	1840	3680	
Peak Stress, psf	1658	2527	3830	
Strain, %	4.2	4.2	5.7	
Ultimate Stress, psf	1076	1882	3235	
Strain, %	9.9	9.9	9.9	
Strain rate, in./min.	0.02	0.02	0.02

**Sample Type:** Undisturbed, Saturated  
**Description:** Topanga Fm. (Tt): Lt. olive brown SILTSTONE/CLAYSTONE  
 LL=            PL=            PI=  
**Assumed Specific Gravity=** 2.65  
**Remarks:** Machine #1
