Phase I Environmental Site Assessment Report

**PHASE I ENVIRONMENTAL SITE ASSESSMENT REPORT FOR
VACANT COMMERCIAL PROPERTY LOCATED AT 29541 AND 29555
CANWOOD STREET, IN THE CITY OF AGOURA HILLS, CALIFORNIA**

CEC Project Number 20-2198
October 23, 2020

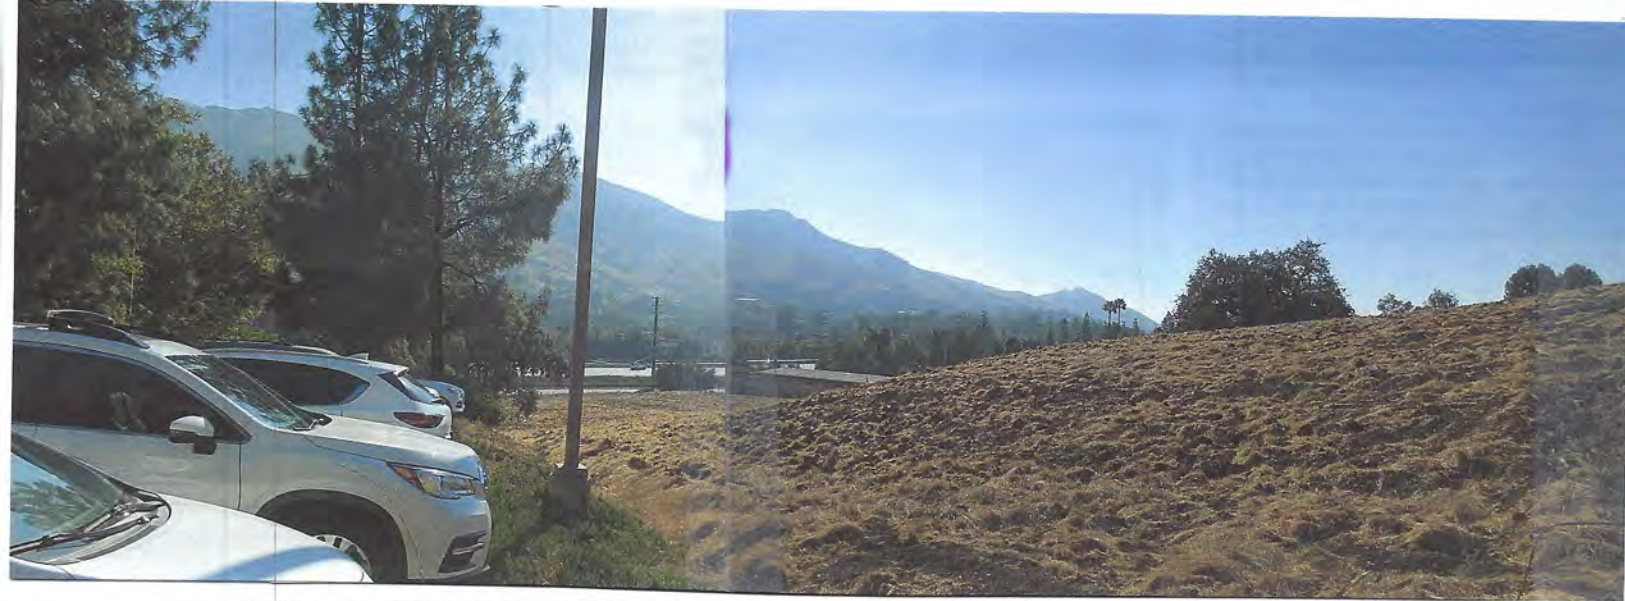
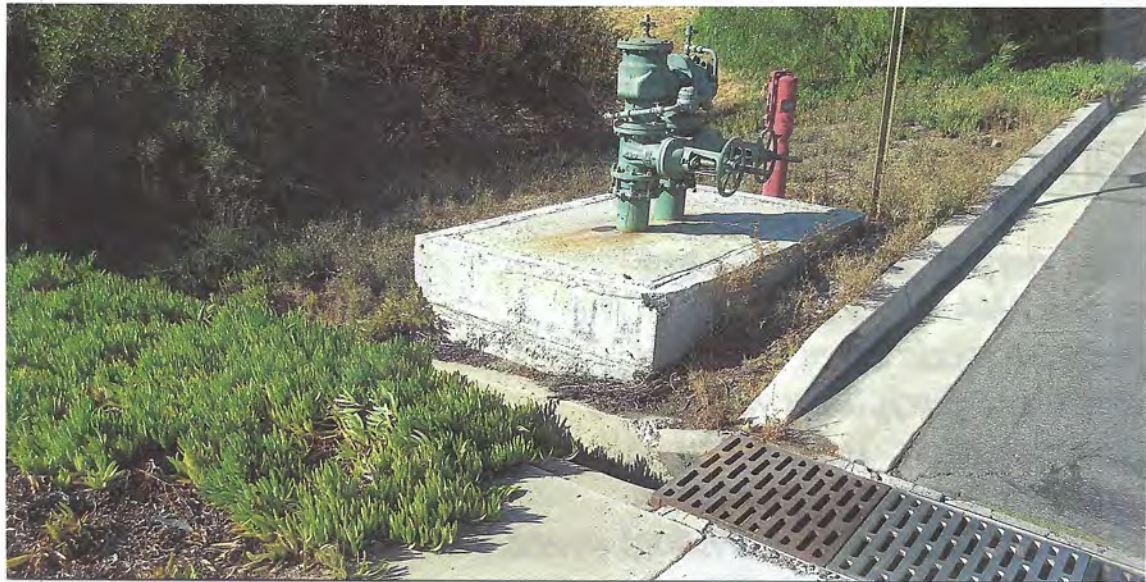
Photographs 5, 6 and 7 - Southerly to southwesterly view of the site and adjacent properties, as seen from the same adjacent-east location; view of municipal-water fixtures and storm drain on the adjacent lot; and view of an on-site storm drain, as observed along the southern edge of the subject site.

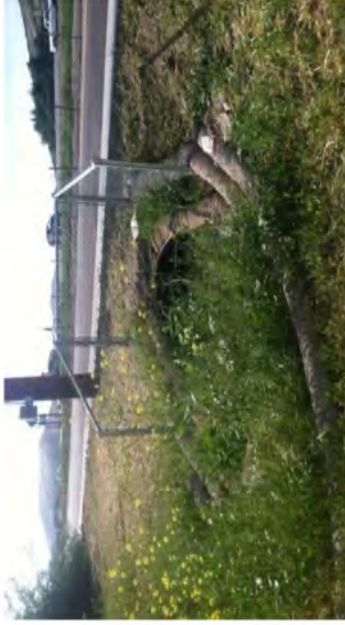
Photograph 5. Drainage culvert on the southeastern corner of the subject property, facing south.

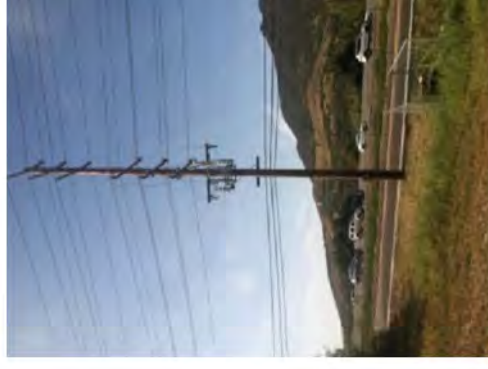
Photograph 6. View of the pole mounted transformer adjacent to the southeastern corner of the subject property, facing south.

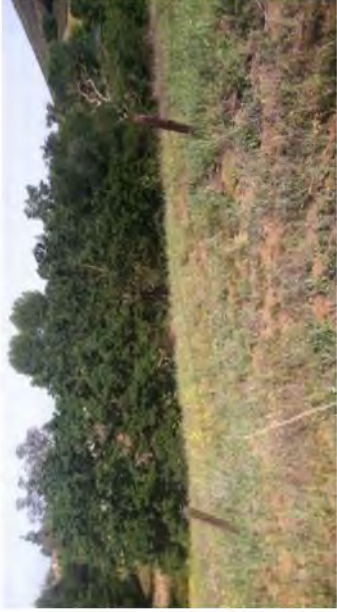
Photograph 7. View of the remains of a wire fence on the northwestern border of the subject property, facing west.
