Biological and Aquatic Resources Assessment
Memo

To: Ms. Jessie Fan, Kimley-Horn
From: Mr. Keoni Calantas, Rocks Biological Consulting
Date: February 1, 2022
Subject: Kanan Road/Agoura Road Ultimate Intersection Improvements Project – Biological and Aquatic Resources Assessment Memo

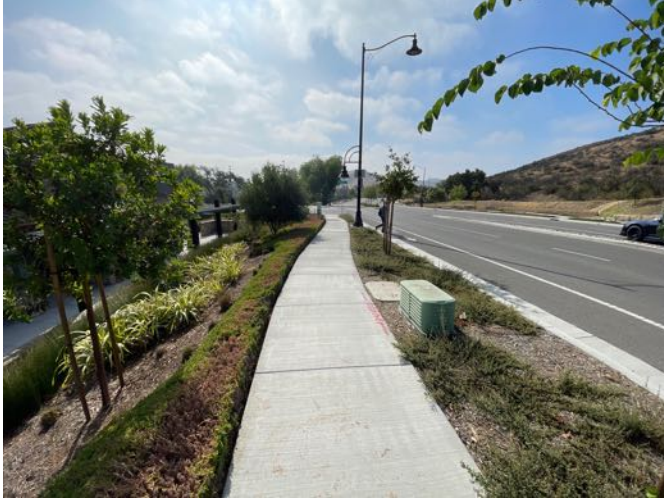
Photo 1. Overview of the northern segment of the Roadside portion of the survey area, dominated by ornamental vegetation and developed land, facing east (34.144590, -118.767299).

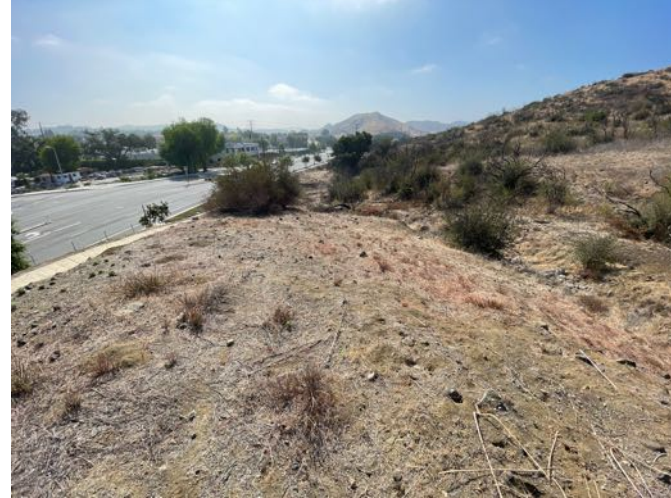
Photo 2. Overview of the southern segment of the Roadside portion of the survey area, dominated by disturbed habitat with some valley oak (*Quercus lobata*) just south of the study area boundary, facing east (34.14246, -118.767534).

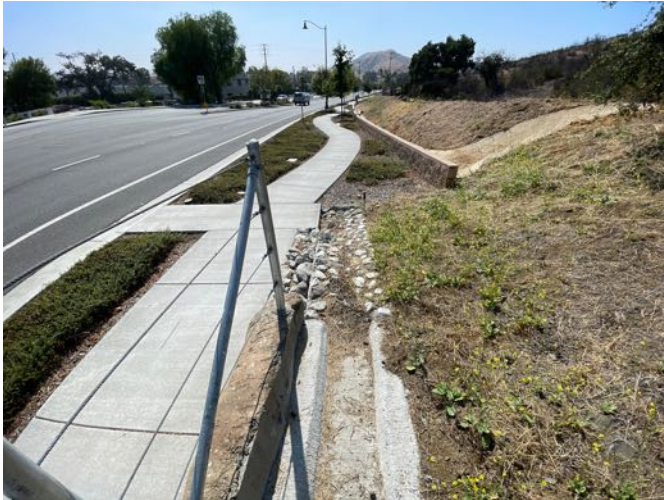
Two concrete ditches and one earthen aquatic resource/drainage occur within the southern segment of the Roadside portion of the project site, south of Agoura Road (Figure 2a). The northern concrete ditch originates west of the Roadside portion of the project site, travels east into the project site, then outlets into a small culvert/storm drain under a sidewalk. The southern concrete ditch also originates west of the Roadside portion of the project site. Once entering the project site, the southern concrete ditch travels east, then gradually turns north before continuing east and exiting the eastern boundary of the Roadside portion of the project site.

Based on the lack of hydrophytic vegetation and wetland hydrology indicators in the concrete ditches, these features are not anticipated to meet the appropriate wetland parameters to qualify as wetland waters of the U.S./State per the Corps and the RWQCB or associated wetland potentially jurisdictional by the CDFW. The concrete ditches would also not qualify as non-wetland waters of the U.S. per the Corps as the concrete ditches appeared to be excavated in uplands (i.e., did not relocate natural drainages or excavated tributaries) based on the field assessment and an initial review of Google Earth Pro⁹ and NetrOnline Historic Aerials¹⁰ aerial imagery. Specifically, the concrete ditches appear to have been constructed on site between May 2015 and October 2016 to manage stormwater runoff from the surrounding developed/paved areas.¹¹ There were no natural features within this area at least as far back as 1947 (i.e., the earliest aerial image reviewed).¹² Thus, based on the current pre-2015 definition of “waters of the U.S.,” which was further defined by the 2001 *Solid Waste Agency of Northern Cook County* (SWANCC) decision and the 2006 *Rapanos* decisions, the concrete ditches should be considered ditches “excavated wholly in and draining only uplands” that do “not carry a relatively permanent flow of water.”¹³

Photo 3. View of the two potentially jurisdictional concrete ditches within the southern segment of the Roadside portion of the survey area, facing east (northern ditch in foreground, southern ditch in background) (34.144305, -118.767273).

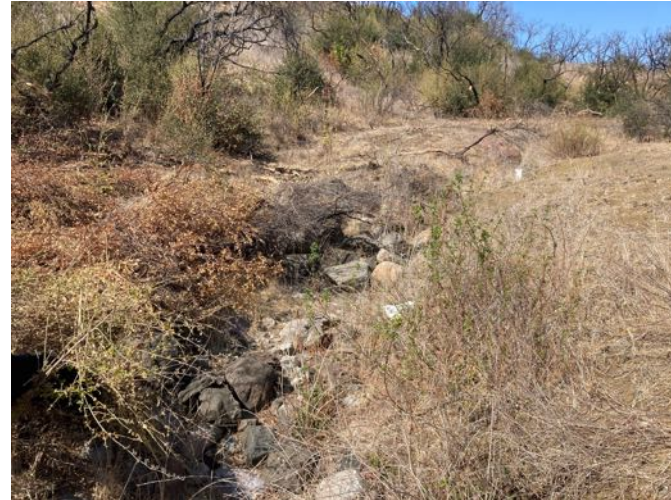
The earthen aquatic resource/drainage originates southwest of the Roadside portion of the project site and briefly enters and exits the project site along the southern boundary. The earthen aquatic resource/drainage occurs within an area mapped as disturbed habitat with some valley oak (*Quercus lobata*). Based on field observations, flows from the southern concrete ditch and the earthen aquatic resource/drainage eventually outlet into a culvert located east of the project site. No standing water was observed in the two concrete ditches or one earthen drainage.

Based on the lack of hydrophytic vegetation observed within the earthen aquatic resource/drainage within the Roadside portion of the project site during the initial assessments, this feature is not anticipated to meet the appropriate wetland parameters to qualify as a wetland waters of the U.S./State per the Corps and the RWQCB, respectively, or associated wetland jurisdictional by the CDFW; however, RBC anticipates a formal aquatic resources delineation would find that this resource qualifies as a non-wetland waters of the U.S./State jurisdictional by the Corps and RWQCB, respectively, and streambed jurisdictional by the CDFW (Figure 2a).

Photo 4. View of the potentially jurisdictional aquatic resource/drainage located in the southern segment of the Roadside portion of the survey area, facing southwest (34.144170, -118.767242).

Because project improvements are proposed in or near the mapped potentially jurisdictional aquatic resources as seen in Figures 2a – 2b, a formal, project-specific aquatic resources delineation and reporting per Corps, RWQCB, and CDFW standards and guidelines and further coordination with the Corps, RWQCB, and CDFW would be required to receive a determination from the regulatory agencies of their concurrence with the findings related to potential aquatic resources on site. Jurisdictional determinations should be made per the latest applicable regulatory requirements and/or guidance.

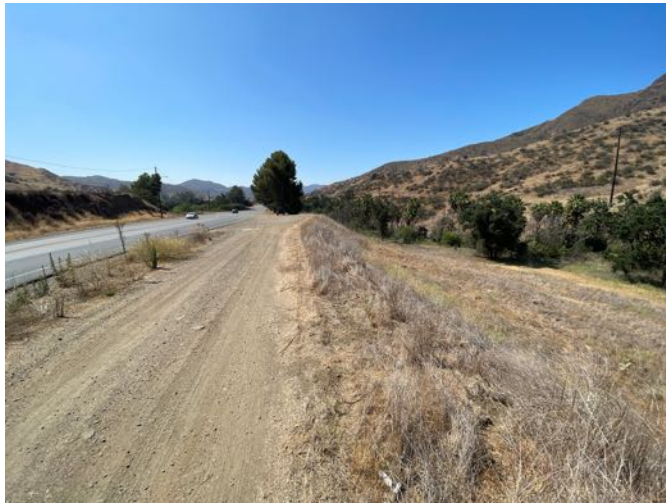
Photo 5. Overview of the western segment of the Kanan portion of the survey area, dominated by disturbed habitat with some non-native grassland, facing south (34.141166, -118.761870).

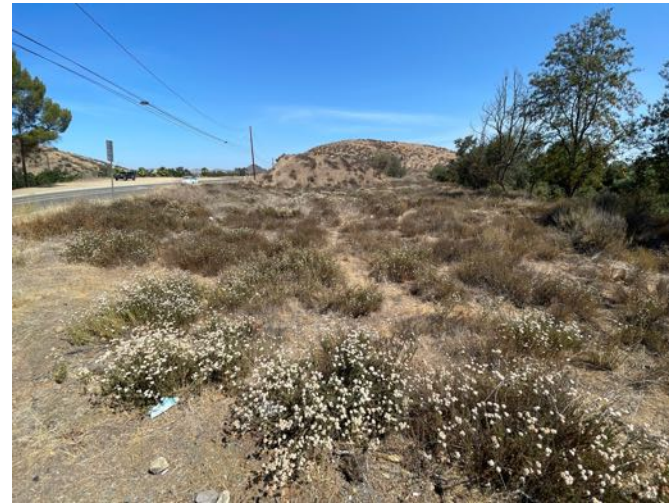
Photo 6. Overview of the eastern segment of the Kanan portion of the survey area, dominated by California buckwheat scrub (*Eriogonum fasciculatum*) - disturbed, facing north (34.140231, -118.760778).

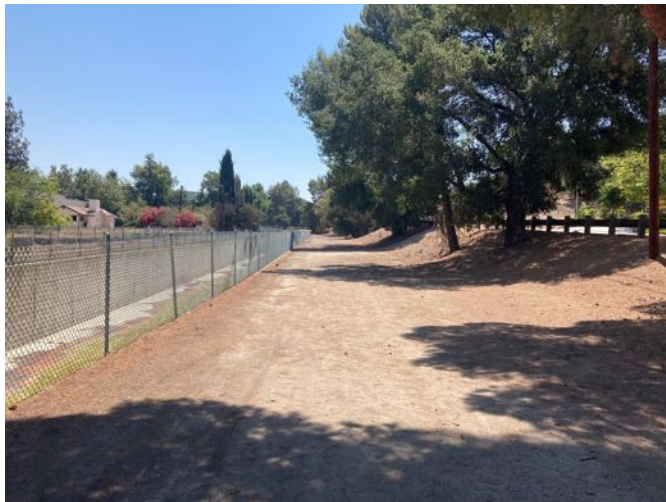
Photo 7. Overview of the northern segment of the Whizin portion of the survey area, dominated by disturbed habitat and valley oak, facing east (34.142825, -118.754104).

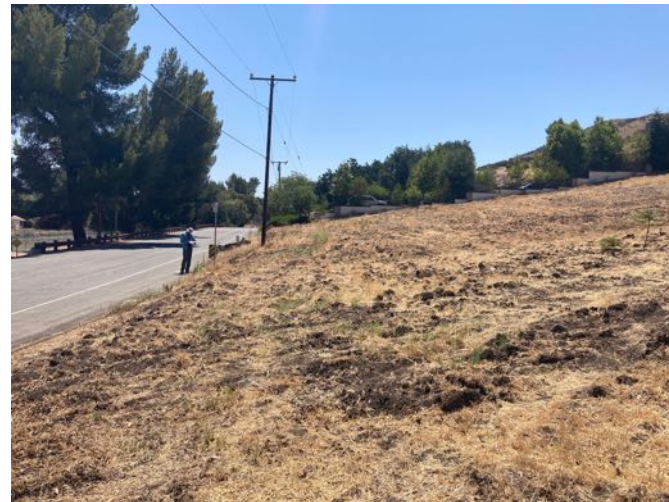
Photo 8. Overview of the southern segment of the Whizin portion of the survey area, dominated by disturbed habitat, facing east (34.142638, -118.754614).
