Initial Site Assessment

US-101 / PALO COMADO CANYON ROAD INTERCHANGE IMPROVEMENT PROJECT

AGOURA HILLS, CALIFORNIA
07-LA-101 PM 33.0/34.4

February 2009

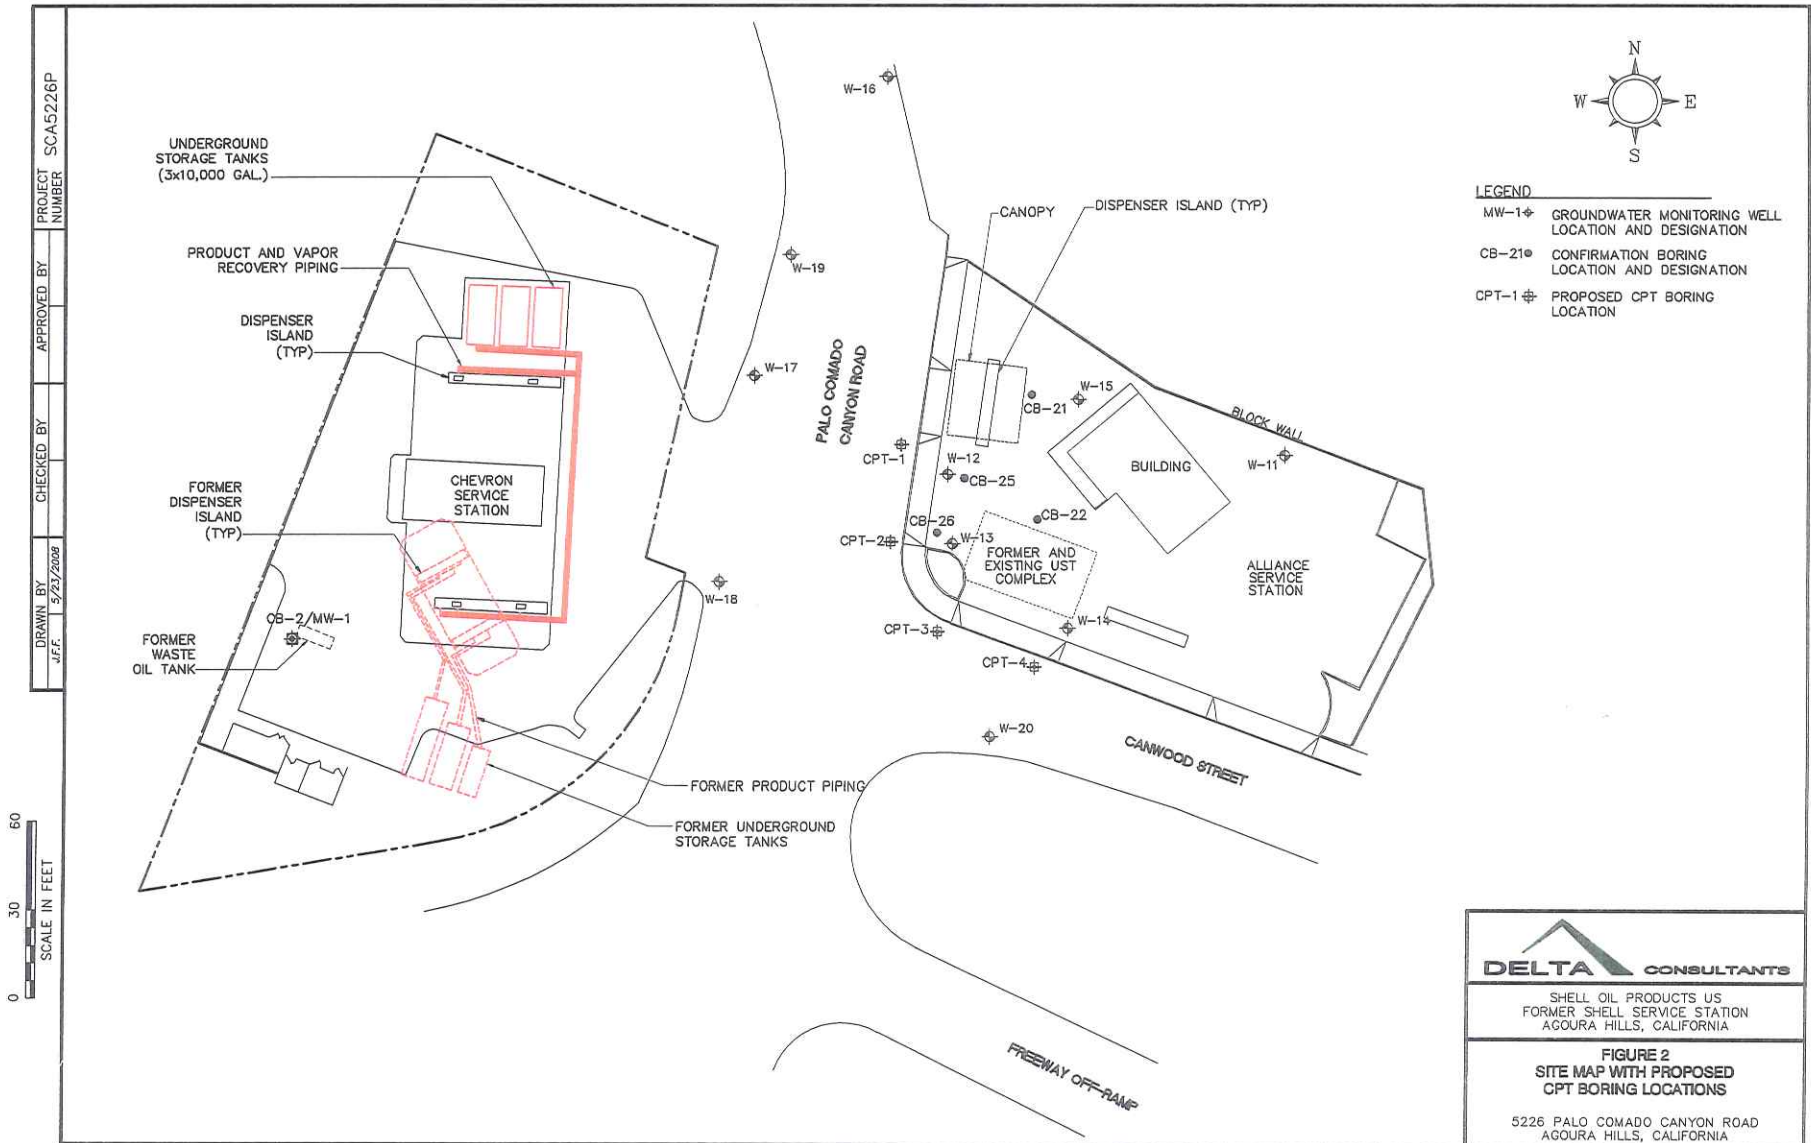
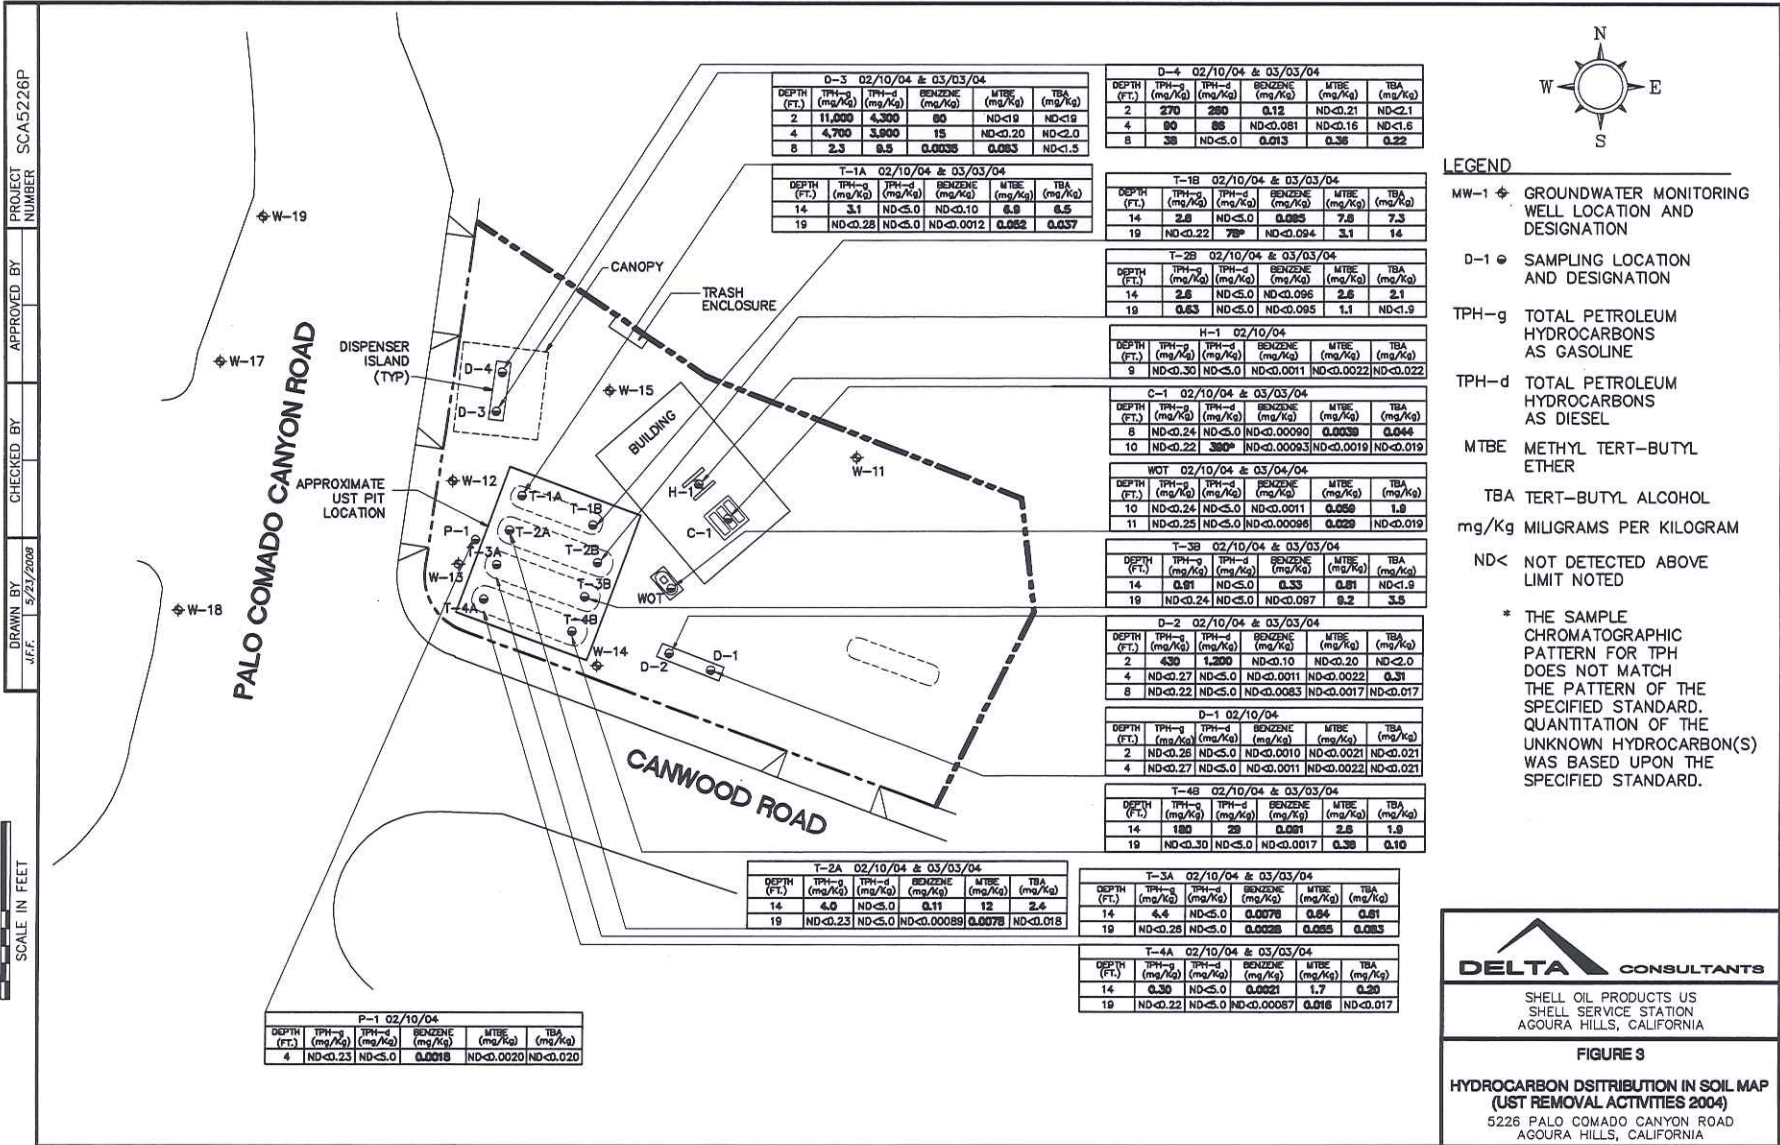
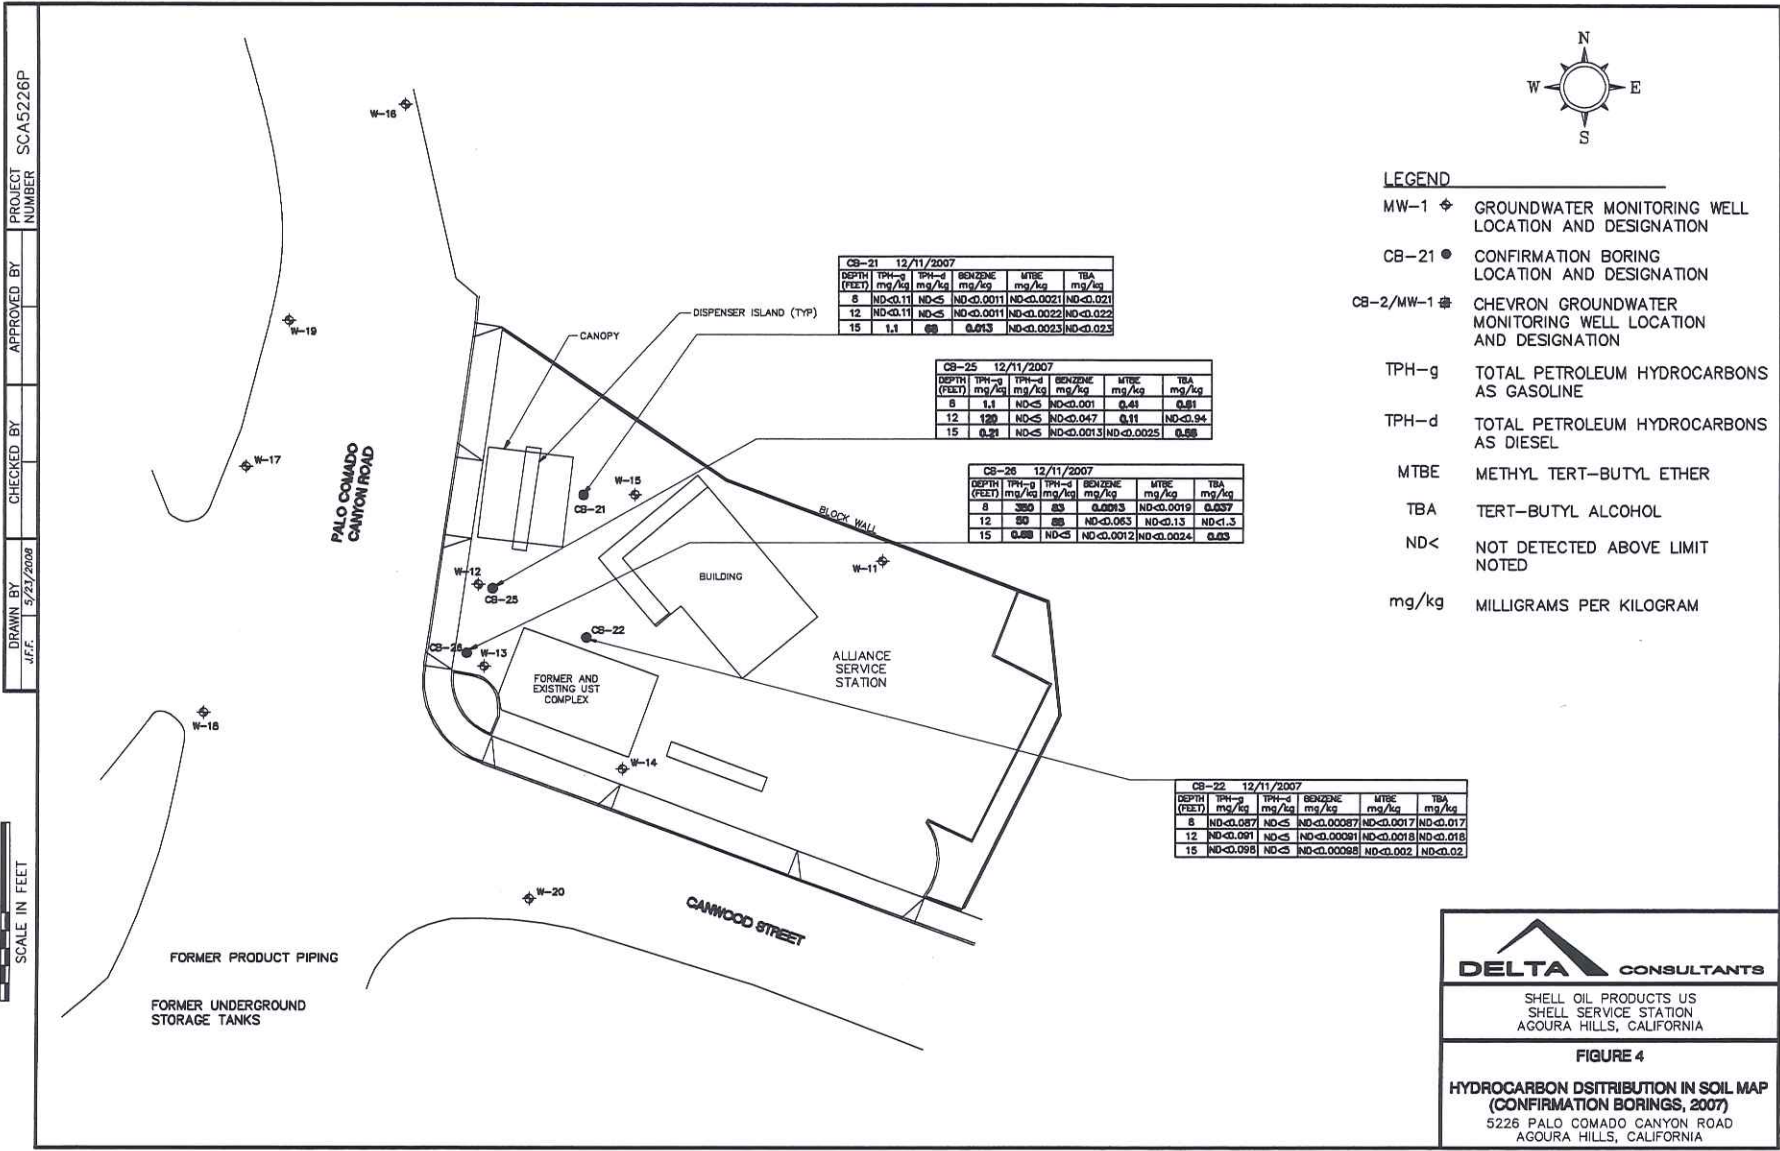
Exhibit 5
Sampling and Groundwater Data for 5226
Palo Comado Canyon Road

Contamination was found during UST removal in 2004. An on-site assessment was conducted in 2004. Soil was excavated and disposed. In 2005, remediation using soil vapor extraction was initiated. Groundwater is contaminated with methyl tert-butyl ether (MTBE) and tert-butyl alcohol (TBA). The current groundwater gradient is 0.14 ft/ft in a southwesterly direction. The latest monitoring data available is from October 2008 (Delta, 2008a). Groundwater at this location ranged from 10.5 feet to 26.25 feet bgs (Delta, 2008b).

The five monitoring wells located off-site are within the project footprint. Exhibit 5 illustrates the locations of all groundwater monitoring wells for 5226 Palo Comado Canyon Road. Any construction/demolition activities will affect these groundwater wells. Coordination between project engineering and the monitoring well owners will be required to determine the best course of action to prevent damage to the groundwater wells. Photo #7 in Appendix B shows monitoring well #20, which is located in Canwood Street. During the course of the site reconnaissance, traffic was too heavy to obtain photos of monitoring wells located in Palo Comado Canyon Road.

- Facilities located at 5221 and 5226 North Palo Comado Canyon Road have had leaking underground storage tanks, which have discharged gasoline, contaminating soil and groundwater. It is recommended that soil and groundwater sampling for petroleum hydrocarbons be conducted prior to excavation activities. This sampling should be conducted in any of the right of way areas being transferred to Caltrans including any acquisitions in the area of the gas stations. Soil samples should be obtained starting at the surface and continuing down to the depth of first encountered groundwater or maximum depth of construction. Groundwater samples should be obtained at the depth of first encountered groundwater.
