Appendix 3
Photographs of Surveyed Trees

Subj: Response to Memorandum: CUP-01150, VAR-01153-2015, OAK-01153-2015, SIGN-01152-2015 - Kruse Huntington Hotel Group - APN 2062-004-030

AGOURA ROAD HOTEL - OAK TREE REPORT

Tree Location and Project Impacts Map

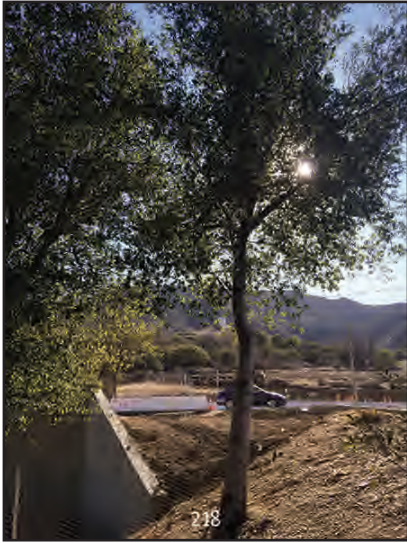
Tree #218

TREE NUMBER	218	220	247
SPECIES	<i>Quercus agrifolia</i>	X	X	X
	<i>Quercus lobata</i>			
	<i>Quercus berberidifolia</i>			
	Other			
FORM	TREE HEIGHT (~ FEET)	23.0	20.0	23.0
	LEAN	S		W
	TRUNK DIAMETER / CIRCUMFERENCE (INCHES)	9.9/31.0	8.0/25.0	7.5/23.5
PHYSICAL CONDITION	TRUNK CAVITY			
	TRUNK EXUDATION			
	TRUNK DAMAGE			
	BURIED ROOT COLLAR			
	EXPOSED ROOTS			
	WEAK CROTCH			
	FUNGAL DISEASE			
	INSECT DAMAGE			X
	FIRE DAMAGE (NEW/OLD)			
	BRANCH CAVITIES			
	MAINSTEM DIEBACK			
	TWIG/BRANCH DIEBACK			
	EPICORMIC GROWTH			X
	THIN FOLIAGE			
	DROUGHT STRESSED			
	UNBALANCED CROWN			
	EXC. HORIZONTAL BRANCH.			
	VIGOR (GOOD/MOD/POOR)	GOOD	GOOD	GOOD
TERRAIN (SLOPE/LEVEL)	SLOPE	LEVEL	SLOPE	
TREATMENT	REMOVE DEADWOOD			
	INSECT TREATMENT			
	DISEASE TREATMENT			
	SAFETY PRUNE			
RATING	HERITAGE			
	HEALTH	A	A	A
	AESTHETICS & CONFORMITY	A	A	A
		NOTES:	NOTES:	NOTES: Located on a slight slope; Scale insects present on underside of leaves.

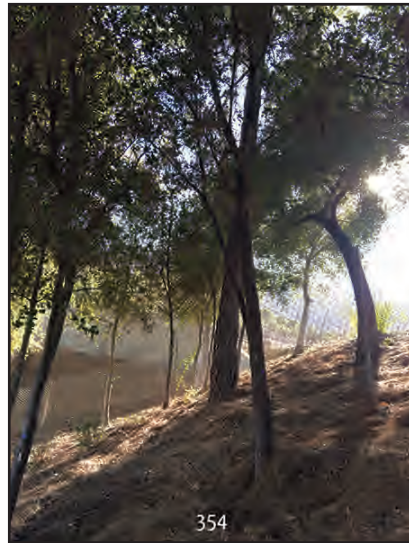
Tree #354

TREE NUMBER	354		355					
SPECIES	<i>Quercus agrifolia</i>	X	NOTES: DBH measured below fork approximately 2.4' from base.	X	NOTES:	NOTES:			
	<i>Quercus lobata</i>								
	<i>Quercus berberidifolia</i>								
	Other								
FORM	TREE HEIGHT (~ FEET)	15.0					20.0		
	LEAN	S							
	TRUNK DIAMETER / CIRCUMFERENCE (INCHES)	6.4/20.0					12.1/38.0		
PHYSICAL CONDITION	TRUNK CAVITY								
	TRUNK EXUDATION								
	TRUNK DAMAGE								
	BURIED ROOT COLLAR								
	EXPOSED ROOTS								
	WEAK CROTCH								
	FUNGAL DISEASE								
	INSECT DAMAGE								
	FIRE DAMAGE (NEW/OLD)								
	BRANCH CAVITIES								
	MAINSTEM DIEBACK								
	TWIG/BRANCH DIEBACK								
	EPICORMIC GROWTH								
	THIN FOLIAGE	X							
	DROUGHT STRESSED								
	UNBALANCED CROWN								
EXC. HORIZONTAL BRANCH.									
VIGOR (GOOD/MOD/POOR)	GOOD			GOOD					
TERRAIN (SLOPE/LEVEL)	SLOPE			LEVEL					
TREATMENT	REMOVE DEADWOOD								
	INSECT TREATMENT

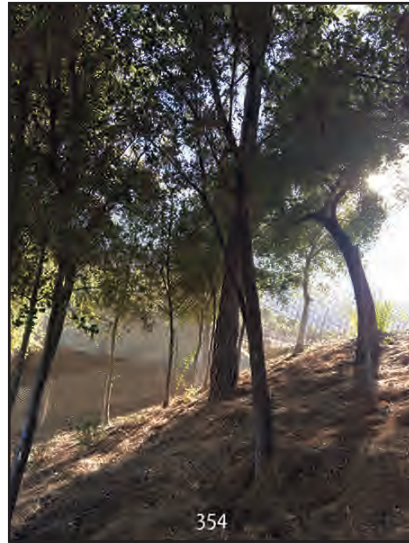
Tree #354

TREE NUMBER	354		355					
SPECIES	<i>Quercus agrifolia</i>	X	NOTES: DBH measured below fork approximately 2.4' from base.	X	NOTES:	NOTES:			
	<i>Quercus lobata</i>								
	<i>Quercus berberidifolia</i>								
	Other								
FORM	TREE HEIGHT (~ FEET)	15.0					20.0		
	LEAN	S							
	TRUNK DIAMETER / CIRCUMFERENCE (INCHES)	6.4/20.0					12.1/38.0		
PHYSICAL CONDITION	TRUNK CAVITY								
	TRUNK EXUDATION								
	TRUNK DAMAGE								
	BURIED ROOT COLLAR								
	EXPOSED ROOTS								
	WEAK CROTCH								
	FUNGAL DISEASE								
	INSECT DAMAGE								
	FIRE DAMAGE (NEW/OLD)								
	BRANCH CAVITIES								
	MAINSTEM DIEBACK								
	TWIG/BRANCH DIEBACK								
	EPICORMIC GROWTH								
	THIN FOLIAGE	X							
	DROUGHT STRESSED								
	UNBALANCED CROWN								
EXC. HORIZONTAL BRANCH.									
VIGOR (GOOD/MOD/POOR)	GOOD			GOOD					
TERRAIN (SLOPE/LEVEL)	SLOPE			LEVEL					
TREATMENT	REMOVE DEADWOOD								
	INSECT TREATMENT
