**City Oak Tree
Consultant's Memorandum
and Oak Tree Report**

OAKMONT SENIOR LIVING

OAK TREE REPORT

March 28, 2016

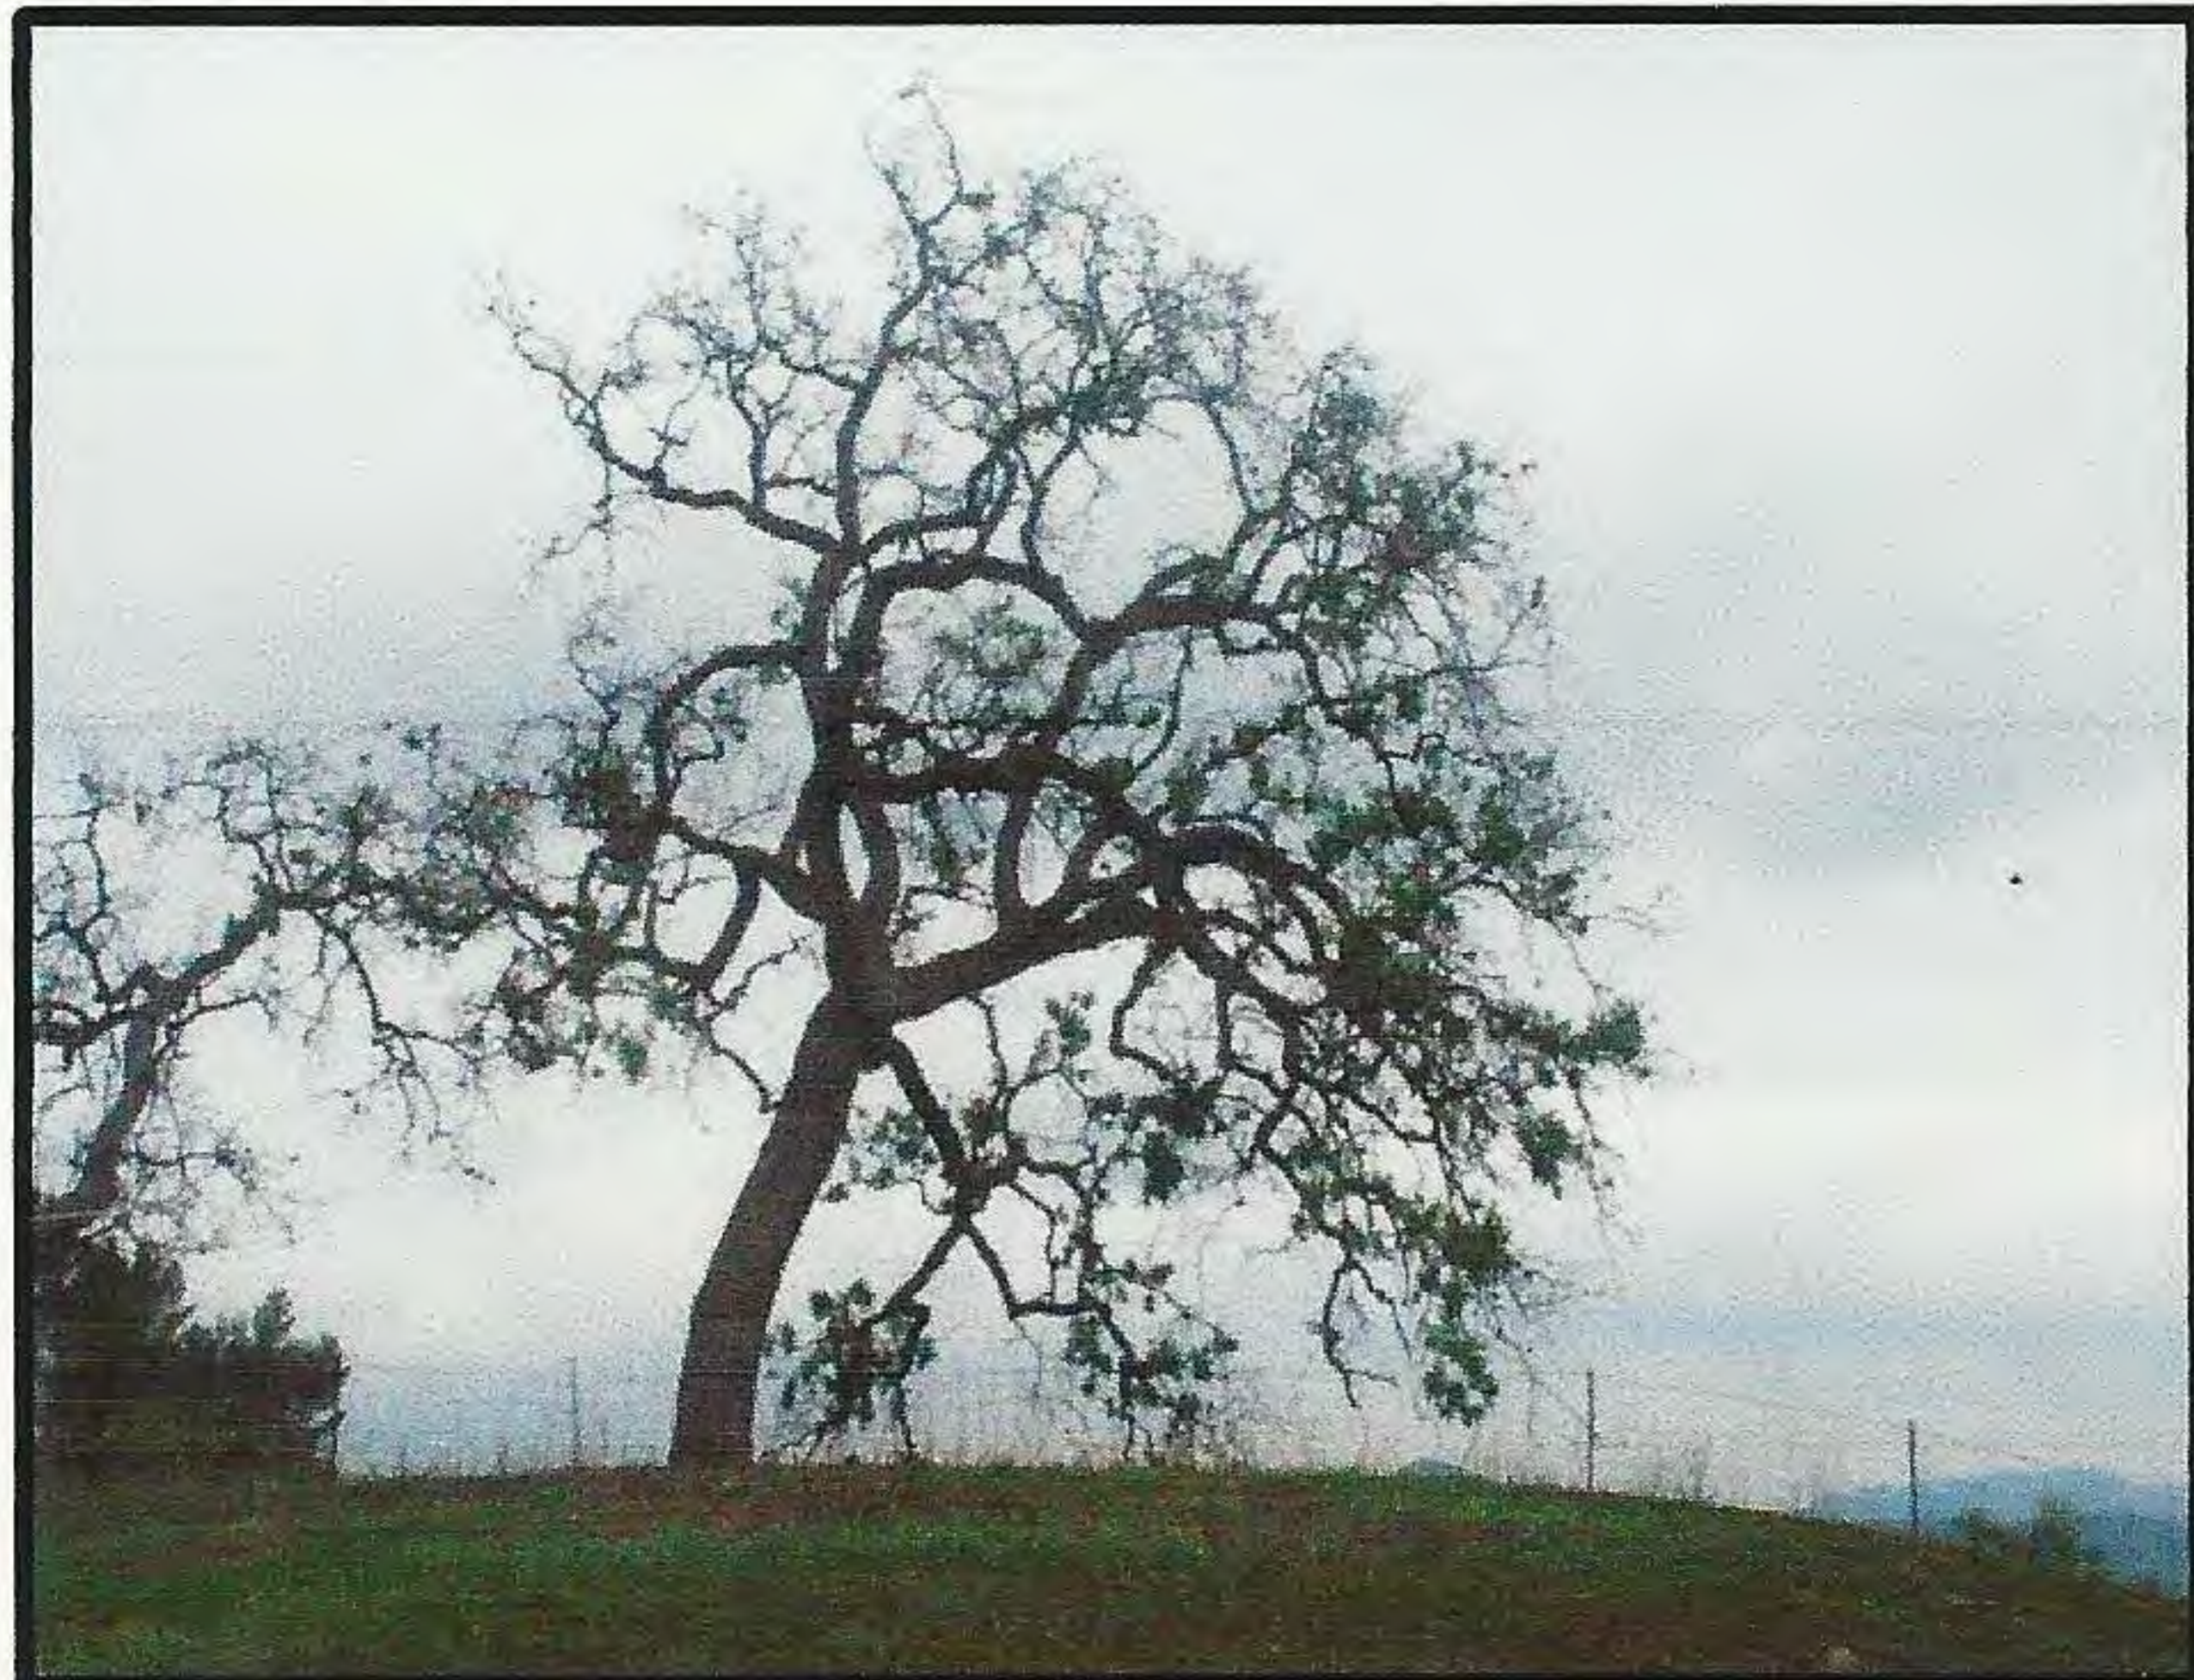
TREE NO.	TREE NAME	TRUNK DIA(S) IN INCHES	N	NE	E	SE	S	SW	W	NW	HT+ IN FEET	H'LTH	AESTH	NOTES & REMARKS
OSL-1	QUERCUS LOBATA	28	16/15	24/16	34/3	30/15	25/1	23/20	13/17	10/10	40	D+	D+	LOCATED ON HILLTOP, BARBED WIRE AROUND TRUNK, BROKEN BRANCH SCARS, DEADWOOD, DIEBACK, EPICORMIC GROWTH, INTERTWINED IN OSL-2, WOODPECKER ACTIVITY
OSL-2	QUERCUS LOBATA	15 1/4	10/17	11/12	16/8	20/14	14/7	7/6	5/8	3/7	26	D	D	LOCATED ON HILLTOP, BARBED WIRE AROUND TRUNK, BROKEN BRANCH SCARS, DEADWOOD, DIEBACK, EPICORMIC GROWTH, INTERTWINED IN OSL-1, LEANS TO SOUTHEAST, STRESSED
OSL-3	QUERCUS LOBATA	25	24/4	30/1	20/6	19/0	18/0	22/0	18/0	24/4	40	D-	B-	LOCATED ON HILLTOP, BRANCHES ON GROUND, BROKEN BRANCH SCARS, DEADWOOD, EXPOSED ROOTS, EXUDATION STAINS, PIT SCALE, SQUIRREL HOLE AT BASE
OSL-4	QUERCUS AGRIFOLIA	8, 4, (2) 3, 13/4, (2) 1	9/0	8/2	10/4	10/1	10/1	12/0	8/0	10/8	20	B	B	LOCATED ON HILLTOP SLOPE, TWIG GIRDLER
OSL-5	QUERCUS AGRIFOLIA	5 3/4, 3 3/4, 2 1/4, (2) 1 1/2, 1	8/3	8/1	12/0	9/0	9/0	9/0	8/0	6/0	20	B	B	BRANCHES ON GROUND, FILL ON TRUNK, INTERTWINED IN OSL-6, LOW BRANCHING, TWIG GIRDLER

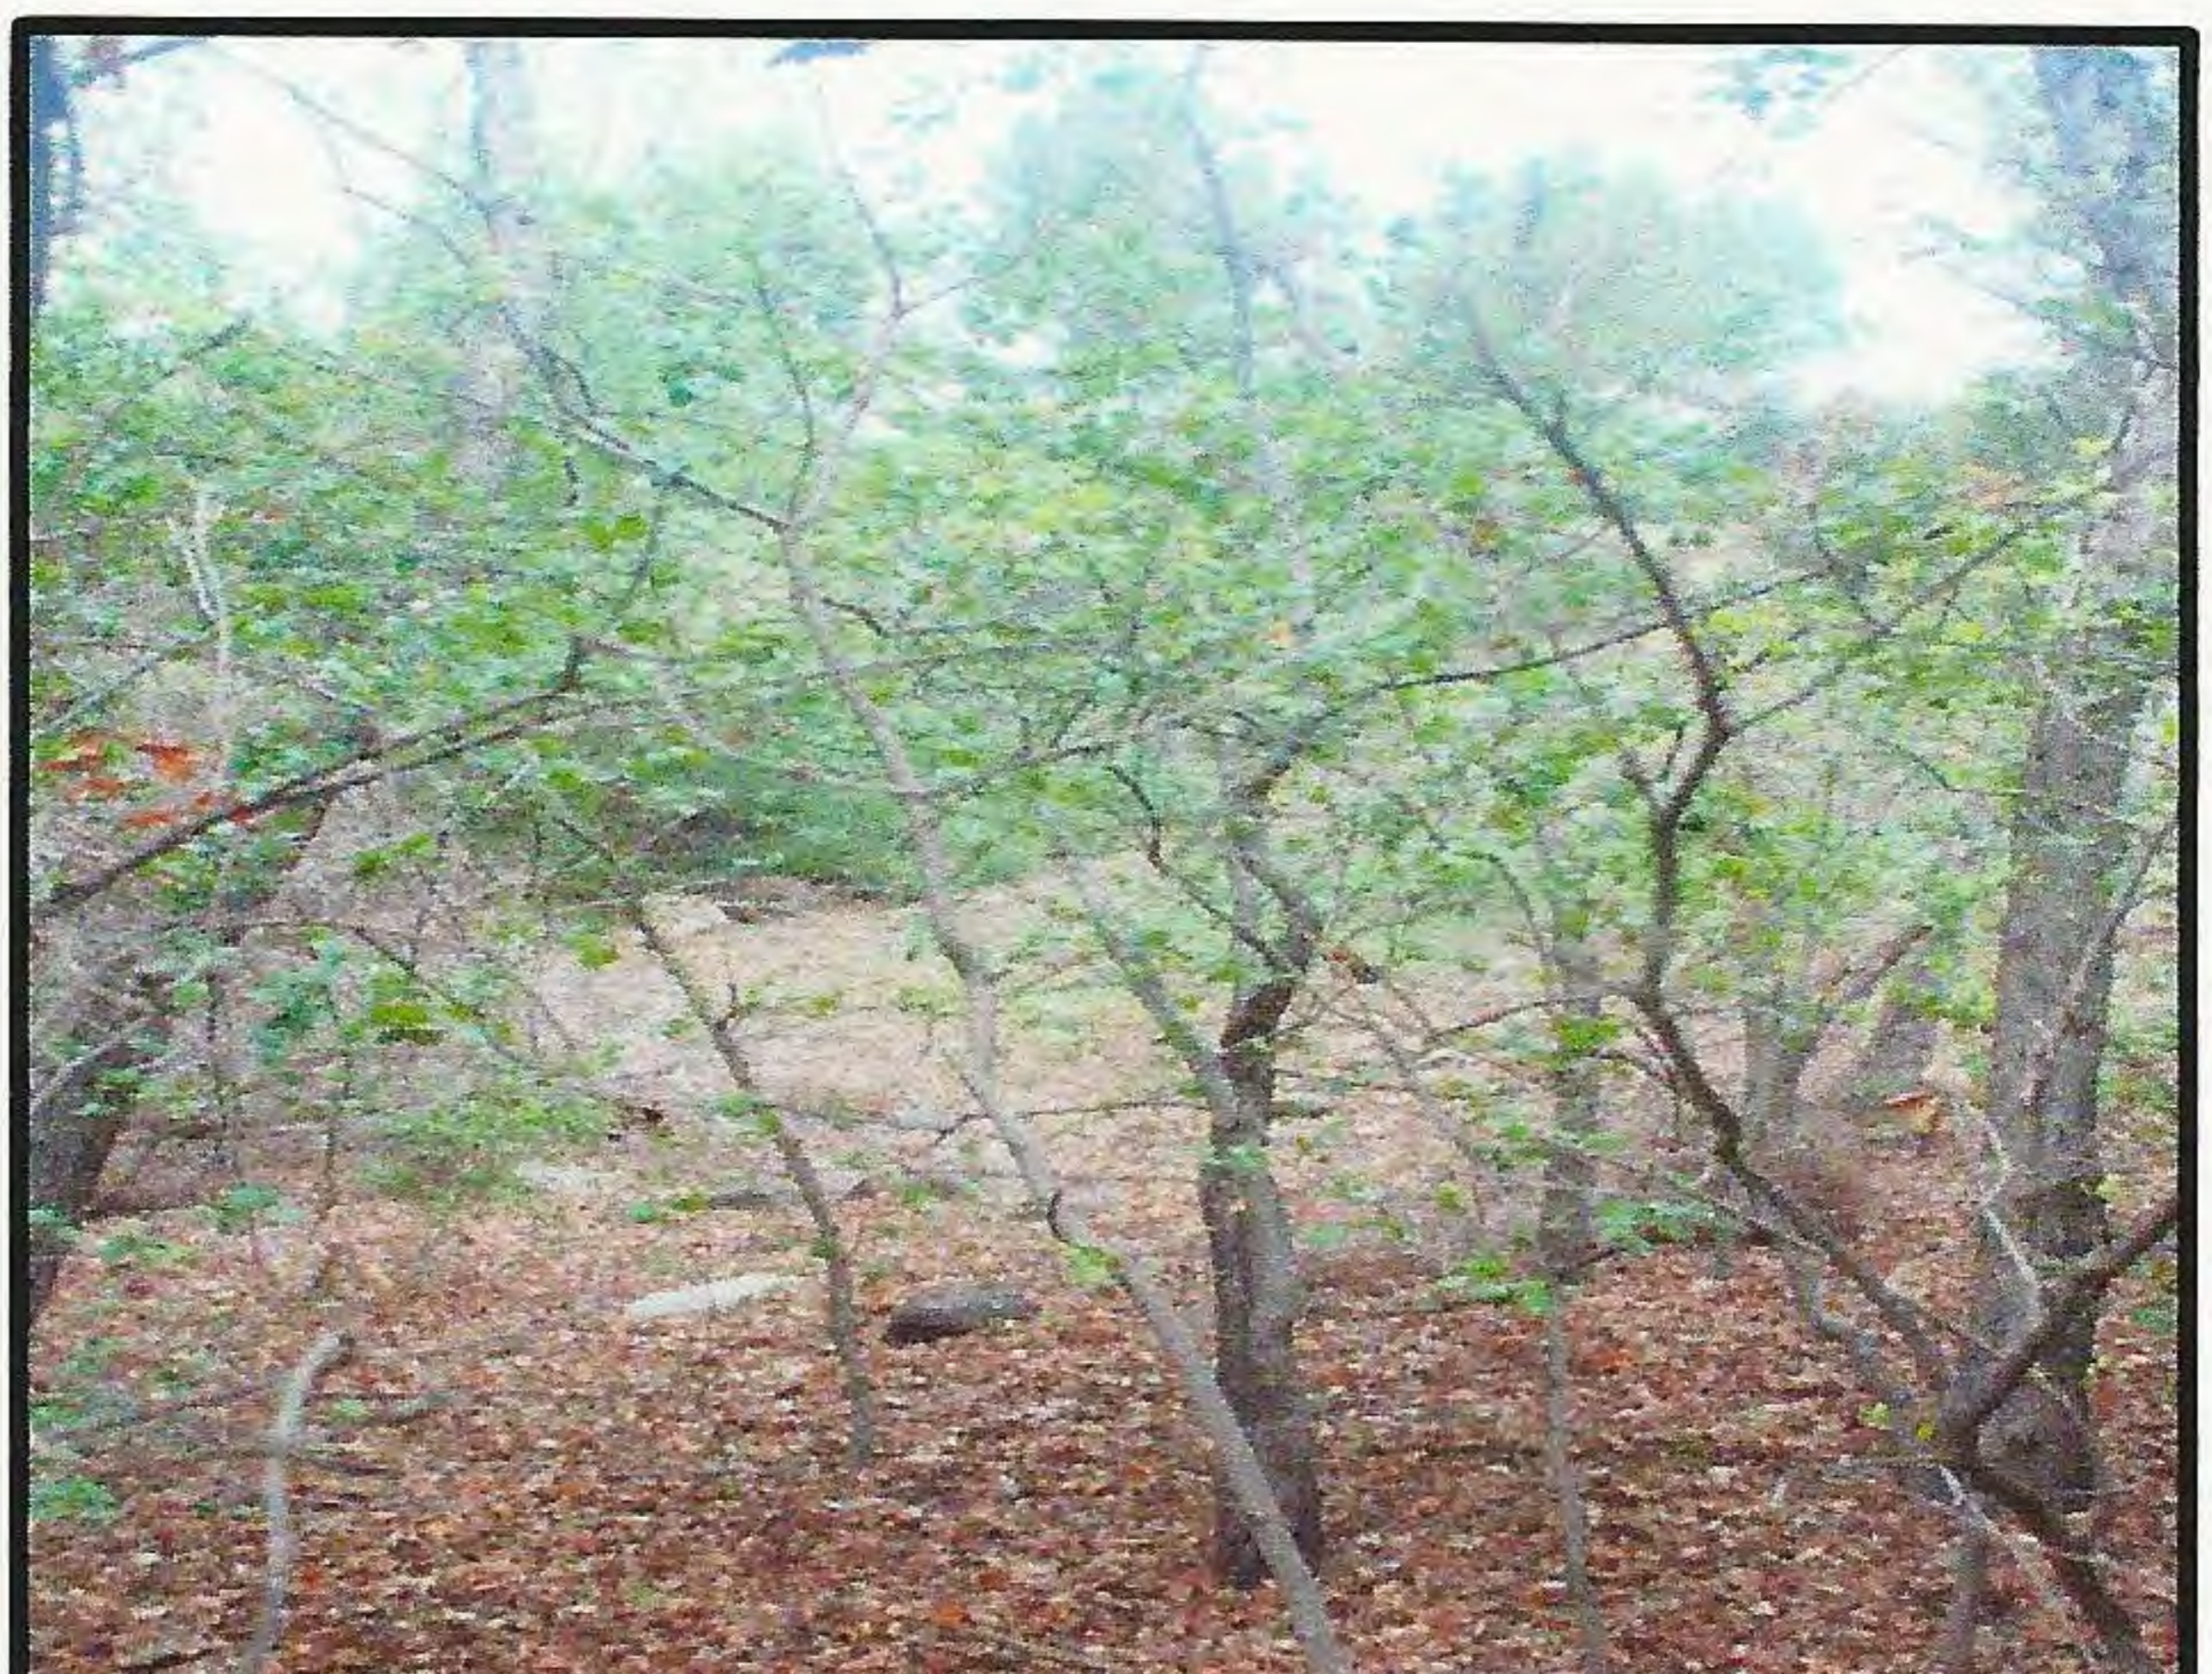
TREE NO.	TREE NAME	TRUNK DIA(S) IN INCHES	N	NE	E	SE	S	SW	W	NW	HT± IN FEET	H'LTH	AESTH	NOTES & REMARKS
OSL-42	QUERCUS LOBATA	7 1/4	24/16	0/0	0/0	0/0	0/0	0/0	0/0	14/14	42	C	C	DEADWOOD, EPICORMIC GROWTH, FILL ON TRUNK, LOPSIDED CANOPY
OSL-43	QUERCUS AGRIFOLIA	3 3/8, 2	19/2	6/6	3/3	4/3	4/4	4/7	6/3	9/3	15	C-	B-	CO-DOMINANT TRUNKS, FILL ON TRUNK, INCLUDED BARK, LOPSIDED CANOPY, LOW BRANCHING, TWIG GIRDLER
OSL-44	QUERCUS LOBATA	5 1/4, 3 1/8	14/15	8/20	4/30	3/20	5/27	14/28	20/30	8/4	42	C-	C	BROKEN BRANCH SCARS, CO-DOMINANT TRUNKS, FILL ON TRUNK, GALLS, INTERTWINED IN OSL-51, LOPSIDED CANOPY
OSL-45	QUERCUS LOBATA	7 1/4	35	94	9/4	8/10	12/6	3/5	3/5	2/5	30	C	C	DEADWOOD, EPICORMIC GROWTH, FILL ON TRUNK, INTERTWINED IN OSL-46 & 54, LOW BRANCHING
OSL-46	QUERCUS LOBATA	5	8/6	8/13	9/11	6/16	7/12	10/17	14/19	11/23	31	C	C	DEADWOOD, EPICORMIC GROWTH, FILL ON TRUNK, INTERTWINED IN OSL-45
OSL-47	QUERCUS LOBATA	2 3/8	5/0	0/0	3/5	4/6	4/10	7/13	7/16	7/15	21	C	C	BROKEN BRANCH SCARS, DEADWOOD, EPICORMIC GROWTH, FILL ON TRUNK
