Oak Tree Reports

OAK TREE SURVEY
FOR
AGOURA OAKS PLAZA
29701 AGOURA ROAD

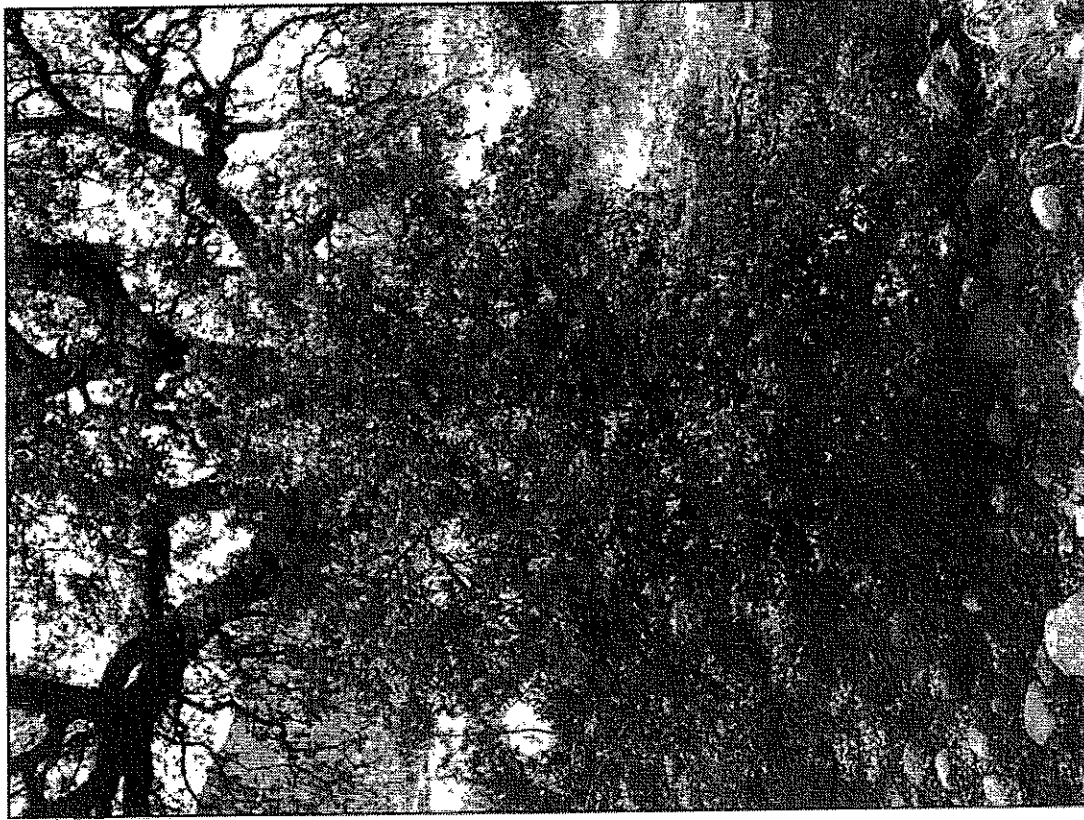
Tree 86 facing southwest

-
- This tree has developed a slight lean to the north.

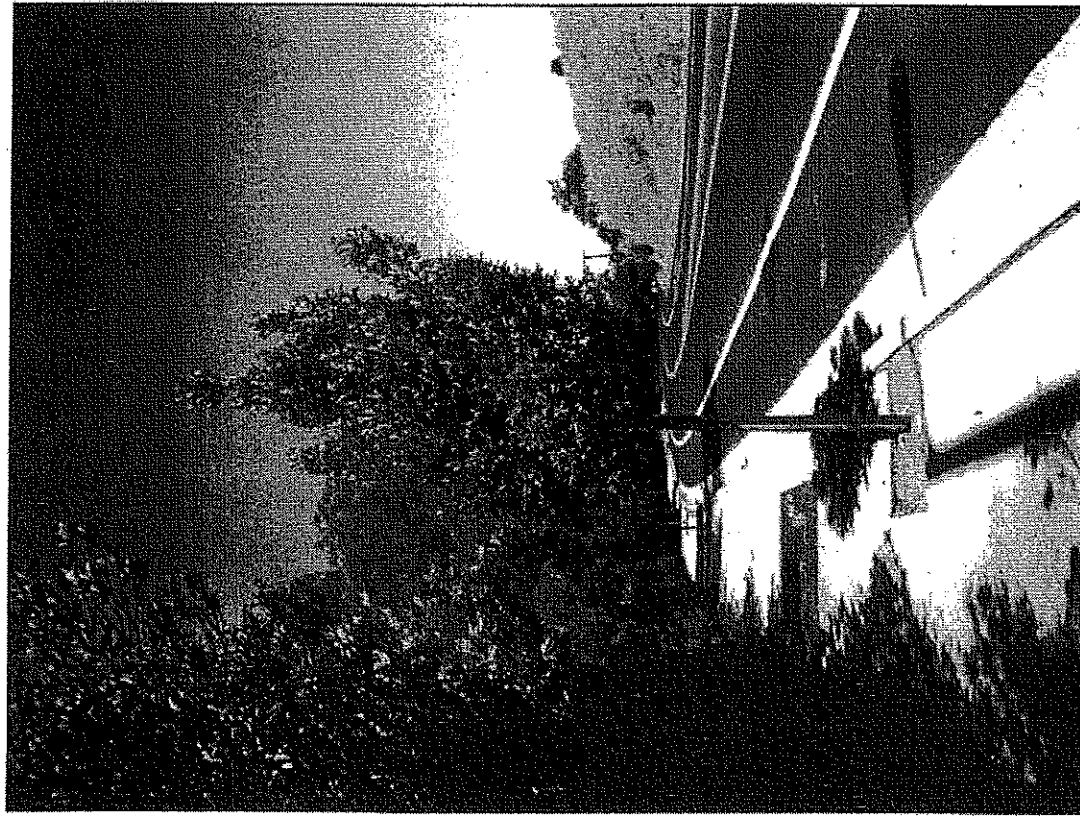
Tree 77 facing east

Tree #77 is a 13-foot tall Holly Oak street tree located in the southwestern corner of the subject property along Agoura Road. Currently the tree has a health rating of "B" and an appearance rating of "B" (Plate 7). This tree has scarred branching and dense internal growth. Additionally, the leaves of the tree are covered with a layer of soot.

The following measures are recommended to preserve the health of this tree, and

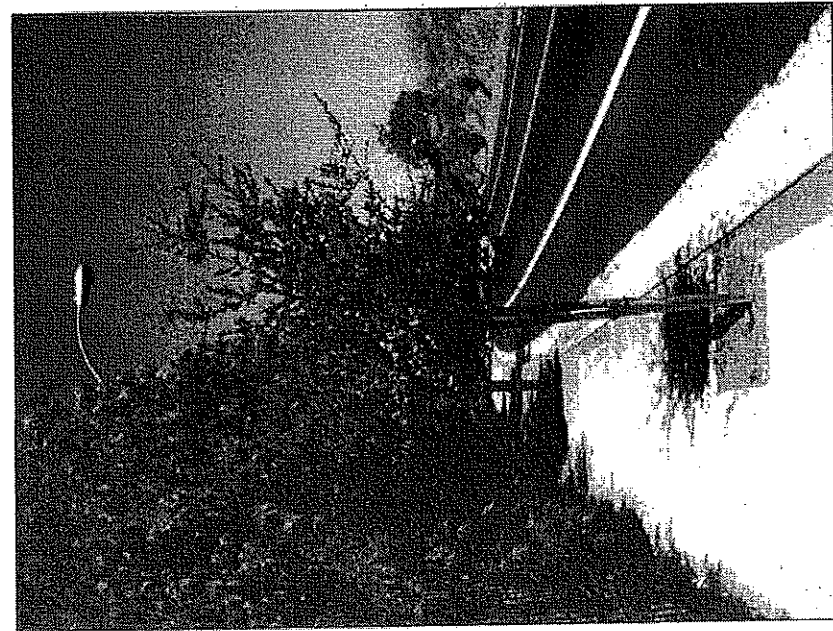
Tree 78 facing east

Trees #78 and #40 are tagged street trees along Agoura Road that are less than two inches in diameter at three and a half feet above grade (Plate 9). Therefore they do not meet the City Oak Tree Ordinance criteria for a protected tree. However, the location of these trees have been noted on the tree location map. Evaluations of these trees have been performed at the request of the City Oak Tree Consultant and have been included under Appendix B.

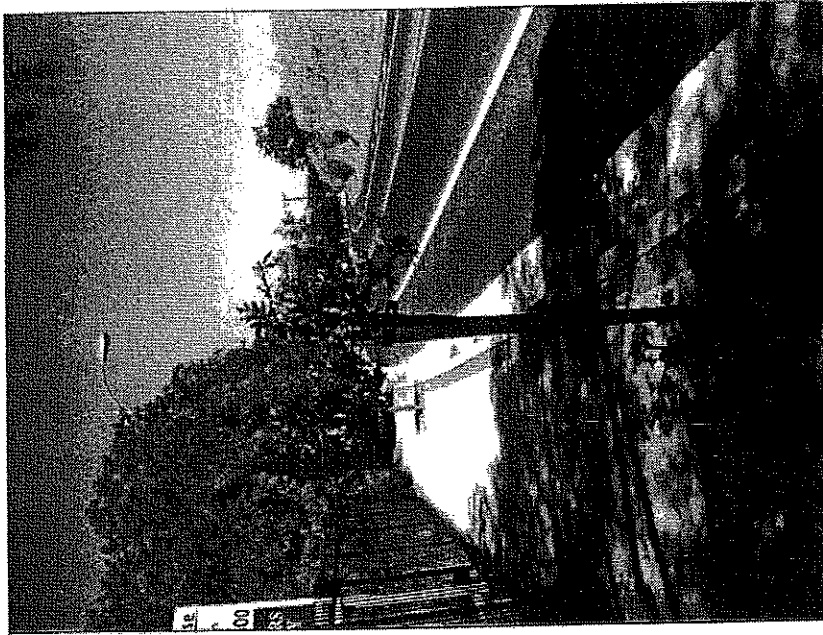
"No Tag" Tree facing east

The proposed project would not result in an encroachment into the root protection zone, nor require the transplant or removal of this tree.

The following measures are recommended to preserve the health of this tree:
