Agoura Landmark Project

Addendum to the Agoura Oaks Plaza Final Initial Study/Mitigated Negative Declaration

October 2009

Oak Tree Survey

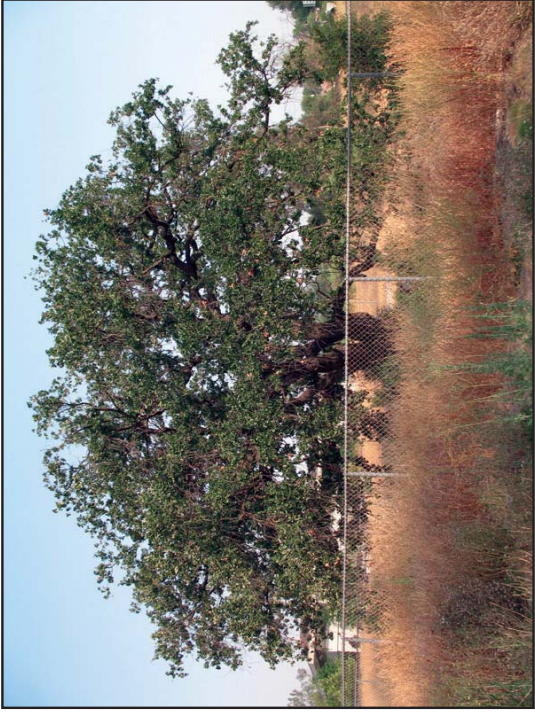
The lower trunk of the valley oak leans to the east. The oak has a weak main crotch, with included bark at the first branch union. There is a trunk cavity in the north side of the upper trunk structure at 13 feet in height, with an old exudation visible below the cavity from 6-12 feet in height. A broken cable was visible in the lower canopy. The cable had helped support a heavy horizontal-trending branch, linking it to another large branch. Horizontal-trending branches that extend to the edge of the canopy are not excessive, and lifting of the canopy for construction access should not be required. There are two collateral branches on the southwest side of the canopy, with one branch subdominant and sparse with foliage. There is a build-up of deadwood in the canopy that should be removed to invigorate the tree. Insect pests, including evidence of wood borers (exit holes) and California oak worm (*Phryganidia californica*, damaged leaves) are deemed to be at a tolerable level.

Oak #100 – View facing west-northwest.

- Replace broken cable that supported heavy horizontal-trending branch
- Remove deadwood from oak canopy
- Remove exotic species growing inside oak's Protection Zone and control subsequent growth of re-sprouts and seedlings
- Remove concrete and other rubbish from under oak canopy
- Retain and supplement leaf mulch under oak canopy

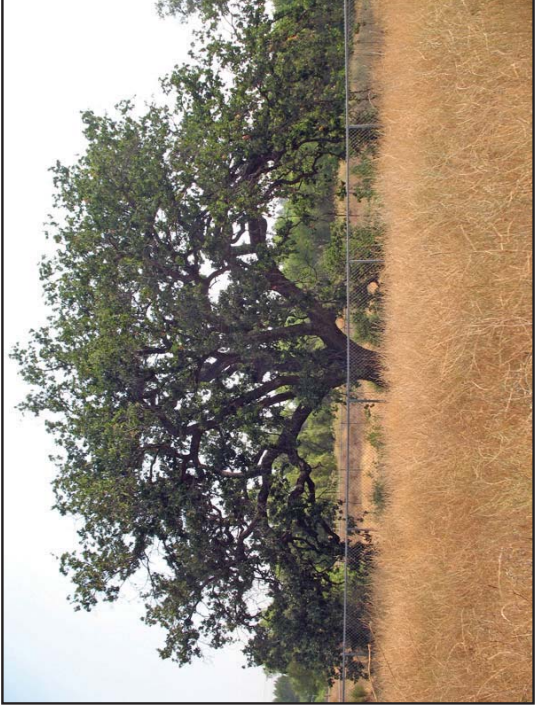
Oak #100 – View facing north.

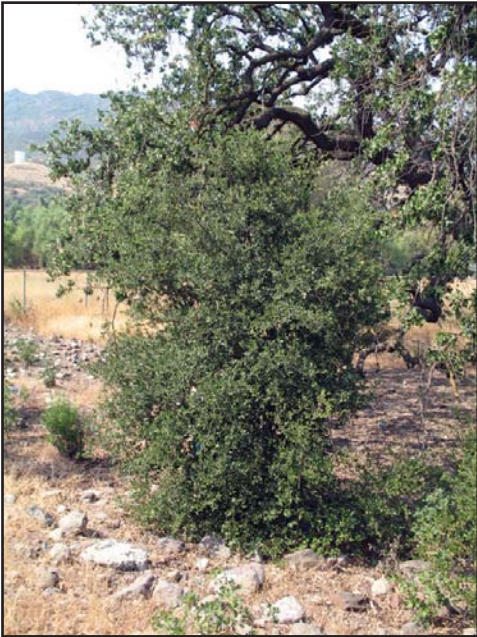
Oak #86 is a 14-foot tall coast live oak located northeast of Oak #100, at the edge of the dominant valley oak canopy. The oak was evaluated with an aesthetic rating of "B", a vigor rating of "B" and a health rating of "B" (**Plate 2, Appendix B**). Due to competition for sunlight with the larger oak, this tree has trunks that lean to the northeast. Insect pests, including Ehrhorn's oak scale (*Mycetococcus ehrhorni*,

visible on branches) and California oak worm (damaged leaves) are deemed to be at a tolerable level. The oak's tree tag has become embedded into the trunk, and should be re-attached and the wound treated with a fungicide.

Oak #86 – View facing south.

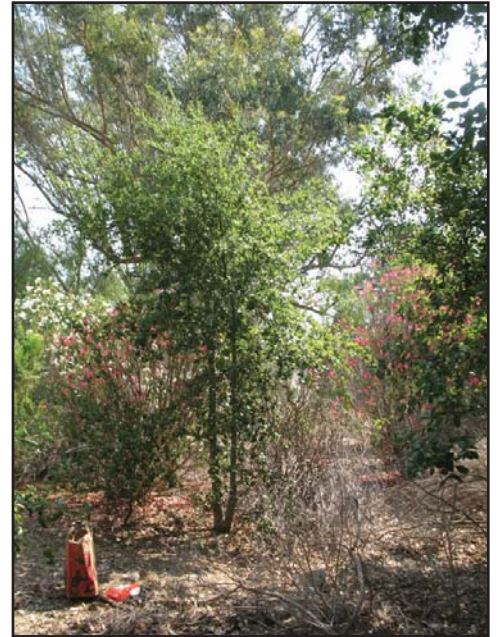
Oak #83 is a 14-foot tall coast live oak located near the southwest corner of the property, in the vicinity of a storm drain structure. The oak was evaluated with an aesthetic rating of "B", a vigor rating of "C" and a health rating of "B" (**Plate 2, Appendix B**). There is a small wound at the base of the north trunk. Insect pests, including Ehrhorn's oak scale (visible on branches), are deemed to be at a tolerable level. The oak's tree tag has become embedded into the trunk, and should be re-attached and the wound treated with

Oak #83 – View facing north-northeast.

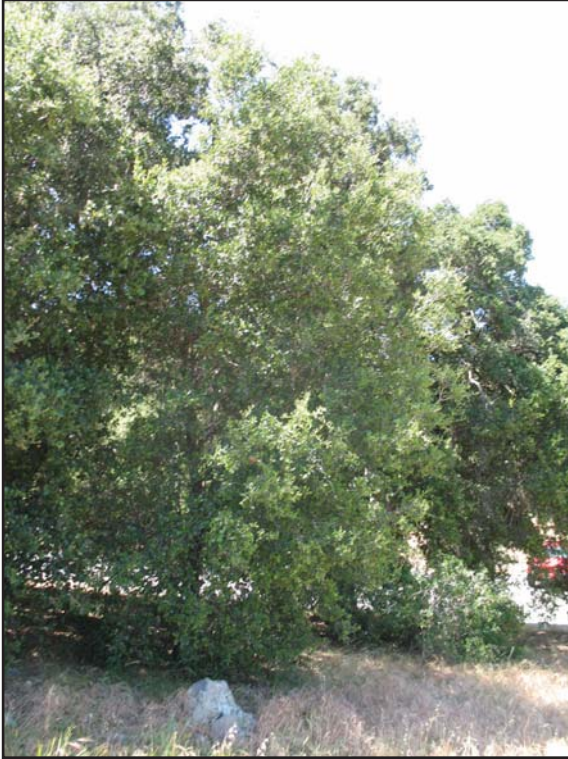
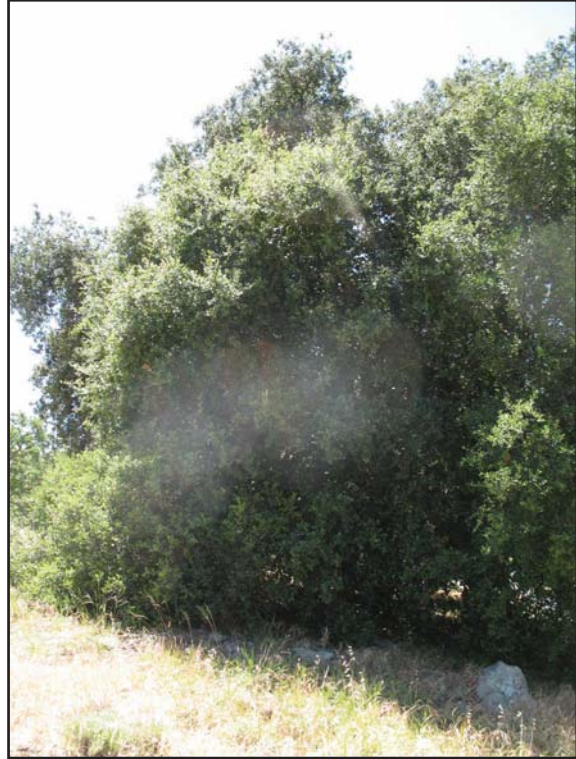
Oak #131 – View facing southwest.

Oak #131 – View facing south-southeast.
