Appendix B
Phase 2 Site Plans

CONCEPT GRADING FOR RESIDENTIAL LOTS
 VESTING TENTATIVE TRACT MAP 2316
 AGOURA HILLS, CA 91301

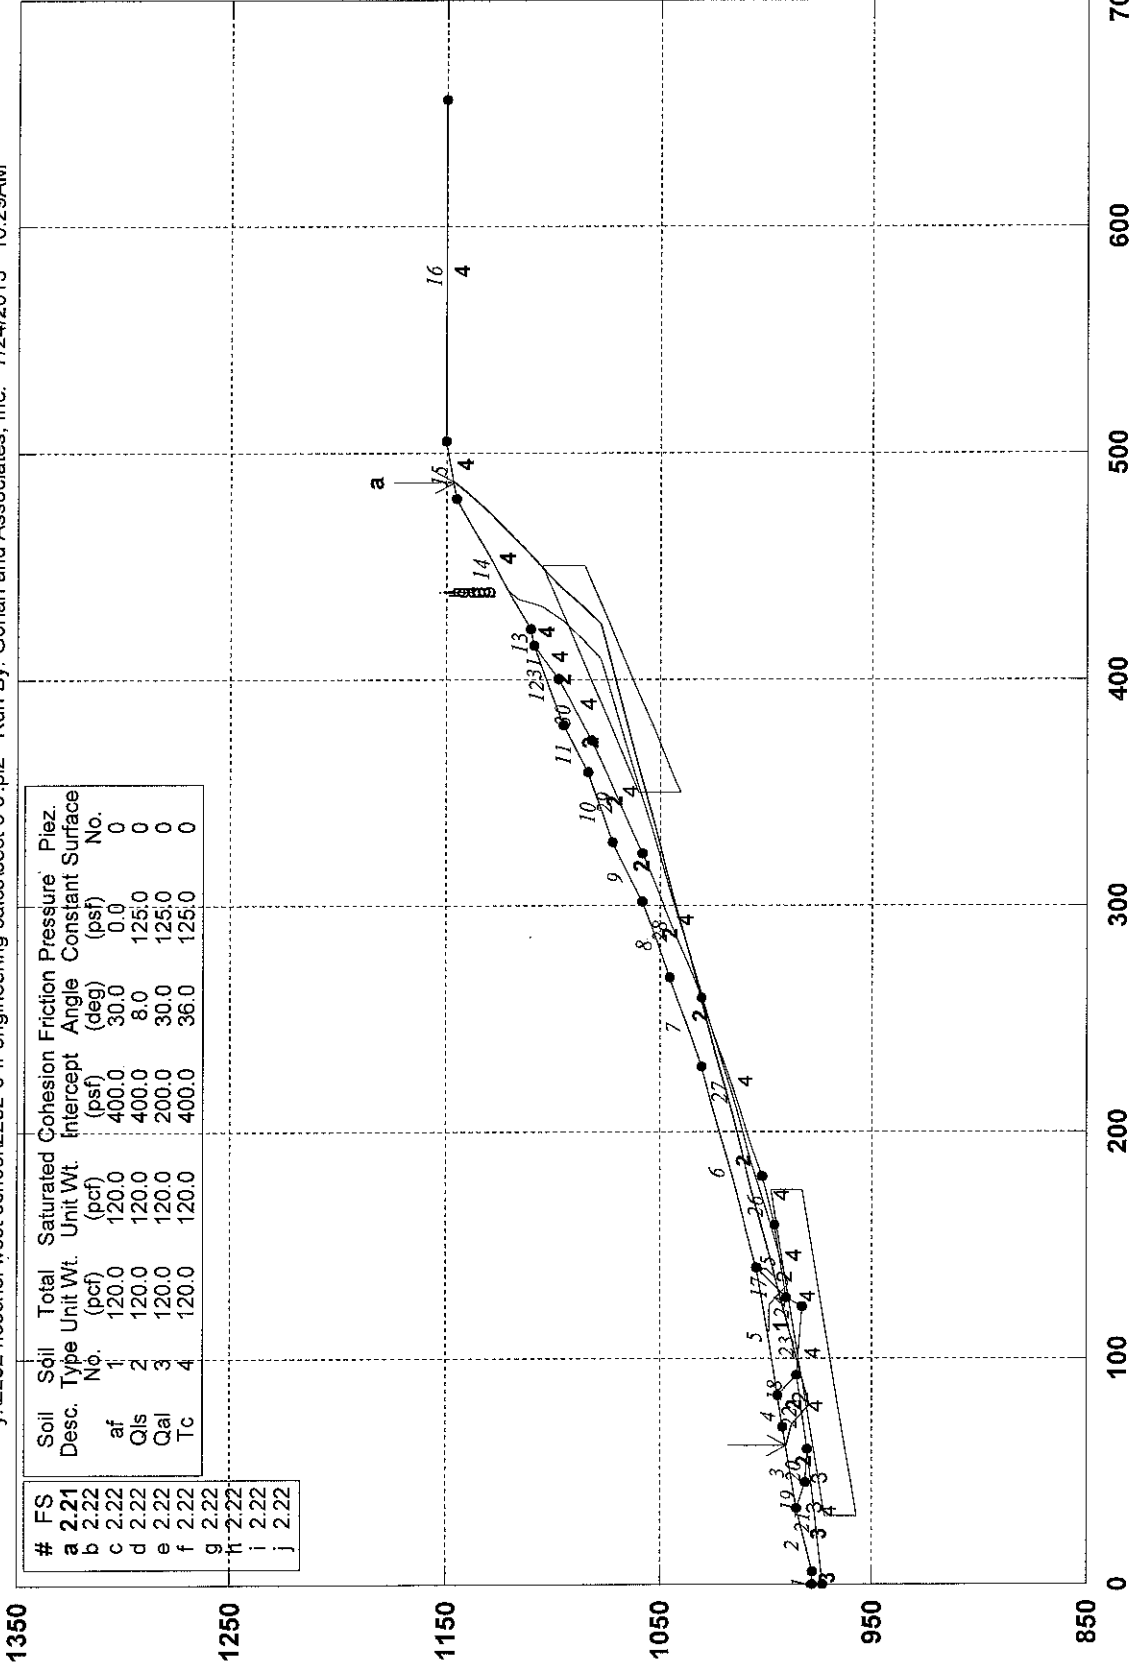
WO 2232-0-FR-100 Section C-C'

#	FS	Soil Desc.	Soil Type No.	Total Unit Wt. (pcf)	Saturated Unit Wt. (pcf)	Cohesion Intercept (psf)	Friction Angle (deg)	Pressure Constant (psf)	Piez. Constant Surface No.
a	2.21	af	1	120.0	120.0	400.0	30.0	0.0	0
b	2.22	Qls	2	120.0	120.0	400.0	8.0	125.0	0
c	2.22	Cal	3	120.0	120.0	200.0	30.0	125.0	0
d	2.22	TC	4	120.0	120.0	400.0	36.0	125.0	0
e	2.22								
f	2.22								
g	2.22								
h	2.22								
i	2.22								
j	2.22

GSTABL7 v.2 FSmin=2.21
Safety Factors Are Calculated By The Simplified Janbu Method

The slide plane, as observed in boring B-10, is shallow and dips at a low angle ($\sim 5^\circ$). In the analyses, the slide was limited to a thickness of approximately 10 feet based on the subsurface data and geomorphic expression of the slope face.

This section portrays the slope in the direction of the landslide movement and represents the worst case scenario. The landslide was modeled as both a shallow planar and rotational failure. All materials above the slide plane were assumed to have the weakened residual clay strength (400 psf and 8°). A buttress is recommended with a minimum width of 30 feet. Construction recommendations are contained in the report text. Because the buttress will be constructed with drainage measures in place, the stability analyses were completed by assuming zero pore pressures in the buttress fill. The location of the buttress should be substantially as shown on Cross Section C and should extend laterally across the width of the landslide. Analyses of the slope following the proposed remedial measures indicate the factors of safety are above the minimum required.
