July 14, 2014
 Letter to Ms. Erika Iverson
 Spring 2014 Rare Plant Survey
 Agoura Cornerstone Mixed-Use Project Site
 Page 10 of 15

**SOIL ENGINEERING INVESTIGATION
FOR PROPOSED OFFICE, RETAIL, RESIDENTIAL BUILDINGS
AT
SOUTHEAST CORNER OF AGOURA ROAD AND CORNELL ROAD
AGOURA HILLS, CA
FOR
AGOURA AND CORNELL ROADS L.P.**

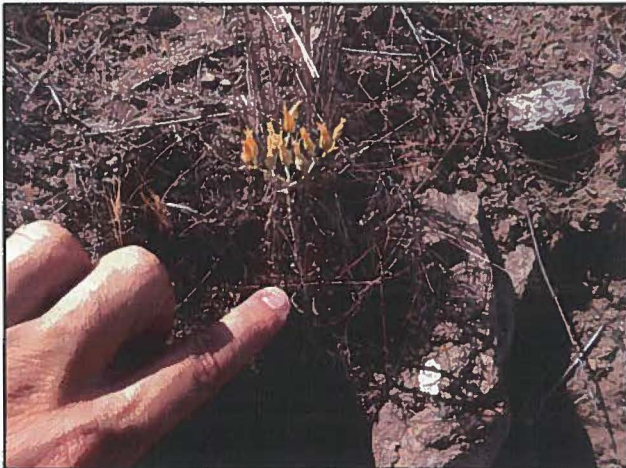
Photo 1A – Agoura Hills dudleya (*Dudleya cymosa* ssp. *agourensis*) is shown in bloom at the site in May 2014. The Agoura Hills dudleya is listed as Threatened under the Federal Endangered Species Act.

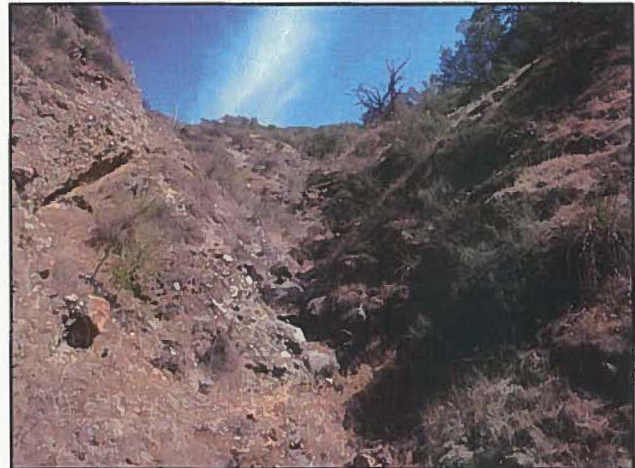
Photo 1B – The occurrence of Agoura Hills dudleya at the site is restricted to the steep gully shown in this photo, which is located near the southwestern property boundary.

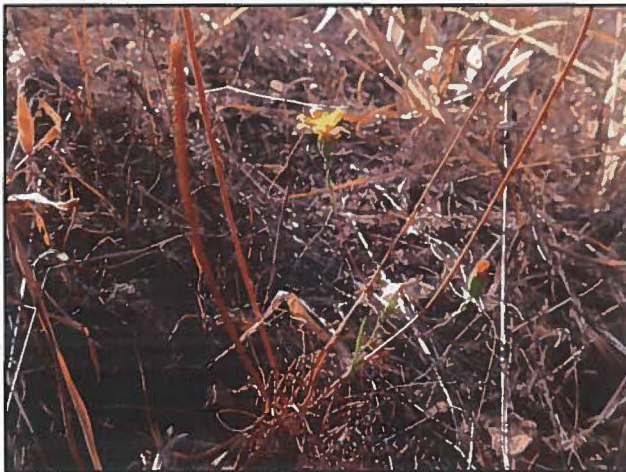
Photo 1C – One (1) Lyon's pentachaeta (*Pentachaeta lyonii*) plant was found at the site in a patch of non-native grassland surrounded by scrub oak chaparral. Lyon's pentachaeta is listed as Endangered under the Federal and California Endangered Species Acts.

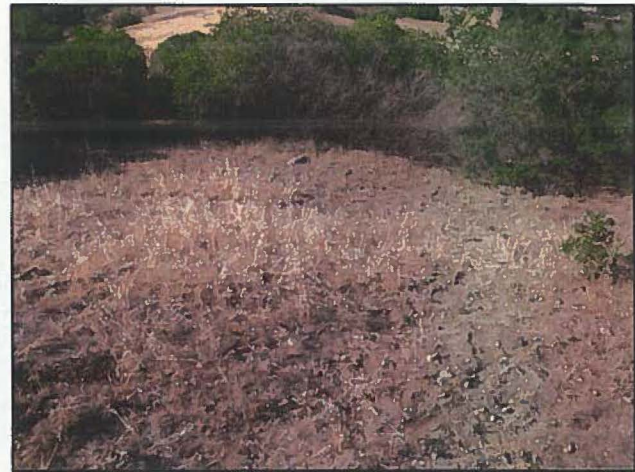
Photo 1D – The patch of non-native grassland where the Lyon's pentachaeta plant was found is shown. Seventy-three (73) Ojai navarretia (*Navarretia ojaiensis*) were also found in this area.

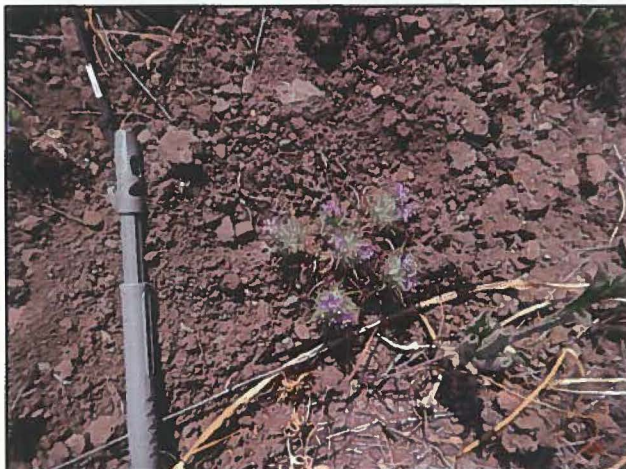
Photo 1E – An Ojai navarretia is shown in bloom at the site in May 2014. This species was previously thought to have all white flowers, but it is now recognized that some populations of Ojai navarretia contain plants with blue and white flowers (i.e., blue corolla lobes and white throats). Originally found in the Ojai, California area, this species has now also been found at several locations in the Santa Monica Mountains.

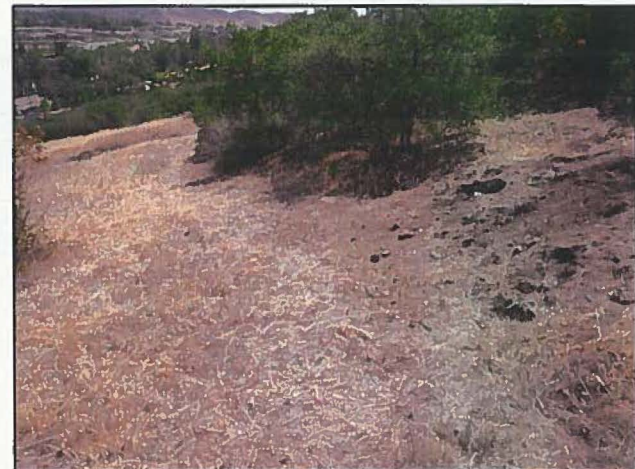
Photo 1F – Ojai navarretia was found at the site within a dirt roadbed and within non-native grassland habitats along the margins of scrub oak chaparral, such as at the location shown in this photo.
