## APPENDIX "B"

## EXPLORATORY LOGS

| DEPTH (ft) | ×<br>SRAPHIC<br>×<br>LOG | VISUAL CLASSIFICATION<br>(Ttuc) Topanga Formation Siltstone, recovered as (CL) | REMARKS | DRIVE | BULK | BLOWS/6 IN. | FIELD<br>MOISTURE (%) | DRY UNIT WT.<br>(pcf) | TESTS |
|---|---|---|---|---|---|---|---|---|---|
| <b>~</b> | СН | OAKMONT OF AGOURA HILLS SENI<br>29353 CANWOOD STREET, AGOURA HIL | | | | A | Job N<br>15473 | | Enclosure<br>B-4b |

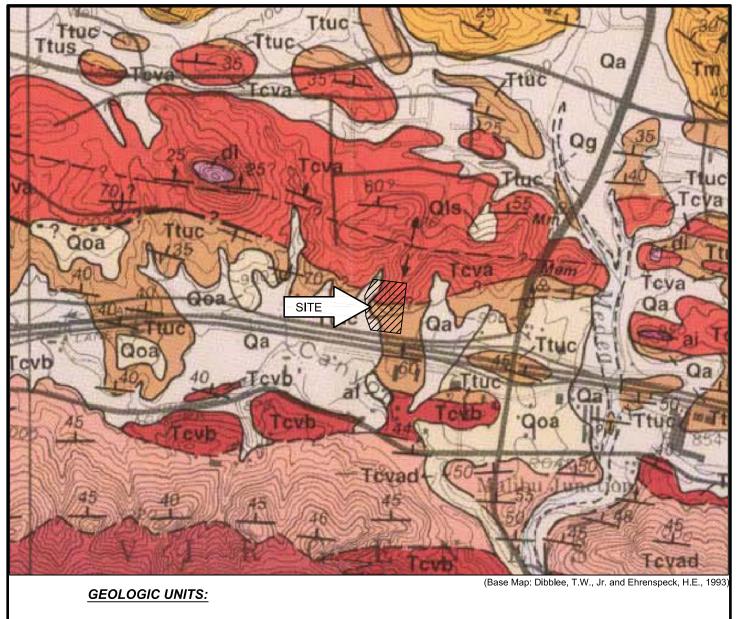
Qa - alluvium

Qoa - older alluvium

Ttus - Topanga Formation - clay shale and siltstone. Includes sandstone interbeds.

Tcva - Conejo Volcanics - andesitic flows and breccias

geologic contact

2. Brief discussions of each geologic unit noted on the map should be provided in the text of the report.

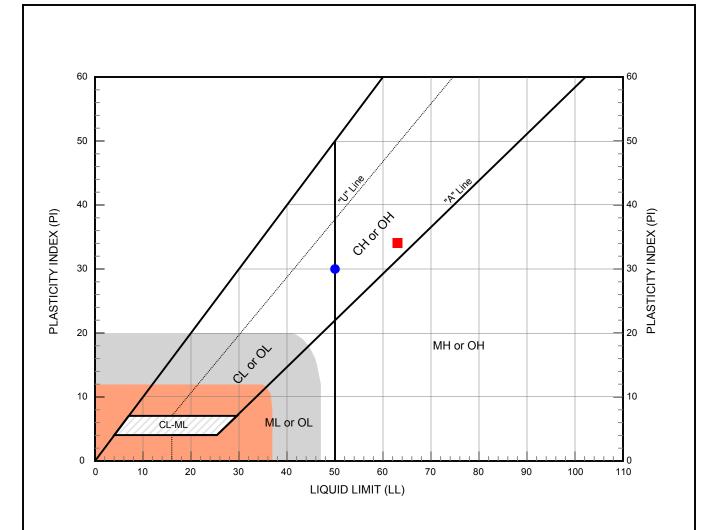
| ſ | | Boring No. Depth (ft) USCS Classification 1 4 (CH) Fat clay 4 0 (CH) Fat clay | PL | LL | PI | | |
| | • | | 20 | 50 | 30 | | |

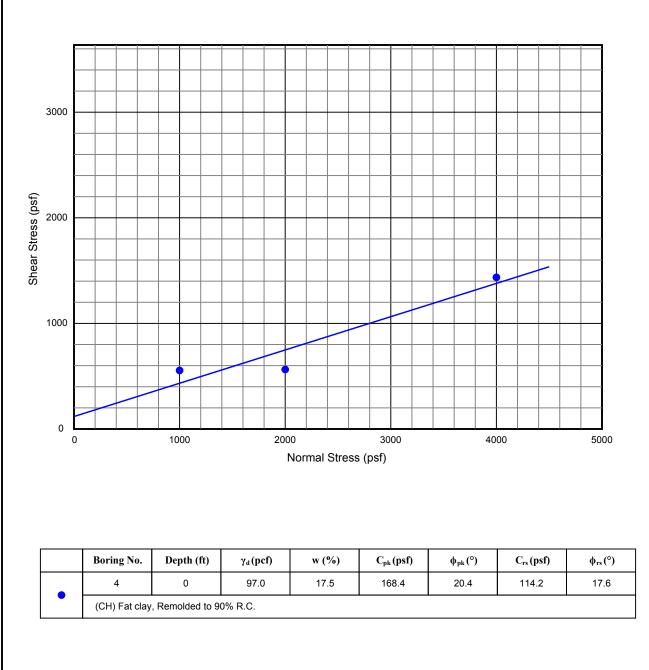
C-3

| | | DIRECT | SHEAR TE | STS (ASTN | I D3080) |
| | Project: | Oakmont of A | Agoura Hills Se | enior Facility | |

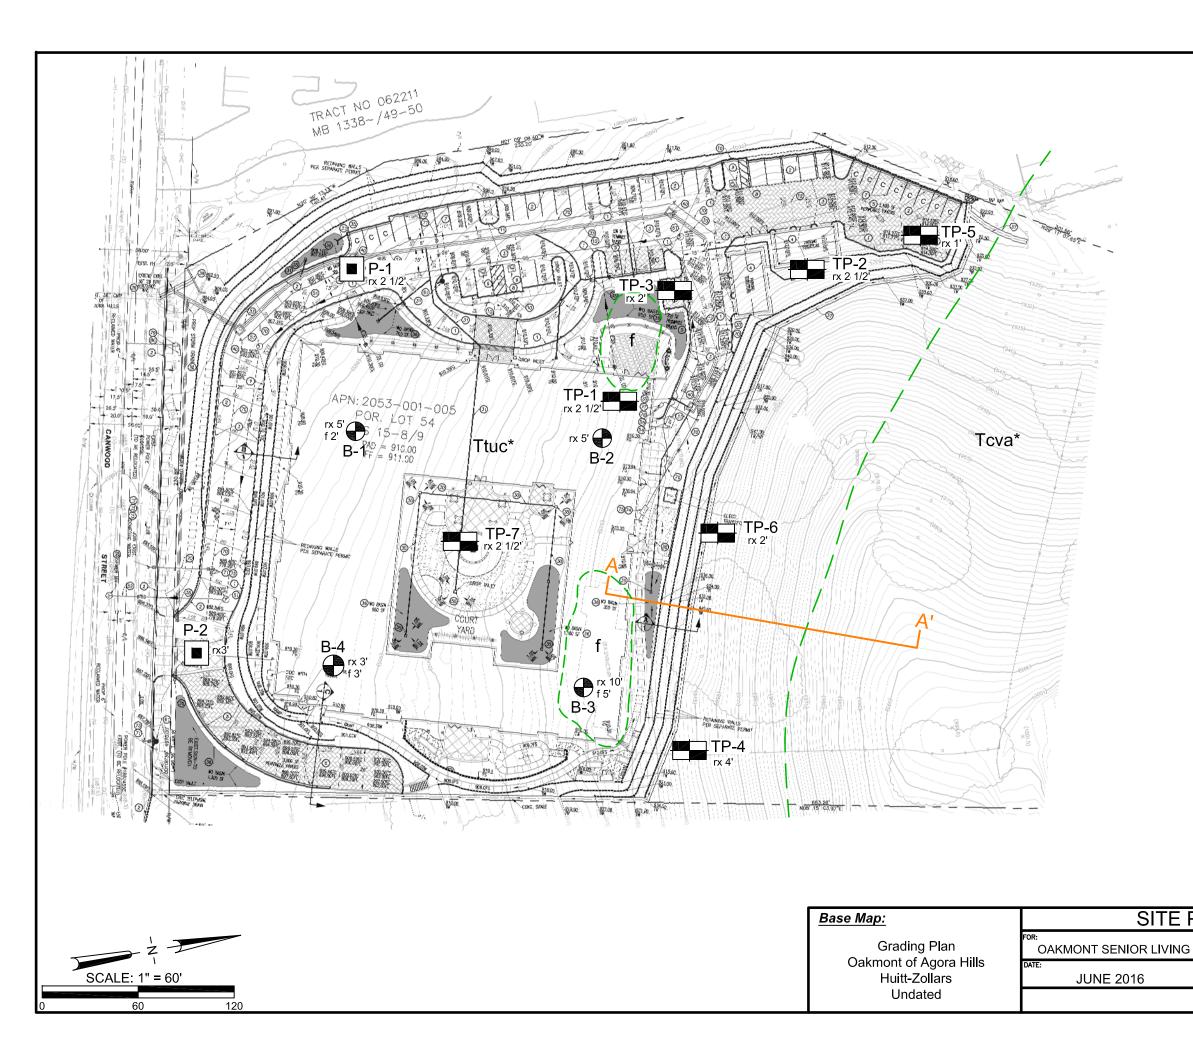
### **GEOLOGIC UNITS:**

f - fill derived from Qcol

Fill (f) occurs in limited areas of the site to depths between 2 and 5 feet below ground surface. The thickest fill occurs near the area of the existing structure foundations in the east-central portion of the site. The fill is derived from local materials (colluvium and bedrock) and is considered unsuitable for support of proposed structures. Recommendations for removal of existing fill are presented in a later section of this report.

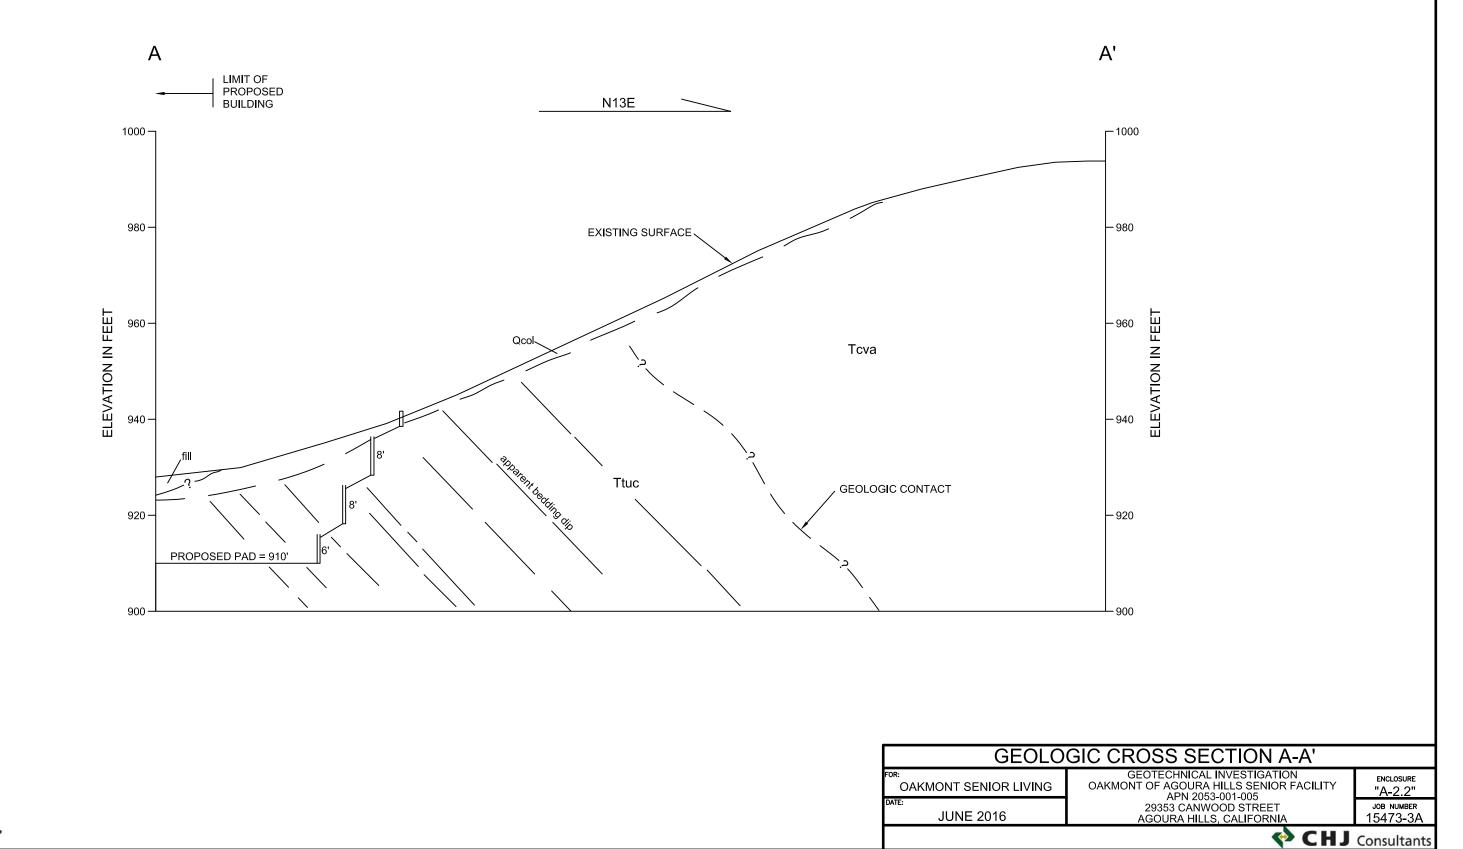
SCALE: 1" = 20'

A cross section illustrating the relationship of existing grades and topography to the proposed building pad, retaining walls and recommended removal depth is attached hereto.

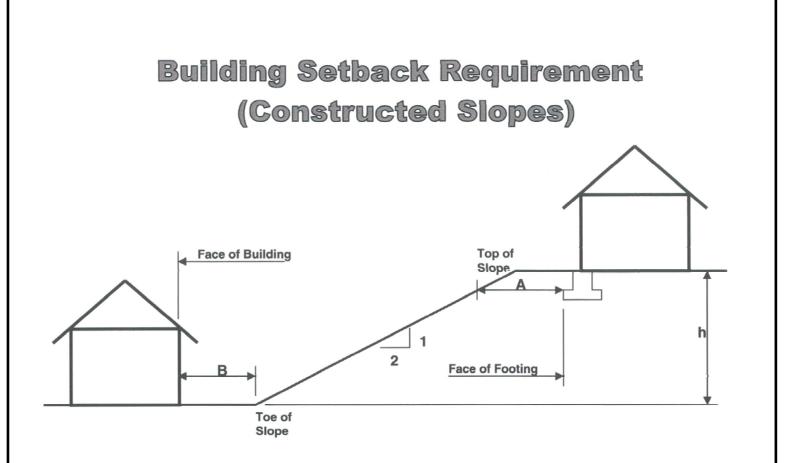
| TOP OF SLOPE | | | | | |
| SLOPE HEIGHT (h) | SETBACK (A) | | | | |
