Appendix F

Geotechnical Site Evaluation

**Geotechnical Site Evaluation
Ladyface Vista Business Center
29555 Canwood Street
Agoura Hills, California**

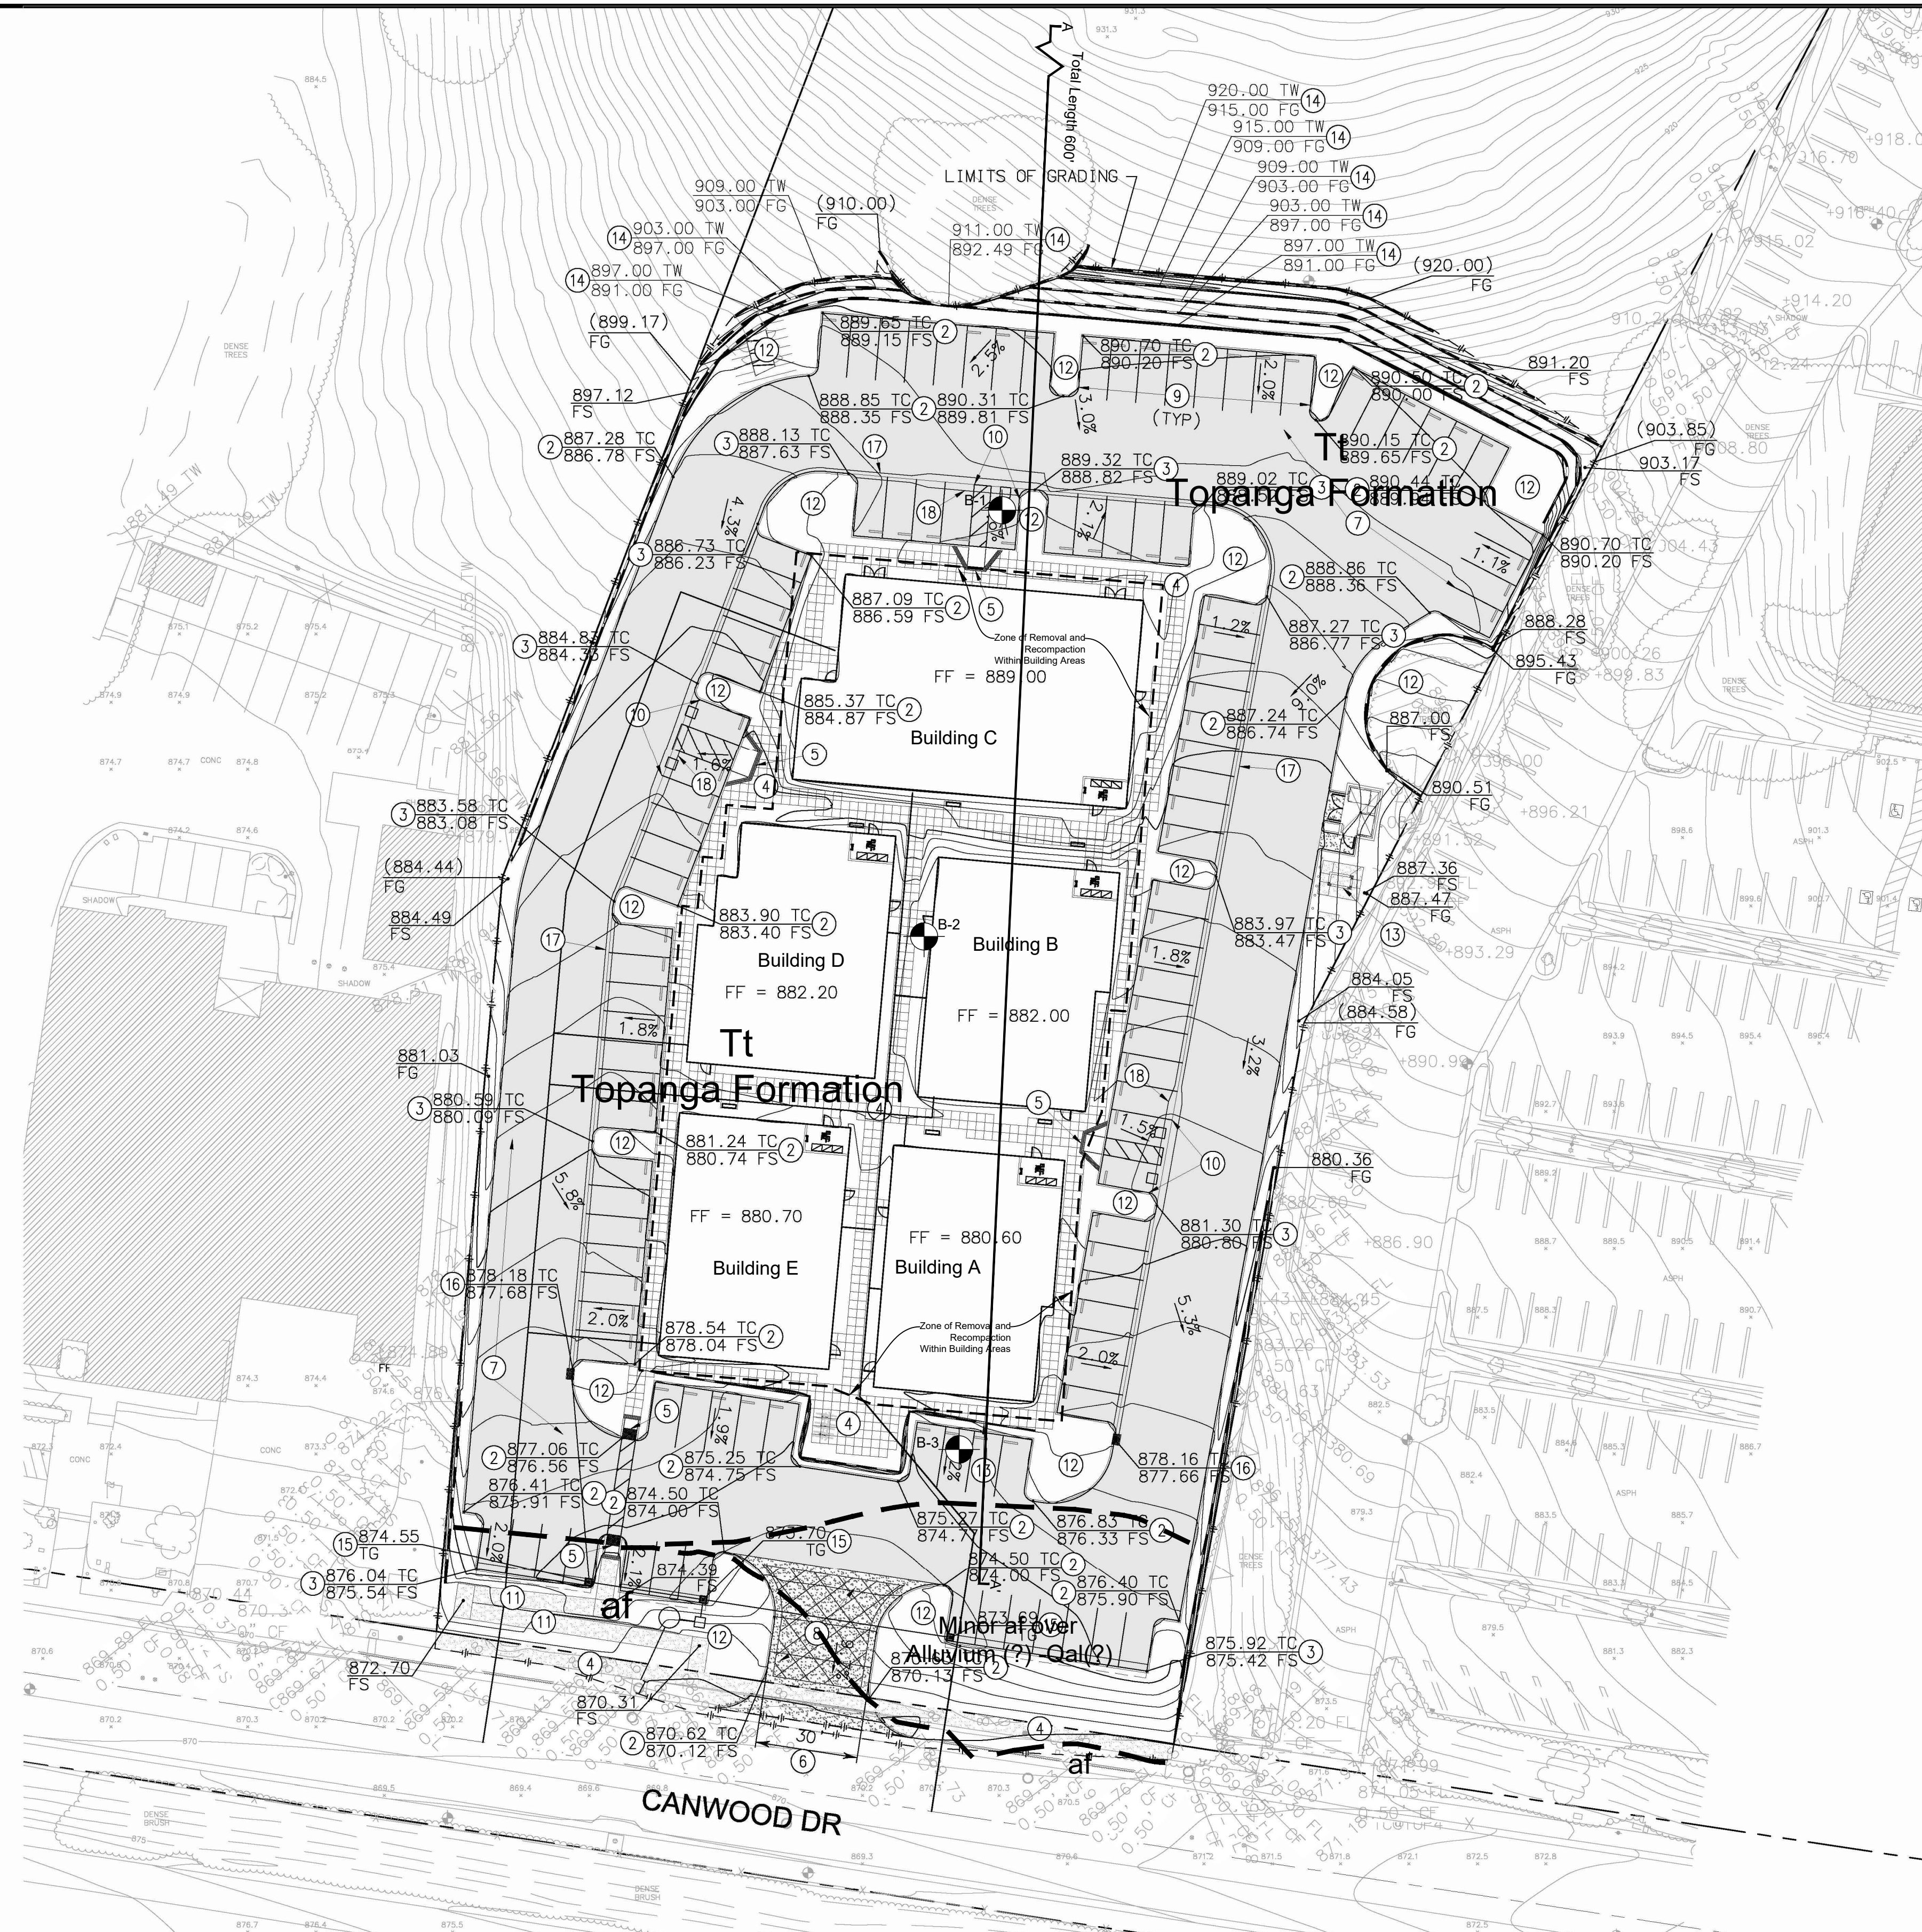
<p>Gorlan & Associates, Inc. Applied Earth Sciences</p>		Date: May 2021
Job No: 3187-0-0-100		Drawn by:
Scale: 1" = 30'		Approved by:
		PLATE 1

- af Artificial Fill
- Qal Alluvium
- Tt Topanga Formation
- - - Approximate Contact Between Geologic Units
- 45° Strike & Dip of Bedding
- B-3 Approximate Location of 24' Diameter Exploratory boring (This Report)
- A-A' Geotechnical Cross Section

GEOTECHNICAL MAP

Plate 1: Geotechnical Map

The following report contains the findings, conclusions, and recommendations of our geotechnical site evaluation addressing design and construction of the Canwood Office Center at 29541 Canwood Street in Agoura Hills, California (Site). Based on a review of the 30 scale Site Plan by Delane Engineering (plot dated April 27, 2021), the development will include five detached buildings surrounded by surface parking and drive areas on the existing gently sloping terrain, as well as retaining walls in several locations. The Site Plan (Sheet 2 of 2) serves as a base for the attached Geotechnical Map (Plate 1).

- a) A description of soil, bedrock and groundwater conditions, as encountered during the subsurface exploration, including Logs of Subsurface Data (Appendix A) and a Geotechnical Map (Plate 1). Geotechnical Cross Section A-A' (Plate 2) was prepared illustrating subsurface conditions and for use in slope stability / soil nail wall analyses.
- b) A description of the laboratory testing program, including test results (Appendix B).
- c) Discussion and geotechnical recommendations regarding:
 - i. Geologic hazards including seismic setting of the site and faulting;
 - ii. Seismic design criteria;
 - iii. Soil expansion potential;
 - iv. Slope stability;
 - v. Site preparation and remedial grading;
 - vi. Conventional foundation design and construction;
 - vii. Retaining wall design parameters including backfill recommendations;
 - viii. Soil nail retaining walls;
