May 19, 2023

Project No. 2023-005

Subject: Geotechnical Services Memorandum
Restroom Building Replacement at Chumash Park
City of Agoura Hills, California

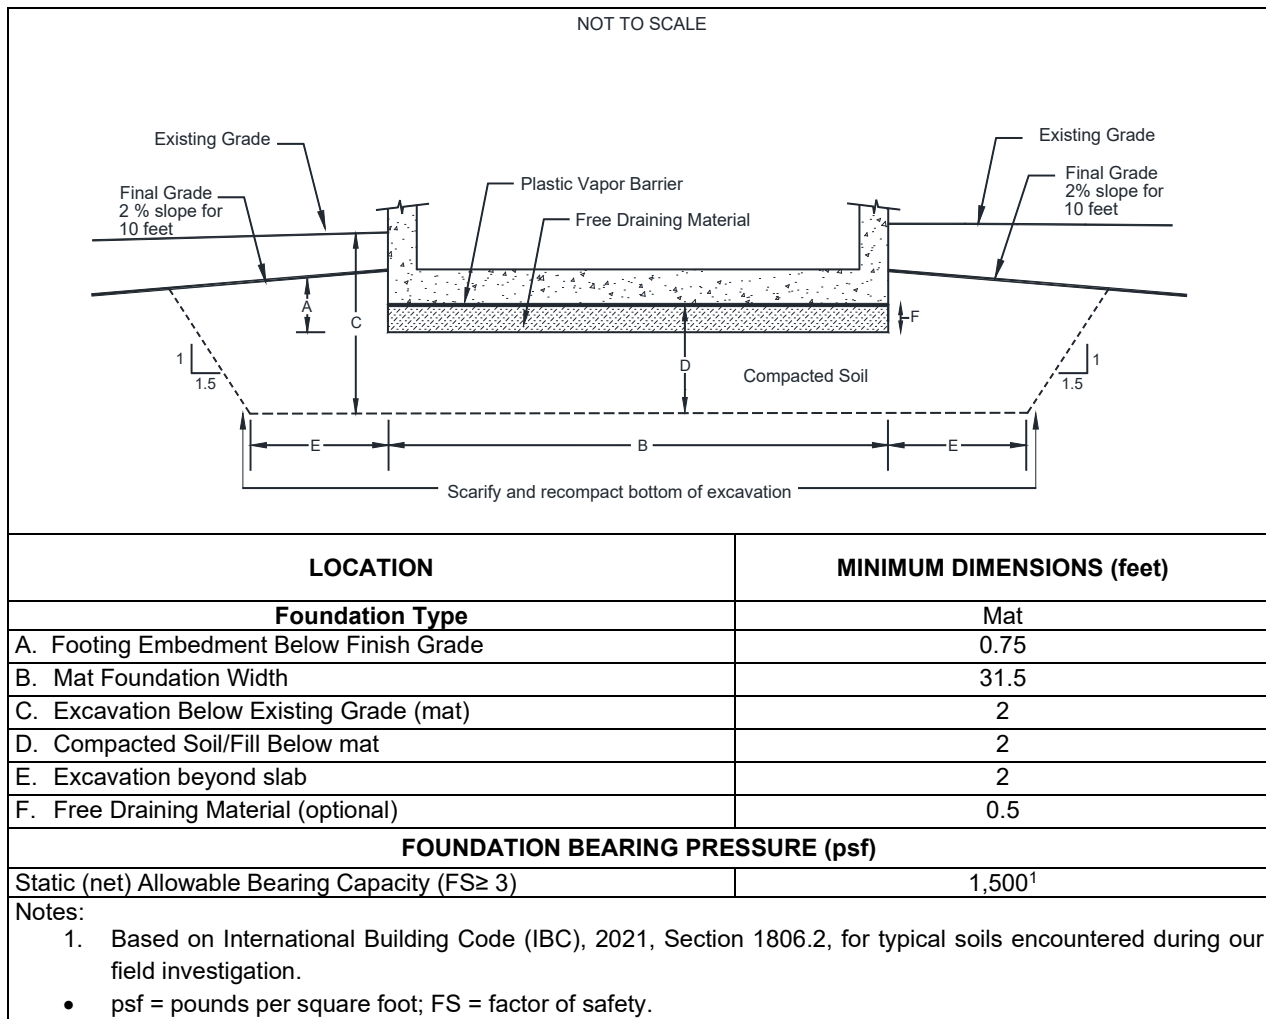
Figure 3 - GRADING/FOUNDATION DETAILS (MAT FOUNDATION)

We understand that the contractor will demolish the restroom facility structure and remove the existing soil underneath and replace with new structural backfill for the construction of the new building pad. In the event loose soil is encountered beneath the proposed foundations, the soils should be excavated and replaced with compacted structure backfill. The upper soil should be excavated and replaced with compacted fill as shown on Figure 3 for mat foundations.

The proposed restroom structure can be supported on a mat foundation placed on a layer of compacted structure backfill as shown on Figure 3. Static allowable bearing capacity for the mat foundation is presented on Figure 3 and include a factor of safety of at least 3, against shear failure. For properly constructed mat foundation supported on compacted fill, total static settlement and differential settlement due to proposed maximum structural load of 1,500 psf is estimated to be less than 1 inch and ½ inch respectively. Most of the static settlements are expected to occur as the loads are applied or shortly thereafter.

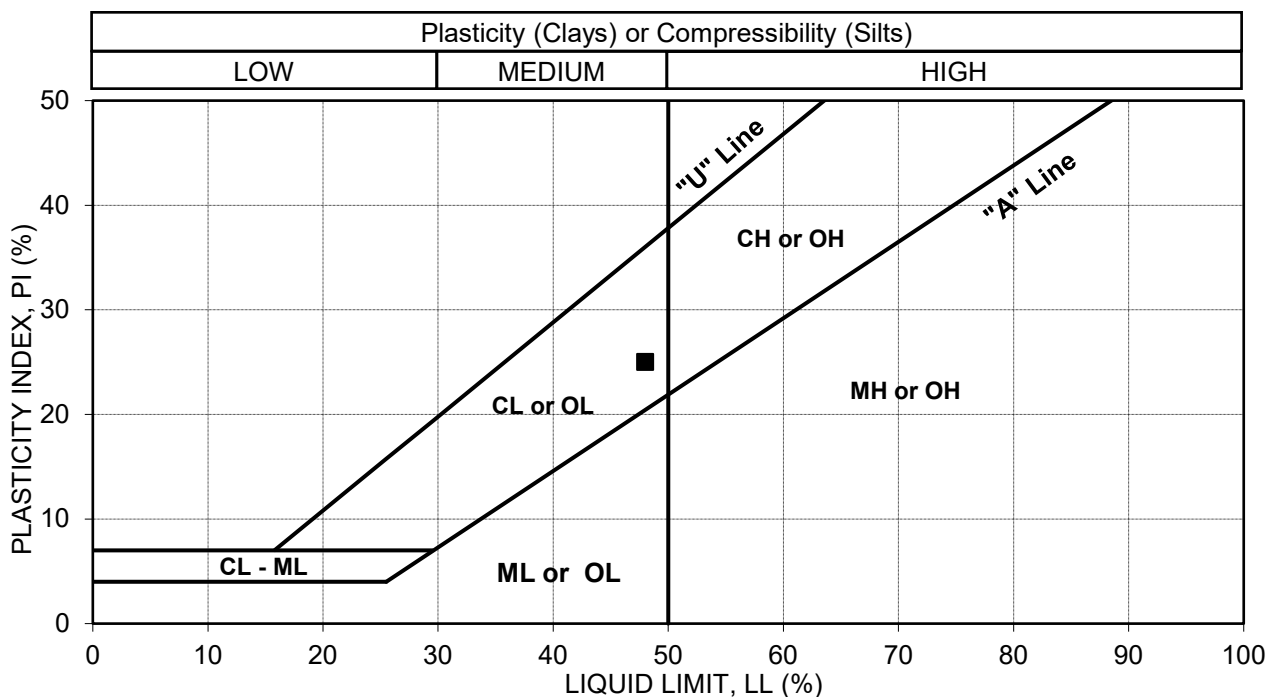
Liquid Limit, Plastic Limit, and Plasticity Index of Soils

Test		LL	LL	LL	PL	PL
No. of blows	-	31	25	19	-	-
Wt. of Wet Soil + Container	(g)	26.2	26.6	26.7	9.4	9.6
Wt. of Dry soil + Container	(g)	21.4	21.5	21.5	7.9	8.0
Wt. of Container	(g)	10.9	11.0	11.2	1.1	1.1
Water content	(%)	46.7	48.6	50.2	23.5	23.4

Liquid Limit (LL)	48
Plastic Limit (PL)	23
Plasticity Index (PI)	25
USCS	CL
Remarks: - Fine Sample is Less than 50% of Passing #200
